Re: Property Survey: Port Granby Waste Management Facility

Type: Gamma Radiation Survey

Date of Survey: 2012 April 12, 13 and 17

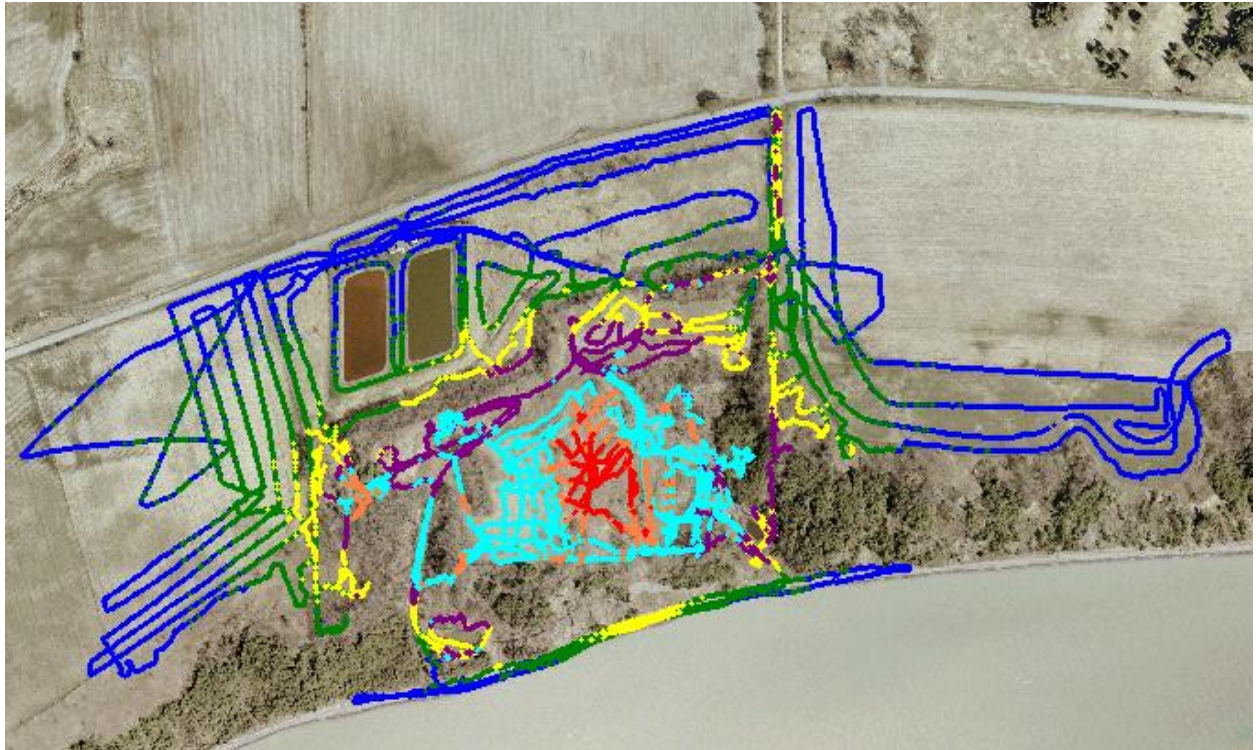
Figure 1: Gamma Radiation Survey

A total of 28,284 CARS data points were collected. Gamma readings recorded in the CARS survey ranged from 3.6 to >811 $\mu\text{R/h}$.

The highest readings were noted in the central plateau area of the site. Slightly elevated gamma radiation fields to the east and west of the site, outside of the fence lines are likely influence from adjacent on-site sources. An exception to this is the driveway leading from the east gate to Lakeshore Road, where the pattern of gamma radiation levels is suggestive of material deposited along the driveway. Slightly elevated readings along the shoreline may be influence from adjacent on-site material, or migration of material down the south slope. Further investigation would be required to determine the cause of these slightly elevated readings.

Near Contact Level

Port Granby Site and Adjacent Areas

April 12, 13 and 17, 2012
