**CORRECTIONAL SERVICE
CANADA**

**BOWDEN INSTITUTION
INNISFAIL, ALBERTA**

ELECTRICAL SUBSTATION SECONDARY TANK COMPLIANCE

FENCE DISPLACEMENT DETAILS

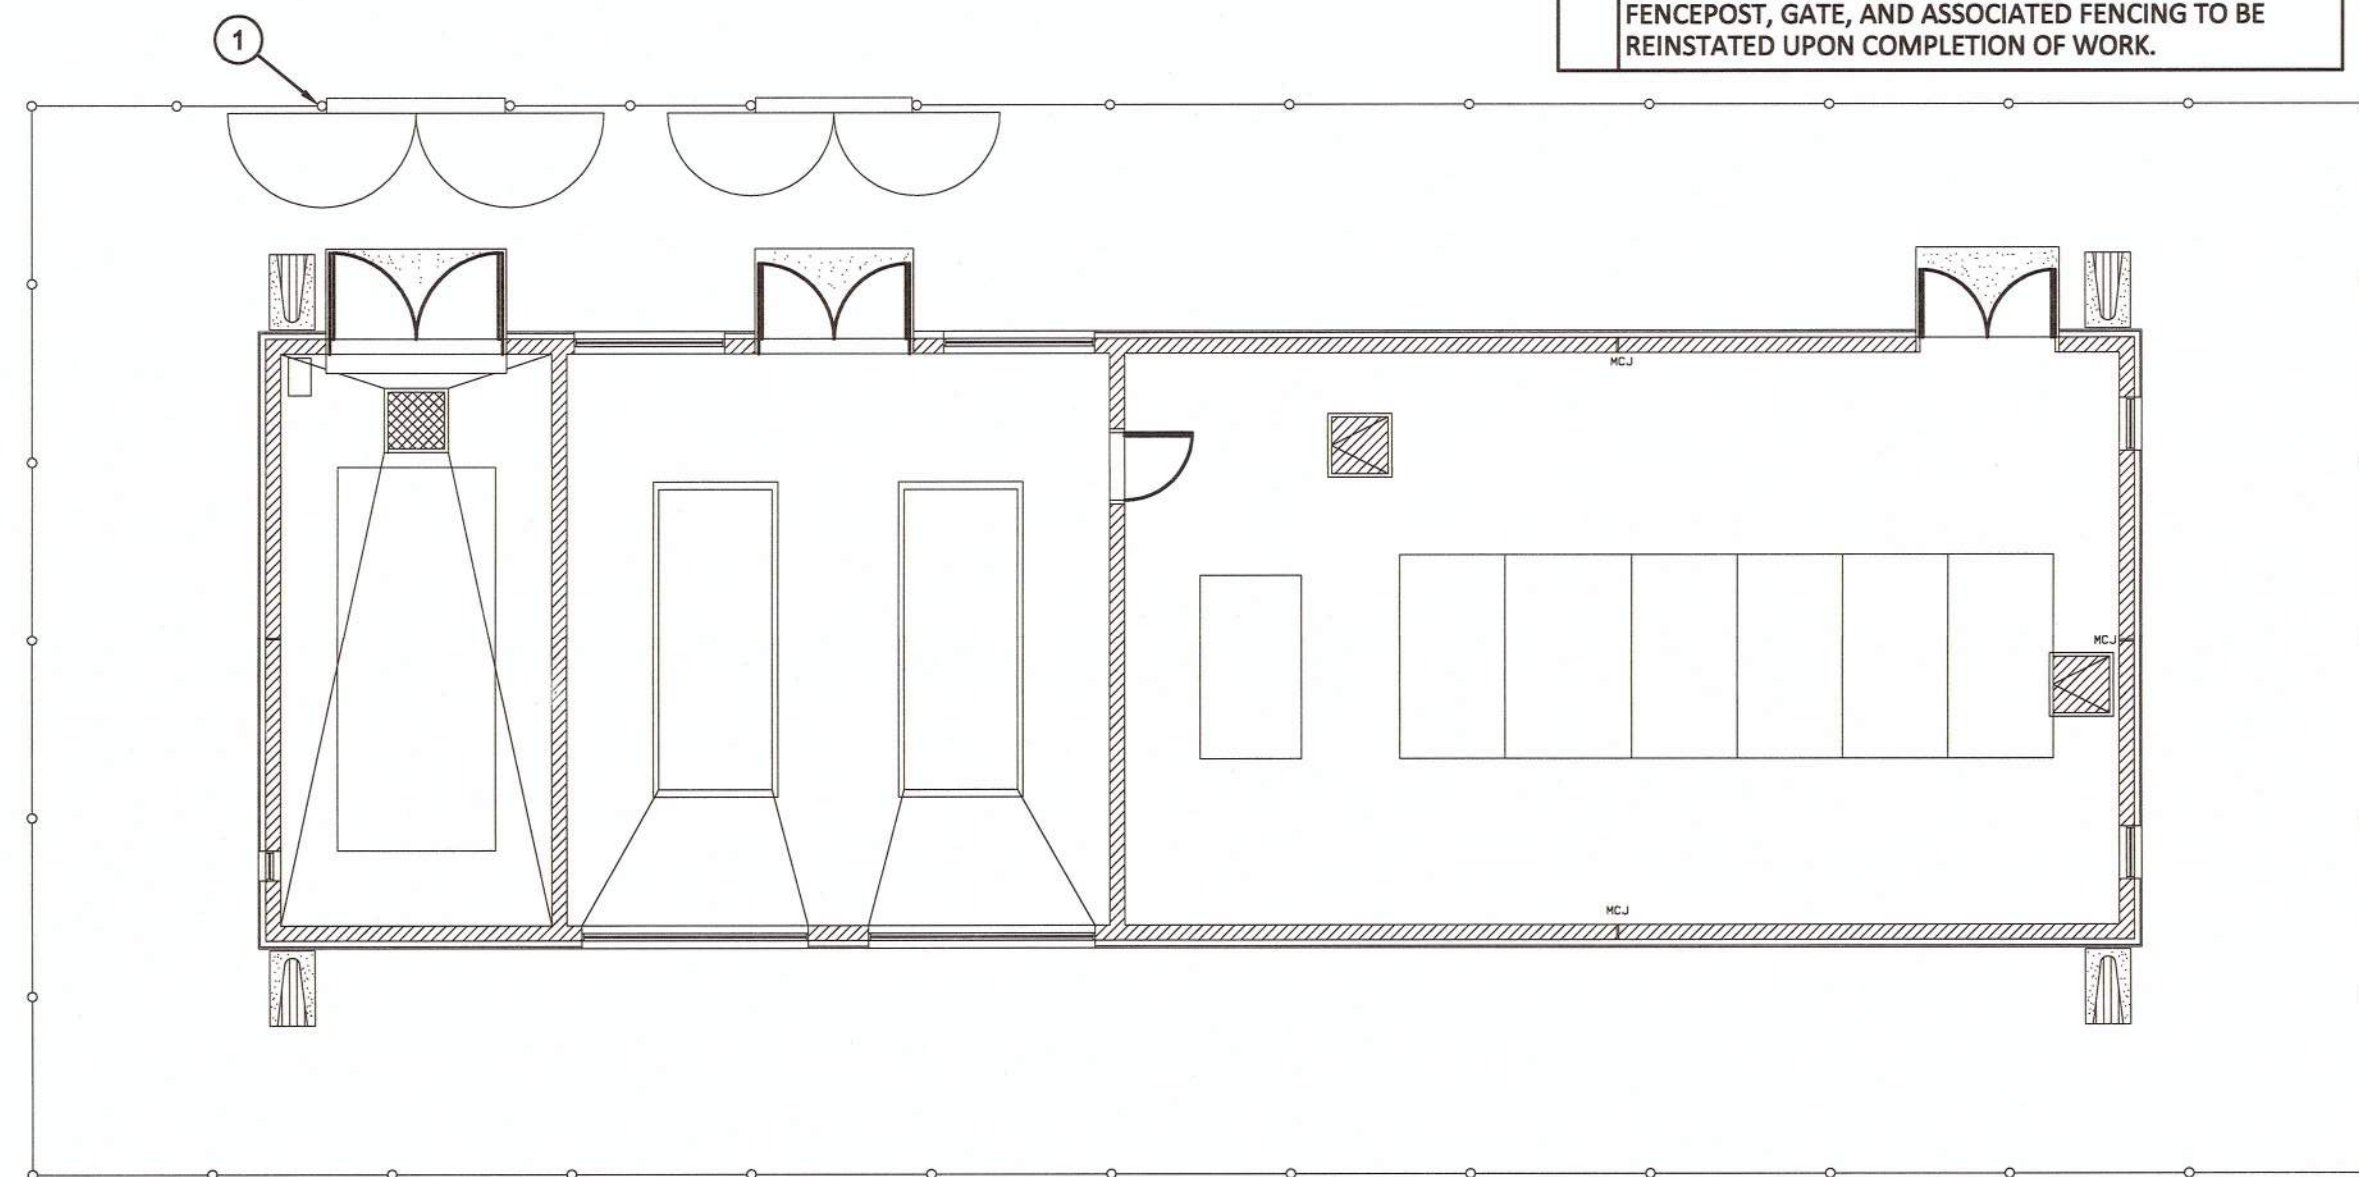
3 FENCEPOST DISPLACEMENT LOCATION
S3 SCALE: NONE

1 EXISTING FENCEPOST, GATE, AND FENCING TO BE TEMPORARILY REMOVED TO ALLOW FOR SUFFICIENT CLEARANCE TO TRANSPORT ST-1 INTO ROOM 101. FENCEPOST, GATE, AND ASSOCIATED FENCING TO BE REINSTITATED UPON COMPLETION OF WORK.

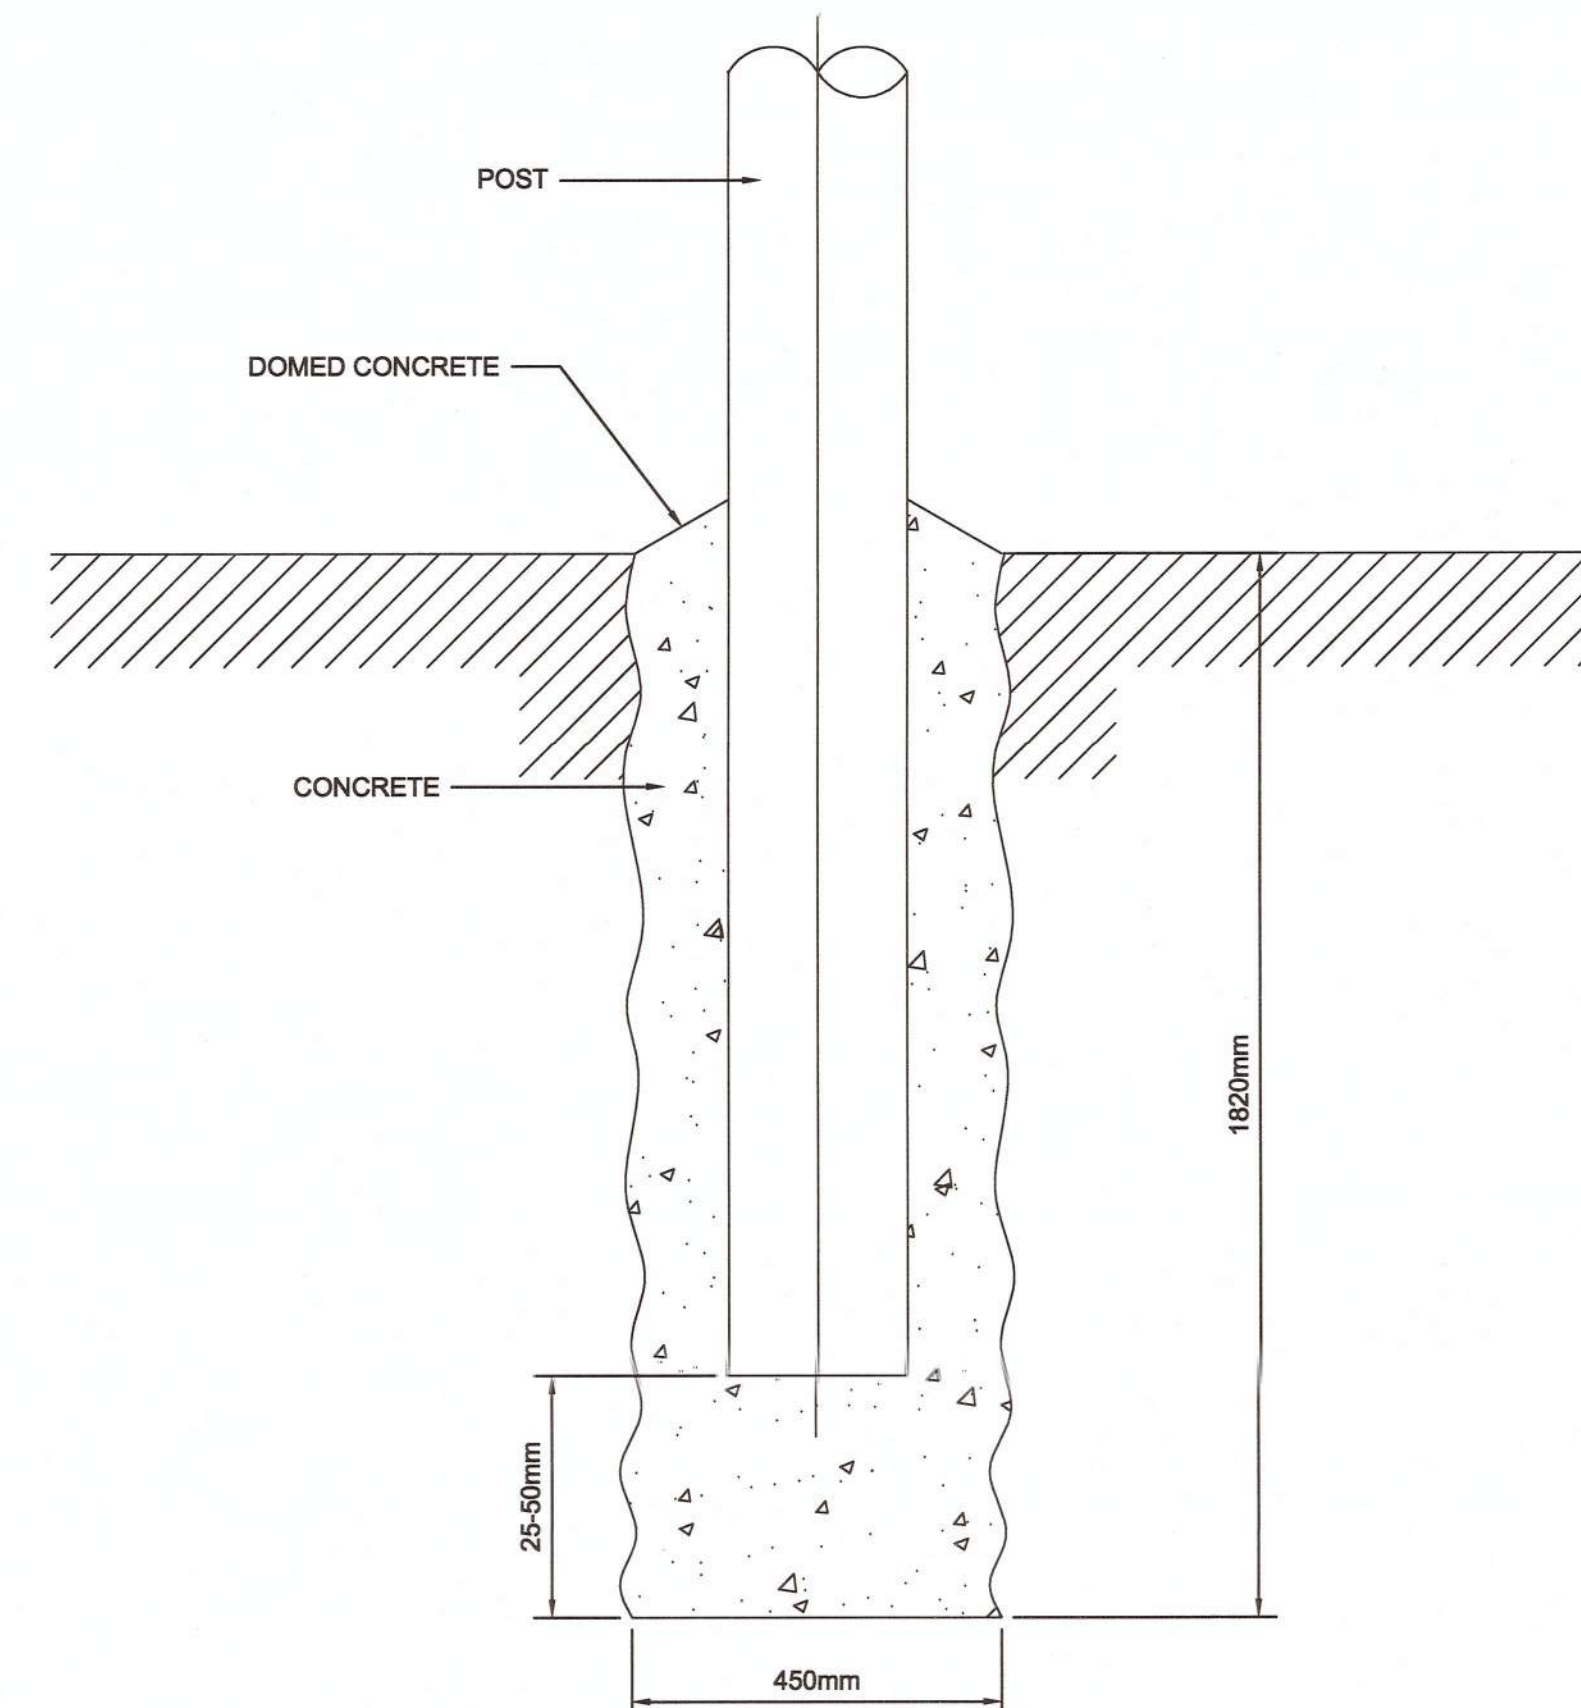
1 EXISTING FENCEPOST REINSTATEMENT

1.	REMOVE EXISTING GATE FROM FENCEPOST TO BE REMOVED.
2.	EXCAVATE EXISTING FENCEPOST FROM CONCRETE BASE.
3.	ROLL BACK EXISTING FENCE SEGMENT AS REQUIRED TO FACILITATE TRANSFER OF NEW TANK ST-1 INTO ROOM 101. TRANSFER OF TANK TO BE DONE BY DIVISION 23.
4.	INSTALL NEW TANK ST-1 IN ROOM 101. INSTALLATION WORK TO BE DONE BY DIVISION 23.
5.	REINSTALL FENCEPOST AND POUR NEW CONCRETE BASE AS SHOWN ON DETAIL 1.
6.	REATTACH FENCE AND GATE TO REINSTALLED FENCEPOST.

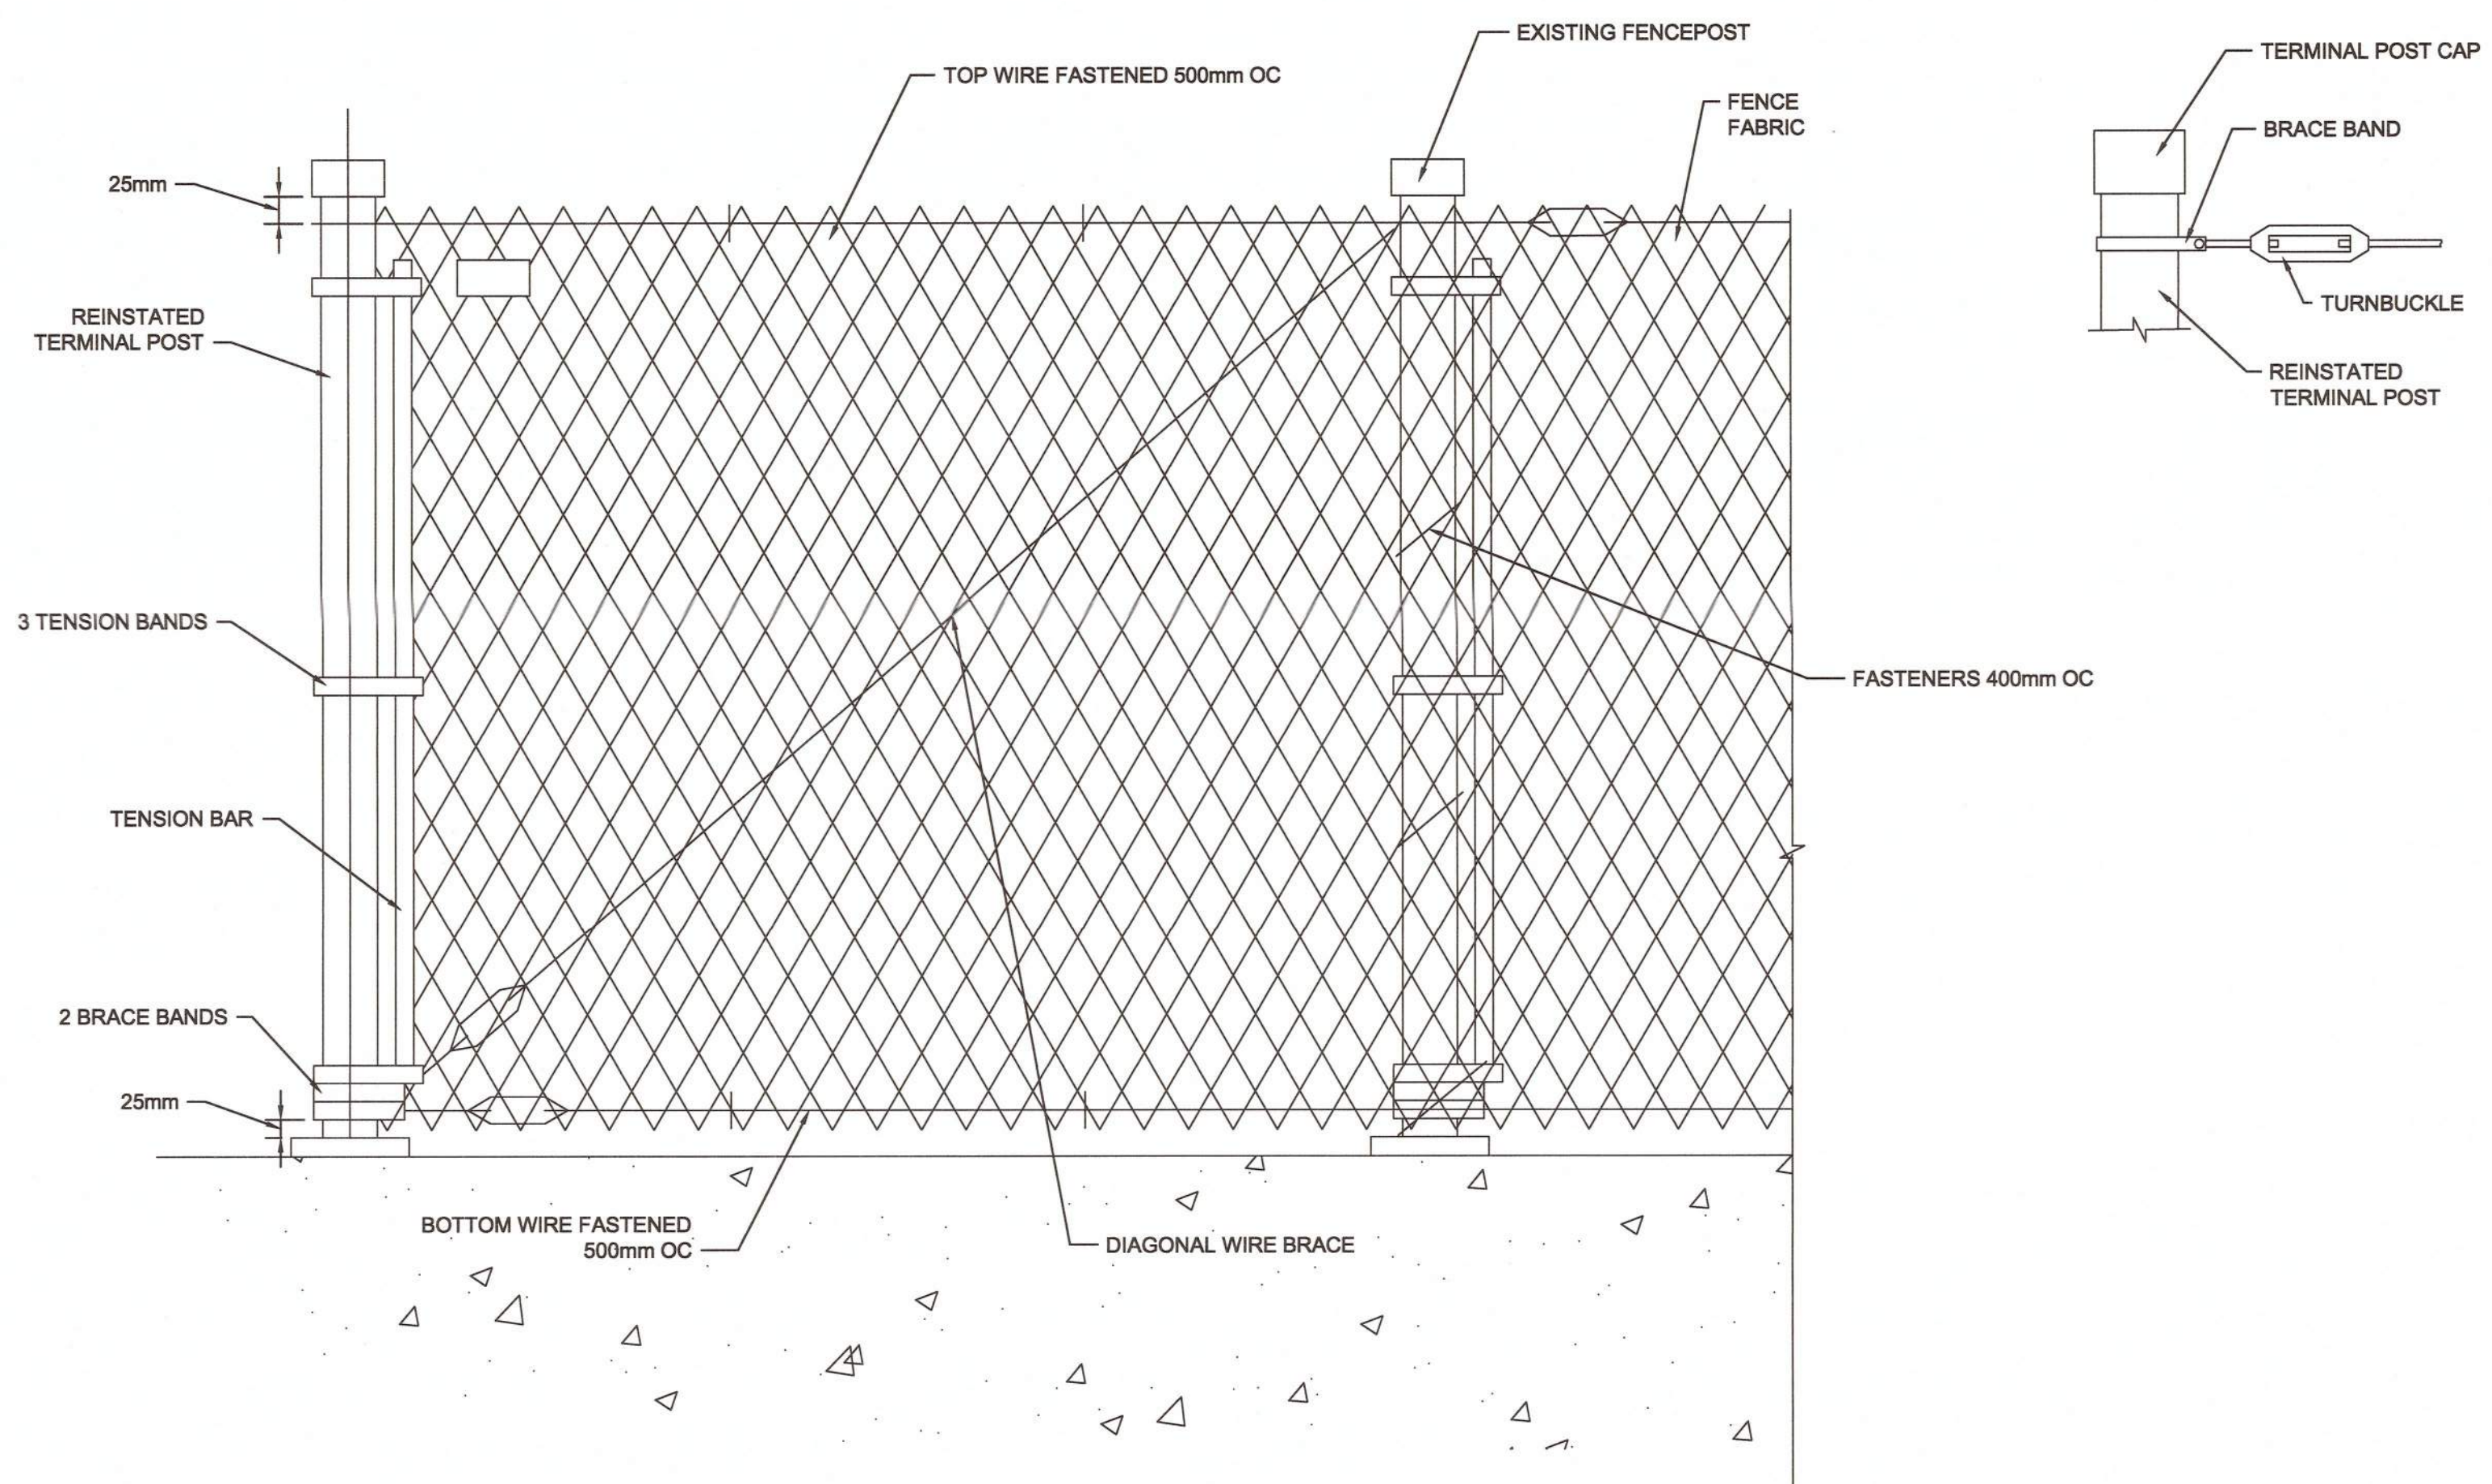
2 EXISTING FENCE REINSTATEMENT

1.	ALL POSTS AND FRAME MEMBERS ARE SCHEDULE 40, REGULAR GRADE, STEEL PIPE.
2.	THE ACTUAL WEIGHT SHALL NOT VARY BY MORE THAN 10% OF THE NOMINAL WEIGHT.
