ÉTUDE DE SOLS

Étude du sol (VERSION FINALE)

***Aire de stationnement du Centre des pensions de la fonction publique de TPSGC
Rue Belliveau, Shediac (Nouveau-Brunswick)
RBIF n° 22404***

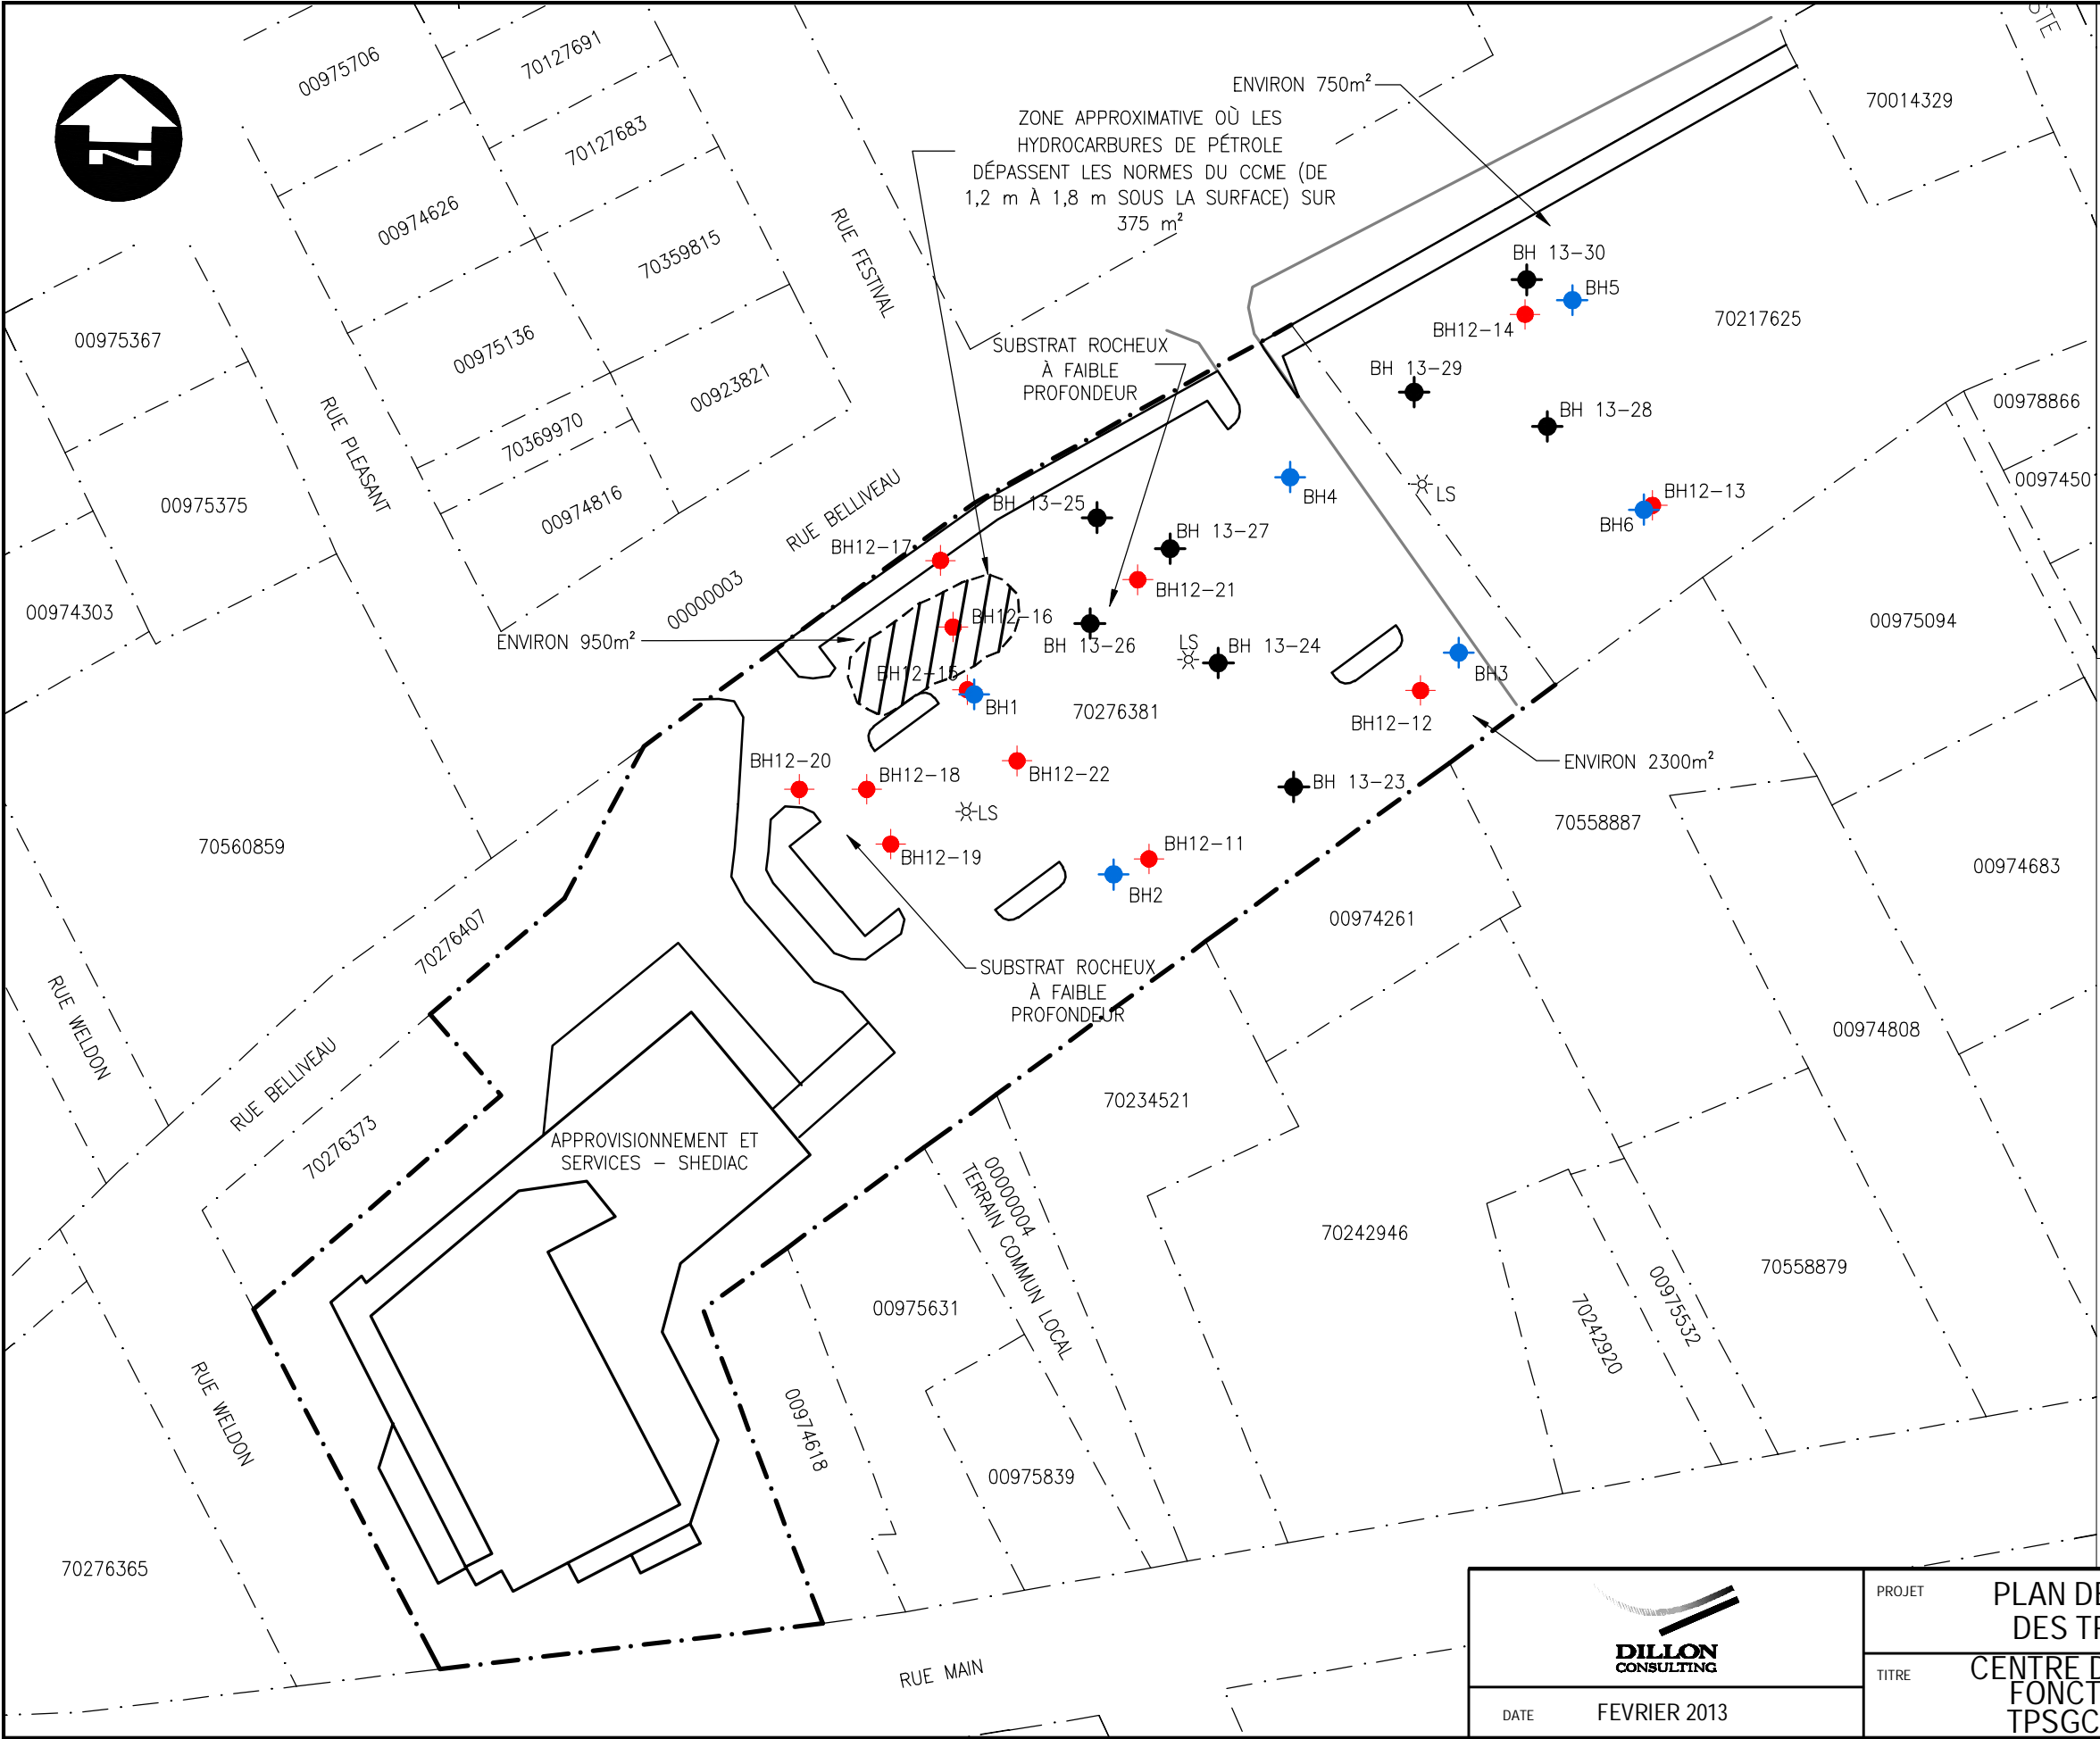
DILLON CONSULTING	PROJET	PLAN DE L'EMPLACEMENT DES TROUS DE FORAGE CENTRE DES PENSIONS DE LA FONCTION PUBLIQUE DE TPSGC À SHEDIAC (N.-B.)	NO. DE PROJET
	TITRE		12-7092
DATE	FEVRIER 2013		FIGURE NO. 1

- PROPRIÉTÉ VISÉE
- LIMITE DE LA PROPRIÉTÉ
- STRUCTURE ACTUELLE EN SURFACE
- ANCIENNE STRUCTURE EN SURFACE
- STRUCTURE SOUTERRAINE ACTUELLE
- ANCIENNE STRUCTURE SOUTERRAINE
- EMPLACEMENT DE TROU DE FORAGE (DILLON, 2013)
- EMPLACEMENT DE TROU DE FORAGE (DILLON, 2012)
- EMPLACEMENT DE TROU DE FORAGE (GEMTEC, 2010)
- LS LAMPADAIRE
- 70276381 NID (NUMÉRO D'IDENTIFICATION)
- ZONE APPROXIMATIVE OÙ LES HYDROCARBONS DE PÉTROLE DÉPASSENT LES NORMES DU CCME

REMARQUE: FIGURE BASÉE SUR LES RÉFÉRENCES DES INGENIEURS-CONSEILS DE GEMTEC, FIGURE 1, DATÉE DE DÉCEMBRE 2010.

La propriété en question est sise rue Belliveau, à Shediac, au Nouveau-Brunswick, et est désignée par les NID 70276381 et 70217625. Selon la base de données du Répertoire des biens immobiliers fédéraux (RBIF) et Service Nouveau-Brunswick, elle porte le numéro 22404 dans le RBIF et appartient à TPSGC. Le bâtiment du Centre des pensions se trouve sur le terrain portant le NID 70276381 et l'aire de stationnement, sur la partie Est du terrain NID 70276381 et sur le terrain NID 70217625, comme illustré aux figures 1 et 2.

Les autres échantillons de sol présentaient des concentrations d'hydrocarbures pétroliers inférieures aux RCQSo du CCME, au standard pancanadien et aux critères d'évaluation en fonction des risques du premier palier du partenariat des provinces de l'Atlantique de l'initiative RBCA pour un terrain commercial avec usage de la nappe phréatique à des fins autres que l'eau potable. Le tableau 3 présente les concentrations d'hydrocarbures pétroliers dans le sol et les figures 1 et 2 en donnent une représentation graphique.
