HOWARD'S COVE WHARF REPAIR

PRINCE COUNTY, PEI

BOREHOLE LAYOUT PLAN AND RECORDS

M5 of 7

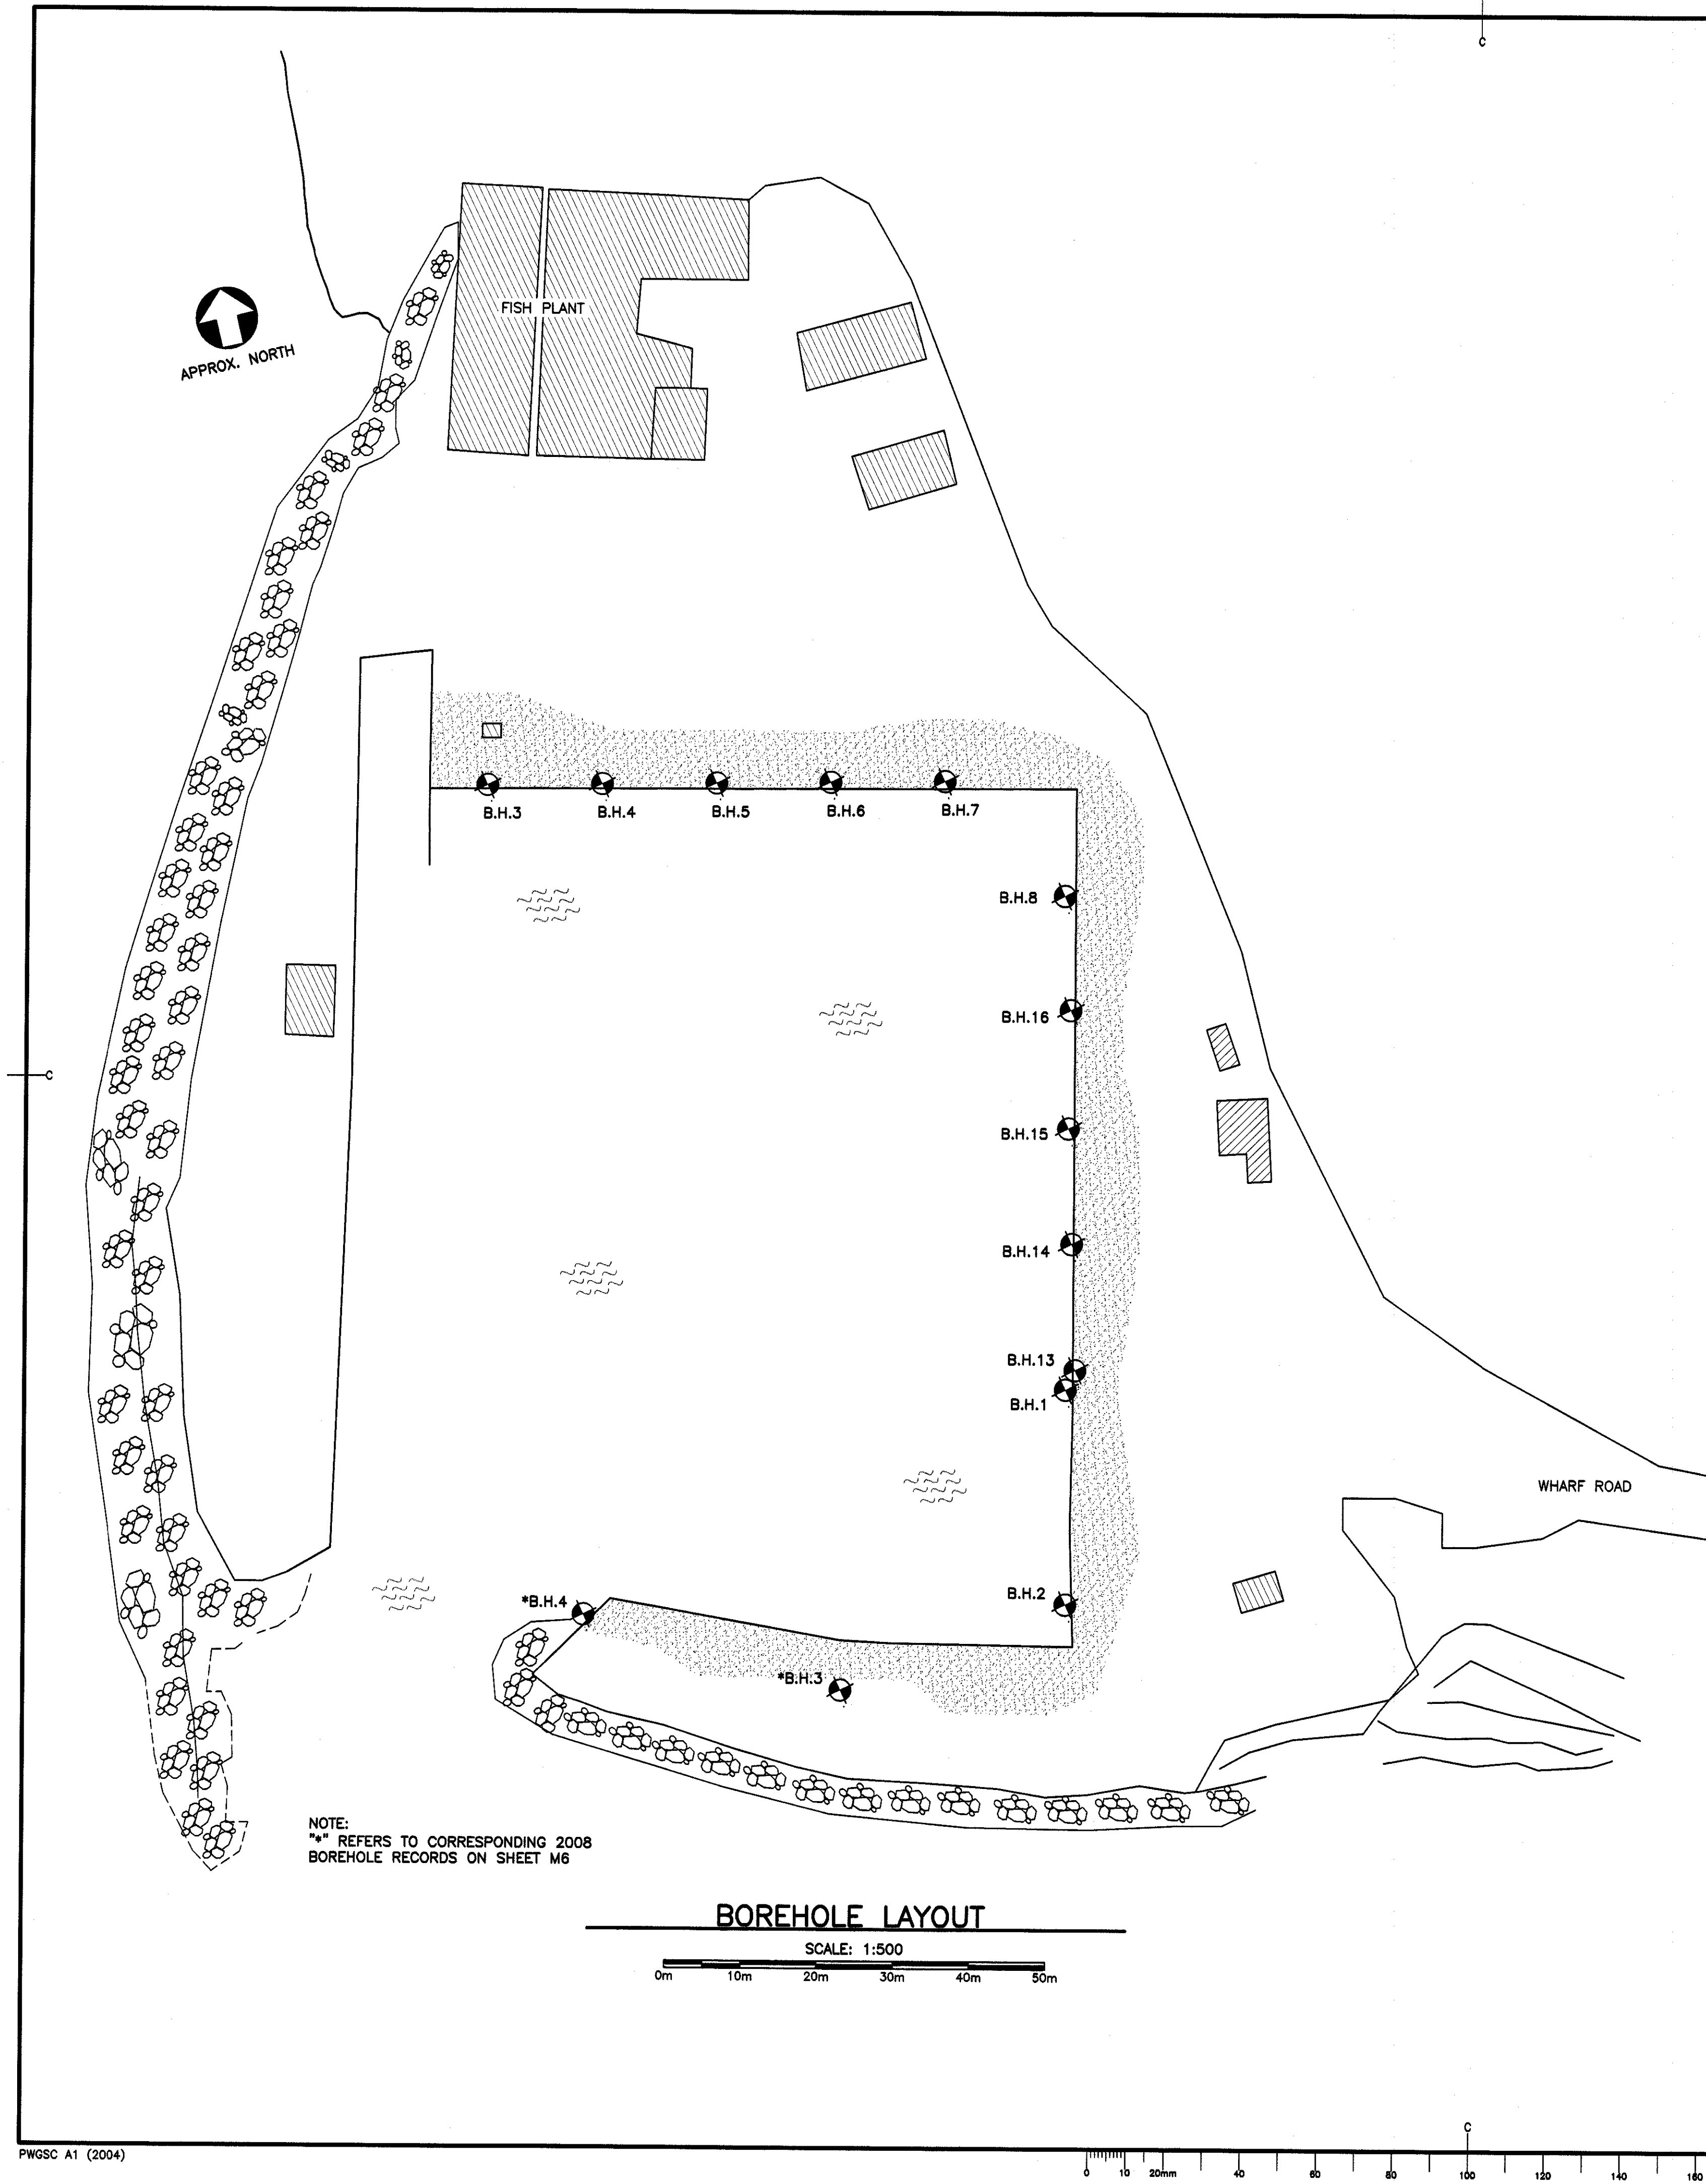
BOREHOLE RECORD									
CLIENT: PUBLIC WORKS AND GOVERNMENT SERVICES CANADA					PROJECT No. 2757-1040371				
LOCATION: HOWARDS COVE, PRINCE COUNTY, PEI					BH SIZE: NW				
DATES: BORING: 2008/06/27					WATER LEVEL: N/A				
					DATUM: ASSUMED				
DEPTH (m)	ELEVATION (m)	SOIL DESCRIPTION	STRATA PLOT	WATER LEVEL	SAMPLES				OTHER TESTS
					TYPE	NUMBER	RECOVERY	ANALYSIS OR-ROD %	
0	96.51	Sea floor

0.62	96.21	Very loose black to reddish brown silty sand: MARINE DEPOSIT			SS	1	500	90/273	mm
0.91	95.91	Some organics							
1		Compact reddish brown silty sand: TILL			NQ	2	97%	RQD 45	
2		Very weak to weak, reddish brown mudstone and siltstone, occasional sandstone seams: BEDROCK			NQ	3	80%	42	
3	93.50	Very weak to weak, reddish brown mudstone and siltstone, occasional sandstone seams: BEDROCK			NQ	4	100%	60	
4		Very weak to weak, fine to medium grained, reddish brown to whitish red sandstone, occasional very stiff to hard mudstone seams and layers: BEDROCK			NQ	5	95%	55	
5		Very weak to weak, fine to medium grained, reddish brown to whitish red sandstone, occasional very stiff to hard mudstone seams and layers: BEDROCK			NQ	6	98%	78	
8	88.24	End of Borehole							
12

BOREHOLE RECORD									
CLIENT: PUBLIC WORKS AND GOVERNMENT SERVICES CANADA					PROJECT No. 2757-1040371				
LOCATION: HOWARDS COVE, PRINCE COUNTY, PEI					BH SIZE: NW				
DATES: BORING: 2008/06/27					WATER LEVEL: N/A				
					DATUM: ASSUMED				
DEPTH (m)	ELEVATION (m)	SOIL DESCRIPTION	STRATA PLOT	WATER LEVEL	SAMPLES				OTHER TESTS
					TYPE	NUMBER	RECOVERY	ANALYSIS OR-ROD %	
0	96.64	Sea floor

0.62	96.19	Very loose reddish brown silty sand: MARINE DEPOSIT			SS	1	450	2	
0.91	95.88	Some organics							
1		Compact reddish brown silty sand: TILL			NQ	2	100%	RQD 47	
2		Very weak to weak, fine to medium grained, reddish brown to whitish red sandstone, occasional very stiff to hard mudstone seams: BEDROCK			NQ	3	95%	43	
3		Very weak to weak, fine to medium grained, reddish brown to whitish red sandstone, occasional very stiff to hard mudstone seams: BEDROCK			NQ	4	100%	78	
4		Very weak to weak, fine to medium grained, reddish brown to whitish red sandstone, occasional very stiff to hard mudstone seams: BEDROCK			NQ	5	97%	68	
6	90.57	End of Borehole							
12
