Title - Sujet Cape Beale Light Tower Refurbishmen	
Solicitation No. - N° de l'invitation F1700-150861/A	Amendment No. - N° modif. 001
Client Reference No. - N° de référence du client	Date 2015-11-03
GETS Reference No. - N° de référence de SEAG PW-\$PWY-031-7646	
File No. - N° de dossier PWY-5-38235 (031)	CCC No./N° CCC - FMS No./N° VME
Solicitation Closes - L'invitation prend fin at - à 02:00 PM on - le 2015-11-12	Time Zone Fuseau horaire Pacific Standard Time PST
F.O.B. - F.A.B. Plant-Usine: <input type="checkbox"/> Destination: <input checked="" type="checkbox"/> Other-Autre: <input type="checkbox"/>	
Address Enquiries to: - Adresser toutes questions à: Leung, Janie	Buyer Id - Id de l'acheteur pwy031
Telephone No. - N° de téléphone (604) 666-8228 ()	FAX No. - N° de FAX (604) 775-6633
Destination - of Goods, Services, and Construction: Destination - des biens, services et construction: DFO - Cape Beale Light Station - Bamfield, BC

This Amendment 001 is raised to provide the list of Bidder's Conference attendees, address questions, provide the Bidder's Conference presentation deck, and provide the Bidder's Conference meeting minutes and site photos.

TOWER REFURBISHMENT: CAPE BEAL

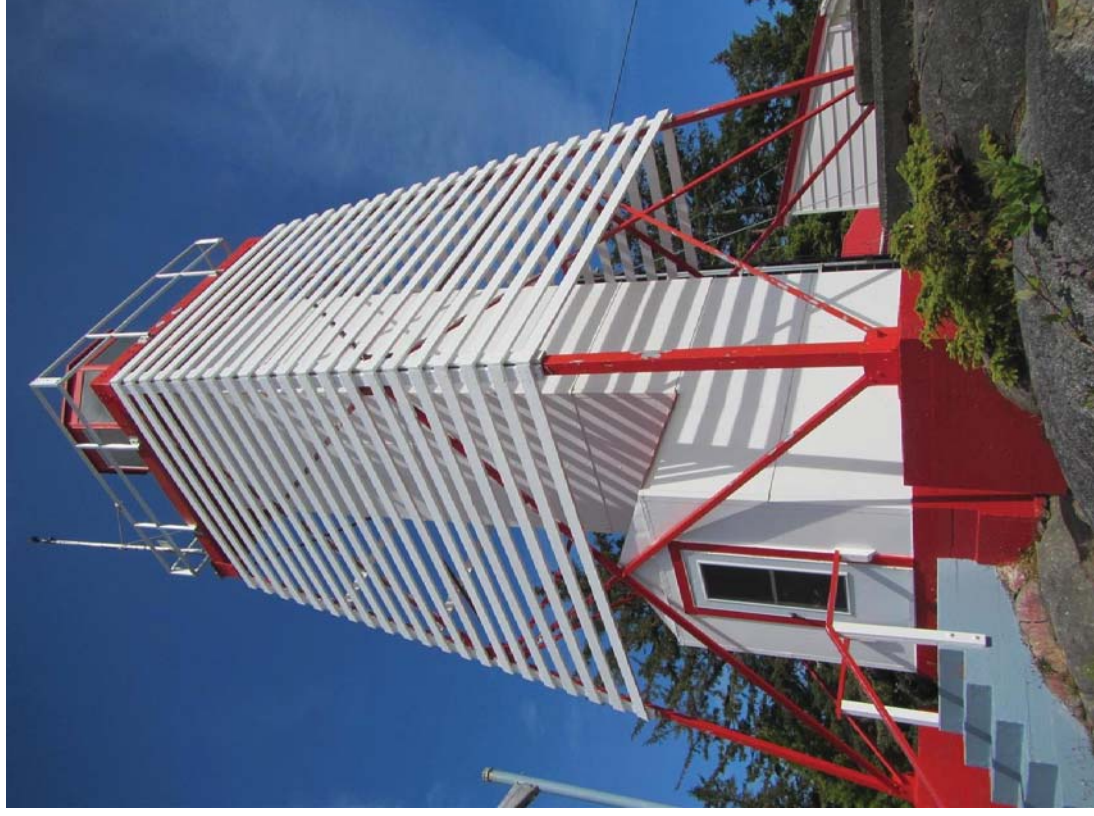
Cape Beale Light Tower

The current light tower was built in 1958 and designated as a 'Heritage Lighthouse' earlier this year (2015).

The steel framed tower has 5 levels (lantern house is level 5) and is ~32 feet in height (lower level floor to lantern house floor). It supports an aluminum lantern house that houses the navigational aid (light). The structure is mounted on several concrete foundations.

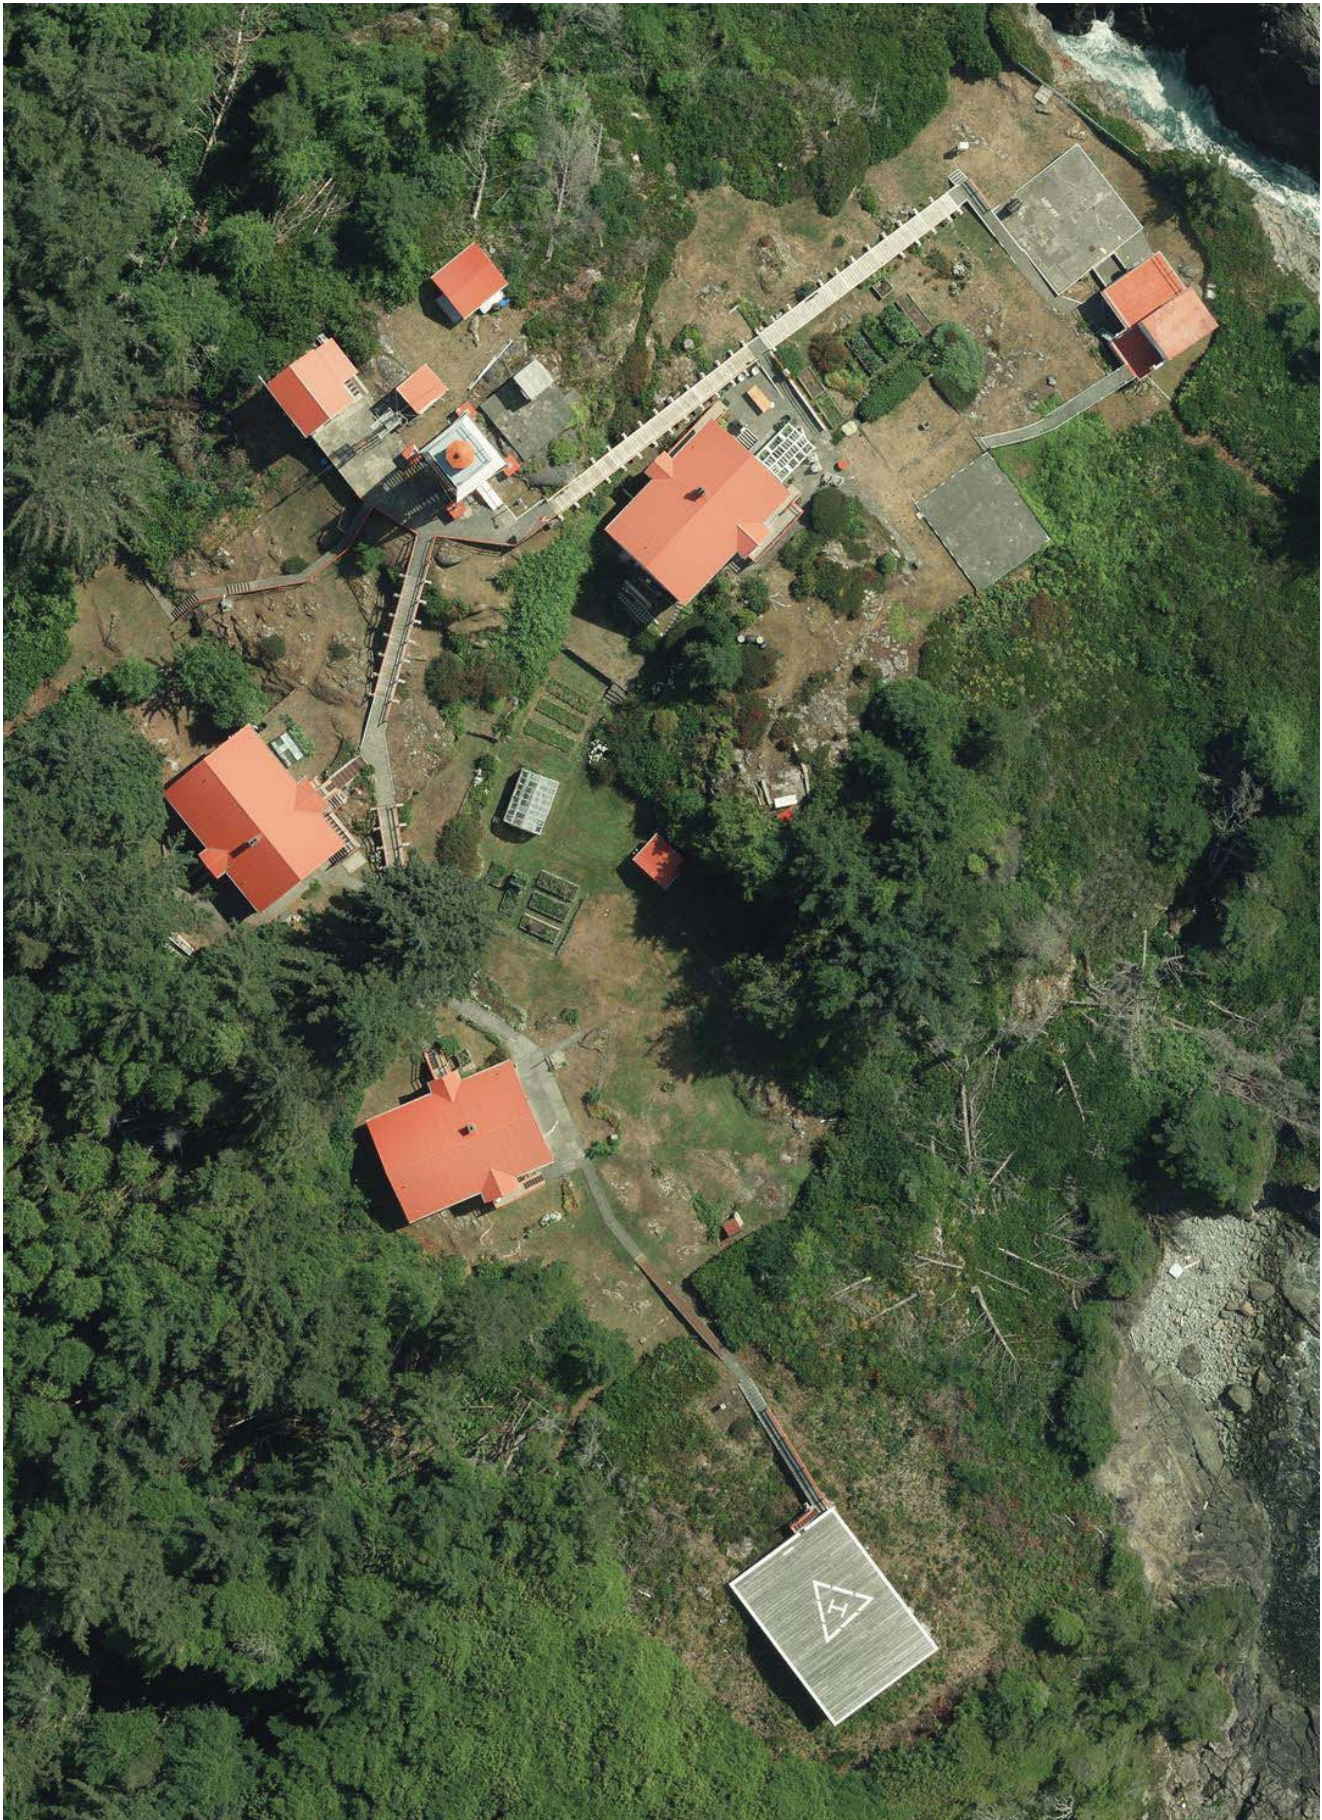
Site Access – Lower Station

CCG vessels (ships) typically deliver materials to the site via a tender workboat using the site's wharf derrick (at lower station) and aerial highline (to upper station), but this is very weather and sea-condition dependent.

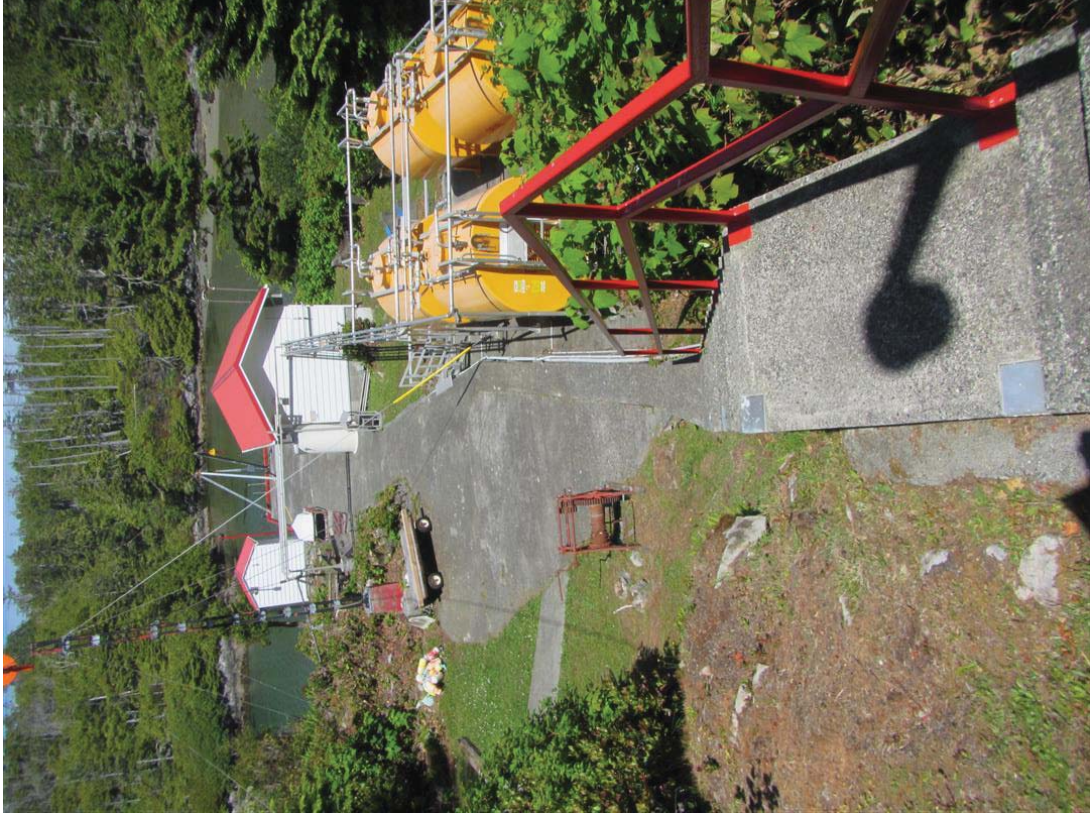
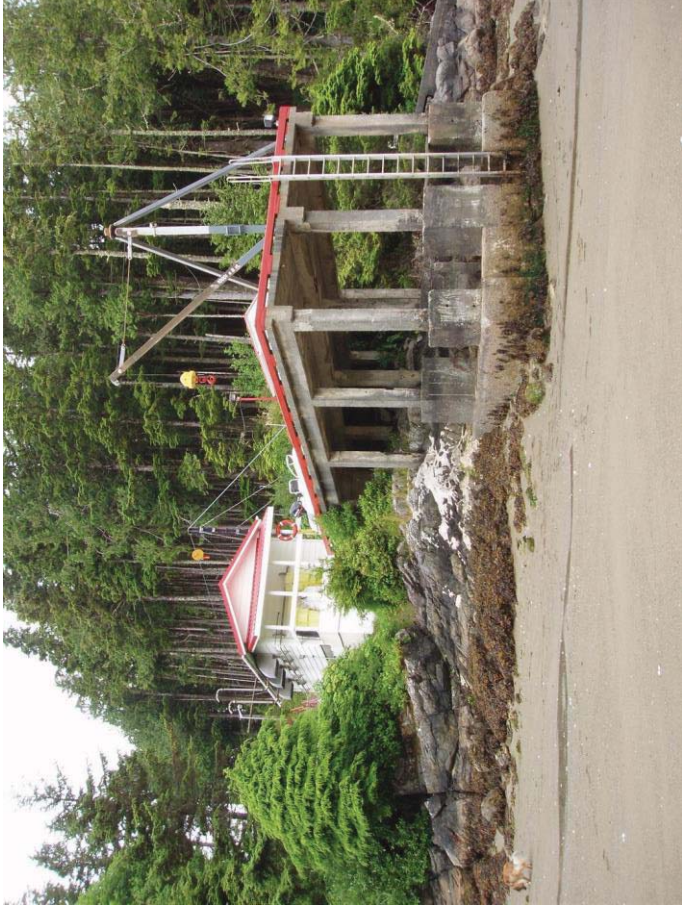
At low tide wharf is not accessible by boat.

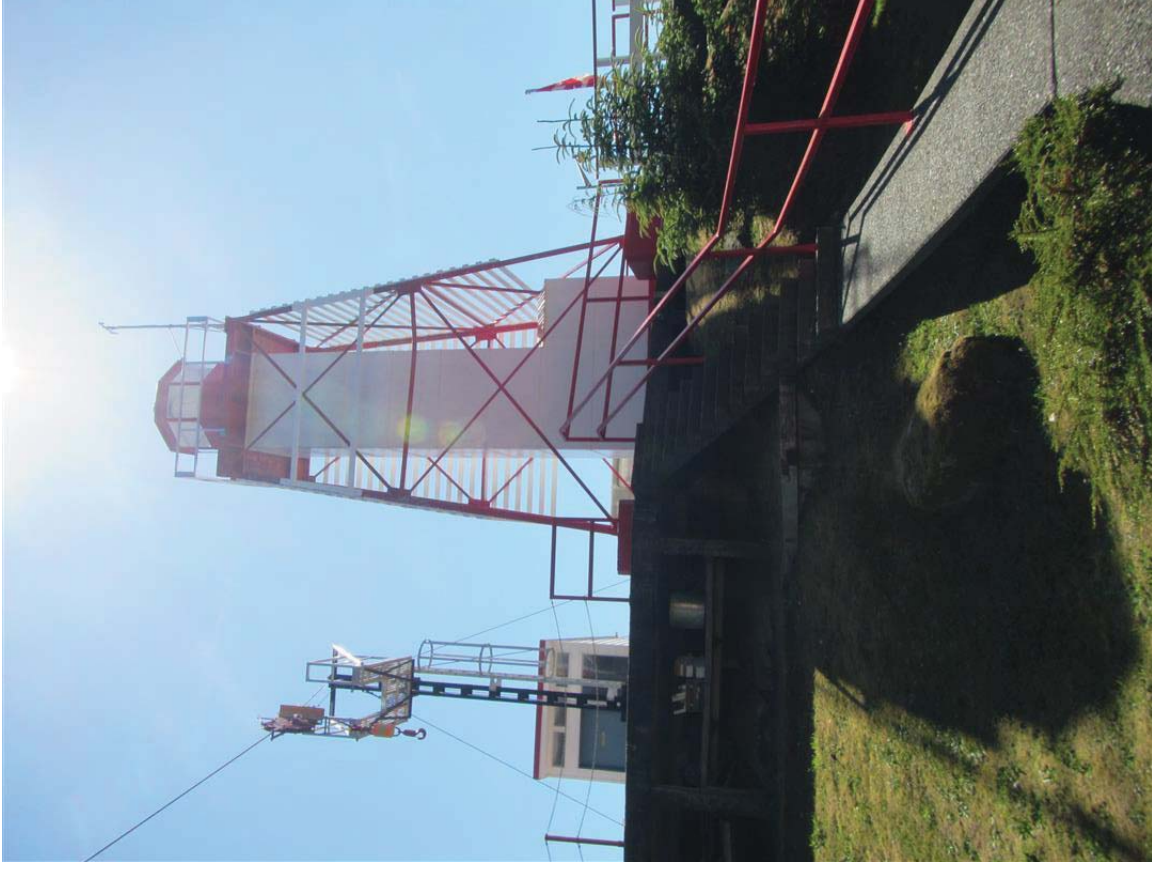
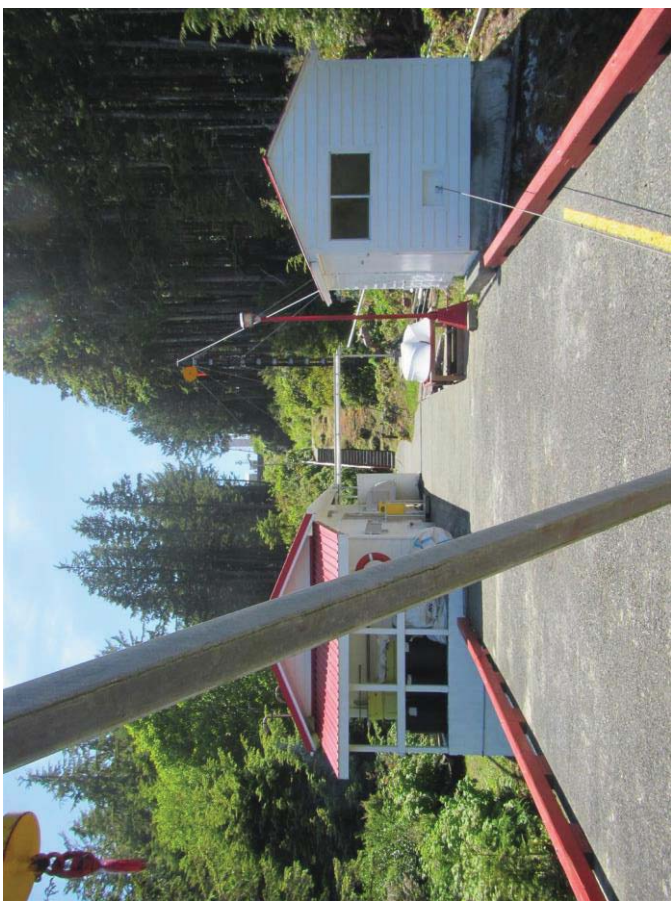
Derrick and Aerial Highline Use

CCG workboats are offloaded with a derrick system that is rated at a 1000 lb Safe Working Load limit. Materials can be moved from lower station (derrick landing) to upper station via aerial highline (slung loads), safe load for aerial highline is also 1000 lbs.

Upper (left) and lower
(above) aerial highline.
Handtruck required to move
materials from derrick to
lower aerial highline.

Use of the derrick or aerial highline must be coordinated with DFO/CCG in advance and the light keepers are the only people permitted to operate.

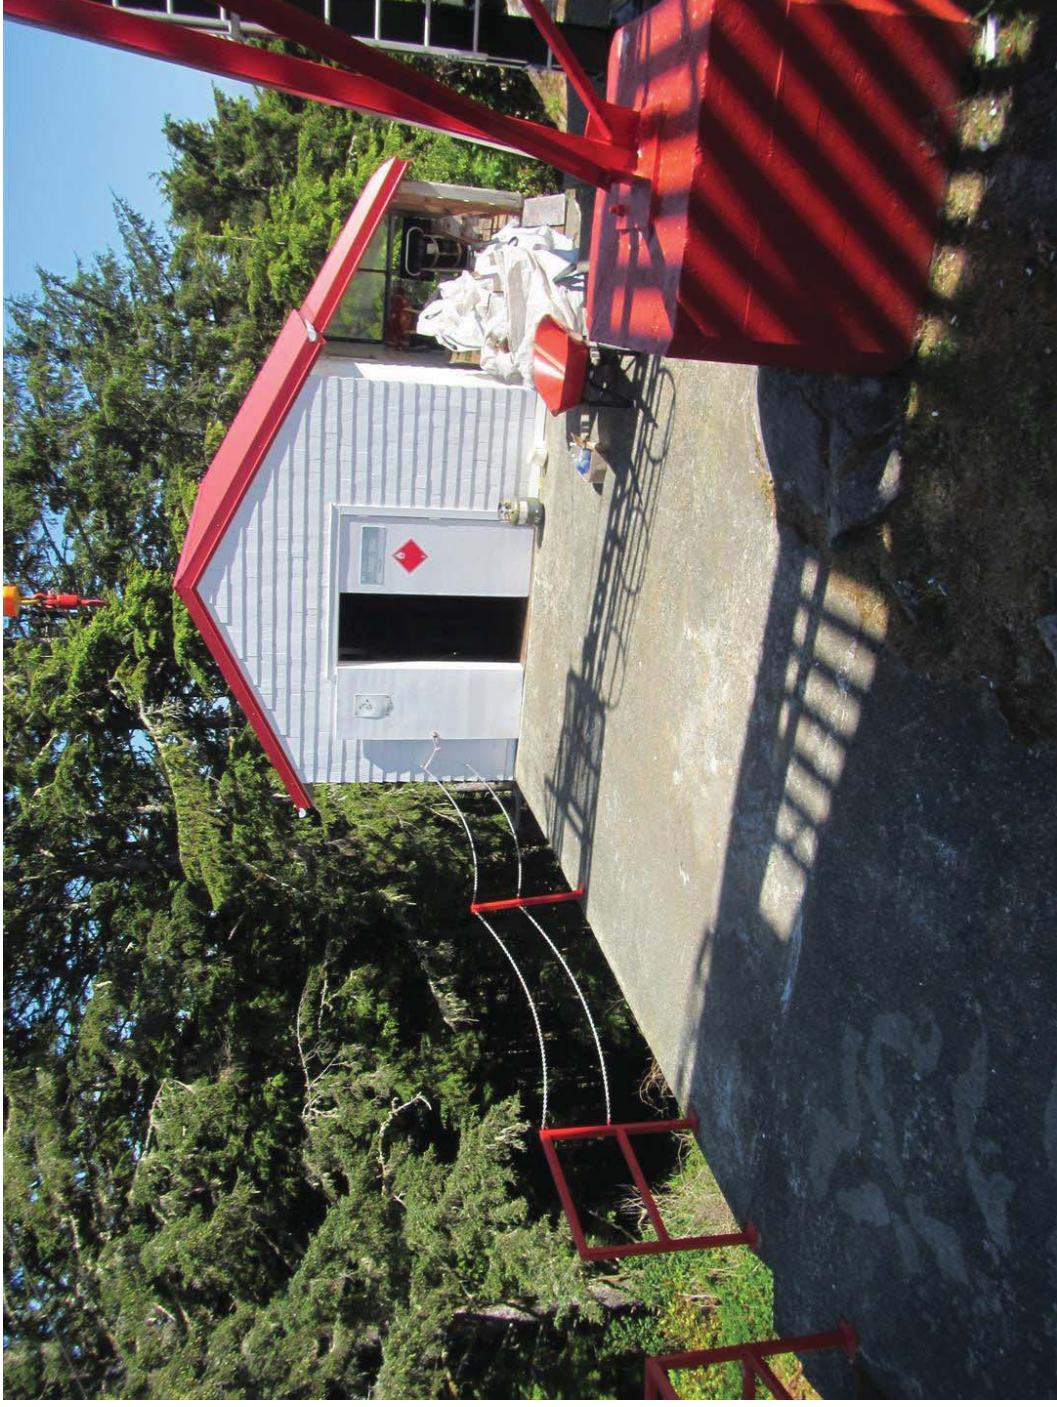
Site Storage

Storage space for equipment and materials on-station is limited.

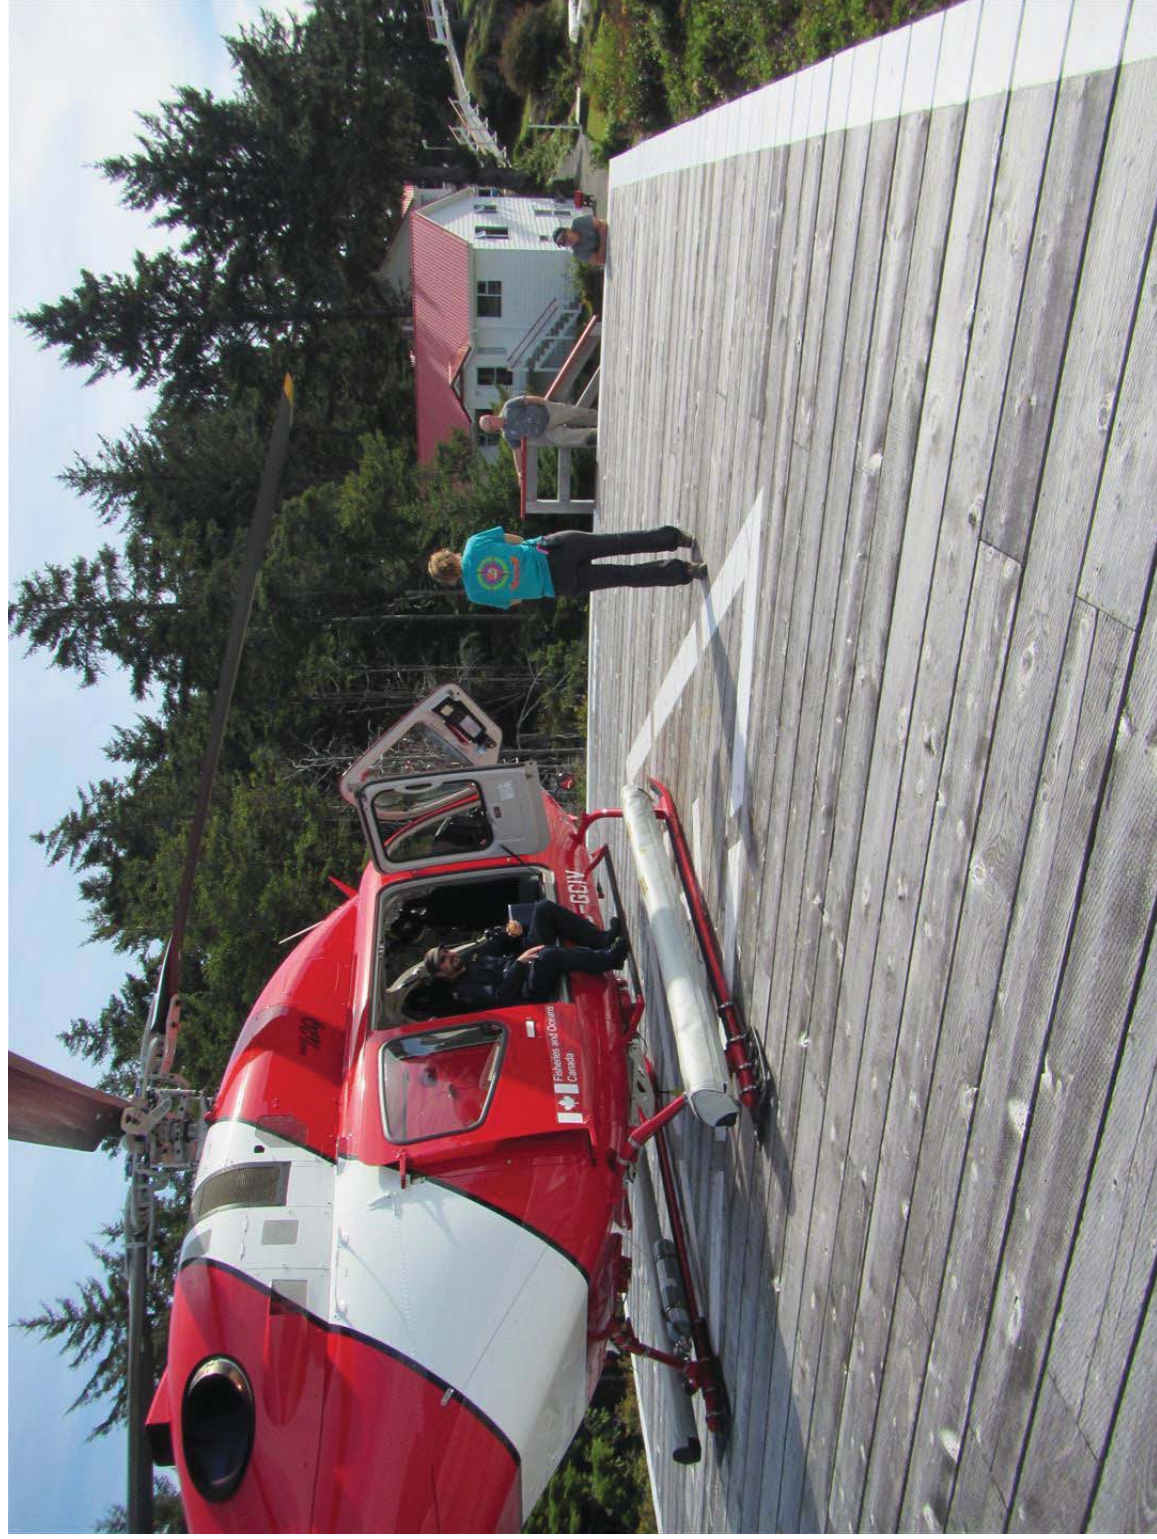
Helipad

The helicopter landing pad is timber construction. The largest helicopter it is rated for is a Bell 212.

The landing pad area is ~35' x 48'

Use of the helipad needs to be coordinated in advance with the CCG and the DFO Project Contact (or DFO Project Manager).

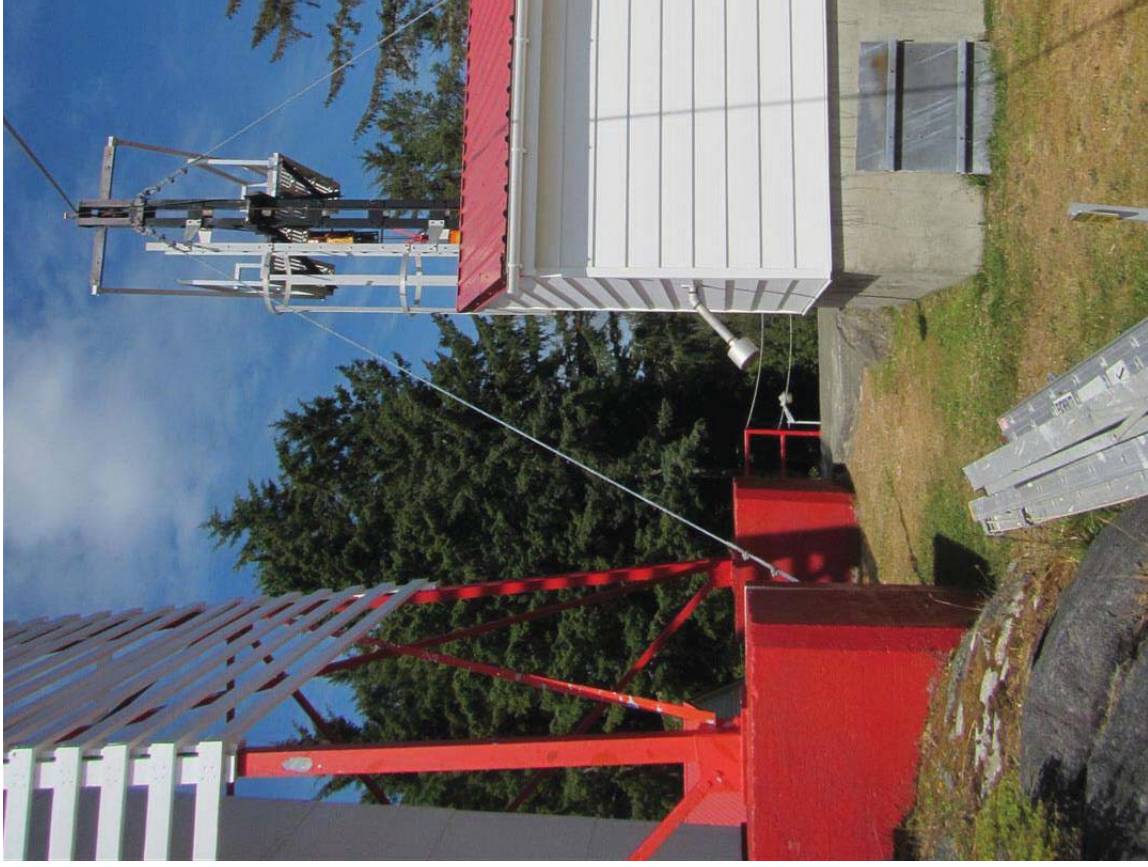
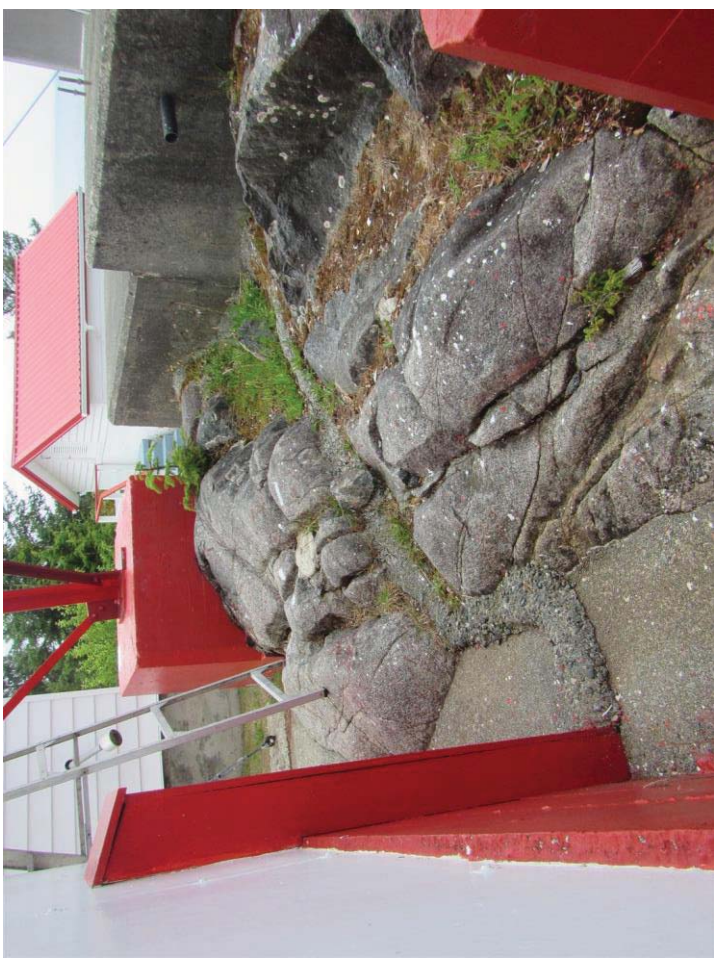
Uneven ground/rock at one side (above). Winch bldg close at one side (left). Daymark signboards confine space (near top of tower).

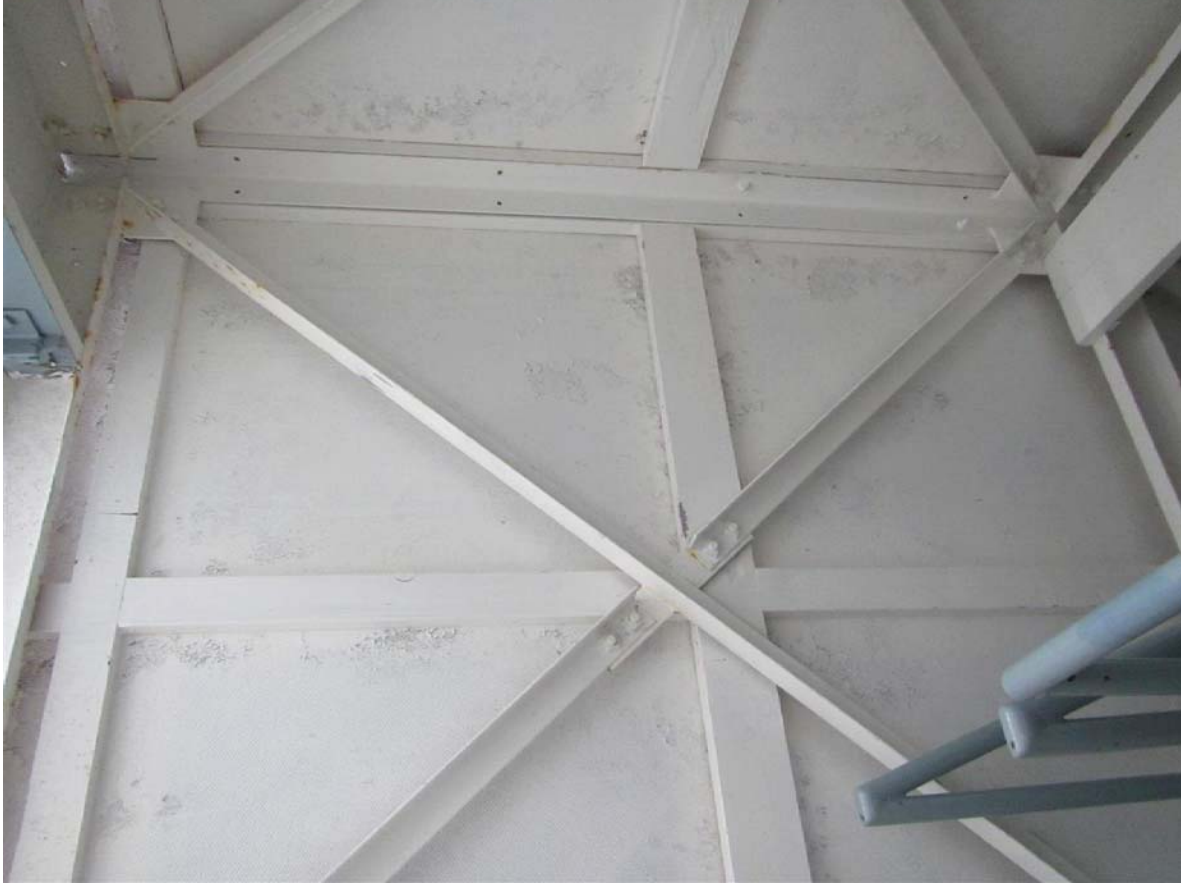
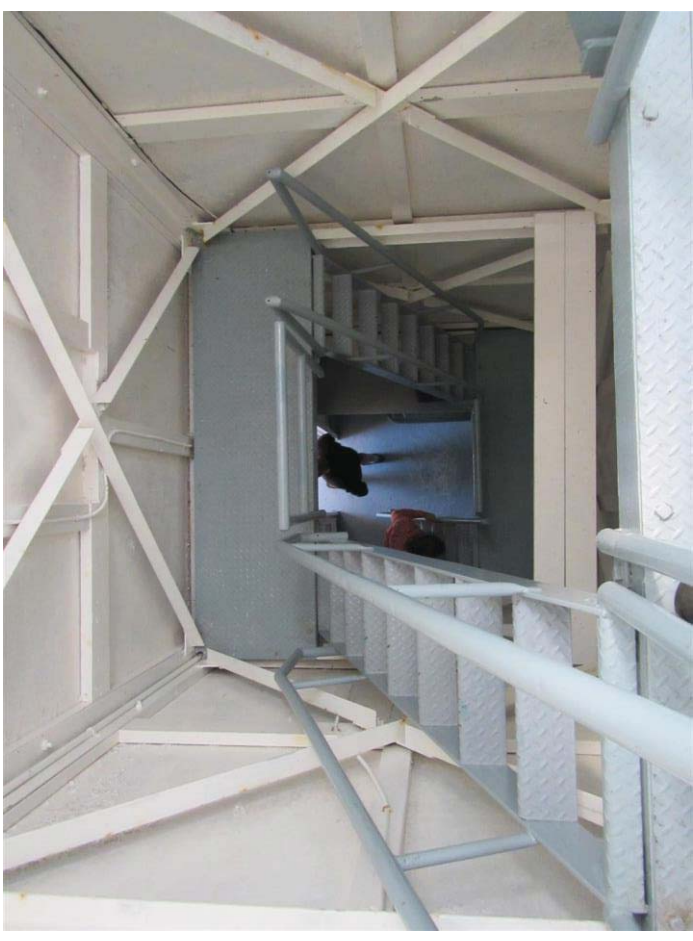
Tower interior. Timber (2x4, 2x6) nailers bolted to steel frame, decayed at lower levels, asbestos sheathing secured-to with small lags.
