REMEDIATION ACTION PLAN FOR 7 ABANDONED MINE SITES, NT

STORM MINE - AREA 1: HAZARDOUS AND NON-HAZARDOUS MATERIALS

FIGURE SM 3 1

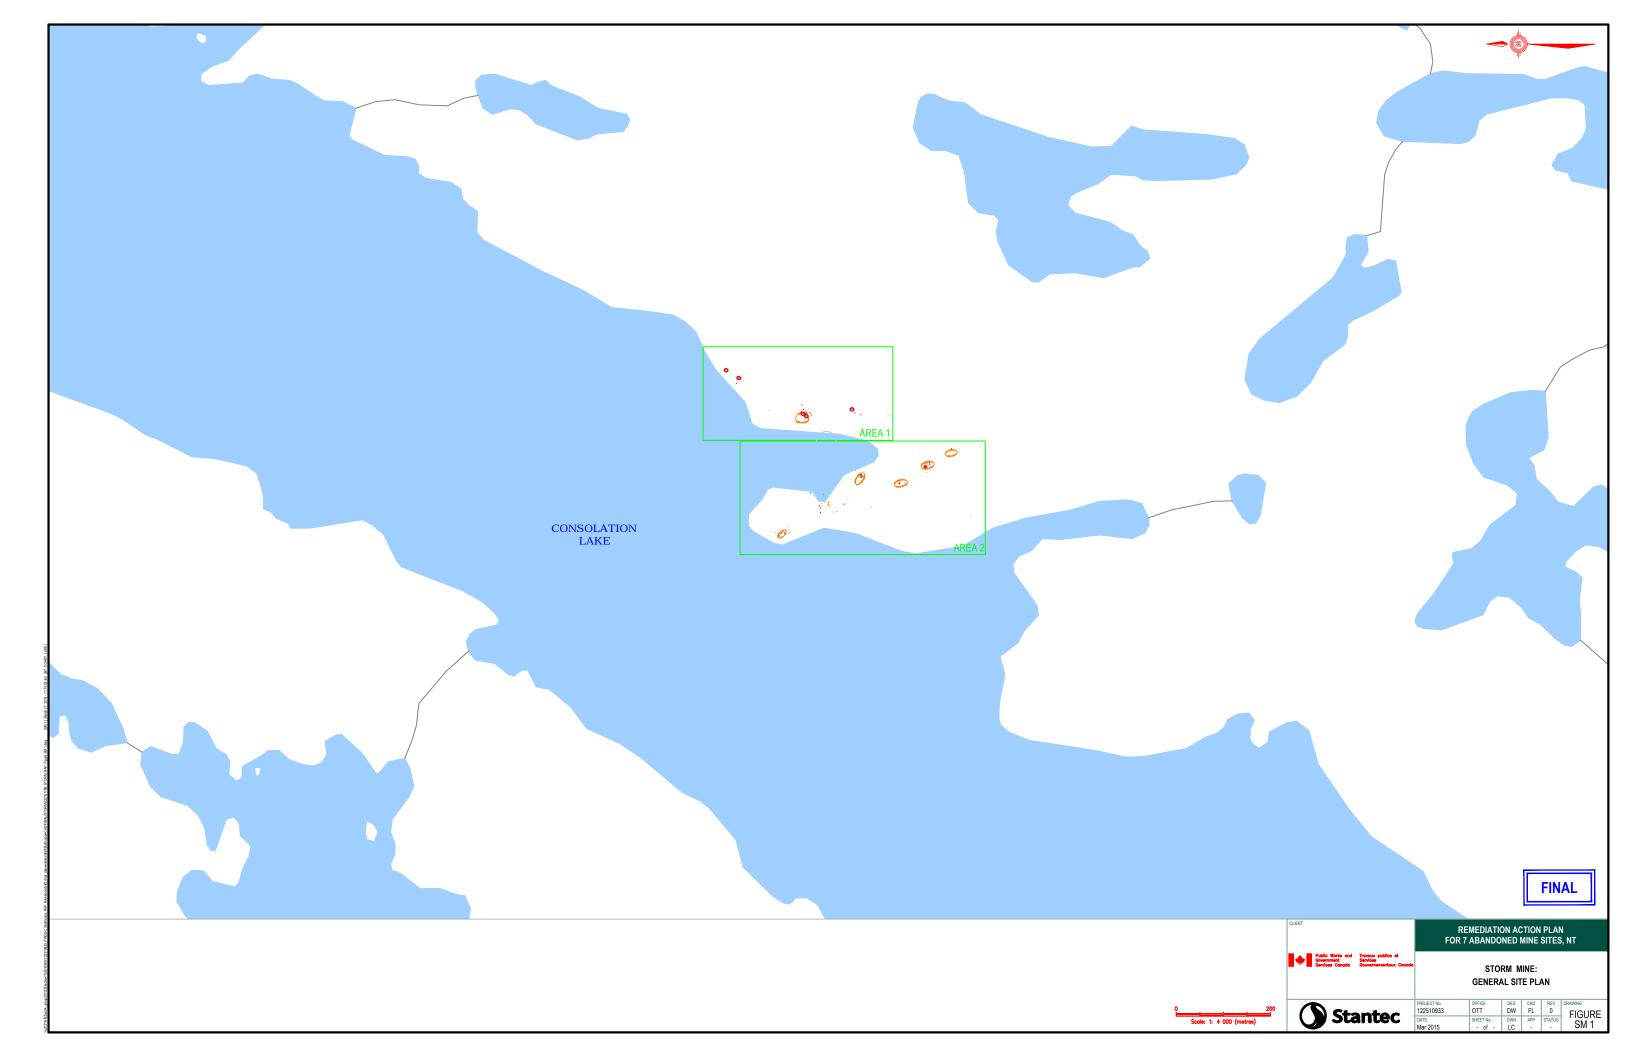
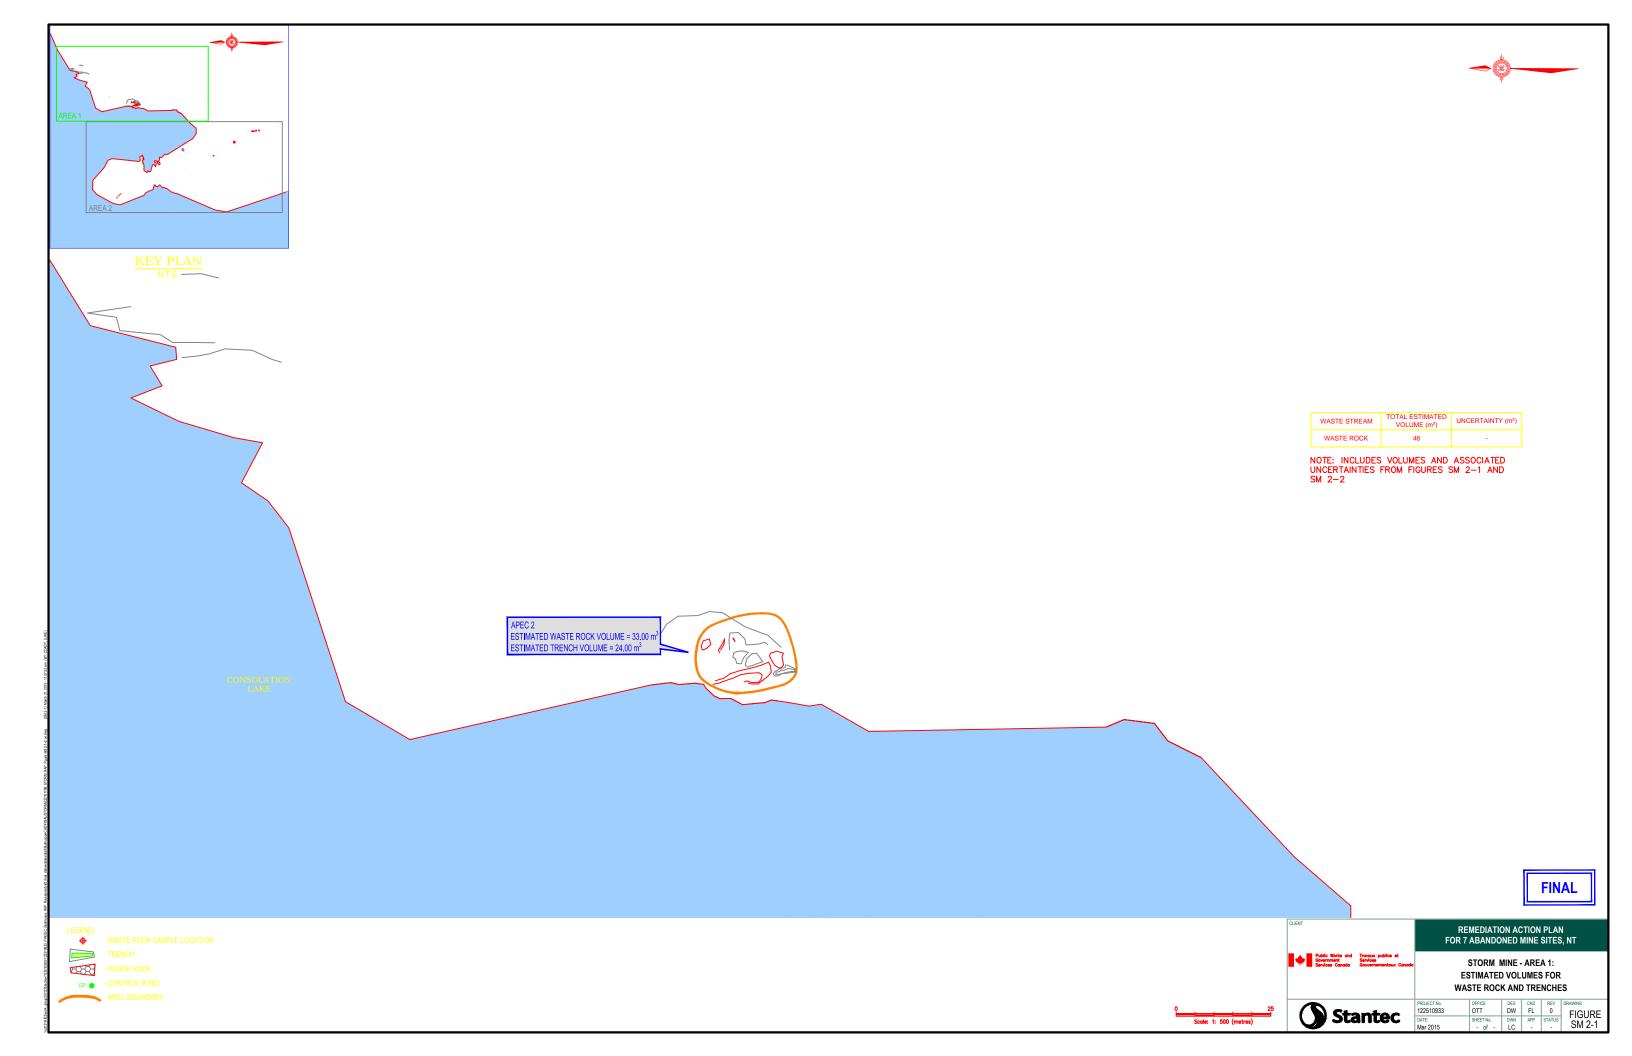
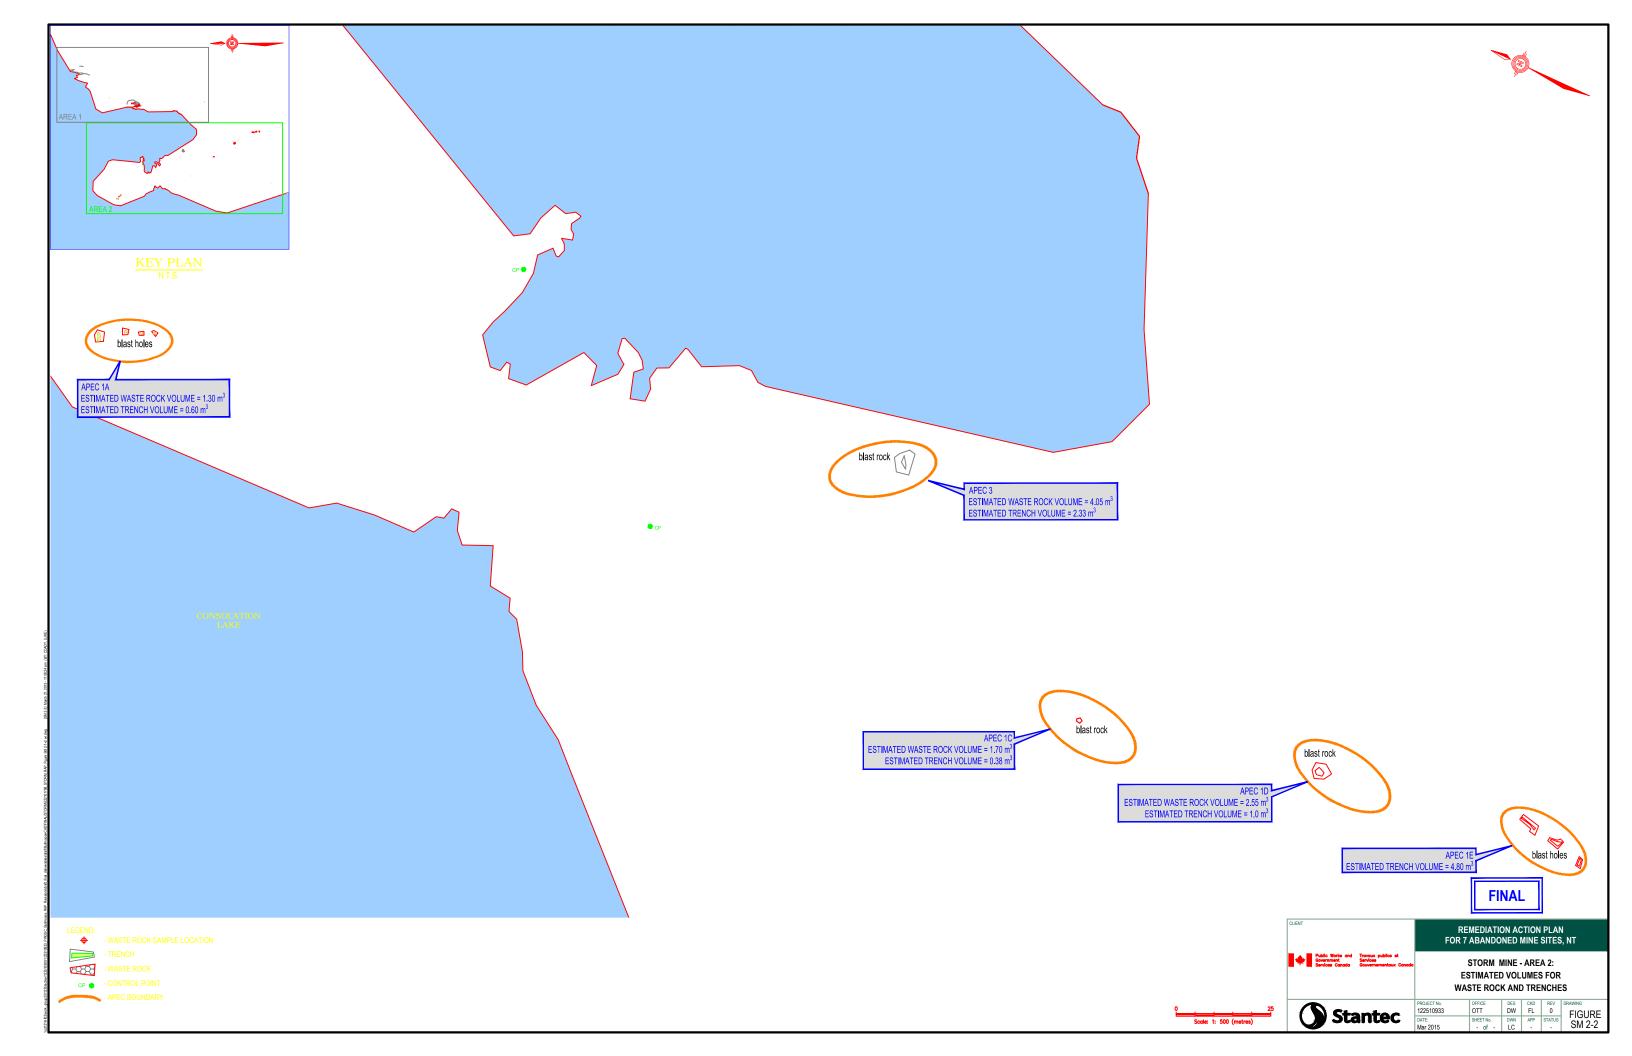
South Camp ruin (3 former buildings APEC 4 & 1 dump)

wooden box with gravel

2 trenches & APEC 2
