SPECIFICATION FOR THE RENOVATION OF CABIN FLOORS & WALLS ON UPPER DECK

C.C.G.S. MARTHA L. BLACK | TYPE-1100 NAVAIDS TENDER

CANADIAN COAST GUARD

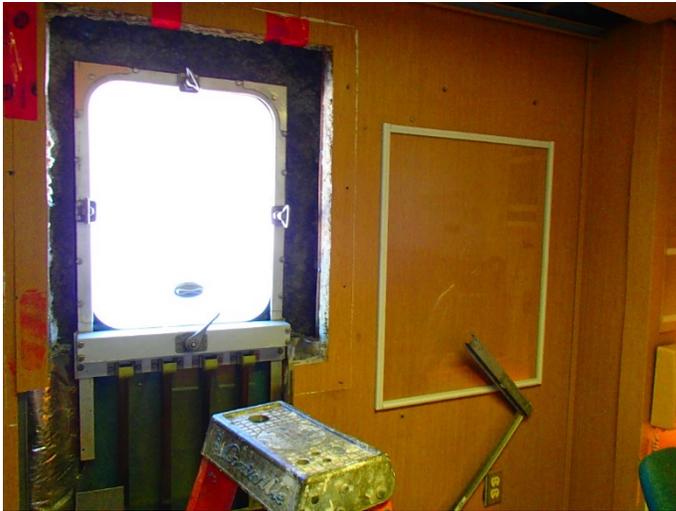
A few lining wall panels on Upper deck cabins were taken down so as to permit us to see firsthand the extent of the damage caused by the ice melt that had formed during winter, principally around the sliding pane window and frame in cabin no.245, Upper deck (see figure no.1).

Figure 1: cabin 245 + typical sliding window

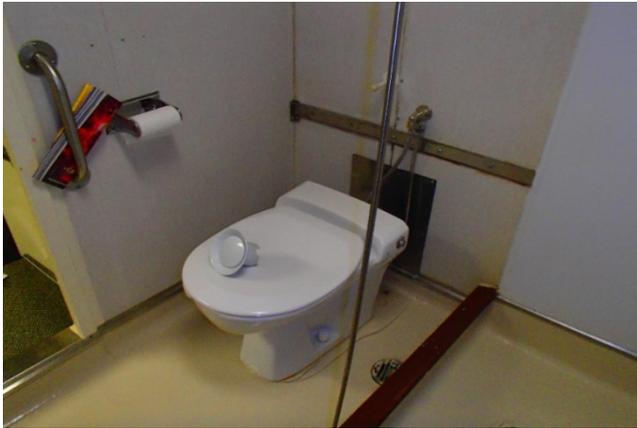
Figure 2: Toilet bowl

Make sure to blank off discharge pipe (vacuum system) and shut off water supply. To be reinstalled at the end of work. See figure 2.

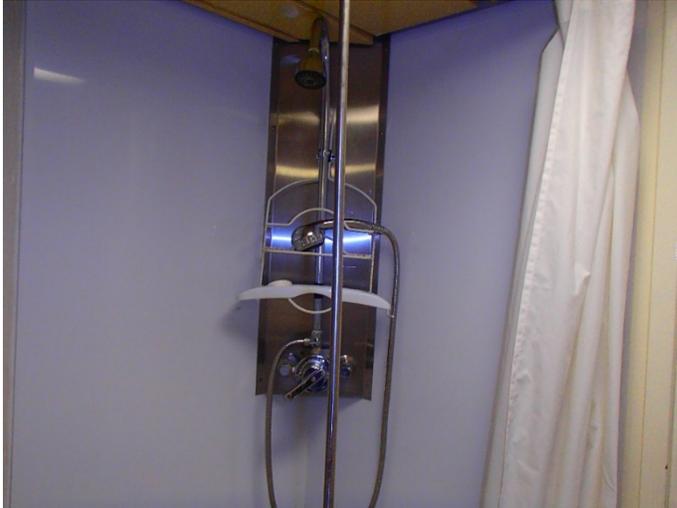
Figure 3: Shower & faucets

The shower corner is fabricated using acrylic panels, all 8 shower acrylic panels shall be replaced with new identical panel. Supply and install 16 shut off valves, ½" brass, silver solder for shower piping, make sure to shut off hot & cold water supply. See figure 3.

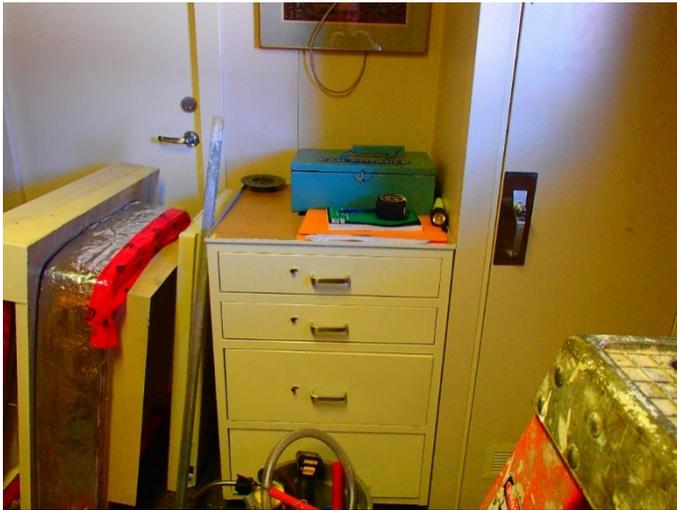
Figure 2: Sliding window frame + 4-drawer dresser cabin 245

This frame will be reinstalled at the end of the prescribed work. See figure 4.

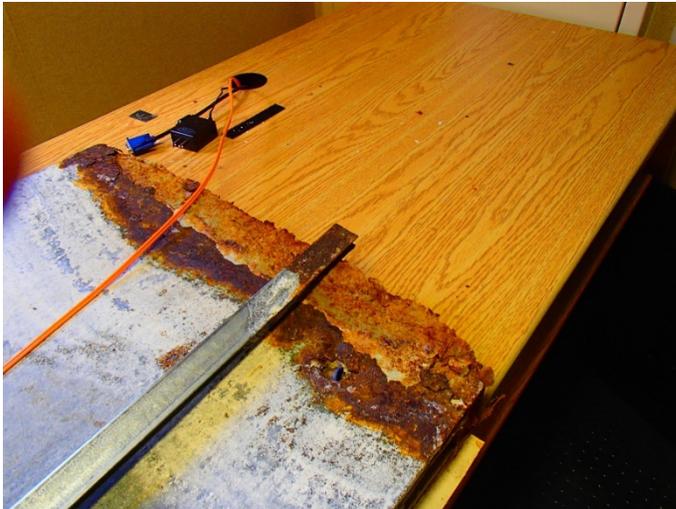
shower panel shall be replaced on both sides, longitudinal and transversal. For a typical 2-cabin assembly, approximately 6.4 meters of paneling will be removed and replaced. The actual panels are deteriorated by corrosion on the lower end, as well as the positioning channels. These will be replaced by new paneling and tracks of the same type and color. See figures 5 & 6.

Figure 3: Corroded lower part of Joiner panel

- a. The old lining panels previously dismantled will be replaced by new Joiner B-15 panels, 50mm X 600mm X 2250mm. Total surface to be covered is approximately 14.4 square meters. These new panels will be installed using all new tracks (lower & upper), inside and outside corners, and end caps.

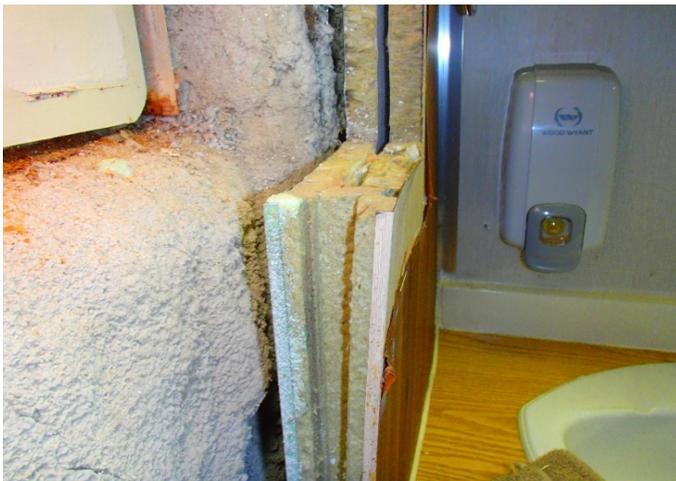
Figure 4: Typical 50mm (2'') Joiner panel

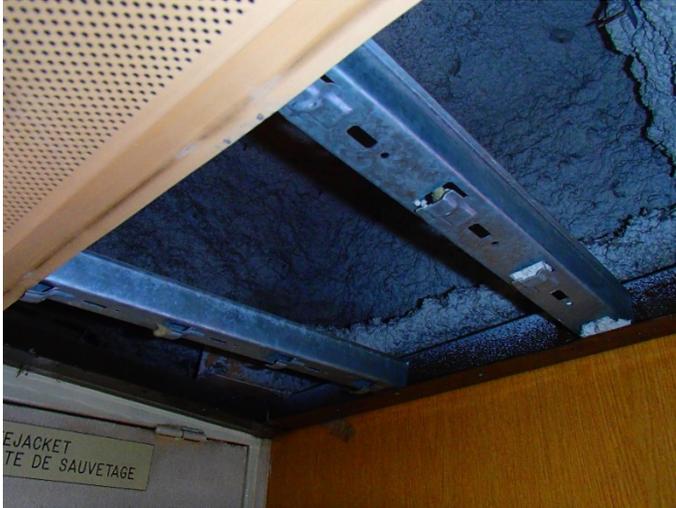
Figure 5: Typical suspension ceiling

Approximately 75cm of suspension ceiling will be removed, from exterior to interior of cabin, to facilitate access to exterior wall insulation. This ceiling will need to be stored, as it will be reinstalled at the completion of work. See figure 7.

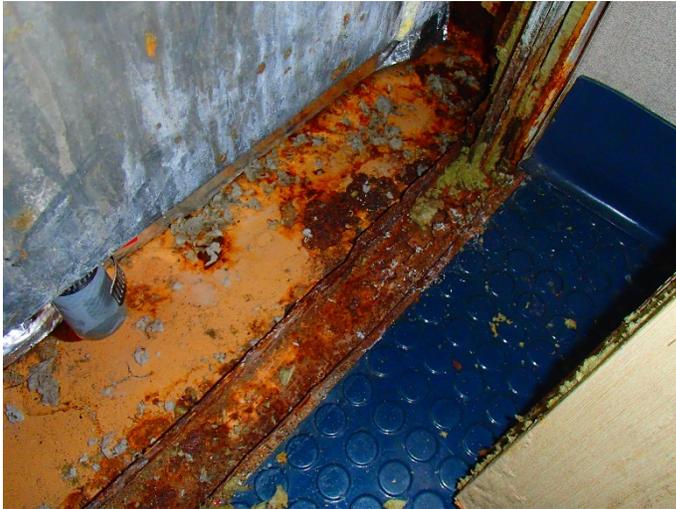
- a. Once all the insulation has been removed, Contractor will mechanically grind off all rust on exterior wall, ceiling and floor plating.
- b. Special attention will be exercised on the deck beneath the porthole, as water and humidity were particularly aggressive in that area. Also the lower lining track will be removed, as it is badly corroded. See figure 8.
- c. Grinding to be performed all around sliding window (frame), if necessary.

Figure 8: Corroded tracking & floor below sliding window

- d. Rusted surface to be grind and painted, 25% overall surface (400 ft² total to be grind), mostly 2 feet above deck, and around the sliding windows, applied on coat of marine enamel primer and two finishing coat.

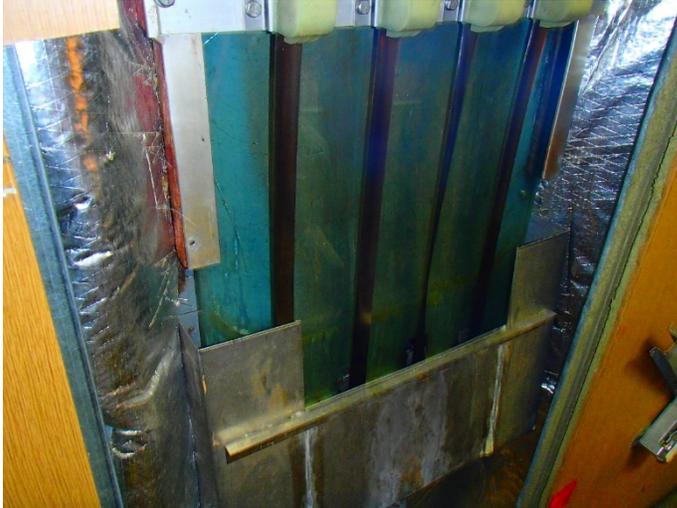
The sliding windows were installed with a stainless steel retention reservoir. This reservoir is too small (not high enough) and cannot prevent accidental overflowing of rain water or sea spray that can drip down to the reservoir when window is partially open or not well sealed. Contractor must proceed with the following modification on all 17 sliding windows:

- a. The actual tank measures approximately 35cm high X 50cm wide. See figure 9.

Figure 9: Retention reservoir cabin 245

- b. A new reservoir approximately 70cm high X 50cm wide will need to be fabricated and installed, as this new tank will allow rain water and sea spray to be more readily captured. The bottom of tank to be designed to permit water being channelled towards drain connection.
- c. This new reservoir will be built using stainless steel 316 material.
- d. The actual reservoir is fitted with a drain connection under, permitting rain water and sea spray to be drained on deck. The new arrangement will need to be fitted with a similar arrangement, c/w flexible drain hose. Make sure drainage connection in wall is free flowing. See figure 10.
- e. A leak tightness test to be performed before boxing up panels.

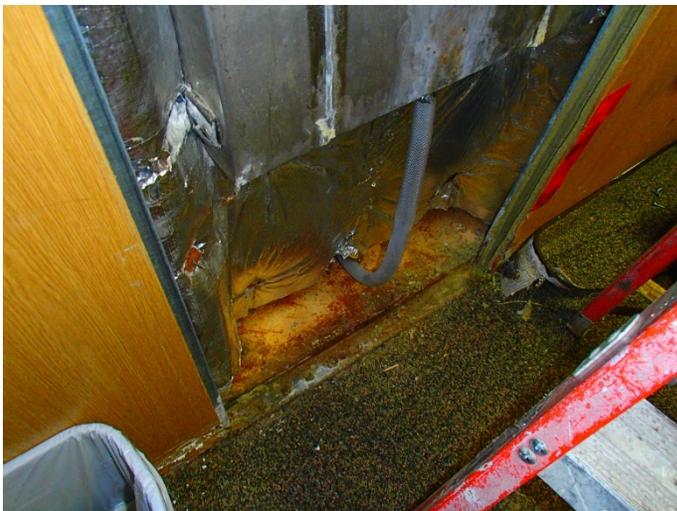
Figure10: Flexible hose connection under reservoir
