Title - Sujet New GOCB Saint-Léonard, NB	
Solicitation No. - N° de l'invitation EC015-162530/A	Amendment No. - N° modif. 002
Client Reference No. - N° de référence du client R.069499.001	Date 2016-03-03
GETS Reference No. - N° de référence de SEAG PW-\$PWB-013-3833	
File No. - N° de dossier PWB-5-38220 (013)	CCC No./N° CCC - FMS No./N° VME
Solicitation Closes - L'invitation prend fin at - à 02:00 PM on - le 2016-03-24	Time Zone Fuseau horaire Atlantic Daylight Saving Time ADT
F.O.B. - F.A.B. Plant-Usine: <input type="checkbox"/> Destination: <input checked="" type="checkbox"/> Other-Autre: <input type="checkbox"/>	
Address Enquiries to: - Adresser toutes questions à: Johnston, Edward PWB	Buyer Id - Id de l'acheteur pwb013
Telephone No. - N° de téléphone (506) 636-3142 ()	FAX No. - N° de FAX (506) 636-4376
Destination - of Goods, Services, and Construction: Destination - des biens, services et construction:

Addendum no. 2

Geotechnical Report – Saint Leonard GOCB

Geotechnical Investigation- Saint Leonard Government of Canada Building (GOCB)

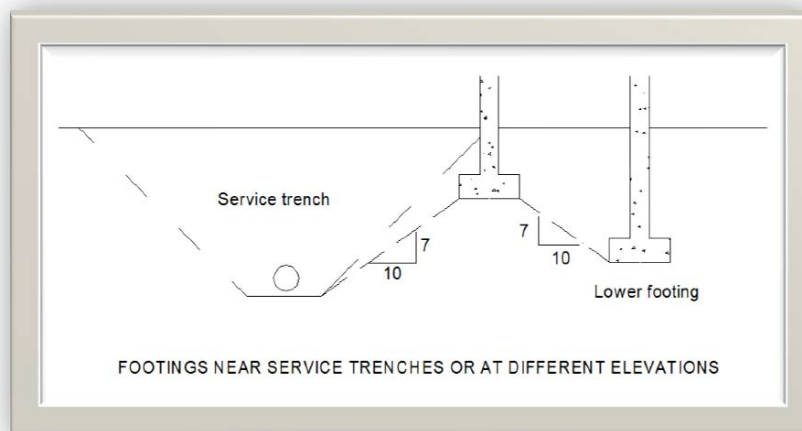
Footings at different elevations, for interior columns, as well as service trenches shall be located such that they do not extend into a 10 horizontal to 7 vertical bearing splay for building foundations. Lower footings and deep service trenches should be placed prior to upper foundations to prevent undermining conditions. The following figure shows the recommended geometry for footings at different elevations to avoid interference with adjacent foundations and describes the bearing splay of the shallow foundations:

Figure 1: Bearing splay for foundations at different elevations

- All topsoil must be stripped and removed from the areas. It can be separately stockpiled for re-use in landscape areas.
- Existing ground within the bearing splay (see Fig.1 for extents of bearing splay) of shallow foundations shall be undercut 1000 mm below underside of footings.

- All topsoil must be stripped and removed from the areas. It can be separately stockpiled for re-use in landscape areas.
- Bedrock within 600 mm of the bottom of strip and spread footing elevation must be excavated within the bearing splay of foundations. Surface of excavated bedrock shall be approved by a geotechnical technician under the supervision of a geotechnical engineer prior to placement of crushed rock.
- The region within the bearing splay of foundations shall be brought up to final grade with NBDTI 75 mm minus crushed rock placed in lifts not exceeding 300 mm (uncompacted thickness) and compacted to 98% SPMDD.
