project **DICKSON BROOK CULVERT REPAIRS FUNDY NATIONAL PARK**
ALBERT COUNTY, NEW BRUNSWICK

drawing **PLAN, SECTIONS, AND DETAILS**

Tender Submission
PWGSC (Project Manager) / Administrateur de projets TPSSC
project number **R.078605.001**
drawing no. **S2 of 3**

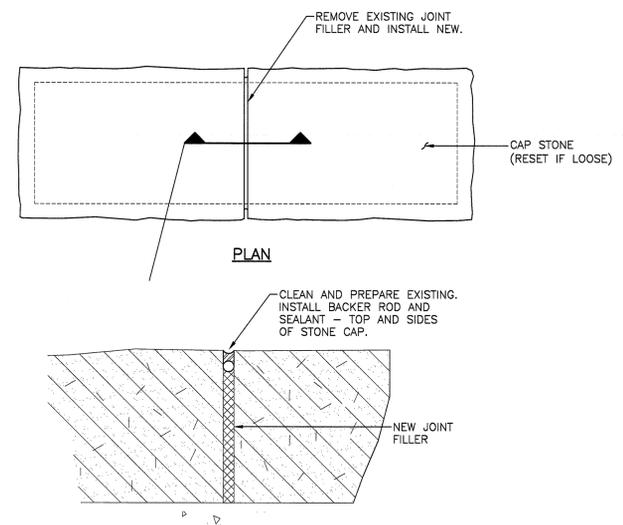
TYPICAL JOINT REPAIR AT TOP/BARRIER WALLS

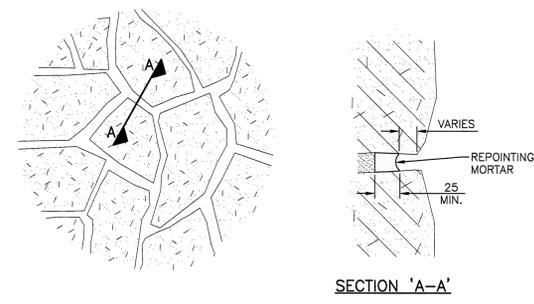
REPOINTING OF STONE MASONRY - TYP. (3)

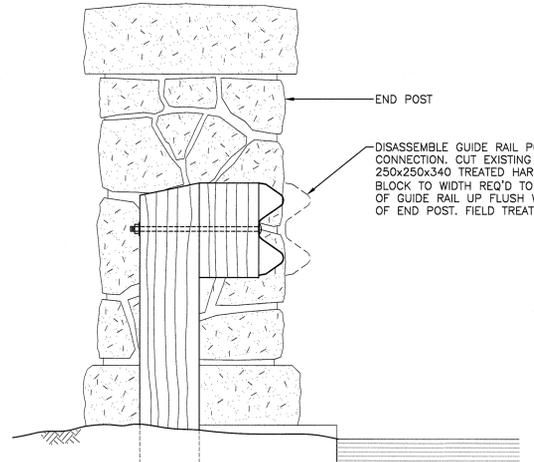
GUIDE RAIL END ADJUSTMENTS - (4 LOCATIONS) (4)
