Environmental Effects Determination (EED) Report

Project: F/G Jetty Optimization Project and Colwood South Remediation Project

Prepared by: Golder Associates Ltd.

Date: July 7, 2016

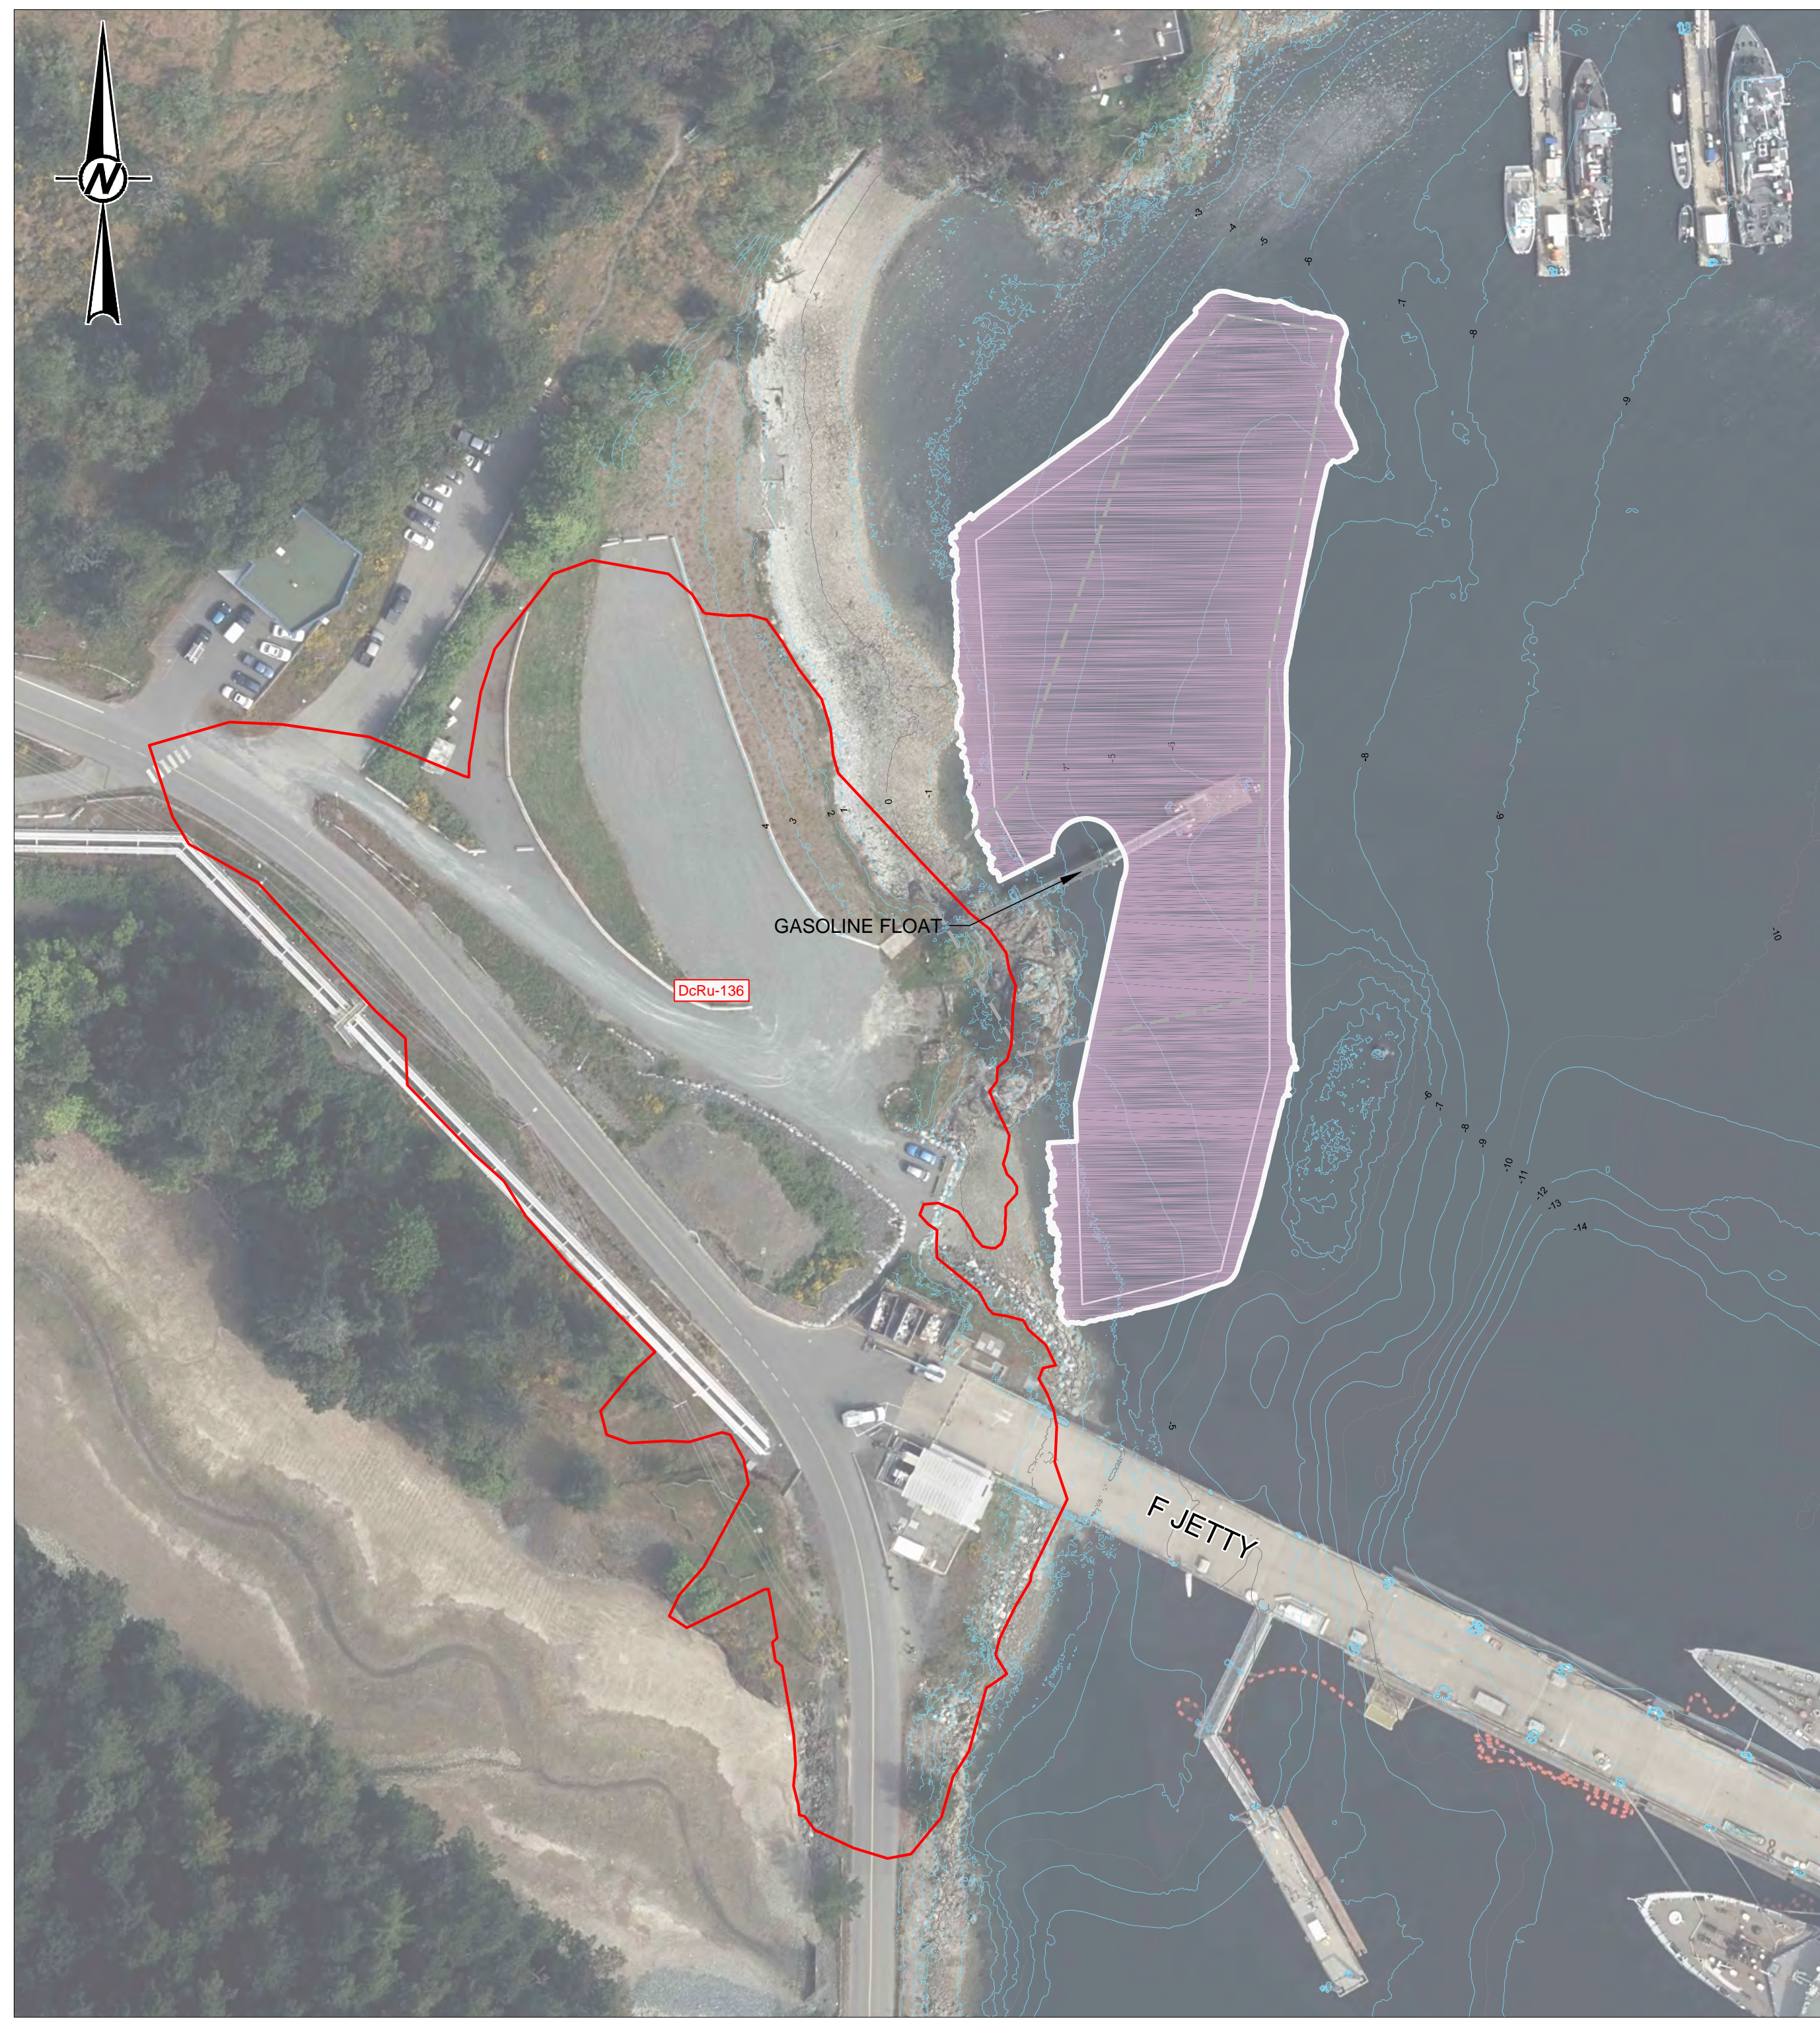
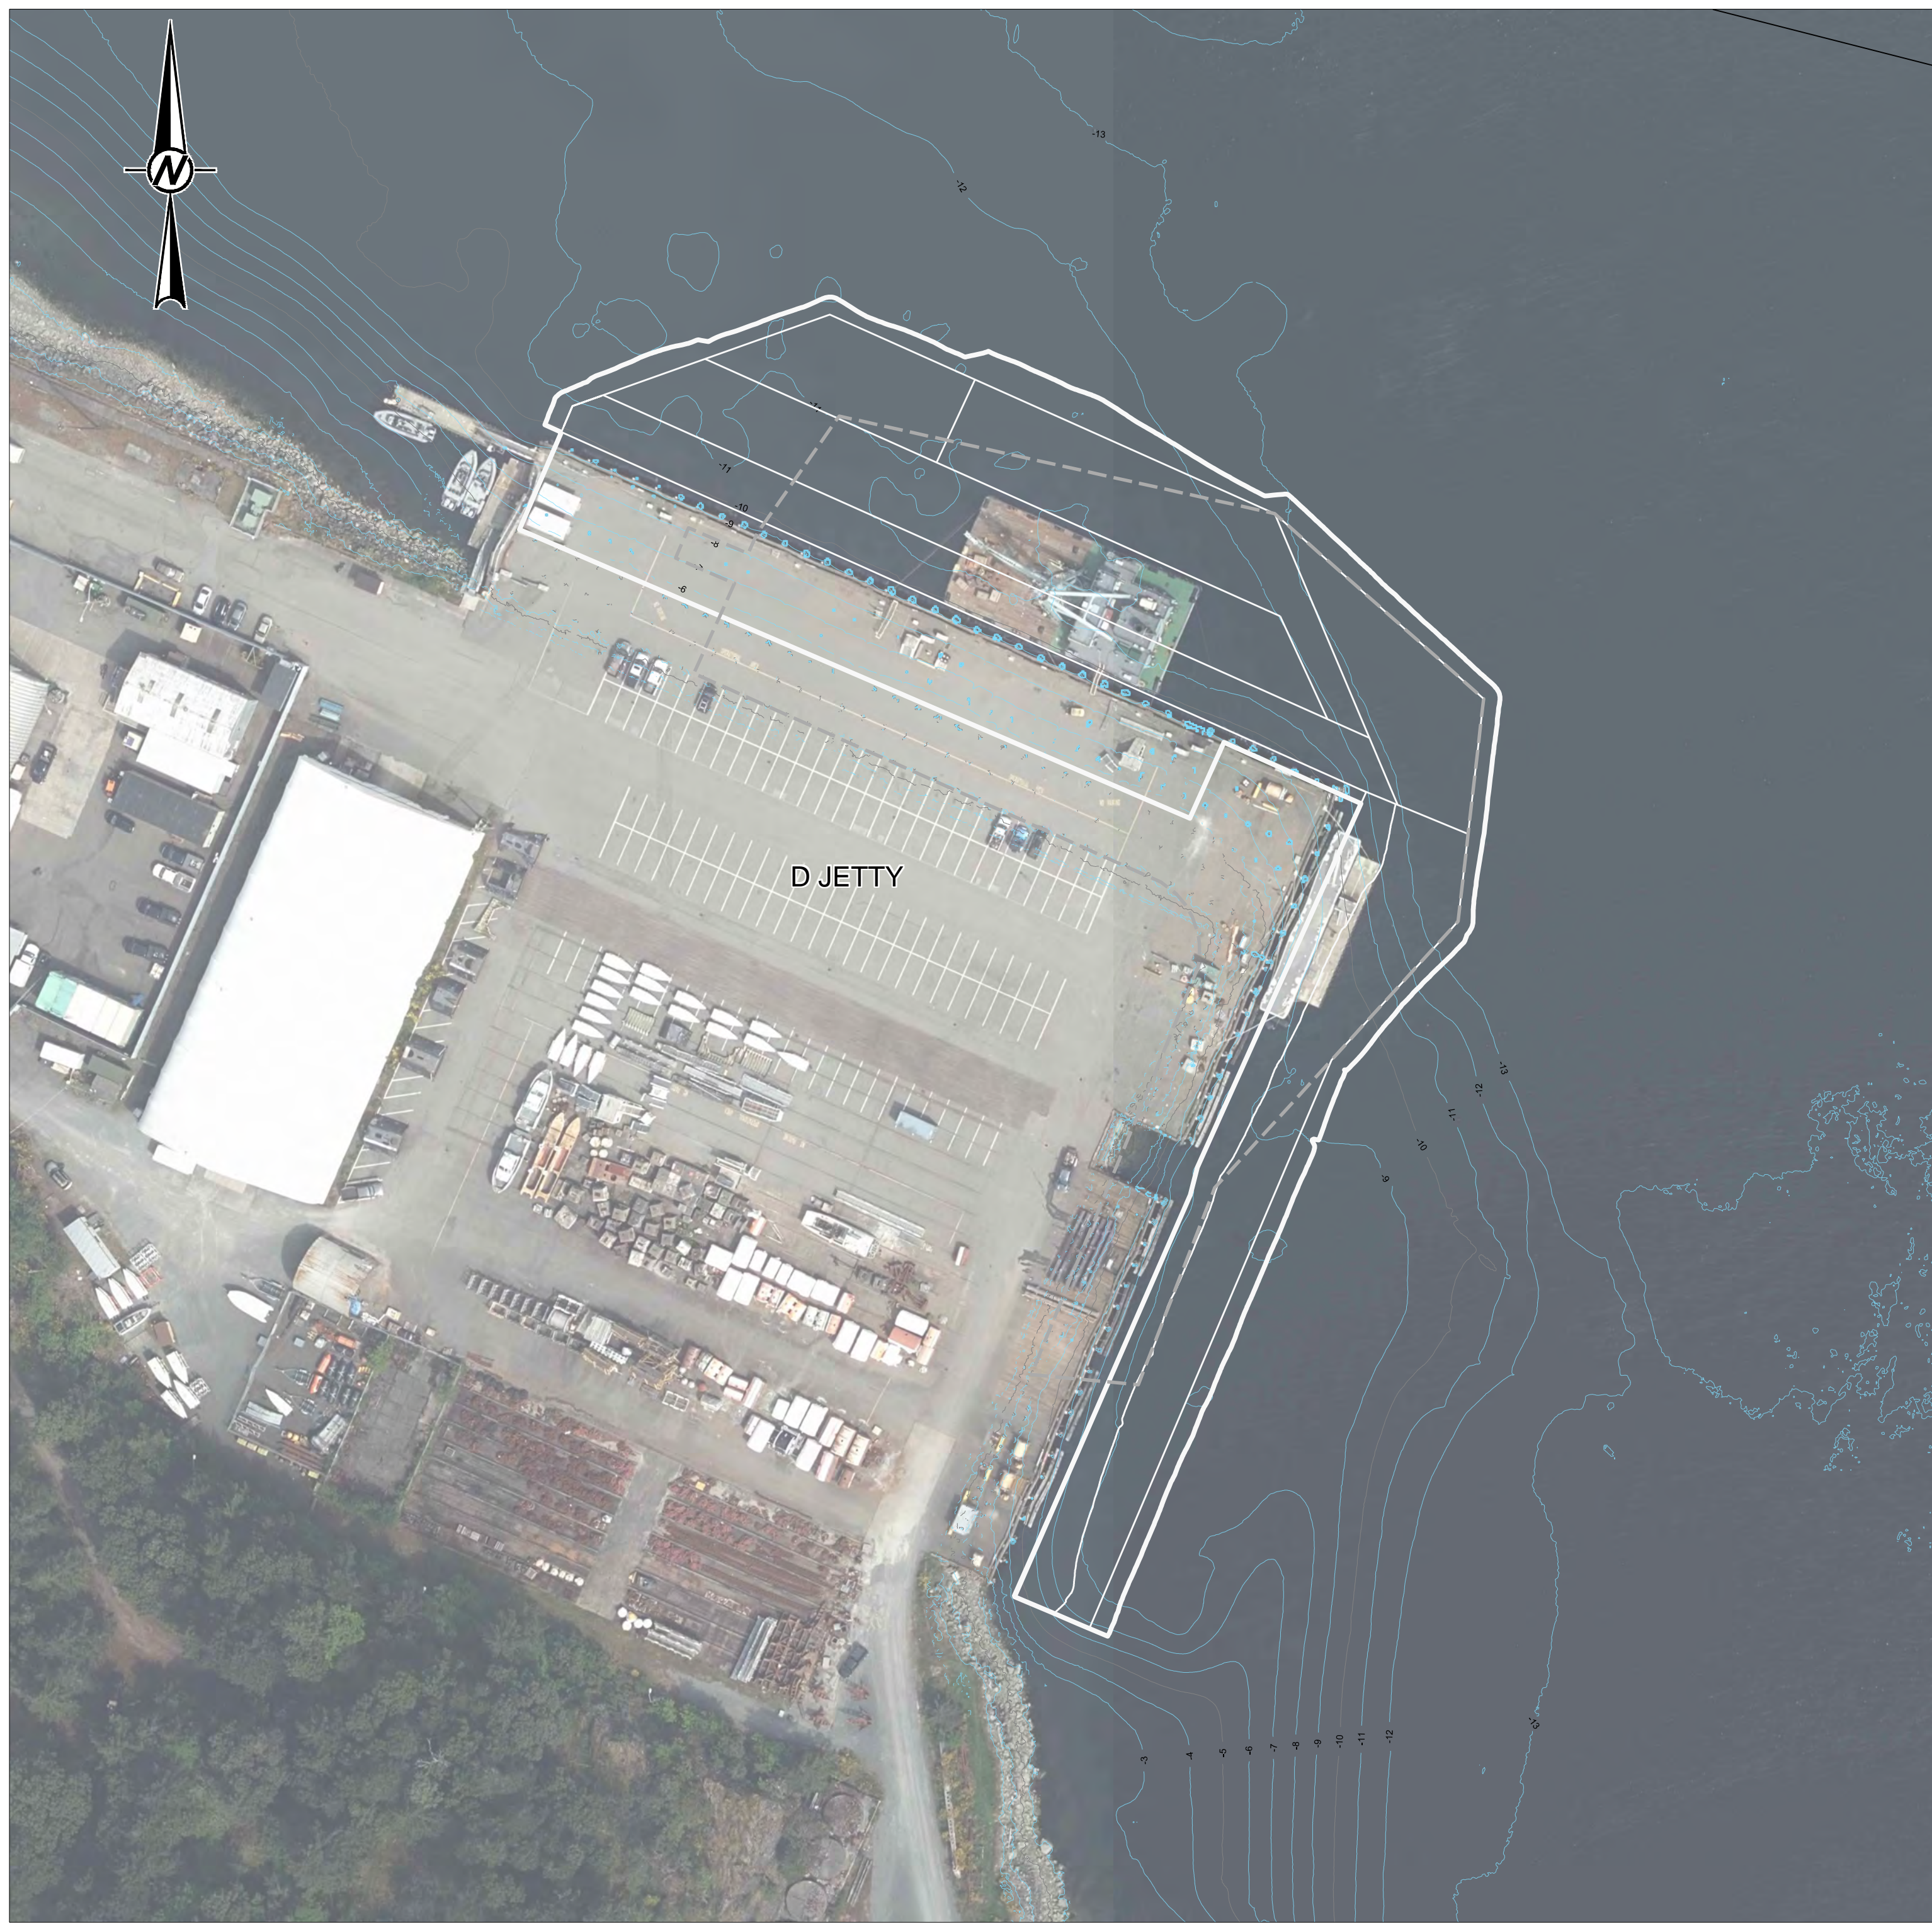
PROJECT NO. 1657898	PHASE 1000	REV. 0	FIGURE 5
------------------------	---------------	-----------	-------------

- REMEDIATION FOOTPRINT (JUNE, 2016)
- DREDGE UNITS (JUNE, 2016)
- FORMER REMEDIATION FOOTPRINT
- ARCHAEOLOGICAL SITE DcRu-136
- AREA OF ARCHAEOLOGICAL POTENTIAL

The registered archaeological site DcRu-136 is located adjacent to the Project Area. The site is located primarily on the bluffs north of Dunn’s Nook; however, part of the site extends down to the shore adjacent to the F/G Jetty Project Area (Figure 5). DcRu-136 includes a precontact village site with associated human remains, shell midden deposits and numerous artifacts and features. In addition, there is a historical component associated with 19th and 20th Century industrial use of the area.

An AOA and associated pedestrian field reconnaissance (PFR) was conducted for the Esquimalt Harbour Remediation Project that included a review of the D Jetty and F/G Jetty (Golder 2015). There are no registered precontact archaeological sites located within these Project Areas; however, the precontact archaeological site DcRu-136 is located adjacent to the F/G Jetty Project Area (Figure 5). In addition, the archaeological overview assessment determined that there were locations with potential to contain undocumented precontact archaeological sites within the F/G Jetty Project Area, including along formerly exposed surfaces of seabed which have been inundated by post-glacial sea-level change (Figure 5). The D Jetty Project Area is considered to be in a location of low archaeological potential.

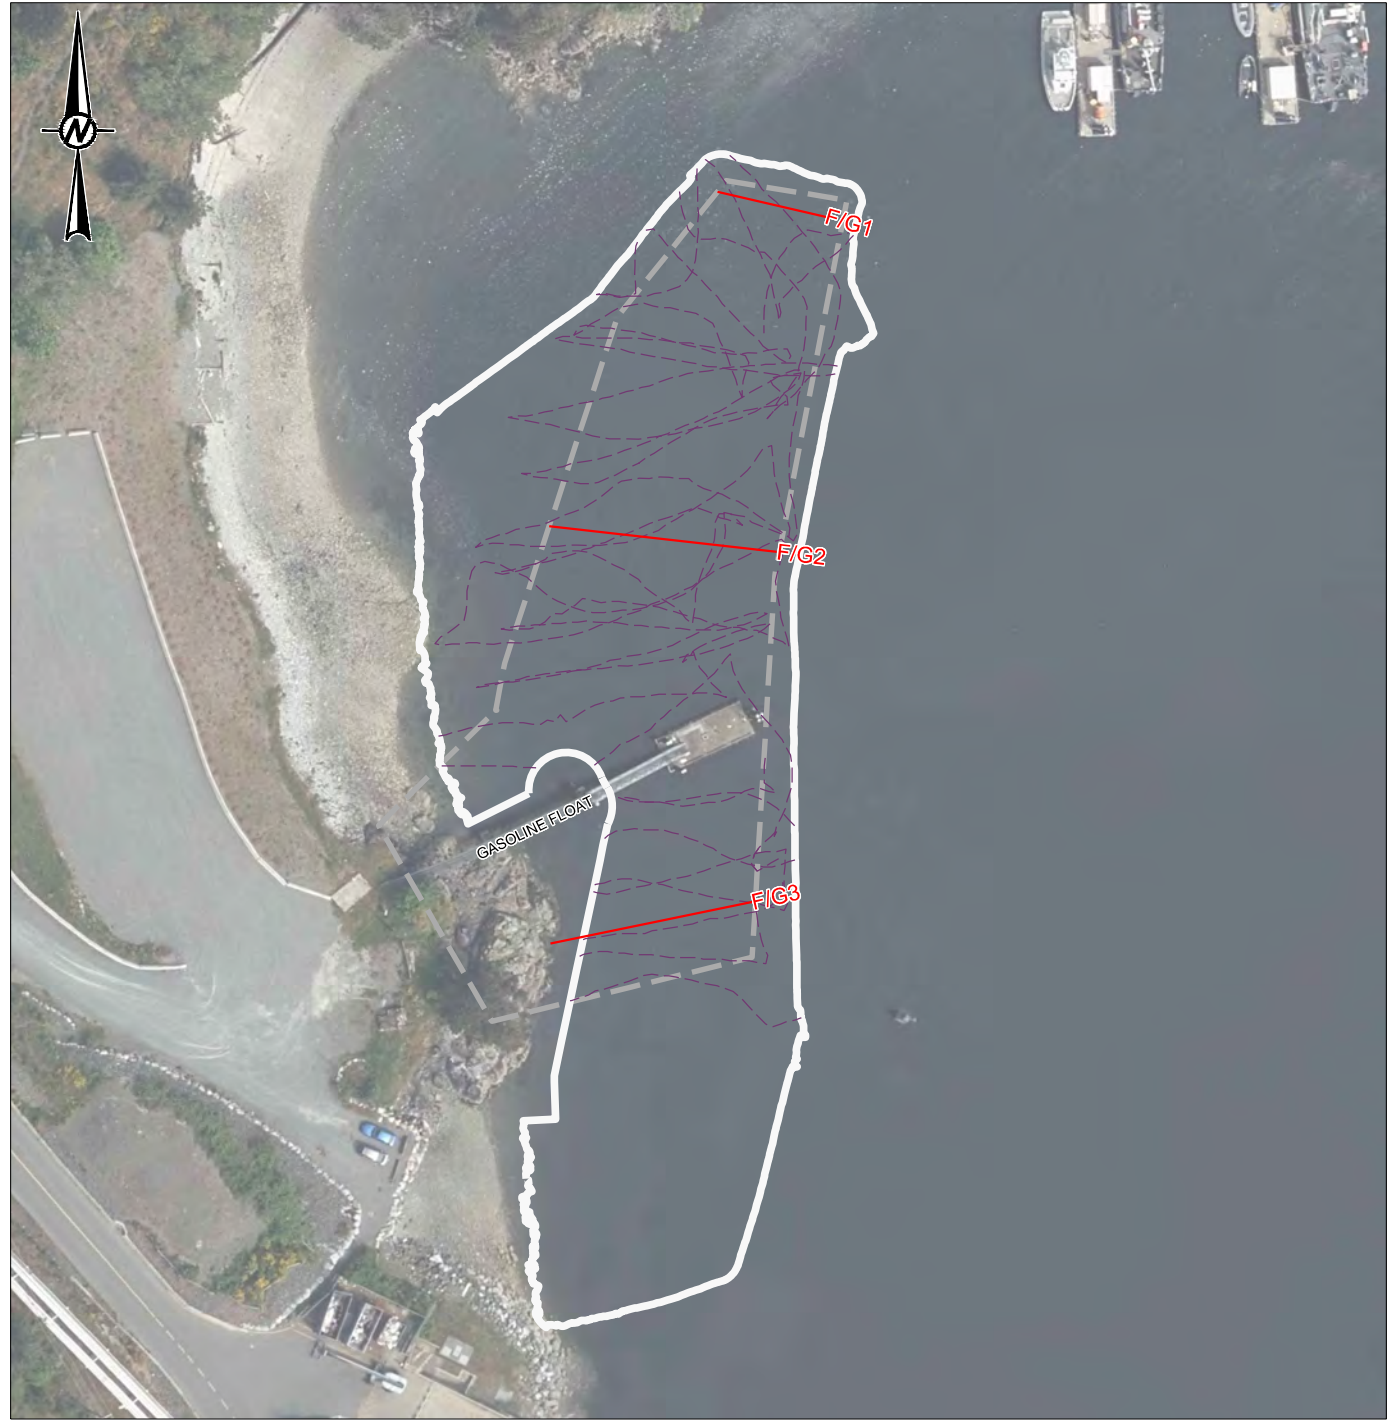
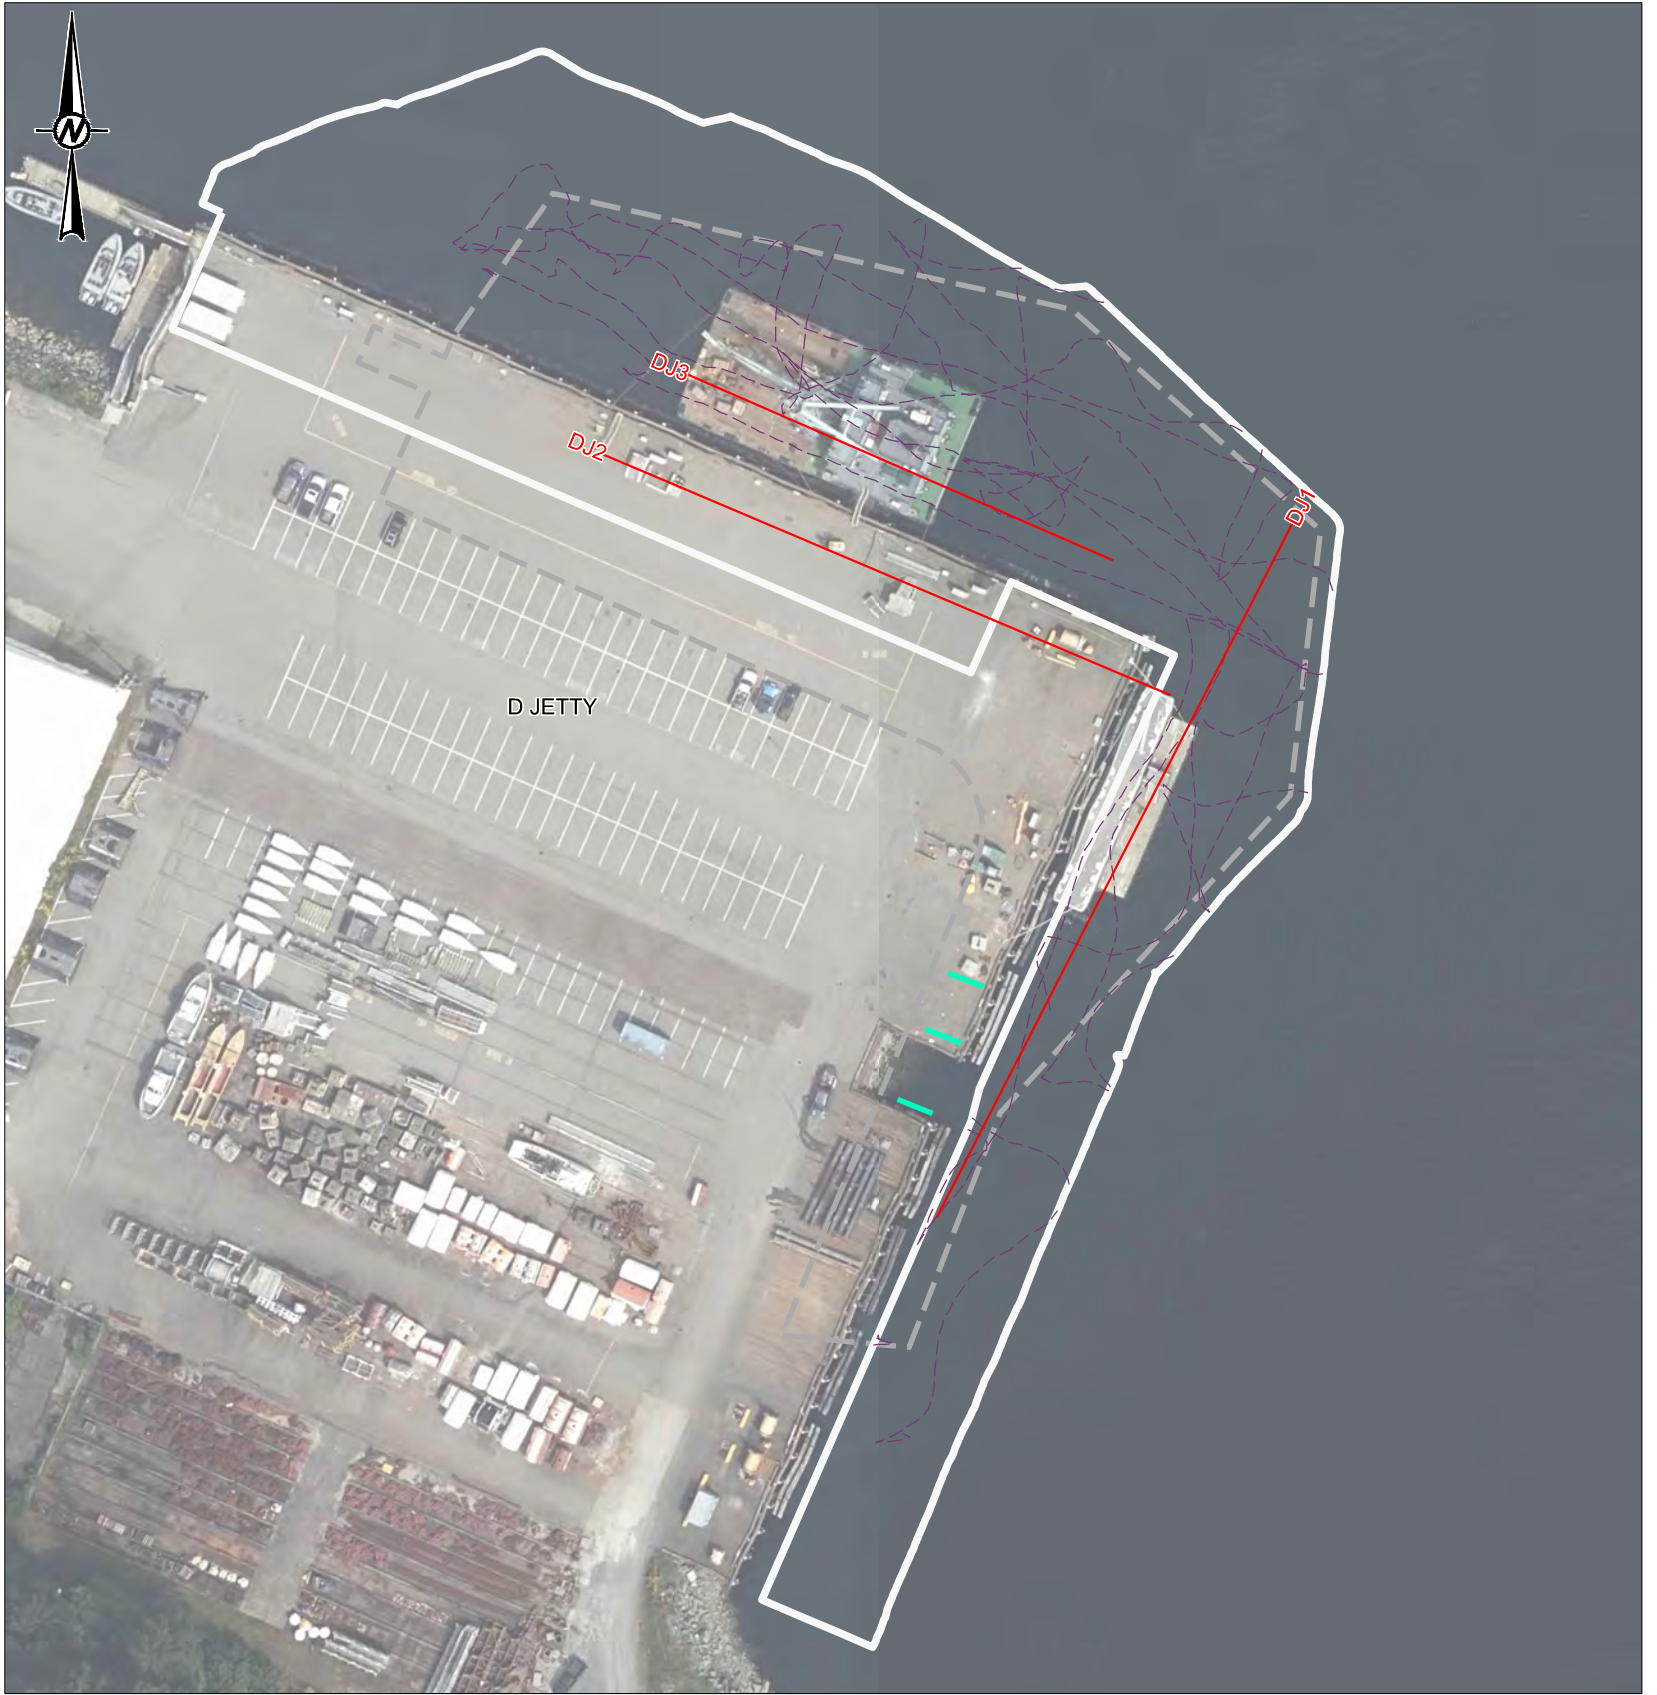
- LEGEND**
- REMEDIATION FOOTPRINT (2016)
 - FORMER REMEDIATION FOOTPRINT
- SURVEY METHODS:**
- ABALONE DIVE TRANSECT
 - BIOPHYSICAL DIVE TRANSECT
 - TOWED VIDEO SURVEY

The objective of this work was to document marine communities in the Project Area (Figure 1) to support environmental permitting and potential habitat offsetting requirements for the proposed remediation activities. The survey design was based on Golder's understanding of the project description at the time of the survey, which was described in Anchor (2013). The proposed project activities and dredge areas identified in Anchor's 2013 preliminary alternative basis of design report were the most up to date project specifications available at the time of the survey.

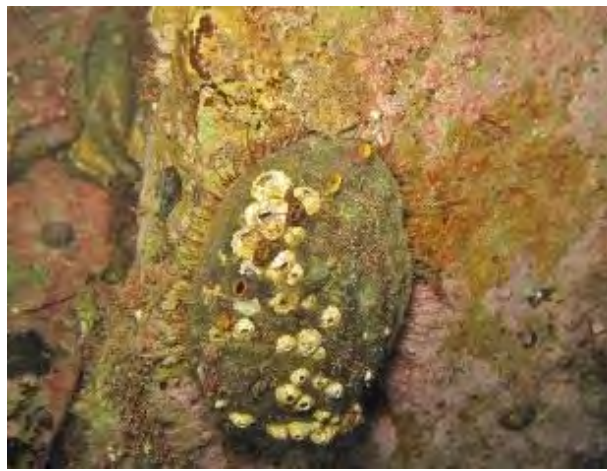
Photograph 4: Northern abalone at D Jetty (dive survey) – Feb 18, 2016

Phase 1 abalone surveys conducted in February 2016 identified the presence of four northern abalone, a gastropod listed federally as threatened and provincially as red-listed, adjacent to the D Jetty Project Area (Golder 2016a [Annex A]). The abalone were observed within boulder habitat in the under-pier area at the east side of D Jetty which is outside of the proposed Project footprint (Figure 3). Abalone were observed in the shallow subtidal zone ranging from 1.0 to 2.5 m below chart datum (Annex A – Figure 4) and ranged in size from 33 to 133 mm in shell length (SL). Suitable abalone habitat adjacent to the D Jetty Project Area was mapped at approximately 43 m in length parallel to the east side of D Jetty, and consisted primarily of boulder habitat covering a total estimated area of 241 m² (Annex A – Figure 4). Abalone predators were not observed within either area nor were abalone observed in association with urchins. A green sea urchin (*Strongylocentrotus droebachiensis*) and a red rock crab were also observed in the boulder area during the abalone survey.

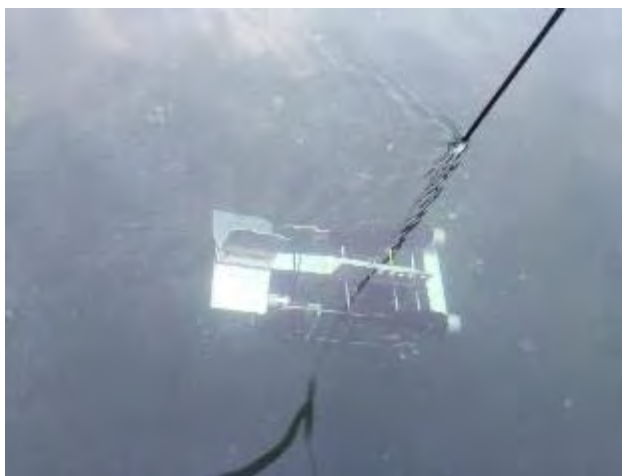
Photograph 2: Towed video camera during survey – Jan 26, 2016

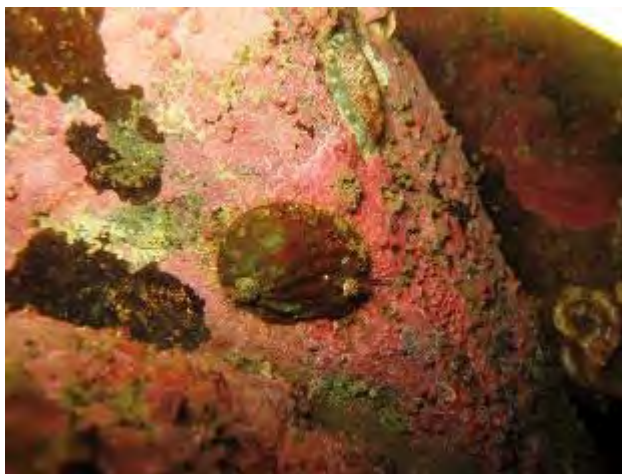
Photograph 3: Northern abalone on encrusting coralline algae at D Jetty (dive survey) – Feb 18, 2016

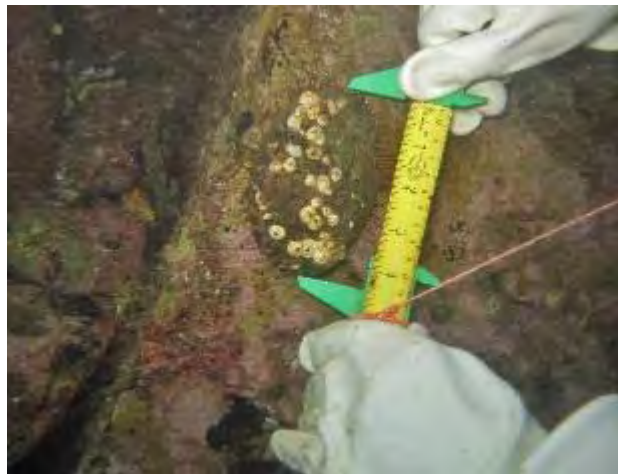
Photograph 6: Measuring northern abalone at D Jetty (dive survey) – Feb 18, 2016

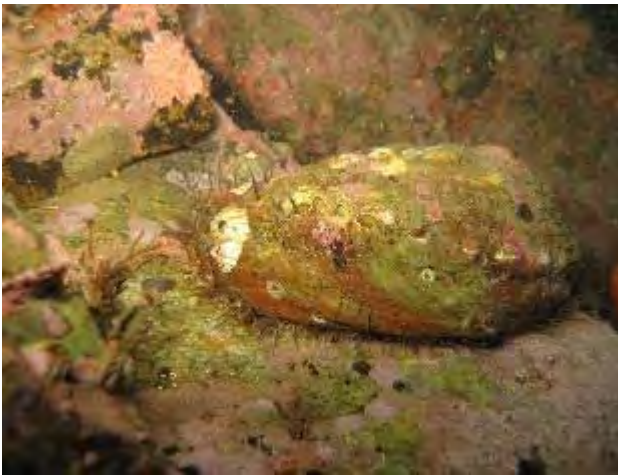
Photograph 7: Northern abalone at D Jetty (dive survey) – Feb 18, 2016

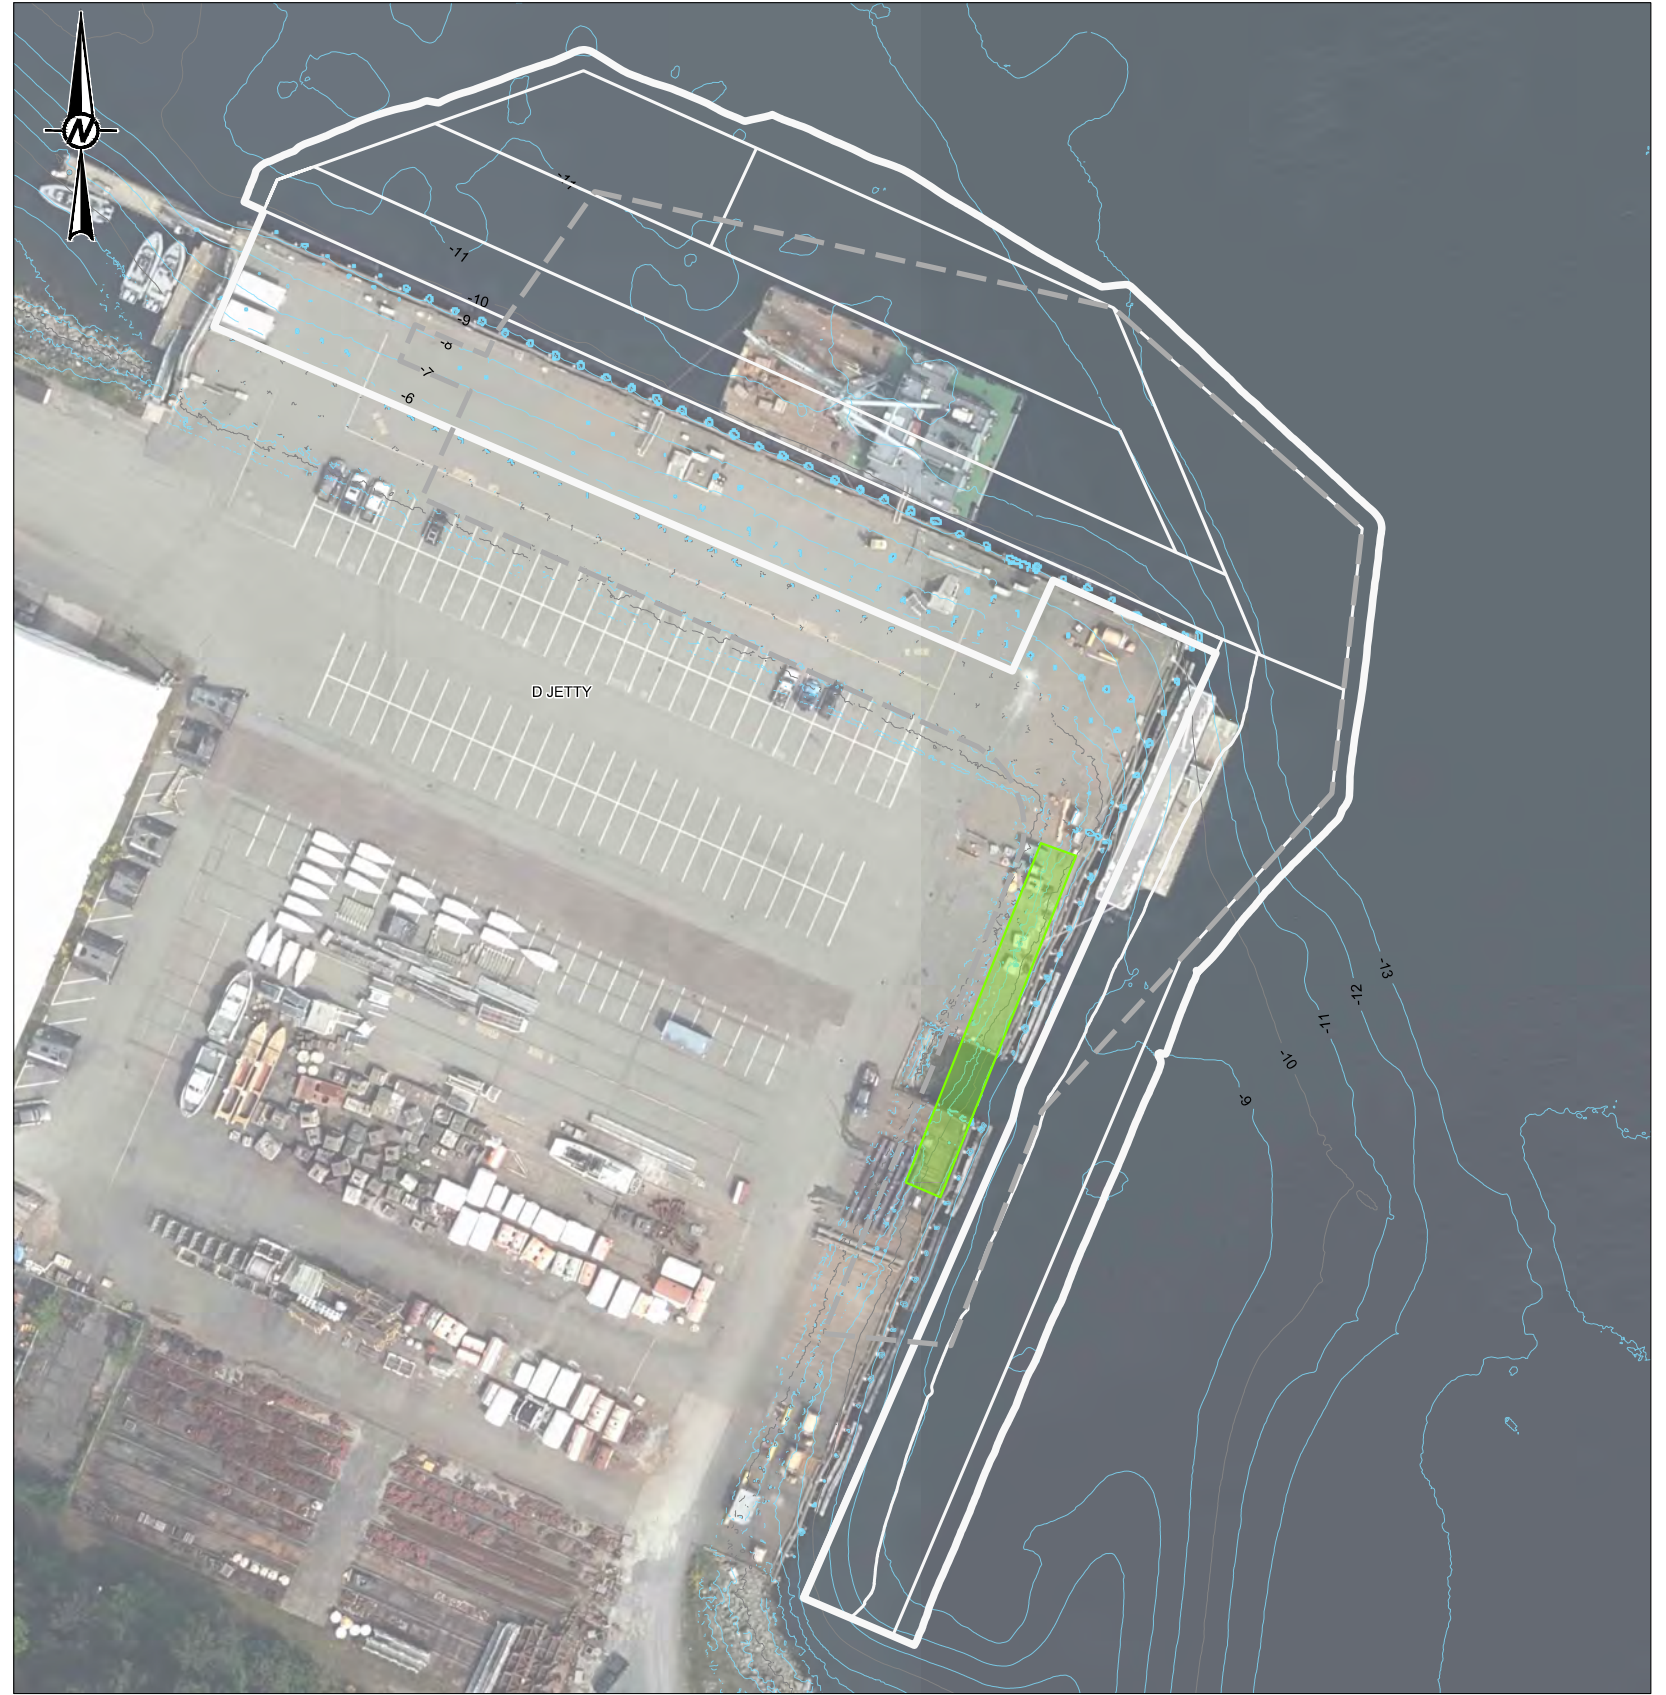
PROJECT	F/G JETTY OPTIMIZATION PROJECT AND COLWOOD SOUTH REMEDIATION PROJECT MARINE HABITAT OFFSETTING		
TITLE	MAPPED SENSITIVE HABITATS		
PROJECT NO.	PHASE	REV.	FIGURE
1657898	2000	0	3
