## Overall plan

## Excavation of the shoals in the Small Lake area Chamby Canal

### General plan

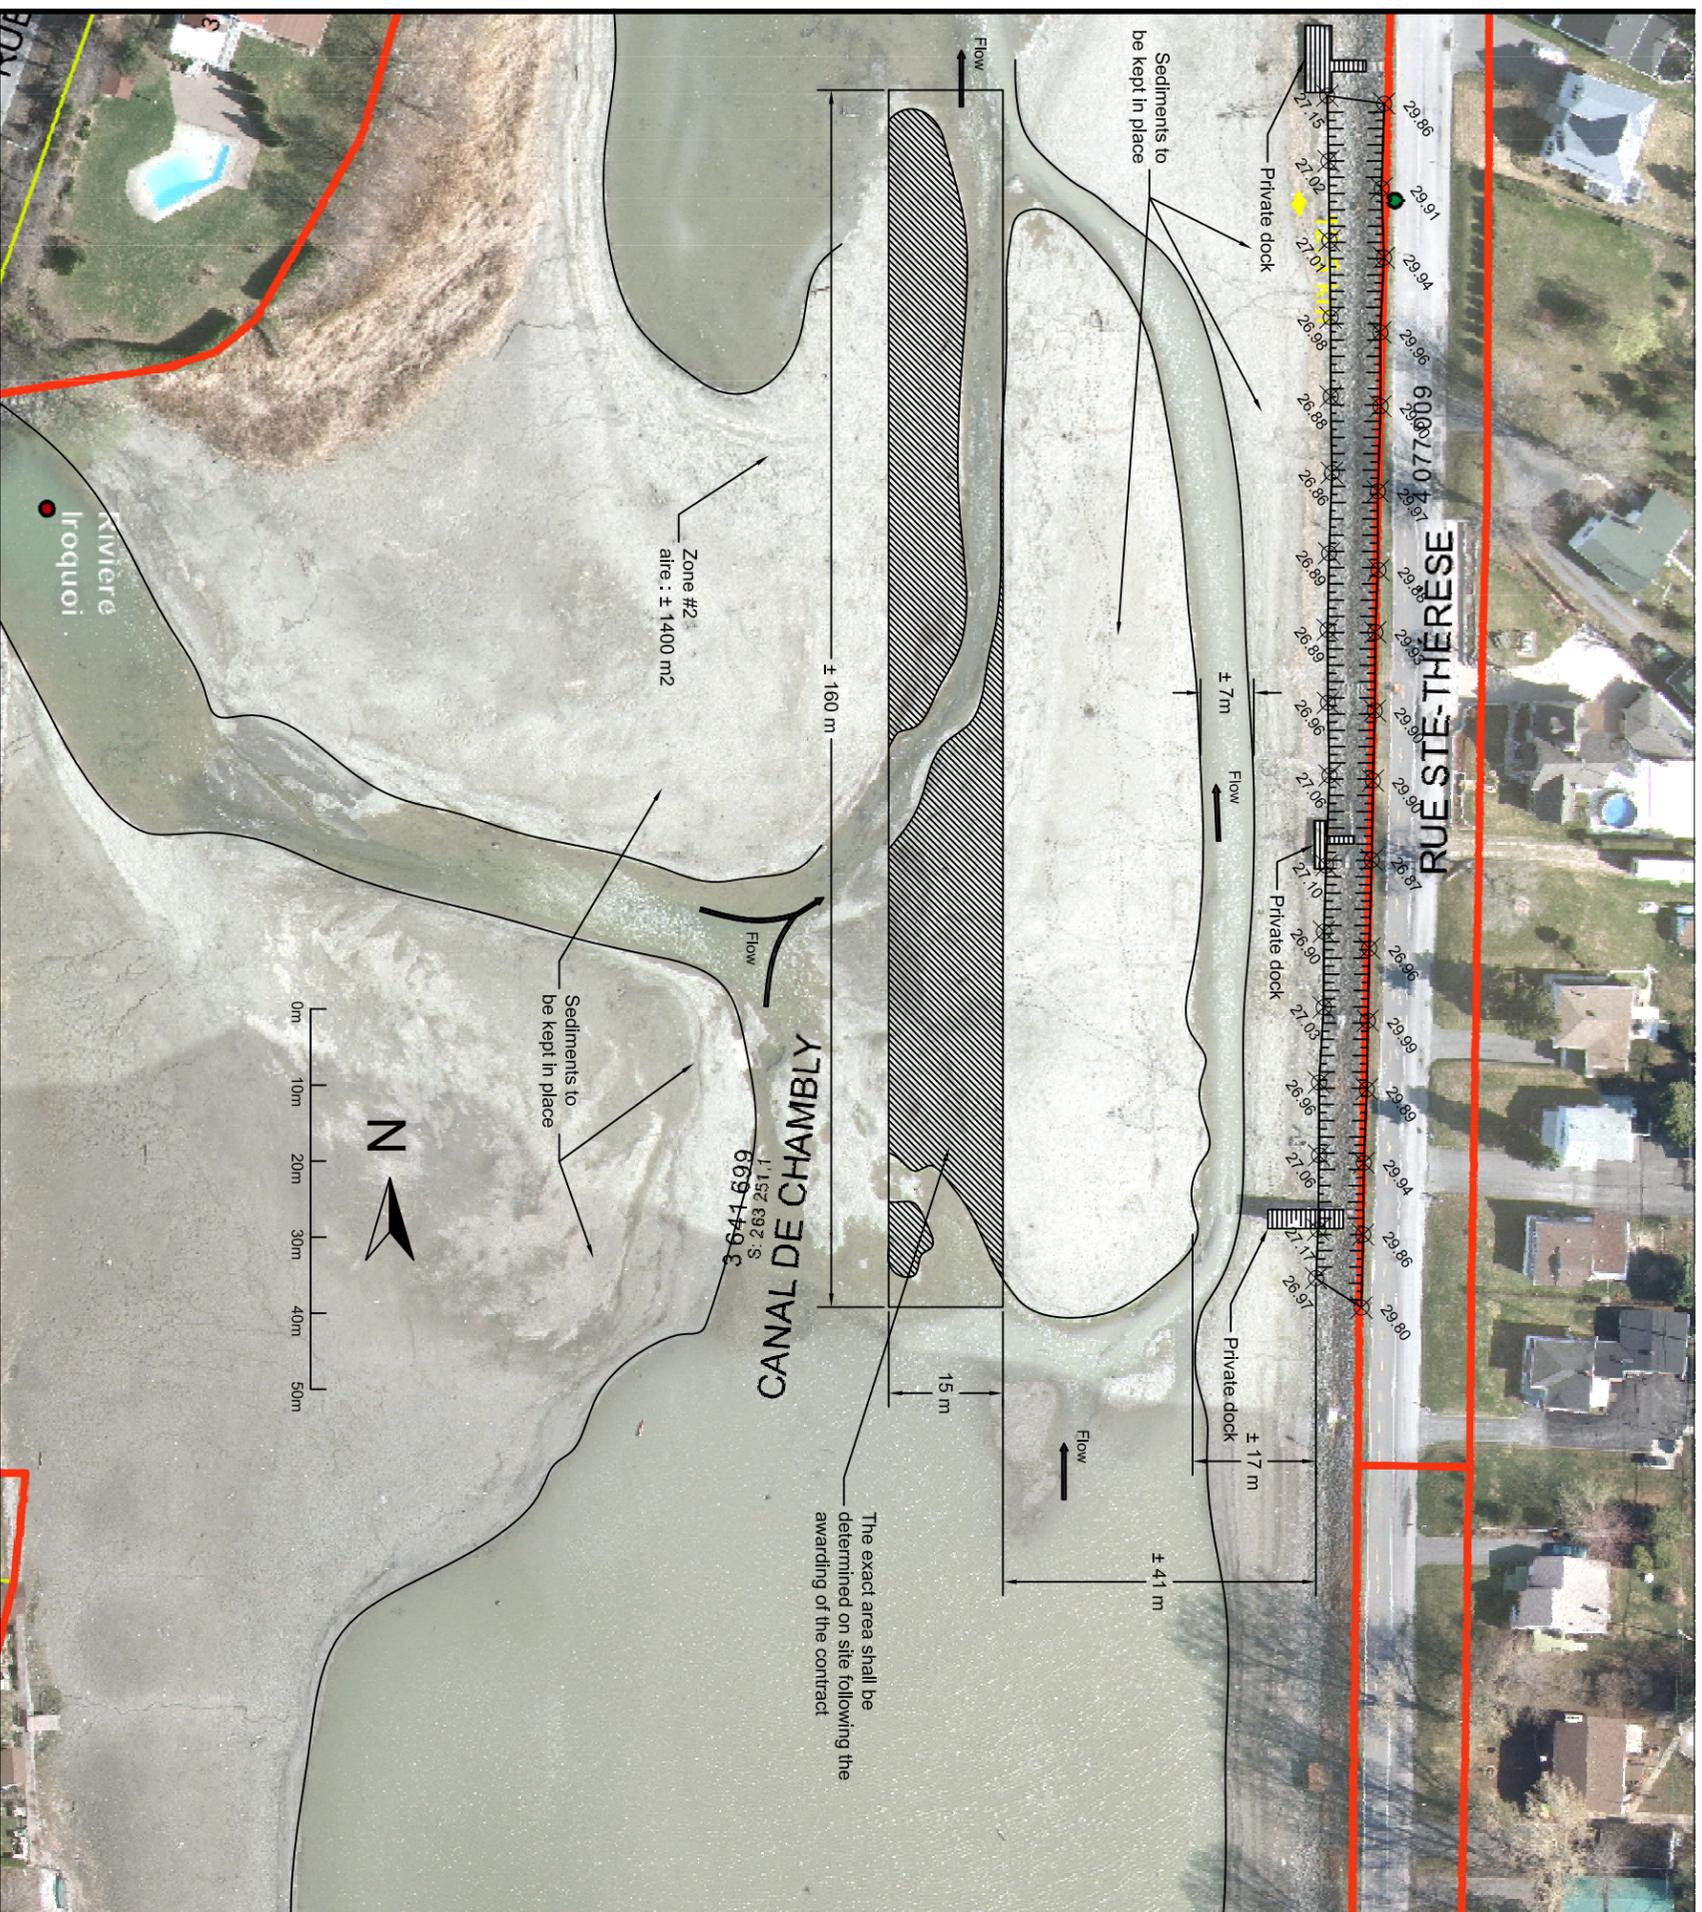
- Coordinates of the intervention : 45.359019, -73.267110 (near 324 rue Sainte-Thérèse, Saint-Jean-sur-Richelieu, Qc)
- The surfaces of area #1 and #2 are based on satellite images from 2012. Surfaces that may be excavated must be confirmed by Parks Canada at the time of the intervention
- The measures on the plan are indicative in order to allow the contractor to provide a price to Parks Canada.
- The bottom of the canal is contaminated by an accumulation of sediments. It may be difficult to move to the bottom of the canal.
- The Contractor shall provide all necessary measures to enable the Contractor to travel without being bogged down.
- The environmental measures required are presented in the appendices and must be considered for the execution of the works.
- Access to the work area must be via Sainte-Thérèse Street
