PUBLIC WORKS AND GOVERNMENT SERVICES
ESQUIMALT FILL SITE
ESQUIMALT, BC

EASTERN UPLAND REMEDIATION

CROSS SECTION A-A'

CROSS SECTION B-B'

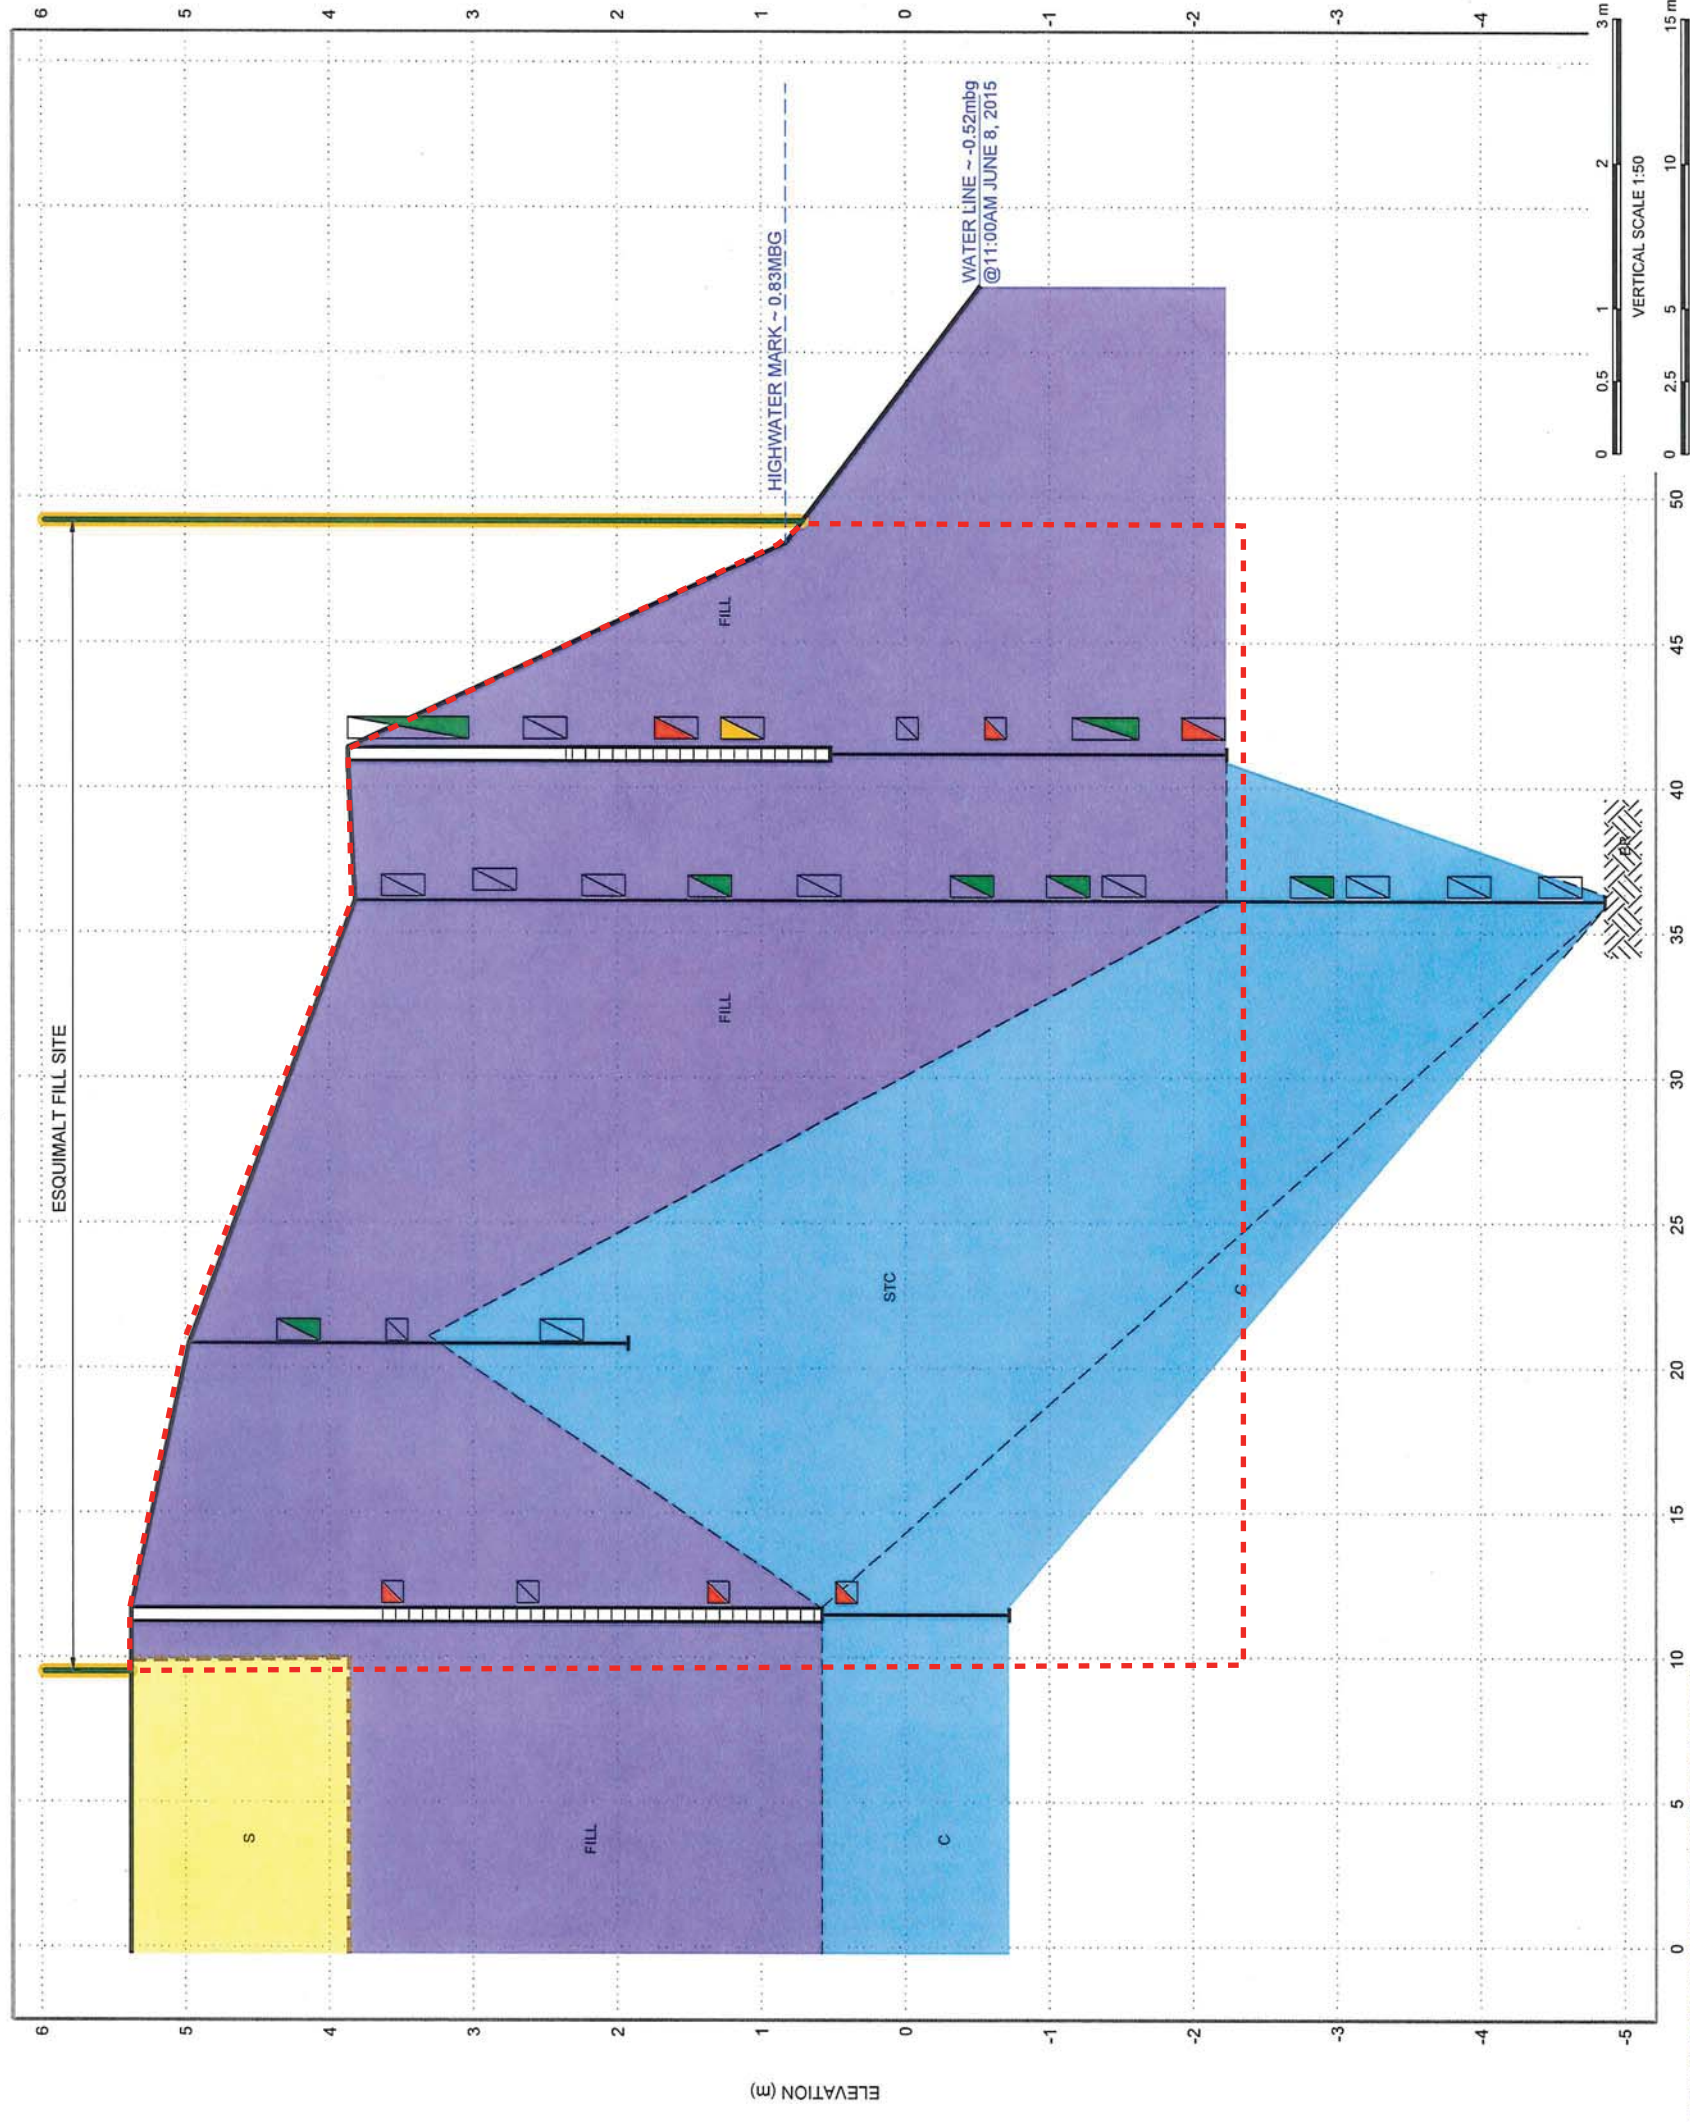
A
NORTHEAST

A'
SOUTHWEST

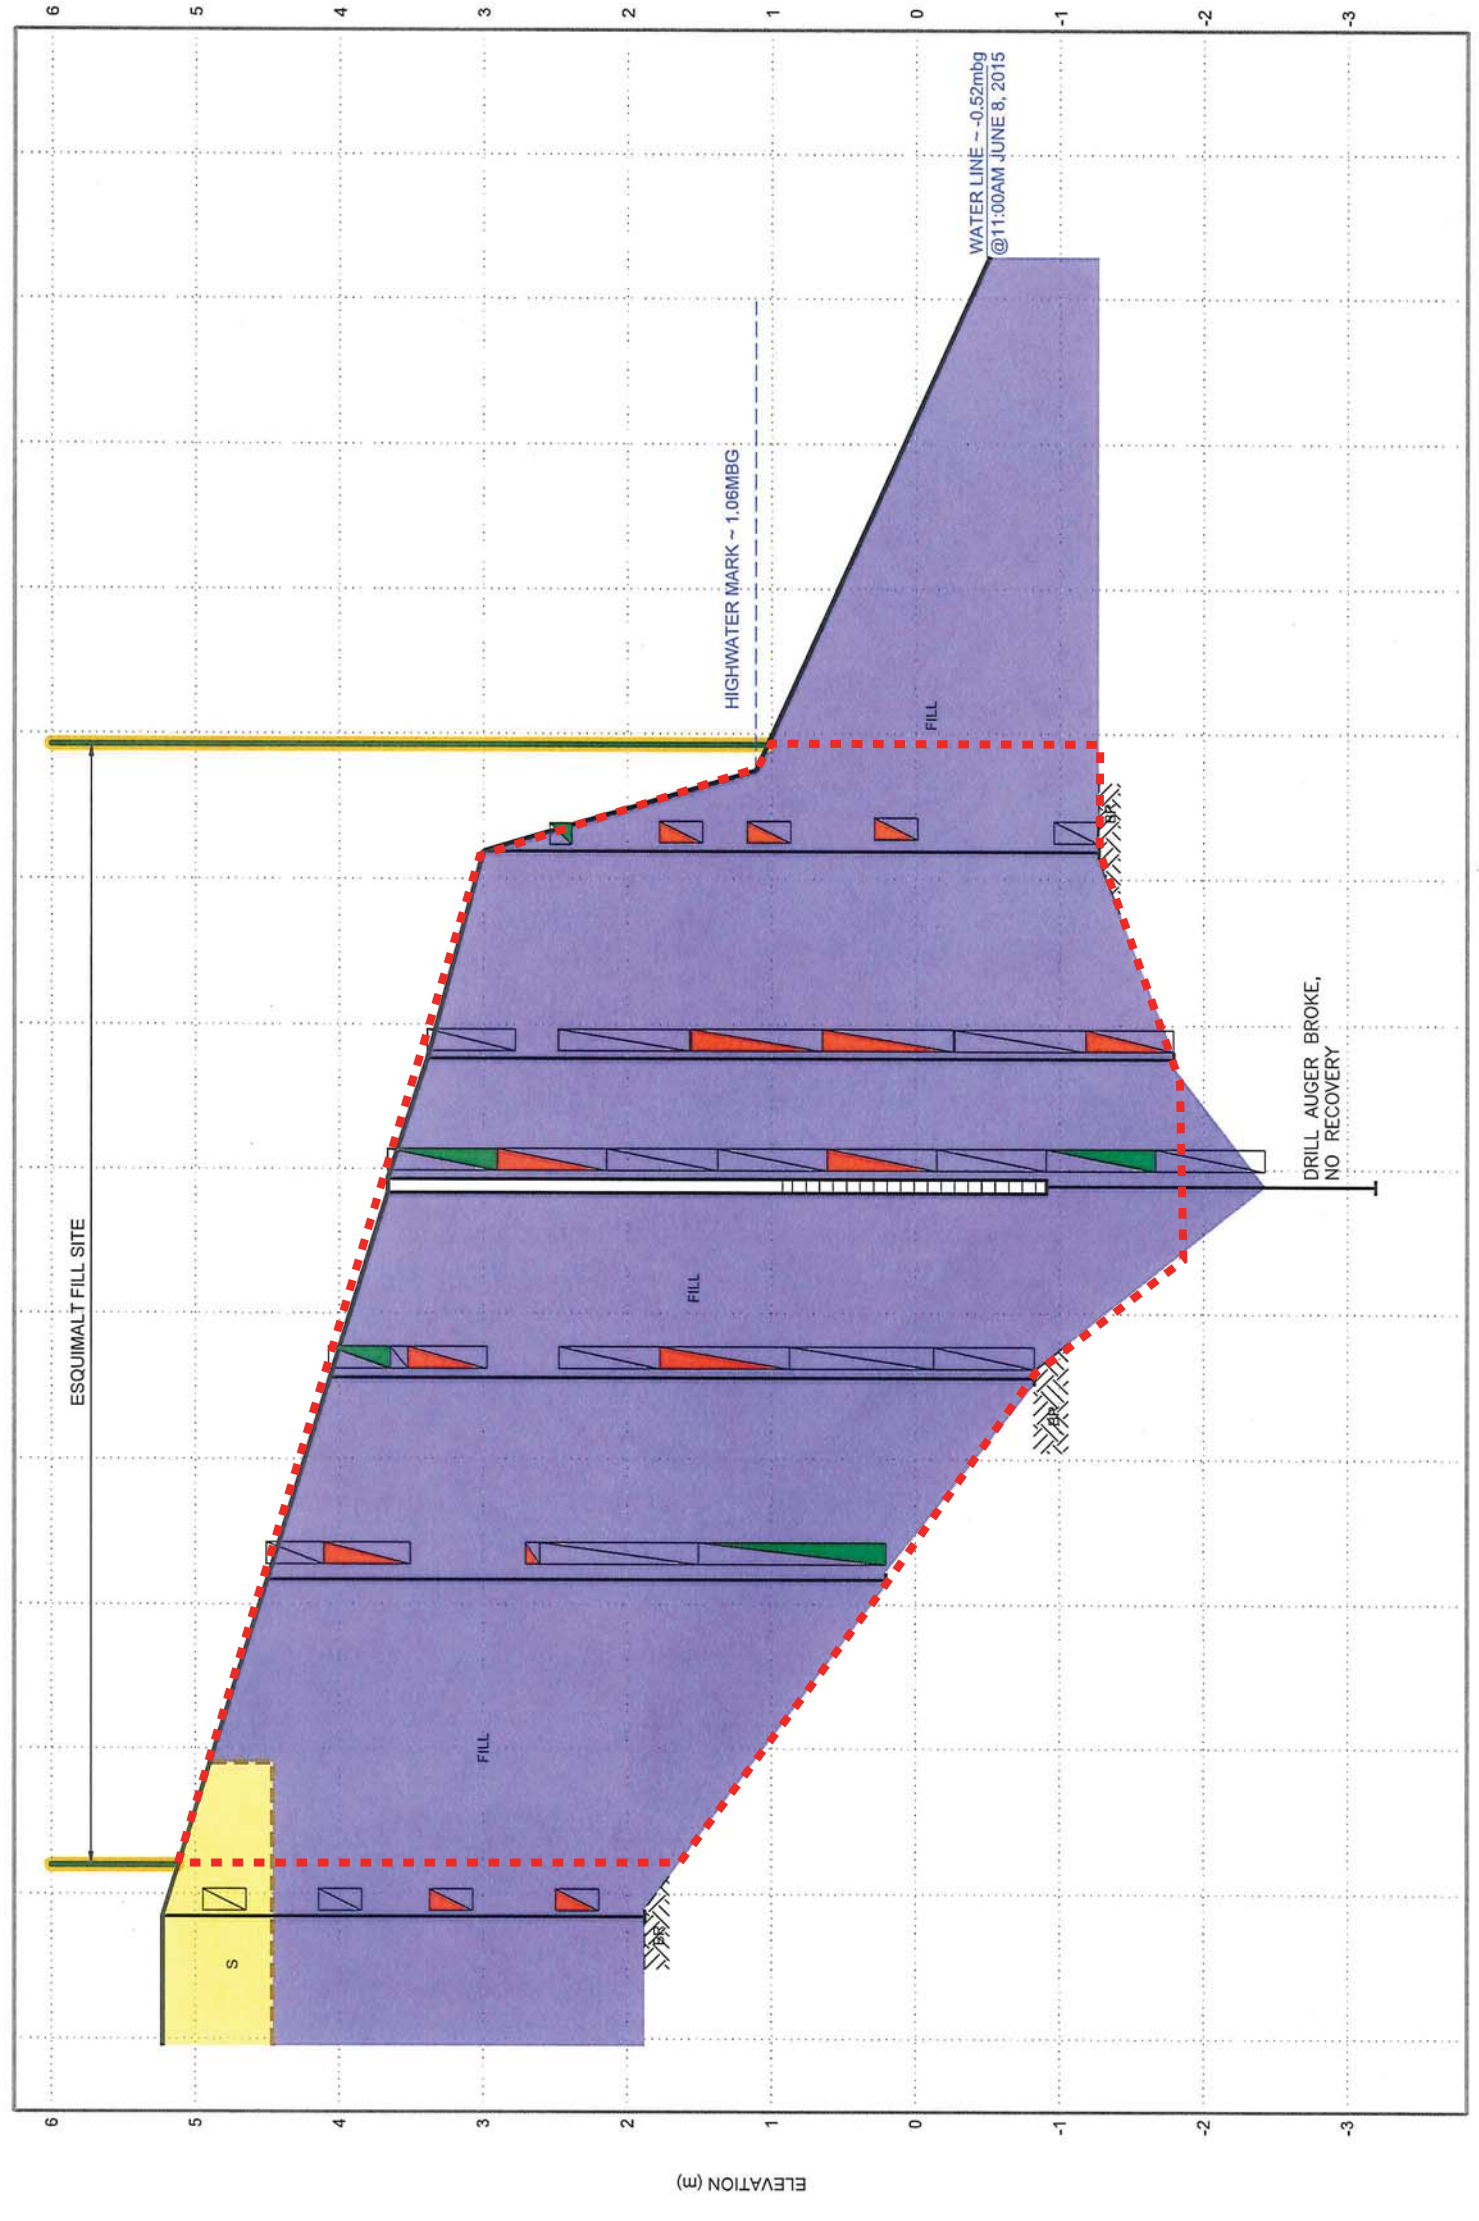
B NORTHEAST
 SOUTHWEST **B'**
