Project title/Titre du projet
BRIDGE REHABILITATION
BANFF NATIONAL PARK, ALBERTA
KM 38.4 - BOW VALLEY PARKWAY
BAKER CREEK BRIDGE

UNDERMINING REPAIRS
FOLLOWING 2013 FLOOD EVENT

Project No./No. du projet 201315	Sheet/Feuille 002 OF 002	Revision no./La Révision no. 0
-------------------------------------	--------------------------------	-----------------------------------

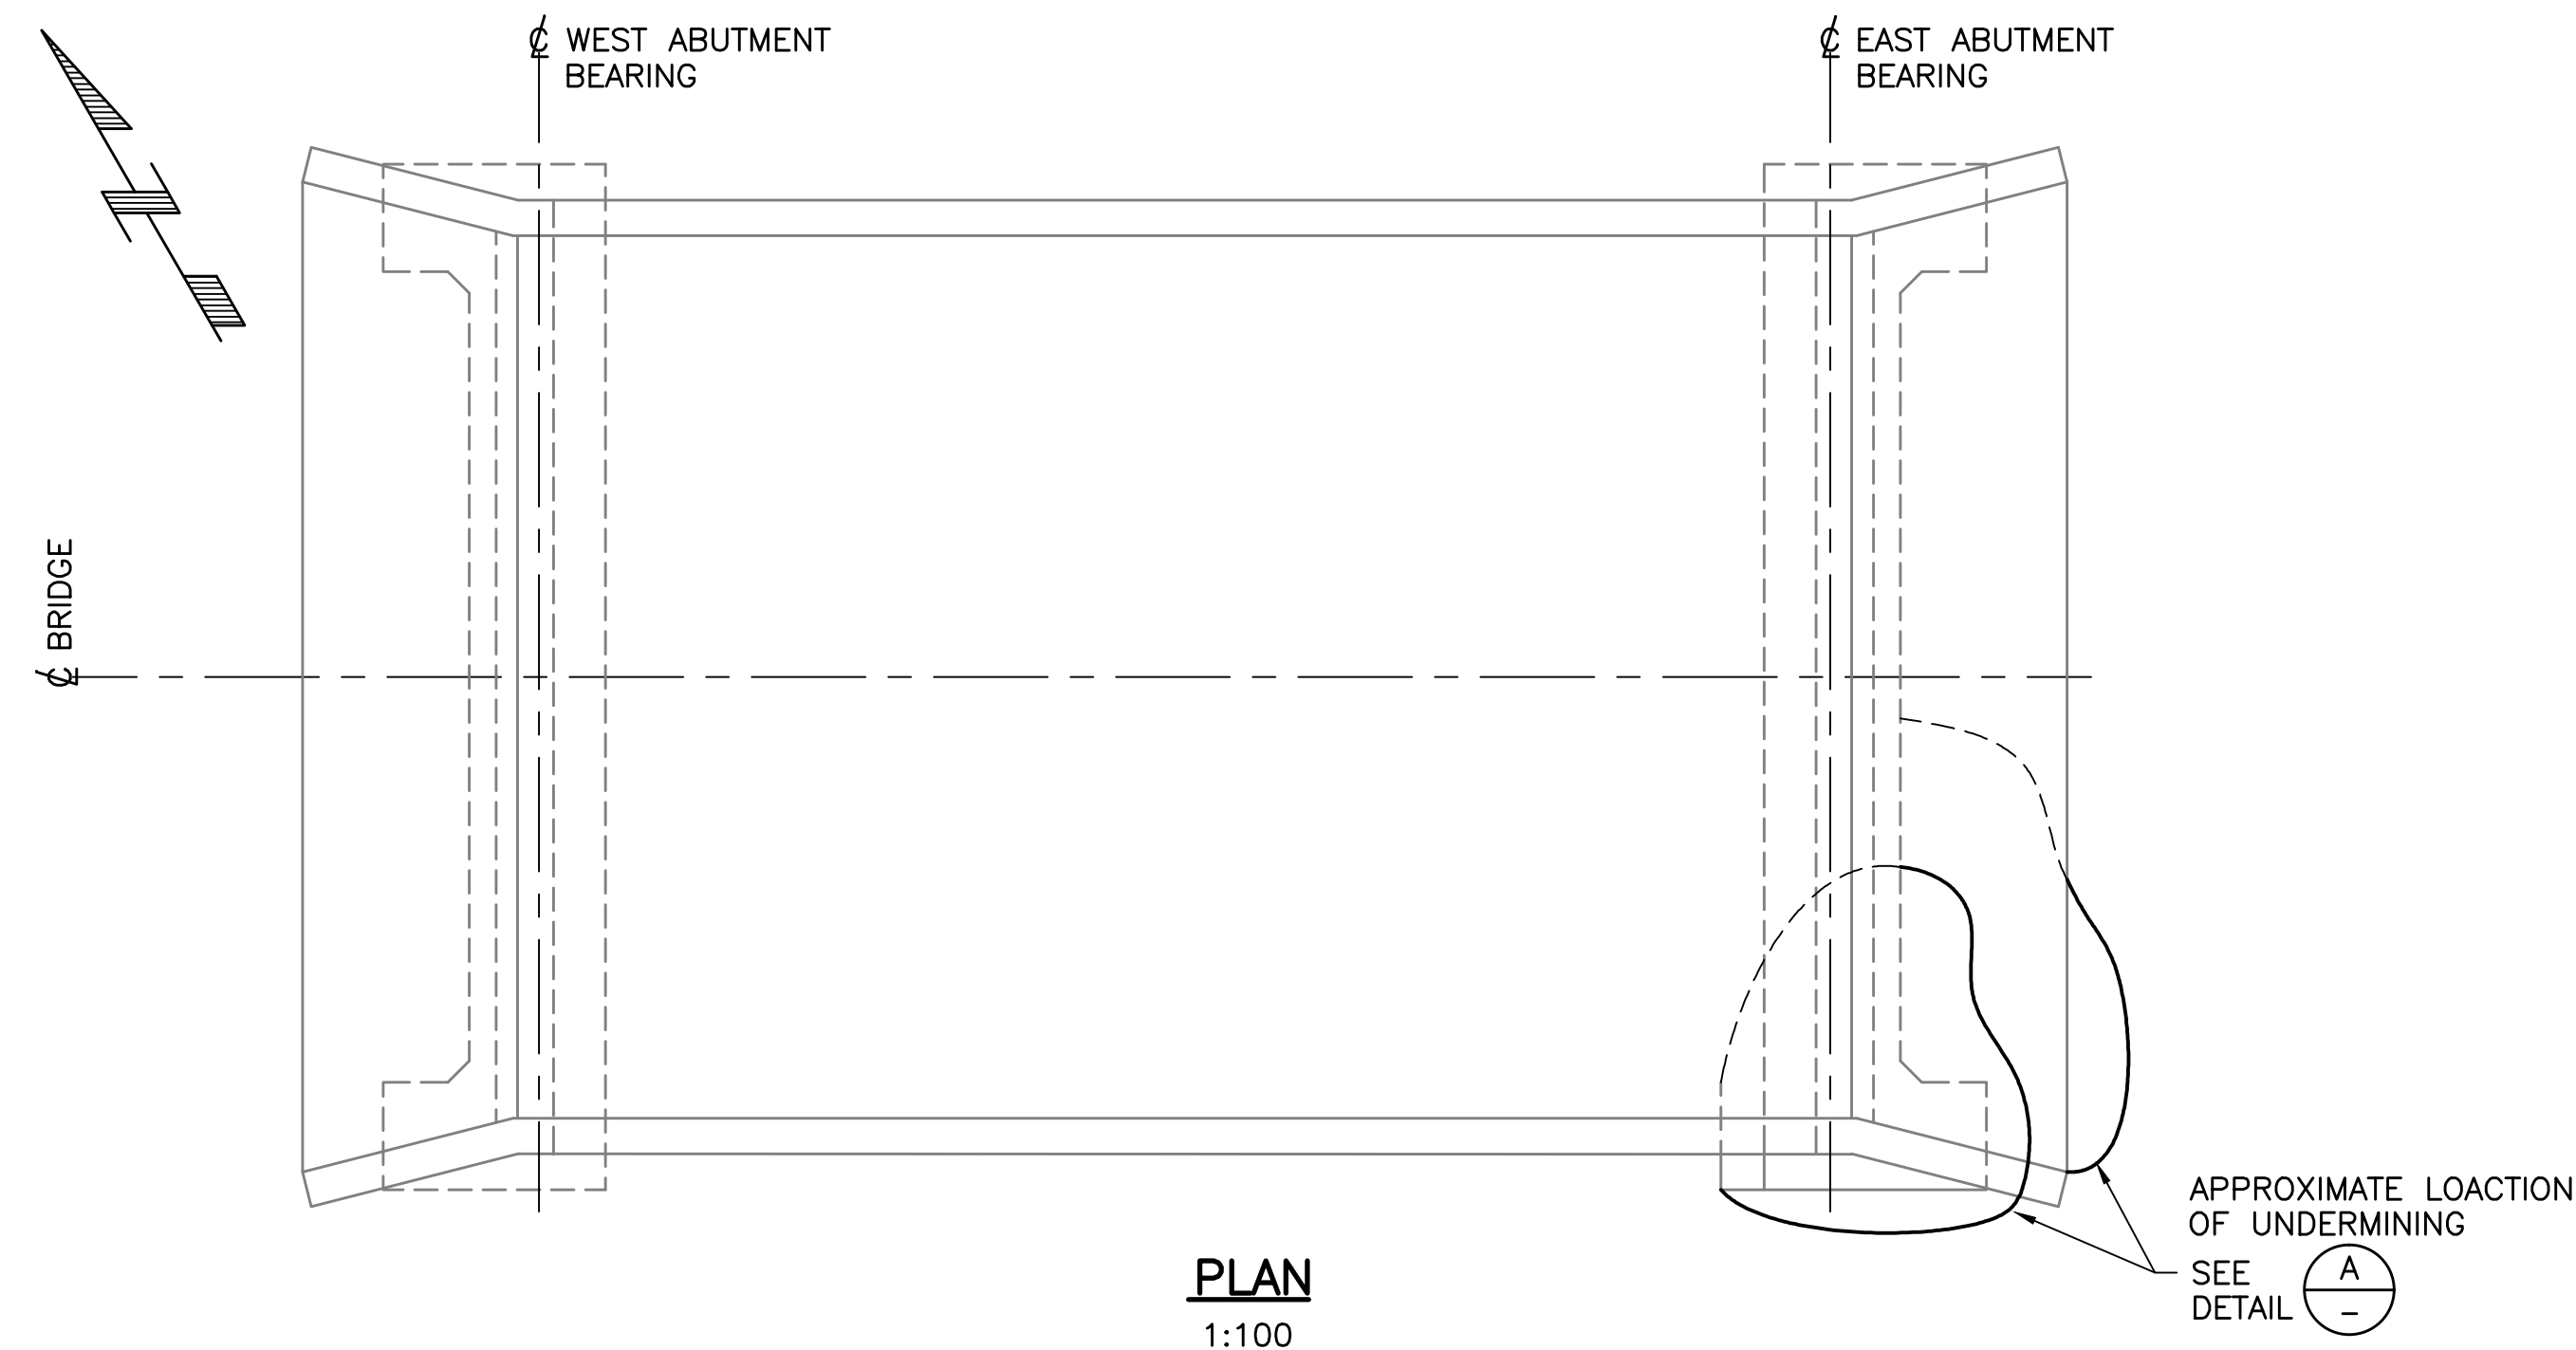
PLAN
1:100

1. UNDERMINING OF EAST ABUTMENT OCCURRED DURING 2013 JUNE FLOOD EVENT.
2. CONCRETE PLACED TO FILL RESULTING VOIDS AS INDICATED.
