MACHIAS SEAL ISLAND LIGHTHOUSE RESTORATION

SECTION DETAIL PHOTOS

designed	conçu
date	
drawn	dessiné
date	
approved	approuvé
date	July 2017
Tender	lan Scales
PWGSC Project Manager	Administrateur de projets TPSGC
project number	no. du projet
	R.080316.001
drawing no.	no. du dessin
	A300

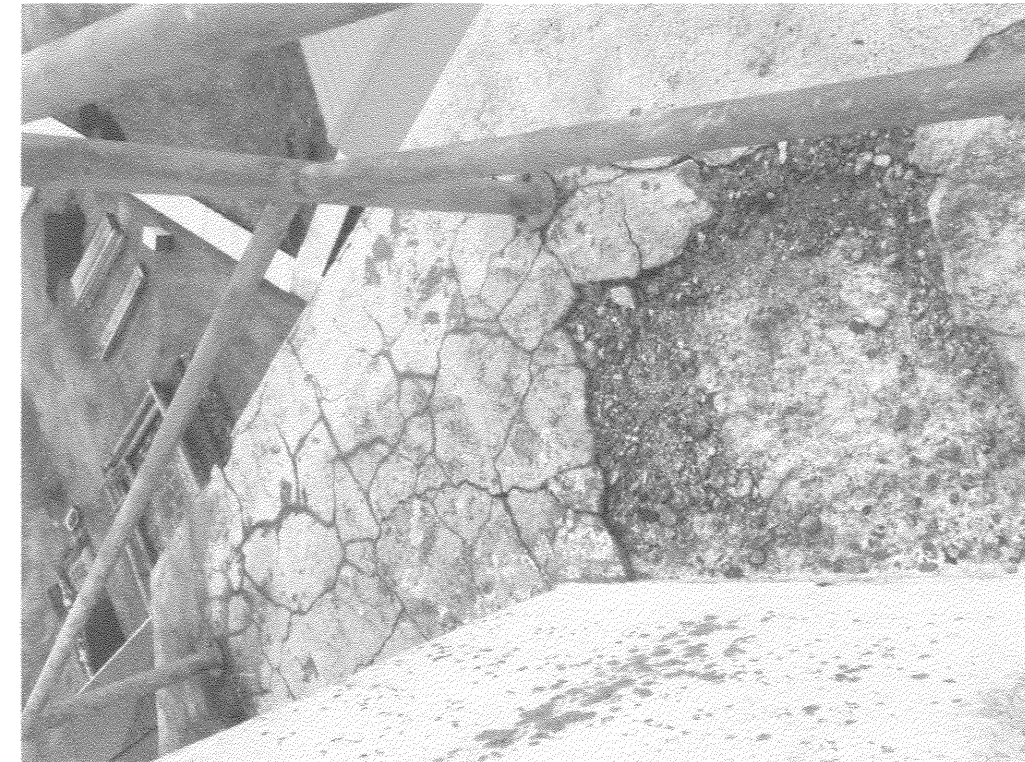
PHOTO 06 - NEW TRAFFIC COATING PROVIDED. NEW RAIL TO BE 125mm FROM GALLERY EDGE. REFER TO DETAIL 1/A500.

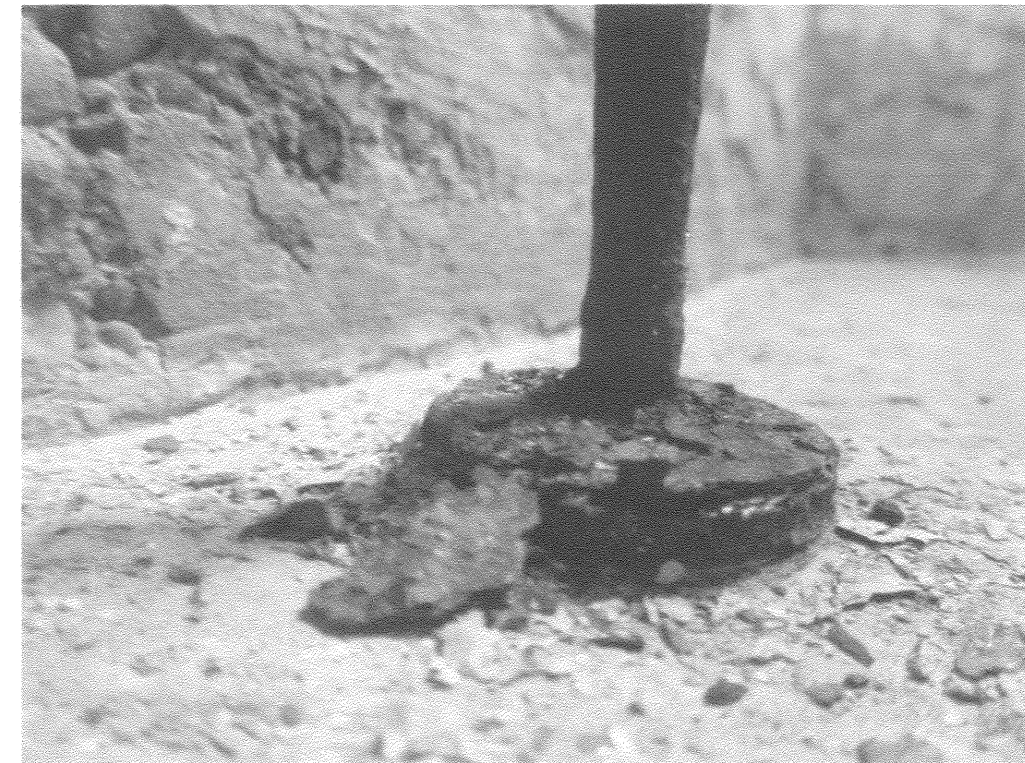
PHOTO 04 - DETAIL OF EXISTING R05 BOOT TO BE REPLACED

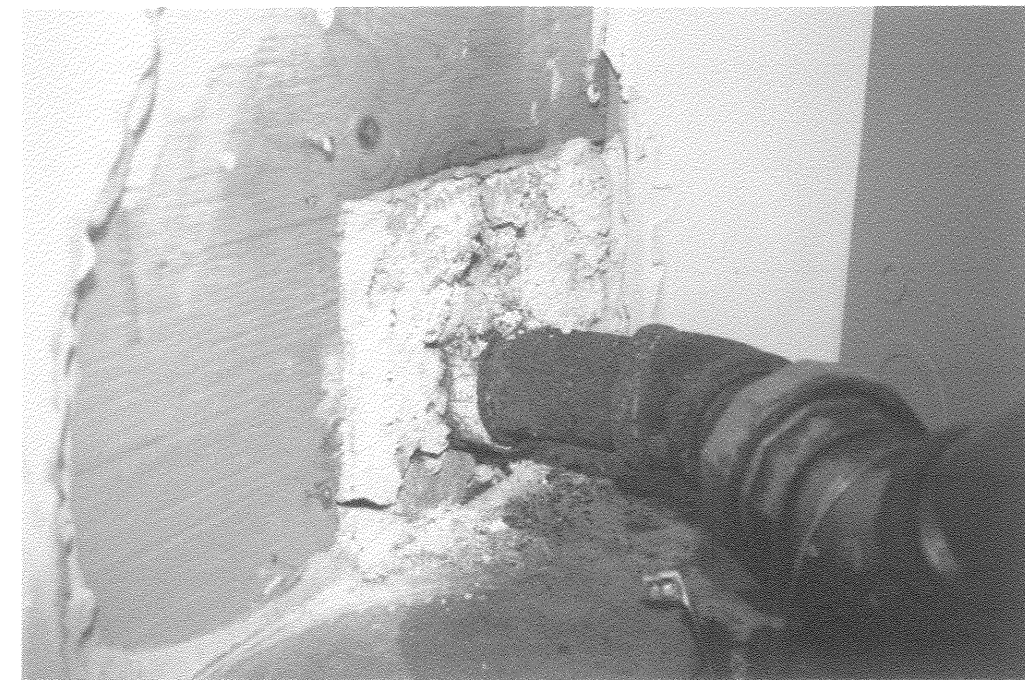
PHOTO 02 - EXTERIOR WALL PENETRATIONS AT FIRST LEVEL TO BE PROPERLY SEALED WITH FIRE PROTECTION AROUND EXHAUST. PROVIDE NEW DRYWALL FINISH, PRIME & PAINT.

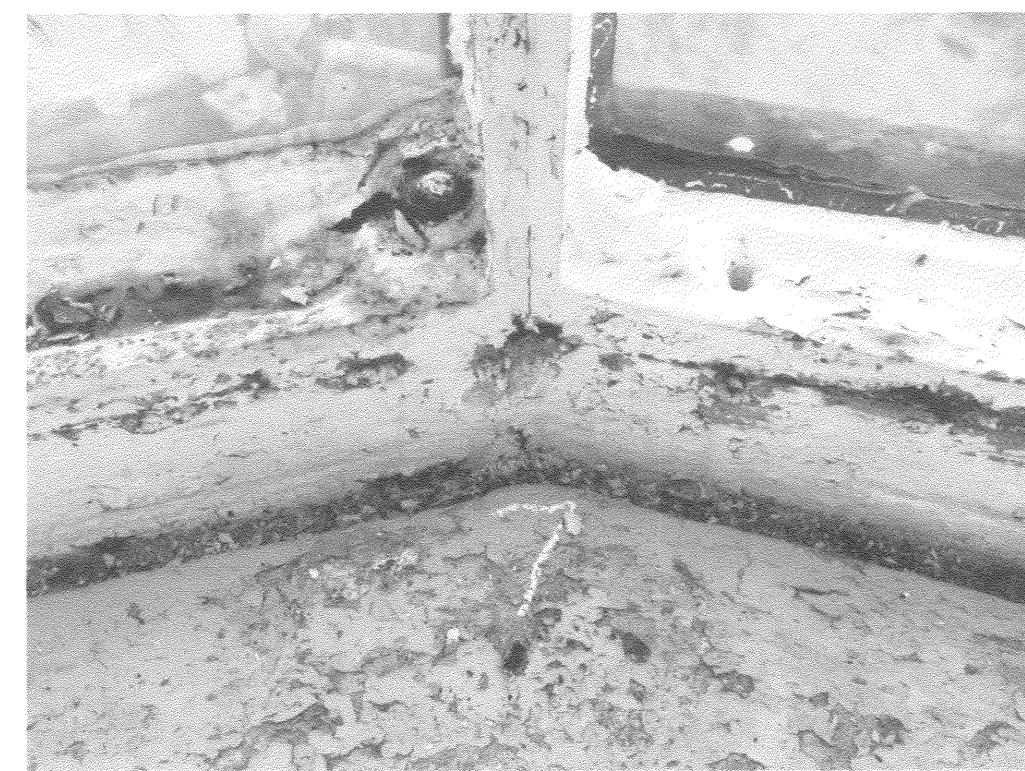
PHOTO 01 - DETAIL VIEW OF INTERIOR LANTERN WINDOW ASSEMBLY
