5 ELEVATION NTS  
MCC 5

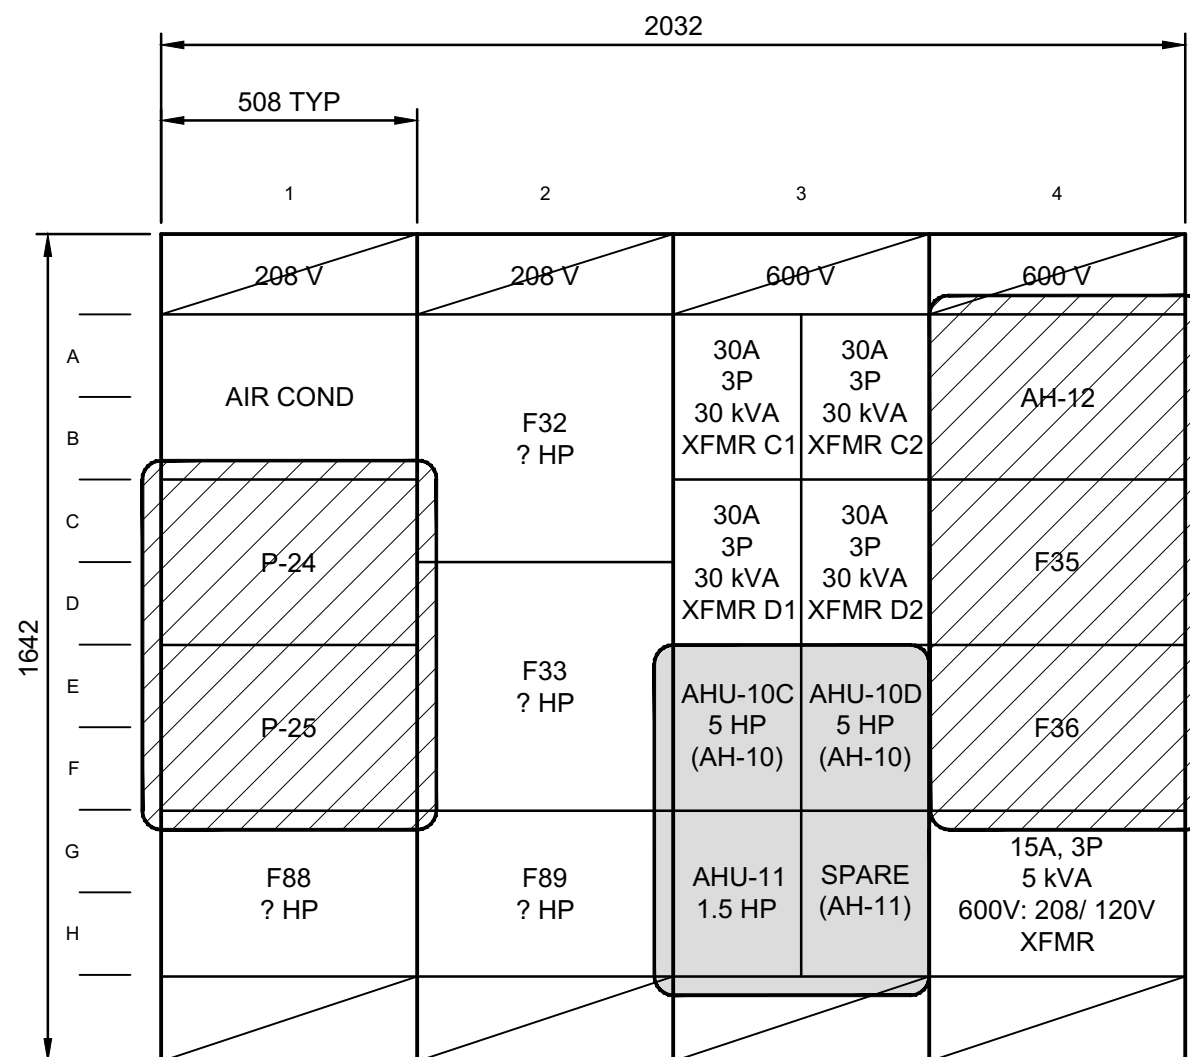
EXISTING MCC BUCKET BEING DEMOLISHED AND REPLACED WITH NEW EQUIPMENT. FORMER LOAD NAME INDICATED IN PARENTHESIS.

EXISTING MCC BUCKET BEING DEMOLISHED AND LEFT AS EMPTY SPACE. DEMOLITION TO INCLUDE INSTALLATION OF NEW DOOR.

NEW MCC BUCKET BEING INSTALLED IN FORMERLY EMPTY SPACE.
