**9801 102 STREET
FORT SIMPSON, NT**

ISSUED FOR TENDER - SEPTEMBER 2017

Duplex Residential Building
9801, 102 Street,
Fort Simpson, NWT

Williams Engineering Canada Structural Assessment Report

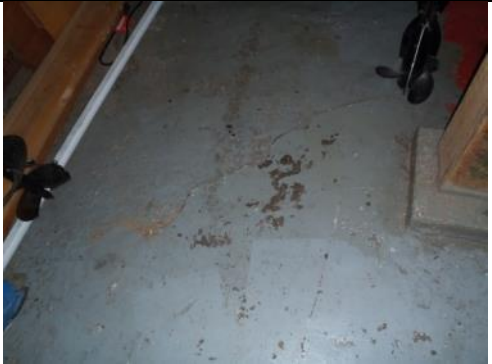
Condition	Recommendation	Photo
Cracks are visible throughout the basement slab. Some of the cracks are associated with the concrete topping delaminating from the concrete slab. A hollow sound can be heard when the slab is tapped with a hard object at these locations.	We would recommend that concrete topping is removed local to areas that have delaminated. The exposed surface area should be prepared with a bonding agent and new concrete topping placed.

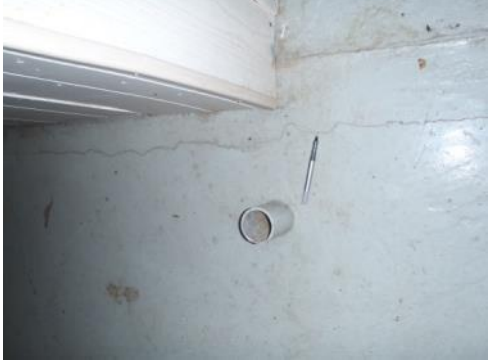
Uniform cracks in the concrete run from the back to the front wall at column locations in both basements. These cracks appear to be old and have not changed recently. Due to the uniform nature of these cracks it is likely that these occurred at or shortly after construction of the basement slab	No recommendation

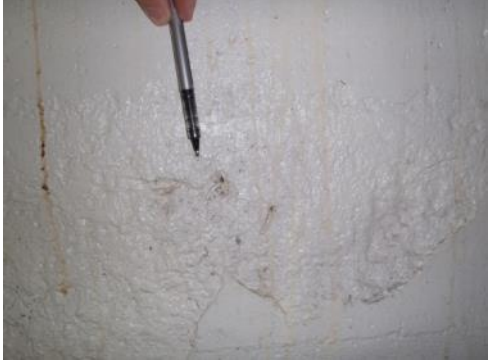
Patches of honeycombed concrete are visible in exposed concrete basement wall. These areas appear to be in fair condition.	No recommendation

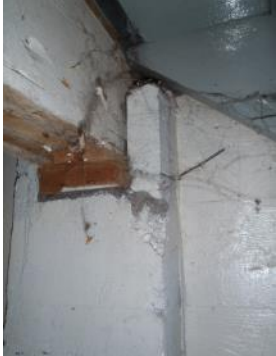
Some cracks and chipped concrete were visible at beam pocket locations in the dividing wall.	It is recommended that these cracks are repaired with an injection mortar that is suitable for the size of crack at this location.

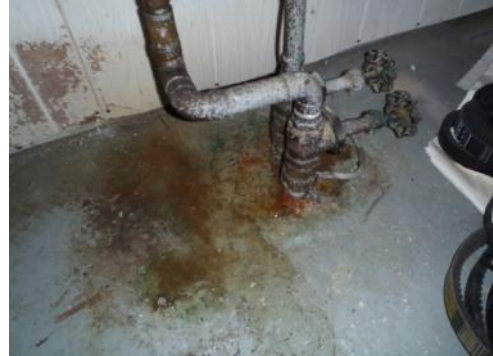
<p>The basement slab area directly around the main water connection is wet to touch. This may have been caused by either a small leak, or condensation forming on a cold pipe. There are signs of corrosion on the pipe.</p>	<p>Although this is a non-structural item, it is recommended that this be repaired to maintain a dry slab.</p>

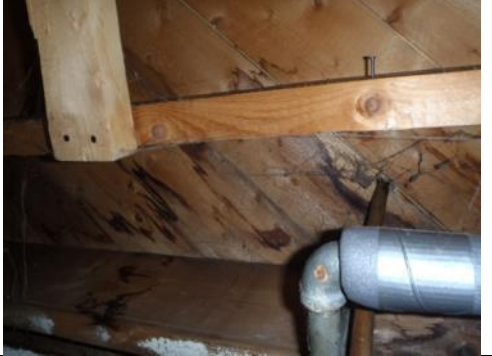
Condition	Recommendation	Photo
Generally the main floor deck was in fair condition. Some small patches of water staining were observed under the kitchen area on the underside of the floor deck and side of joists. These appear to have been localised leaks some time back and have been repaired and are currently dry.	No recommendations

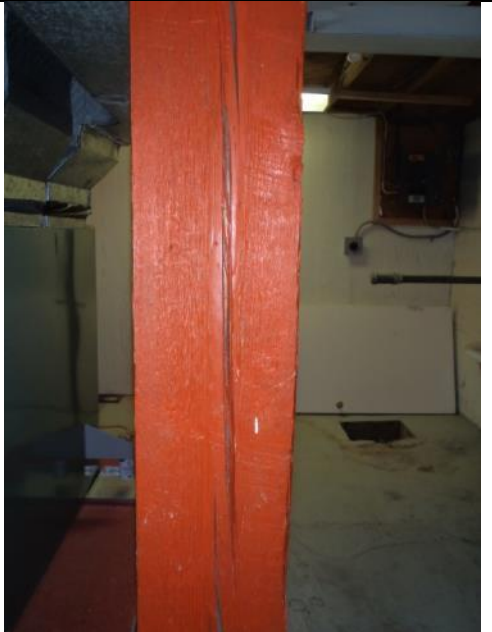
Joists and main floor beams that were observe were in fair condition.	No recommendations	See Photos10 – 14 above
Wood columns are generally plumb and straight and in fair condition. There is some vertical checking along the columns.	No recommendations

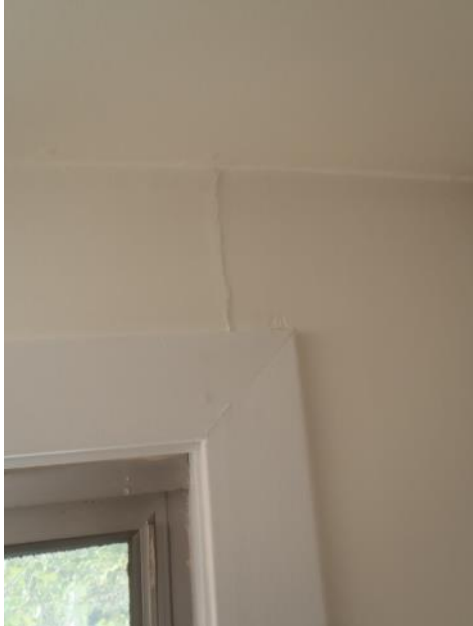
<p>Walls at main floor level were generally in fair condition. At the time of our assessment, baseboards and some trim had been removed and it appeared that drywall and paint had been touched up recently. Some small cracks and bulges similar to the accompanying picture were observed around some window and door openings and on the walls in the stair area.</p>	<p>No recommendations</p>

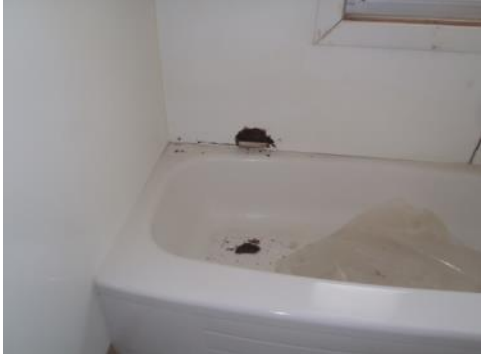
Condition	Recommendation	Photo
Wall finishes in room 9 were water damaged. It is likely that water has been entering the external wall assembly in this area.	We recommend that the wall finishes are removed in the area in the vicinity of the bath to assess the damage. Compromised structure shall be replaced with similar.

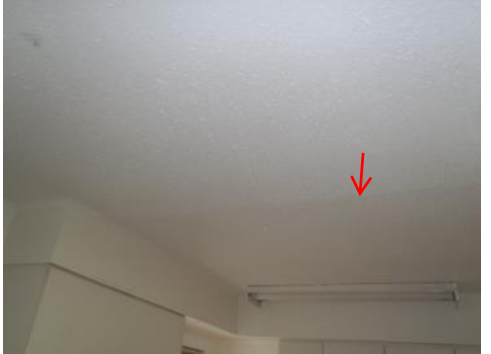
At main floor level bulges were observed in the ceiling finishes. An example of this is shown in the attached photo.	No recommendations.

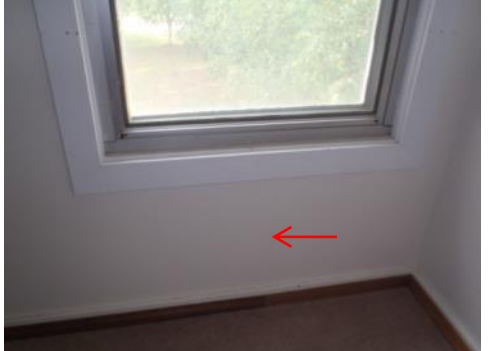
Walls at second floor level were generally in fair condition. Some small cracks and bulges similar to the accompanying picture were observed around some window and door openings.	No recommendations.

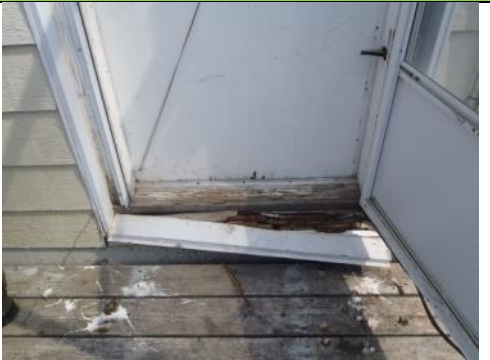
Condition	Recommendation	Photo
The back door threshold in Unit B is rotted.	Door threshold is to be removed to assess if damage extends further into structure. Replace with similar as required.

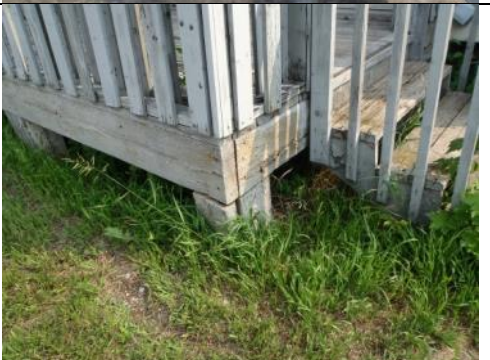
The east deck in both units is in poor condition. There are signs of decay throughout the structure.	We recommend that the existing deck is fully removed. The area within the deck footprint shall have all vegetation removed and the organic layer of soil stripped back. Subgrade is to be prepared and a new pressure treated wood deck structure constructed.

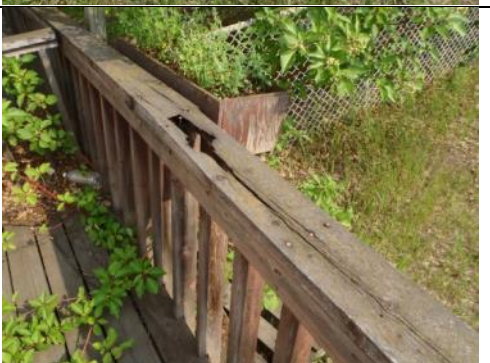
The west deck in both units is in poor condition. There are signs of decay throughout the structure.	We recommend that the existing deck is fully removed. The area within the deck footprint shall have all vegetation removed and the organic layer of soil stripped back. Subgrade is to be prepared and a new pressure treated wood deck structure constructed.

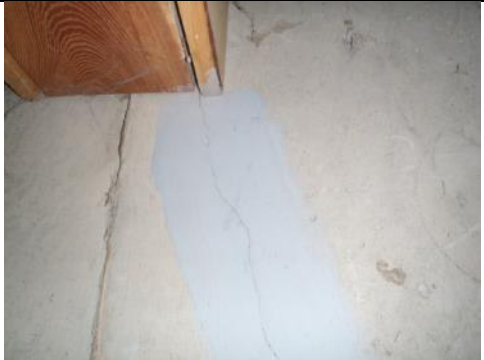
Condition	Recommendation	Photo
The north basement wall is cracked local to the main floor beam pocket. A waterproofing paint has been applied to the crack.	We recommend that this crack is repaired with an injection mortar suitable for the size of crack.

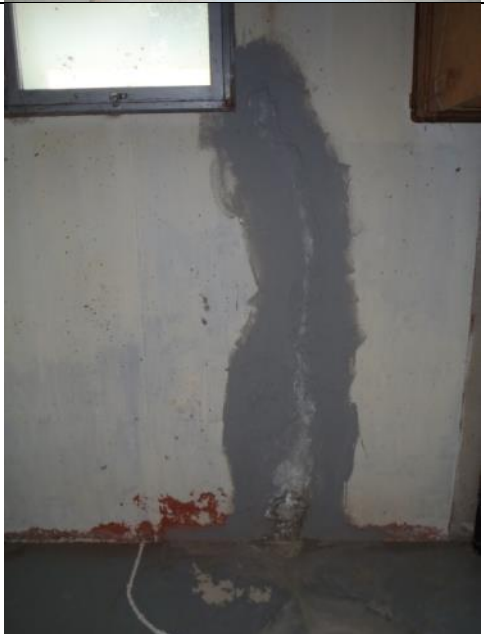
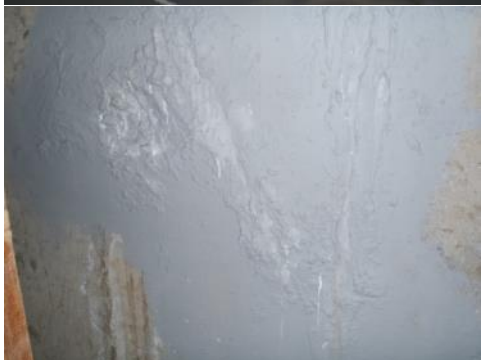
Substantial cracking was observed throughout the basement walls. On the west basement wall cracks generally occur at window openings and extend down to the floor slab, see photo 38 above. Efflorescence was observed at most cracks. There is also a build-up over cracks which have been coated with a waterproofing paint. The buildup may be a crack repair attempt.	<p>We recommend that sections of basement wall with substantial cracking are to be removed and replaced with new reinforced concrete wall.</p> <p>A concrete specialist should be consulted to investigate the properties of the existing concrete.</p> <p>We also recommend that access to the basement be limited to only essential maintenance tasks.</p>

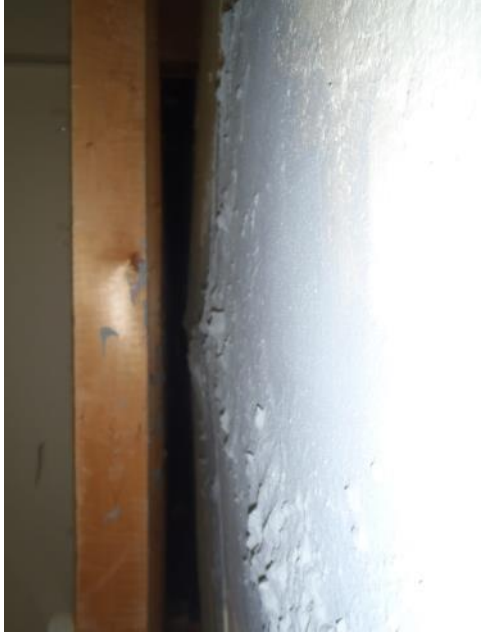
<p>The South basement wall is in the most critical condition. The wall is severely cracked in a typical failure pattern for a laterally loaded panel, see photo 39 above. The photo to the right is taken across the face and shows the wall deflecting inward, with wide open cracks on the tension face of the wall. This wall has failed.</p>	<p>We recommend that the south basement wall be removed and replaced with a new reinforced concrete basement wall.</p> <p>The new basement wall design should be done by a structural engineer in consultation with a geotechnical consultant that has conducted a site specific investigation.</p> <p>A concrete specialist should be consulted to investigate the properties of the existing concrete.</p> <p>We also recommend that access to the basement be limited to only essential maintenance tasks.</p>

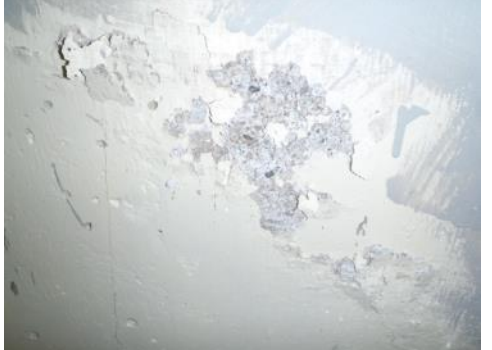
<p>Some area of the basement wall show signs of water ingress.</p>	<p>A concrete specialist should be consulted to investigate the properties of the existing concrete and provide recommendations for repair or replacement.</p>

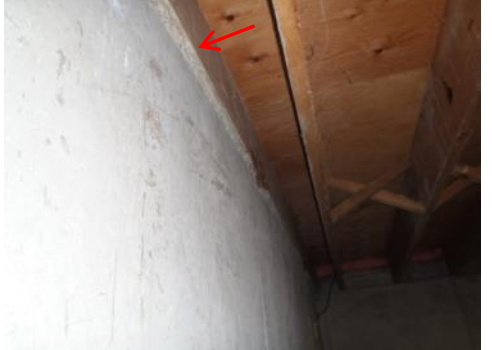
<p>The rim joist along the basement end walls appear to have been pushed inward. The bottom of the joist in the photo is visible toward the centre of the wall.</p>	<p>Joists are to be adjusted to correct position as concrete wall repairs are done.</p>

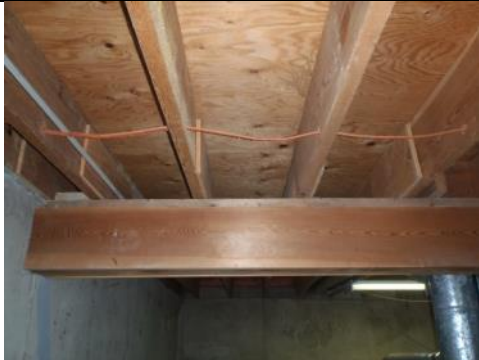
Condition	Recommendation	Photo
No blocking between joists provided over main floor beam.	We recommend installing blocking between joists

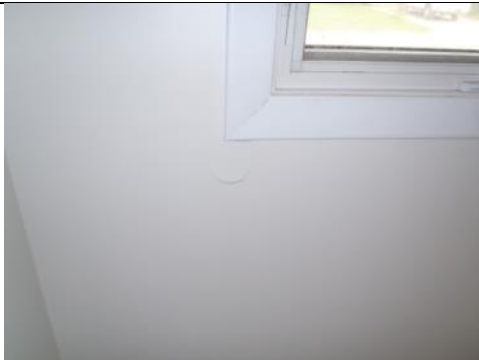
During our assessment we took some level measurements throughout the main floor. Our level survey showed that the north end of the main floor is approximately 42mm lower than the south end.	No recommendations, but house could be relevelled as basement walls are replaced.	
Generally there are very few signs of distress at main floor level. Some minor cracks or bulges in drywall finishes are visible around window openings. Generally main floor framing and walls are in fair to good condition.	No recommendations
