EAST BLOCK CARPET REPLACEMENT
TENDER DOCUMENTS

EAST BLOCK
CARPET REPLACEMENT

COVER PAGE
INDEX, SITE PLAN,
KEY PLAN AND
CARPET SCHEDULE

- A0 - COVER PAGE, INDEX, SITE PLAN, KEY PLAN, AND CARPET SCHEDULE
- A1 - BASEMENT NEW CARPET PLAN & BASEMENT SUBSTRATE PLAN
- A2 - MAIN FLOOR NEW CARPET PLAN & MAIN FLOOR SUBSTRATE PLAN
- A3 - 2ND FLOOR NEW CARPET PLAN & 2ND FLOOR SUBSTRATE PLAN
- A4 - 3RD FLOOR NEW CARPET PLAN & 3RD FLOOR SUBSTRATE PLAN
- A5 - TYPICAL REFERENCE DETAILS

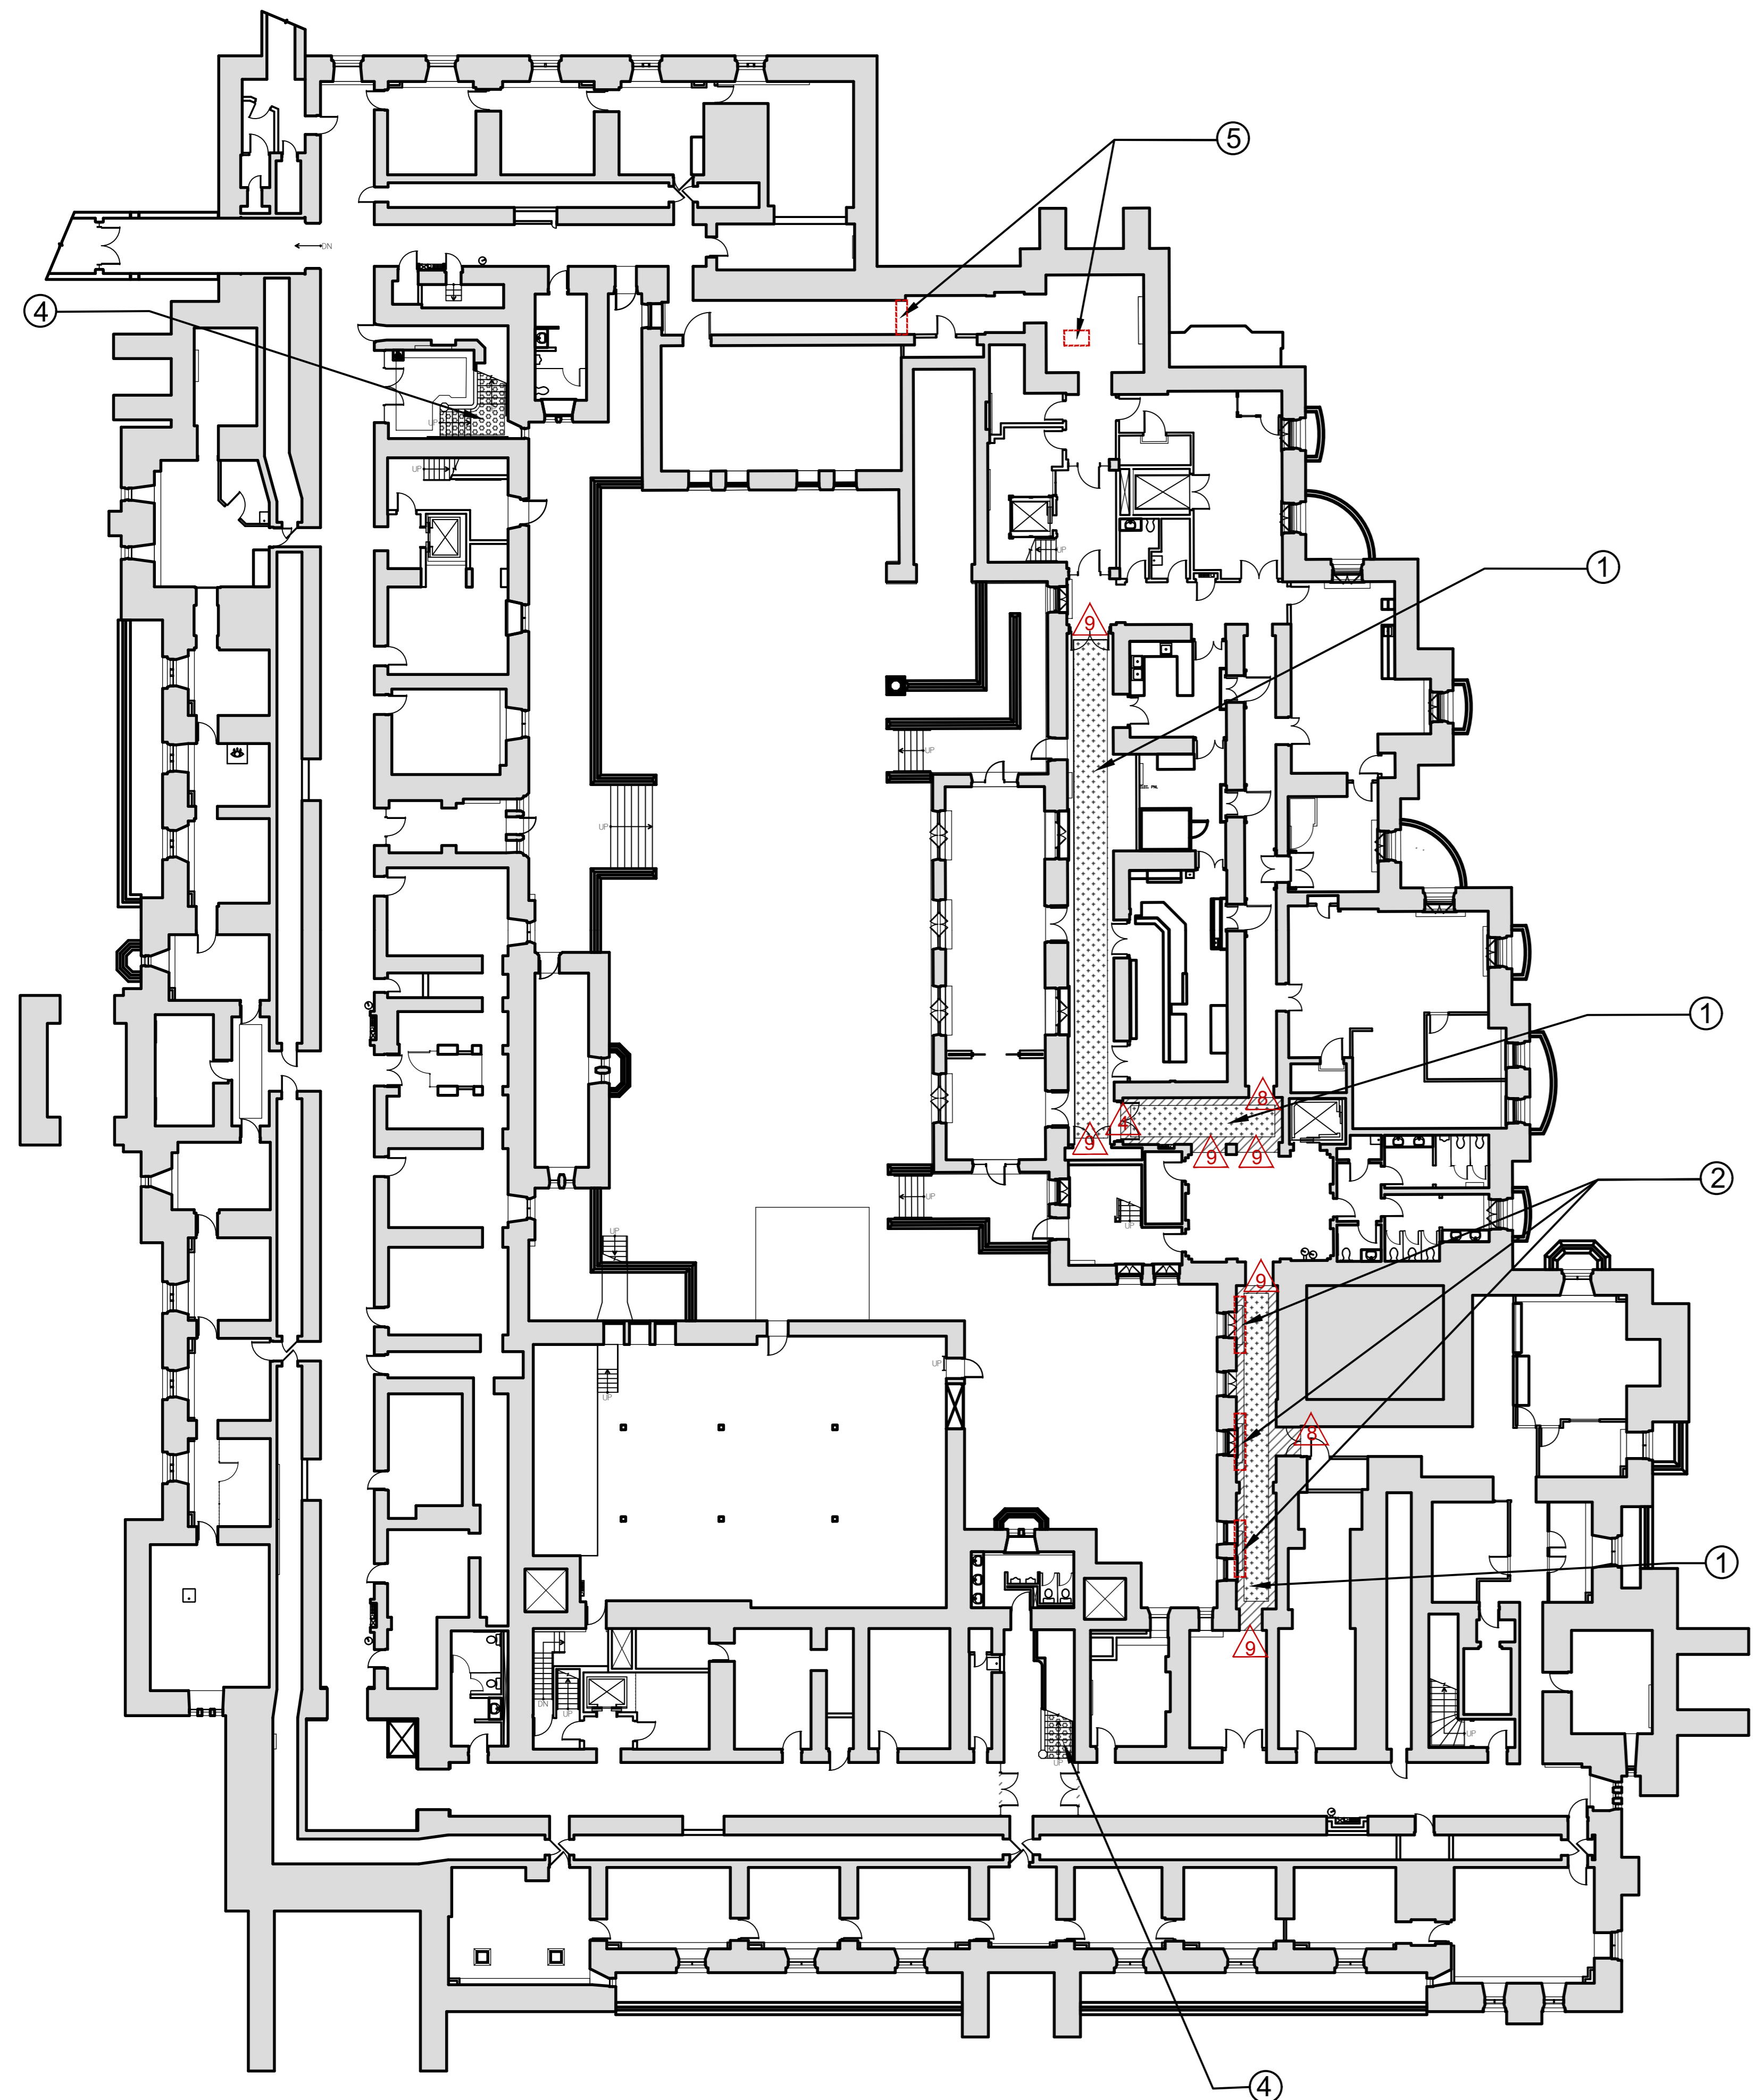
1 BASEMENT NEW CARPET PLAN
A1 1:200

- EXISTING CARPET TO BE REMOVED AND REPLACED WITH CORRESPONDING NEW CARPET TYPE.
- RADIATOR COVERS TO BE TEMPORARILY REMOVED AND STORED FOR THE DURATION OF WORK AND REINSTALLED FOLLOWING COMPLETION. APPROX. 20 LOCATIONS.
- NOT USED.
- EXISTING STAIR CARPET TO BE REMOVED AND REPLACED WITH NEW CARPET. EXISTING DIAMOND PATTERNS TO BE REPLICATED WITH NEW CARPET.
- TRIP HAZARD TO BE REPAIRED.
- WEATHER CARPET TO BE INSTALLED FOR SEPTEMBER 2018.
- EXISTING CARPET TO BE REMOVED. TILES BENEATH TO BE CLEANED AND TO REMAIN EXPOSED.

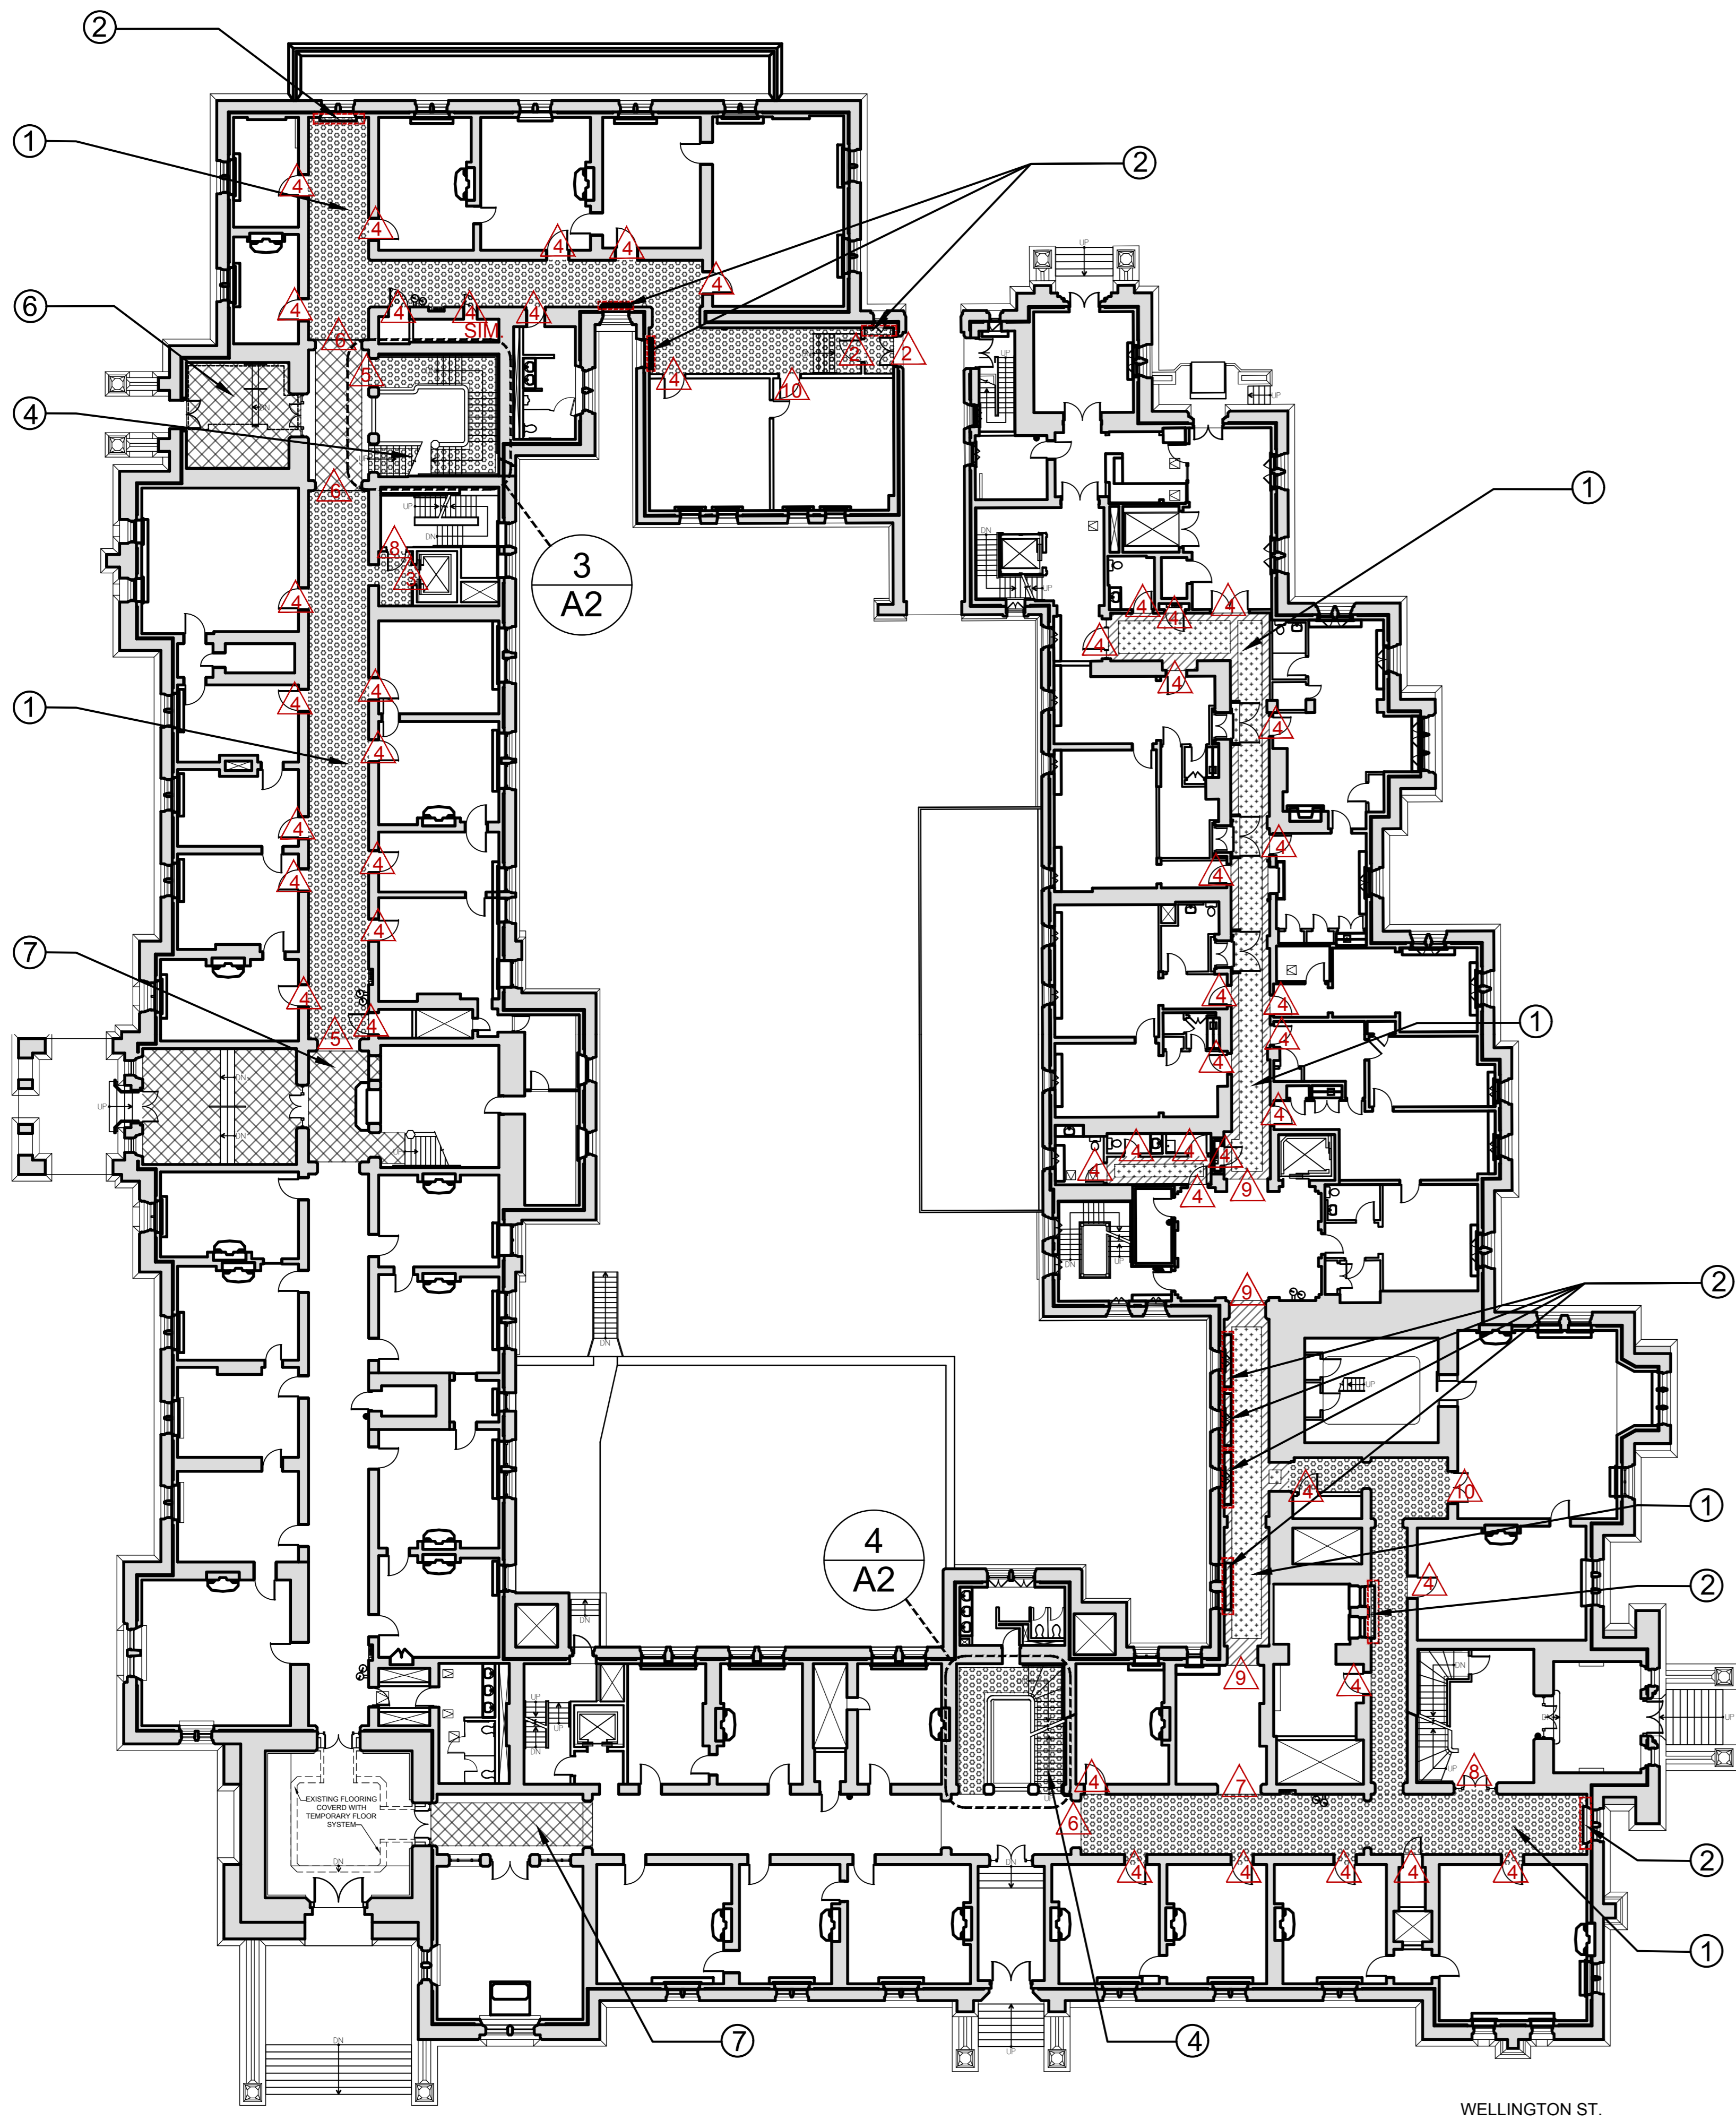
1 MAIN FLOOR NEW CARPET PLAN
A2 1:200

- EXISTING CARPET TO BE REMOVED AND REPLACED WITH CORRESPONDING NEW CARPET TYPE.
- RADIATOR COVERS TO BE TEMPORARILY REMOVED AND STORED FOR THE DURATION OF WORK AND REINSTALLED FOLLOWING COMPLETION. APPROX. 20 LOCATIONS.
- NOT USED.
- EXISTING STAIR CARPET TO BE REMOVED AND REPLACED WITH NEW CARPET. EXISTING DIAMOND PATTERNS TO BE REPLICATED WITH NEW CARPET.
- TRIP HAZARD TO BE REPAIRED.
- WEATHER CARPET TO BE INSTALLED FOR SEPTEMBER 2018.
- EXISTING CARPET TO BE REMOVED. TILES BENEATH TO BE CLEANED AND TO REMAIN EXPOSED.

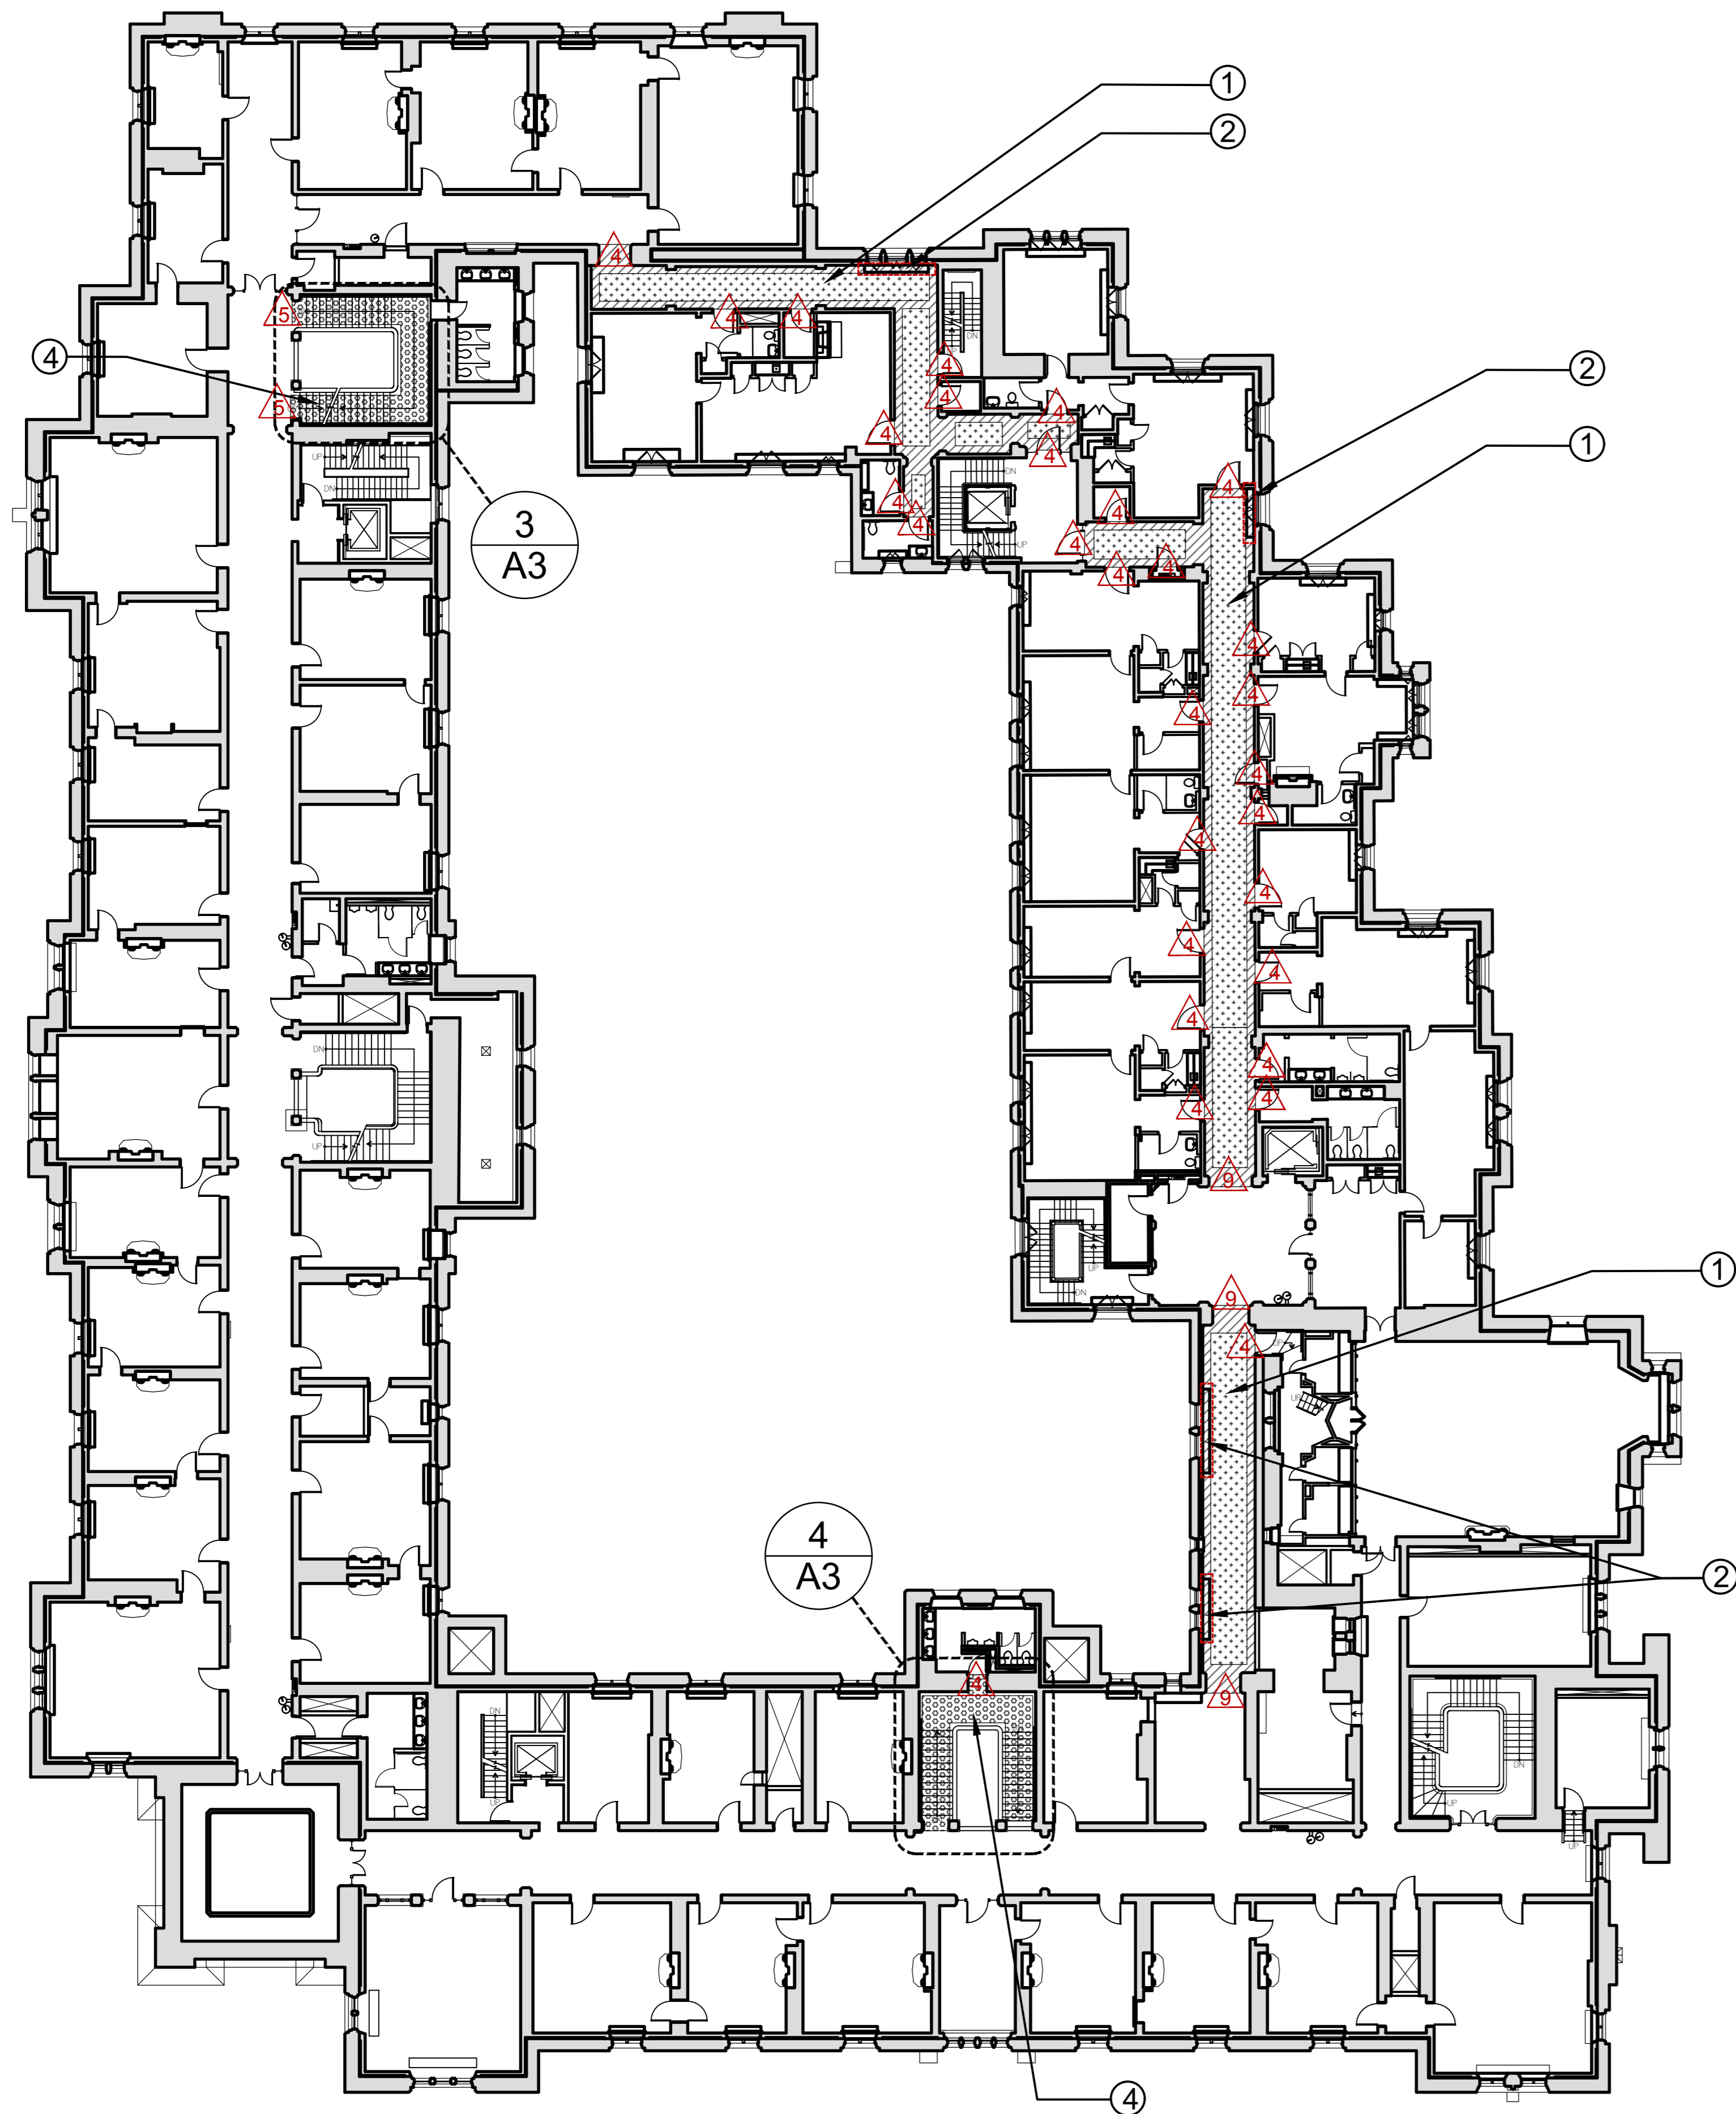
1 2ND FLOOR NEW CARPET PLAN
A3 1:200

- EXISTING CARPET TO BE REMOVED AND REPLACED WITH CORRESPONDING NEW CARPET TYPE.
- RADIATOR COVERS TO BE TEMPORARILY REMOVED AND STORED FOR THE DURATION OF WORK AND REINSTALLED FOLLOWING COMPLETION. APPROX. 20 LOCATIONS.
- NOT USED.
- EXISTING STAIR CARPET TO BE REMOVED AND REPLACED WITH NEW CARPET. EXISTING DIAMOND PATTERNS TO BE REPLICATED WITH NEW CARPET.
- TRIP HAZARD TO BE REPAIRED.
- WEATHER CARPET TO BE INSTALLED FOR SEPTEMBER 2018.
- EXISTING CARPET TO BE REMOVED. TILES BENEATH TO BE CLEANED AND TO REMAIN EXPOSED.

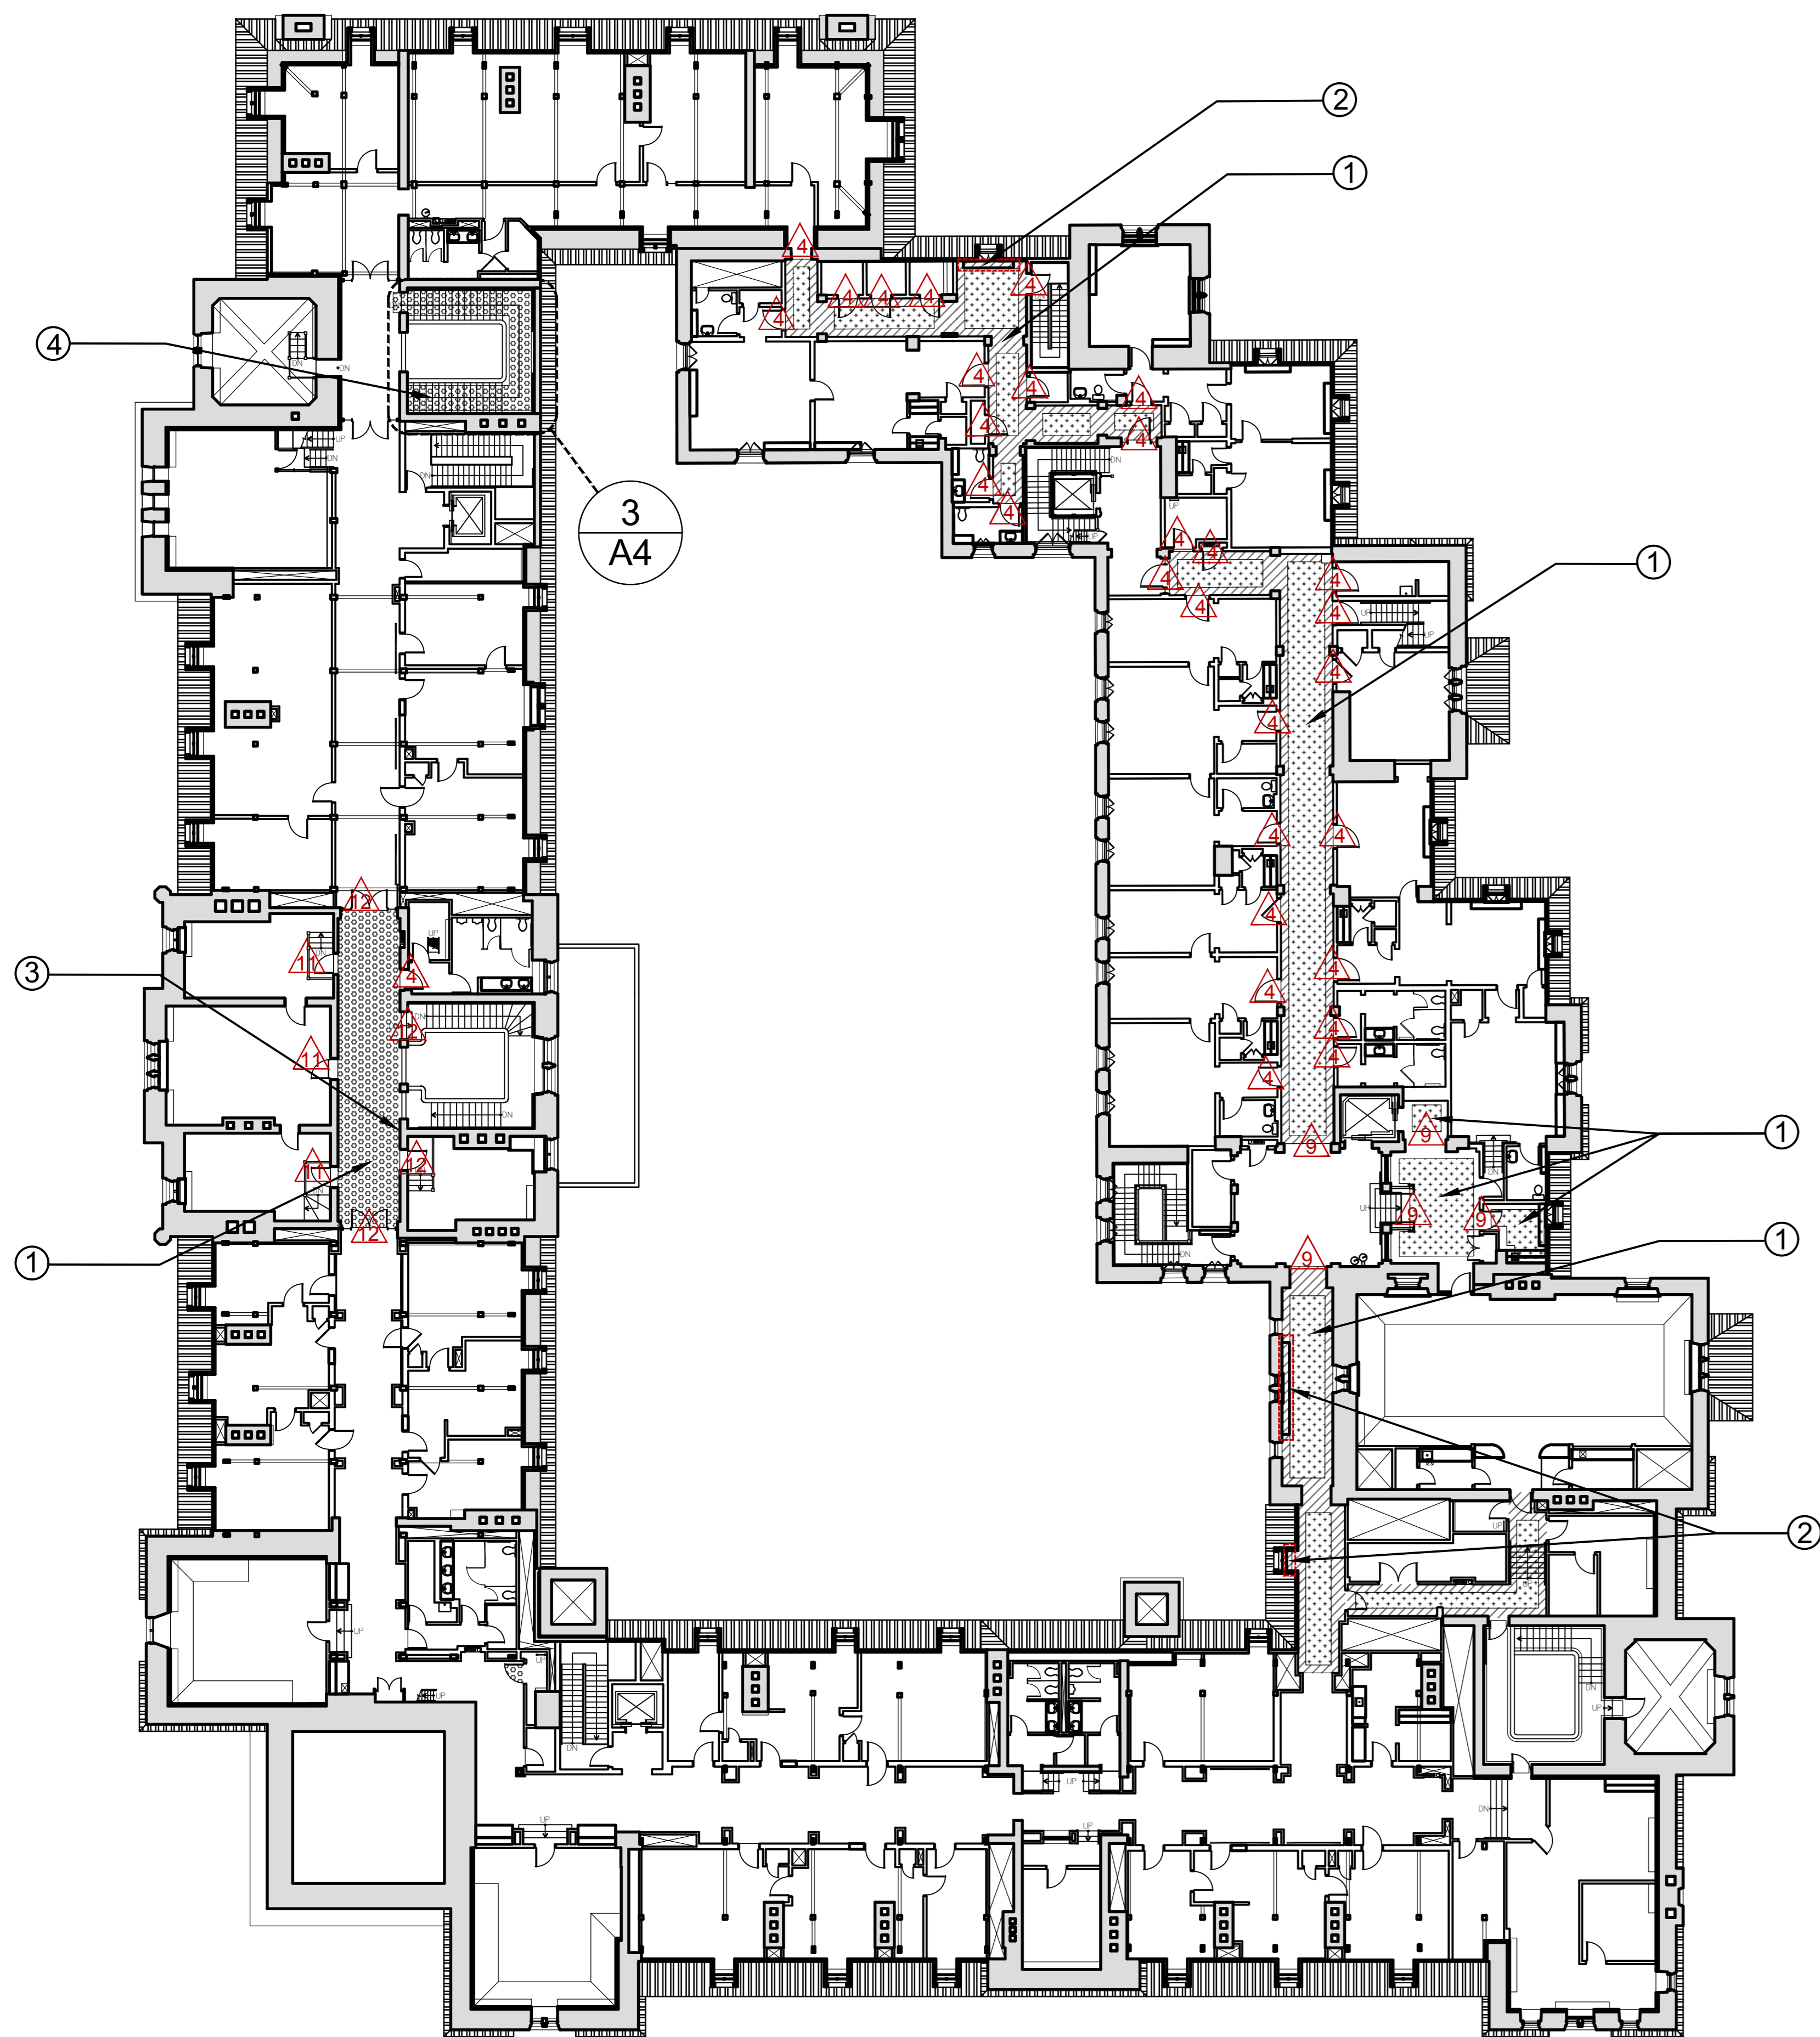
1
A4
3RD FLOOR NEW CARPET PLAN
1:200

- EXISTING CARPET TO BE REMOVED AND REPLACED WITH CORRESPONDING NEW CARPET TYPE.
- RADIATOR COVERS TO BE TEMPORARILY REMOVED AND STORED FOR THE DURATION OF WORK AND REINSTALLED FOLLOWING COMPLETION. APPROX. 20 LOCATIONS.
- NOT USED.
- EXISTING STAIR CARPET TO BE REMOVED AND REPLACED WITH NEW CARPET. EXISTING DIAMOND PATTERNS TO BE REPLICATED WITH NEW CARPET.
- TRIP HAZARD TO BE REPAIRED.
- WEATHER CARPET TO BE INSTALLED FOR SEPTEMBER 2018.
- EXISTING CARPET TO BE REMOVED, TILES BENEATH TO BE CLEANED AND TO REMAIN EXPOSED.

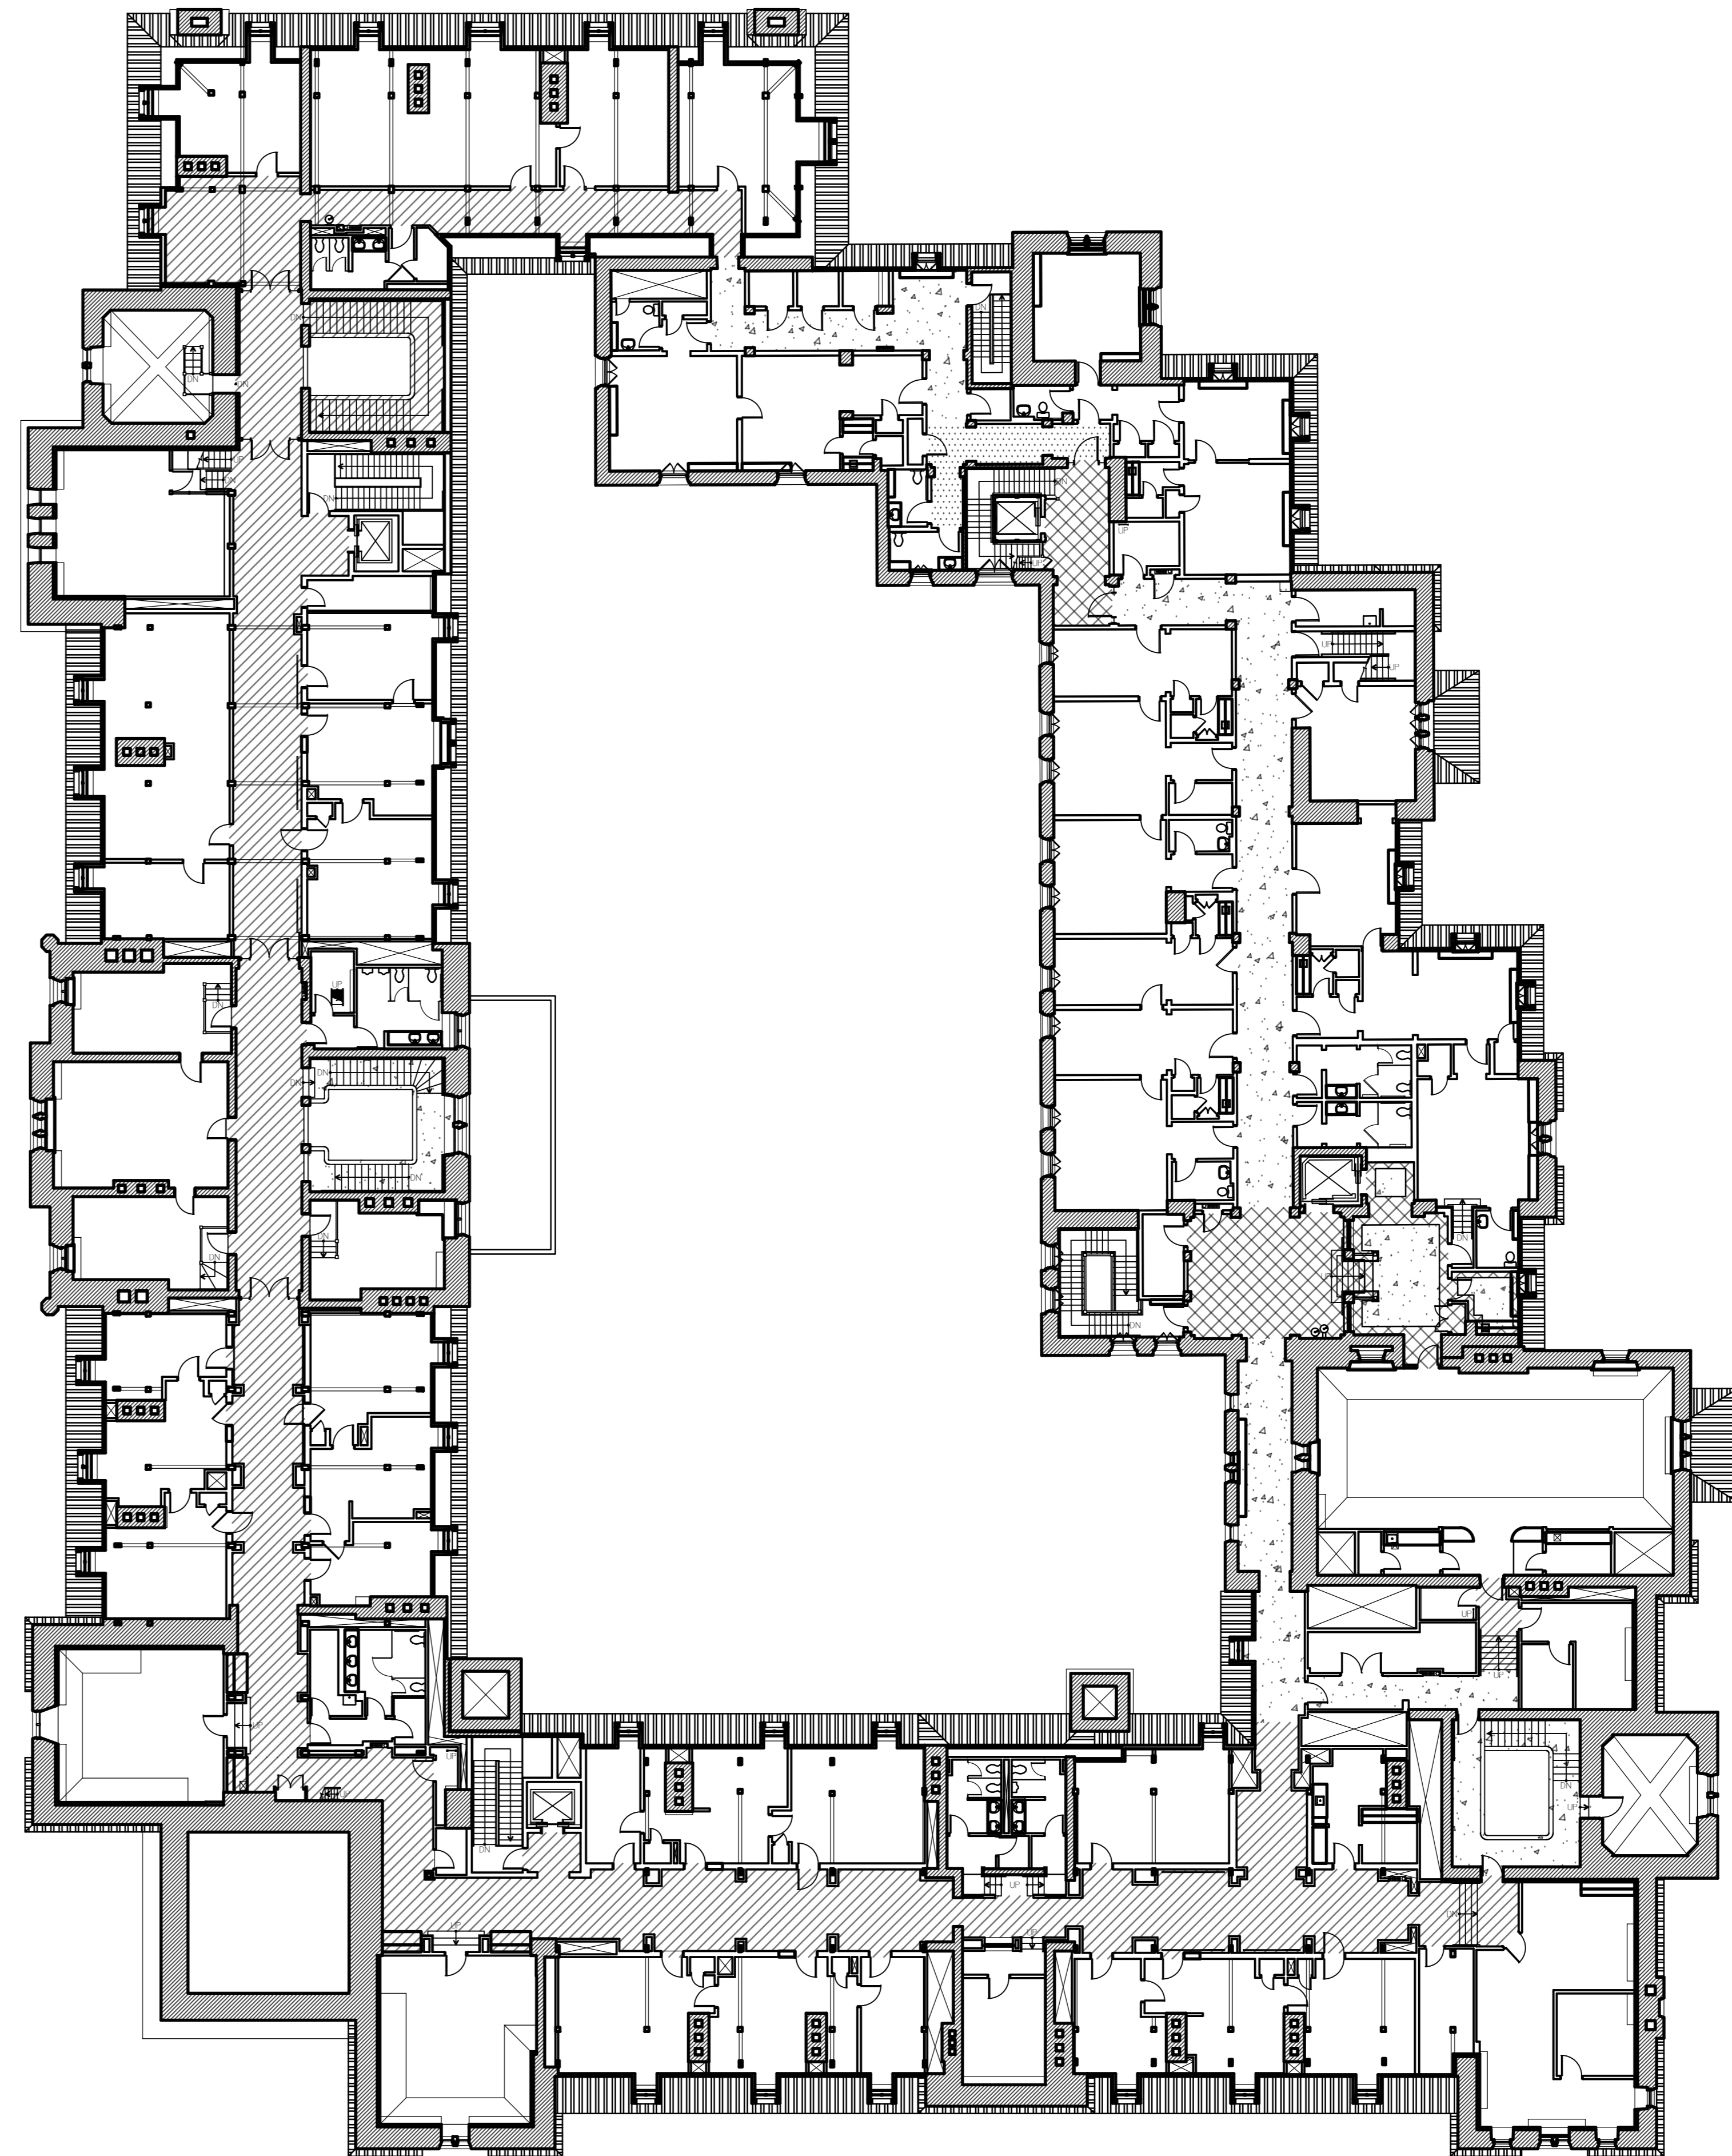
2
A4
3RD FLOOR SUBSTRATE PLAN
1:200

TYPE 1-A CARPET REFER TO SCHEDULE		TYPE 1 SUBSTRATE CONCRETE
	TYPE 1-B CARPET REFER TO SCHEDULE		TYPE 2 SUBSTRATE MARBLE MOSAIC
	TYPE 3 CARPET REFER TO SCHEDULE		TYPE 3 SUBSTRATE ENCAUSTIC TILE
	TYPE 3-B CARPET REFER TO SCHEDULE		TYPE 4 SUBSTRATE MARBLE
	TYPE 4 WEATHER CARPET REFER TO SCHEDULE		TYPE 5 SUBSTRATE TERRAZZO
	NO PHOTO		TYPE 6 SUBSTRATE UNKNOWN SUBSTRUCTURE

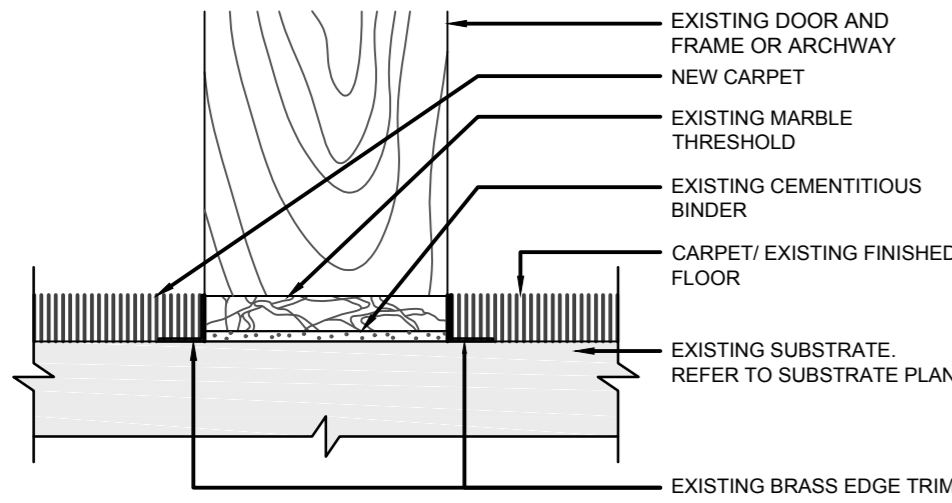
01
A5
TYPICAL OFFICE THRESHOLD DETAIL

- TYPICAL OFFICE THRESHOLD DETAIL IN 1867 WING. APPROXIMATELY 0 LOCATIONS. REFER TO DETAIL 01 A5.
- TYPICAL EXTERIOR DOOR THRESHOLD DETAIL IN 1867 WING. APPROXIMATELY 2 LOCATIONS. REFER TO DETAIL 02 A5.

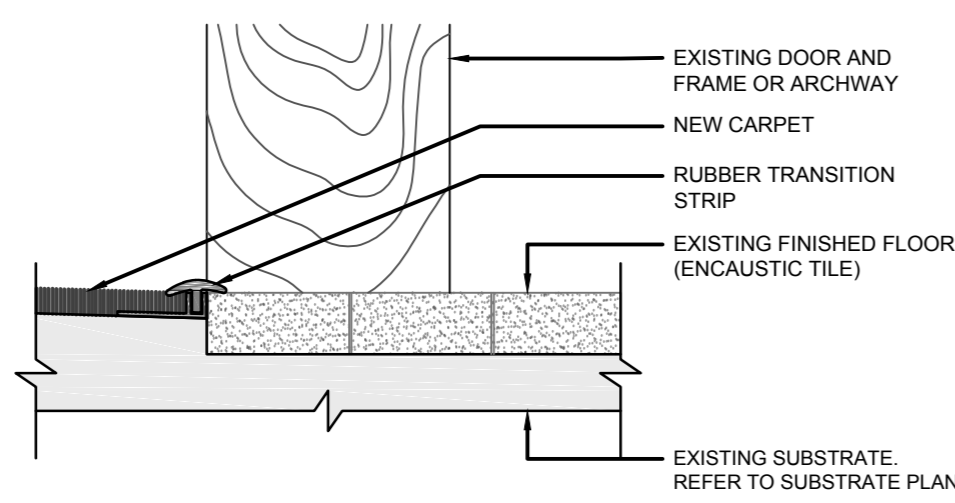
02
A5
TYPICAL CARPET-TILE TRANSITION DETAIL

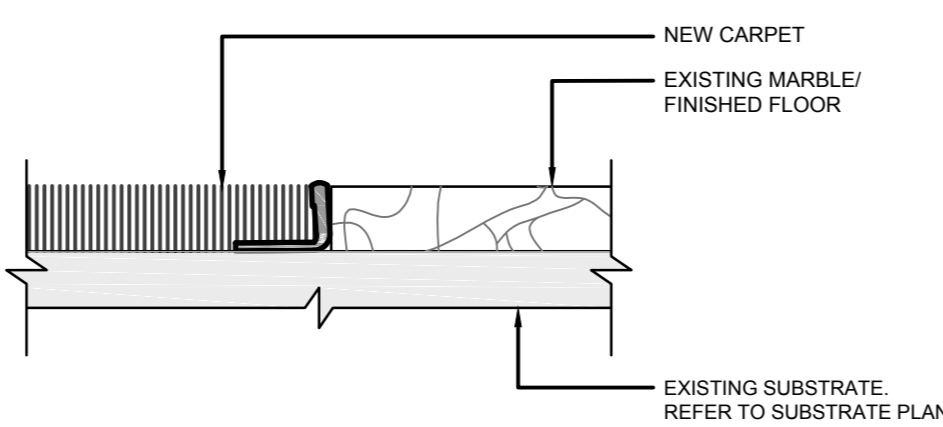
03
A5
TYPICAL METAL LOBBY EDGING DETAIL

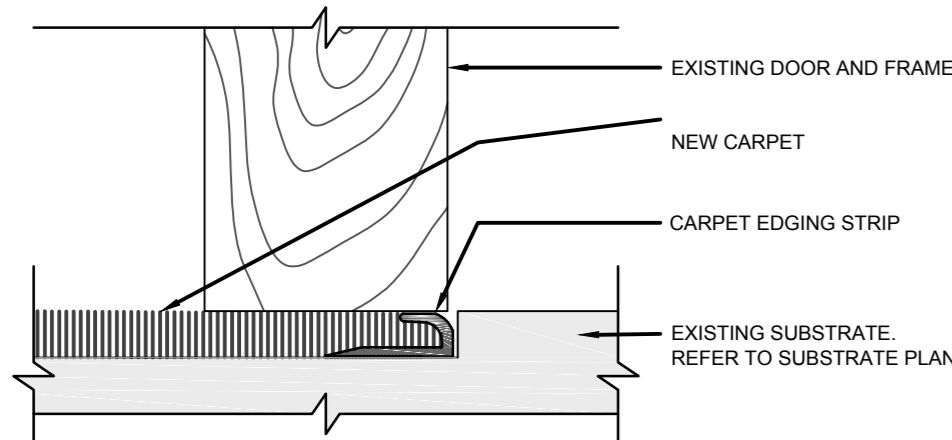
04
A5
TYPICAL SECONDARY THRESHOLD DETAIL

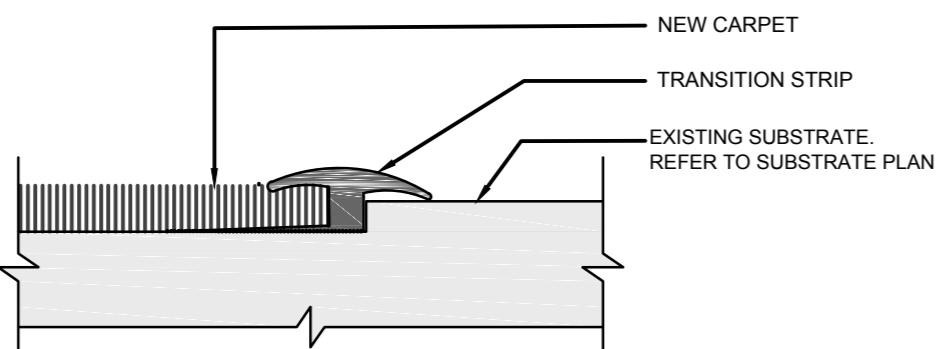
05
A5
TYPICAL CARPET-CONCRETE TRANSITION DETAIL

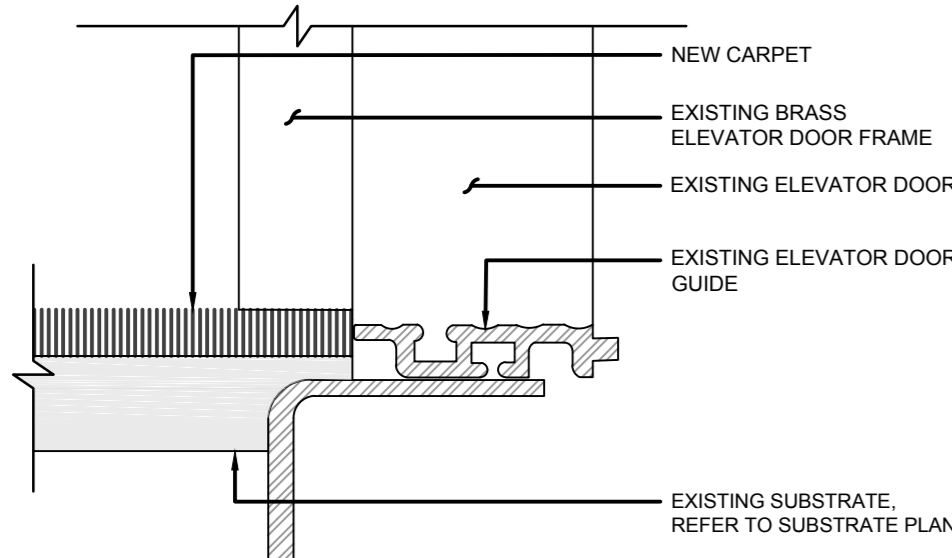
06
A5
TYPICAL ELEVATOR THRESHOLD DETAIL

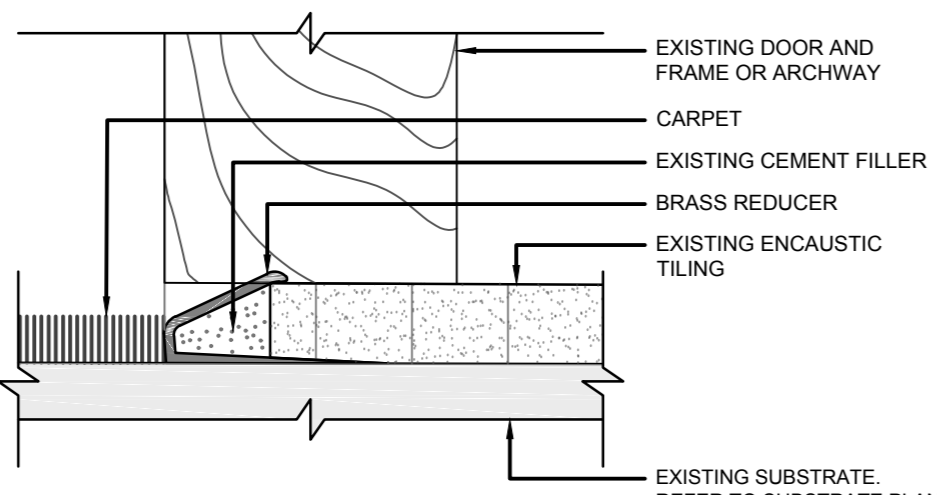
07
A5
TYPICAL CARPET-TILE TRANSITION

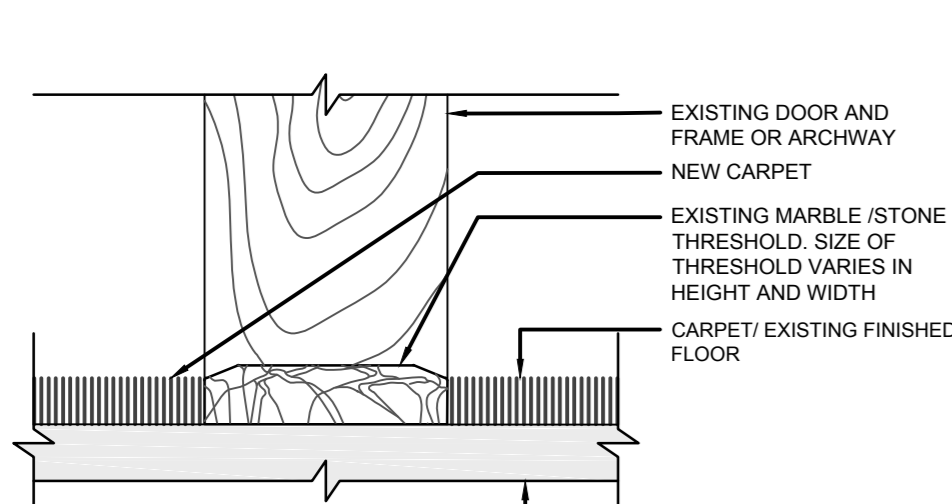
08
A5
TYPICAL OFFICE THRESHOLD DETAIL
