EAST BLOCK CARPET REPLACEMENT
TENDER DOCUMENTS

EAST BLOCK
CARPET REPLACEMENT

COVER PAGE
INDEX, SITE PLAN,
KEY PLAN AND
CARPET SCHEDULE

- A0 - COVER PAGE, INDEX, SITE PLAN, KEY PLAN, AND CARPET SCHEDULE
- A1 - BASEMENT NEW CARPET PLAN & BASEMENT SUBSTRATE PLAN
- A2 - MAIN FLOOR NEW CARPET PLAN & MAIN FLOOR SUBSTRATE PLAN
- A3 - 2ND FLOOR NEW CARPET PLAN & 2ND FLOOR SUBSTRATE PLAN
- A4 - 3RD FLOOR NEW CARPET PLAN & 3RD FLOOR SUBSTRATE PLAN
- A5 - TYPICAL REFERENCE DETAILS

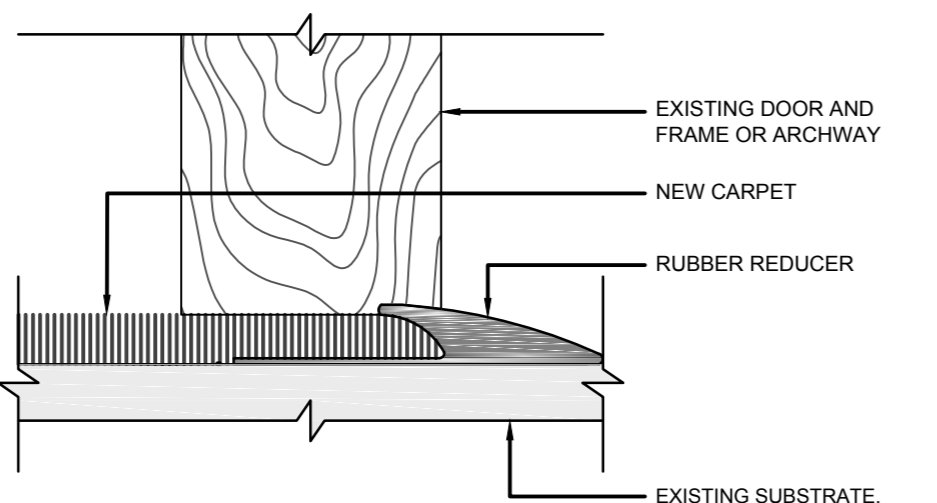
09
A5
TYPICAL CARPET REDUCER DETAIL
