Geotechnical Investigation Val Comeau Wharf Replacement

SHM Canada Consulting Limited

Val Comeau Wharf Replacement Geotechnical Investigation, Val Comeau, New Brunswick

HFX-00248944-A0

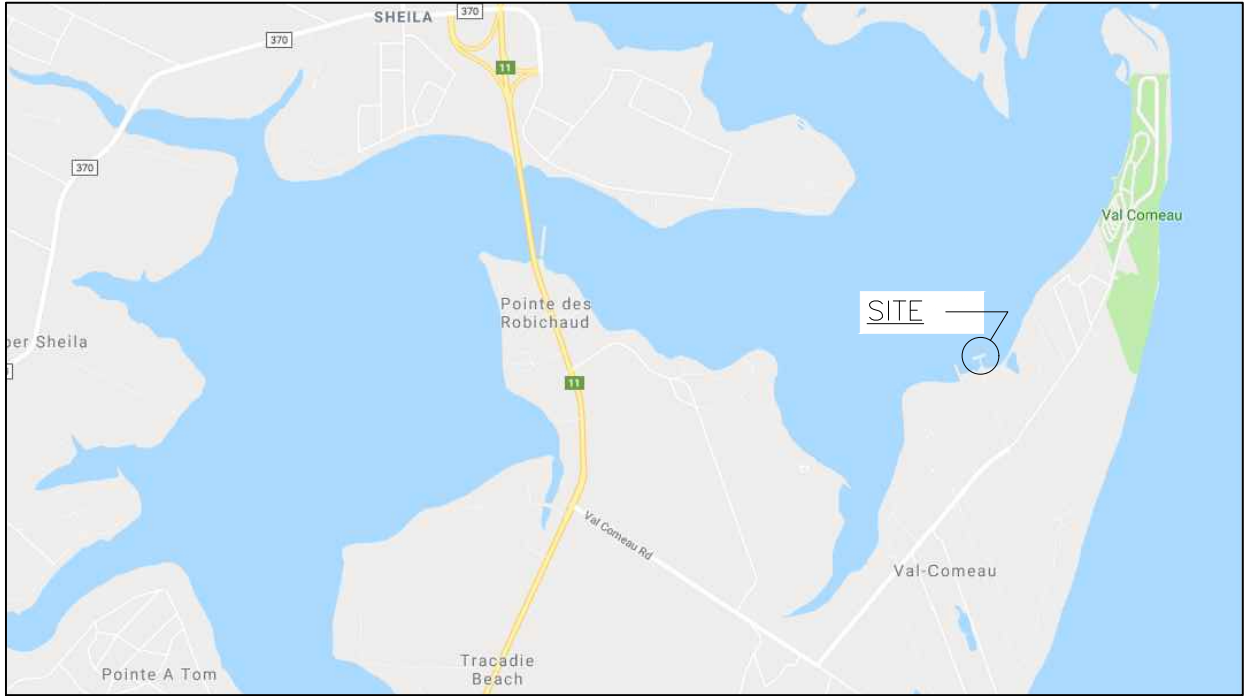
Dwg. No.	Rev. No.
FIG. 1	0

The general site arrangement and location of the boreholes are shown on Figure 1, attached.

BOREHOLE LOCATION PLAN

The fieldwork for the geotechnical investigation consisted of advancing five boreholes (BH18-01 to BH18-05), with depths extending from 9.0 to 14.0 m below harbour bottom. The investigation was carried out using a skid-mounted marine drill rig and were drilled within the harbour from a barge. The drill and barge were supplied and operated by Lantech Drilling Services out of their operation located in Dieppe, New Brunswick. The investigation took place between September 25 and 27, 2018.

Drilling was previously completed by GEMTEC at this site for Public Works and Government Services Canada in February 2013. Four boreholes (BH-01 to BH-04) were drilled for structures 401, 402, and 405. Subsurface conditions from these boreholes were used to supplement the current investigation.

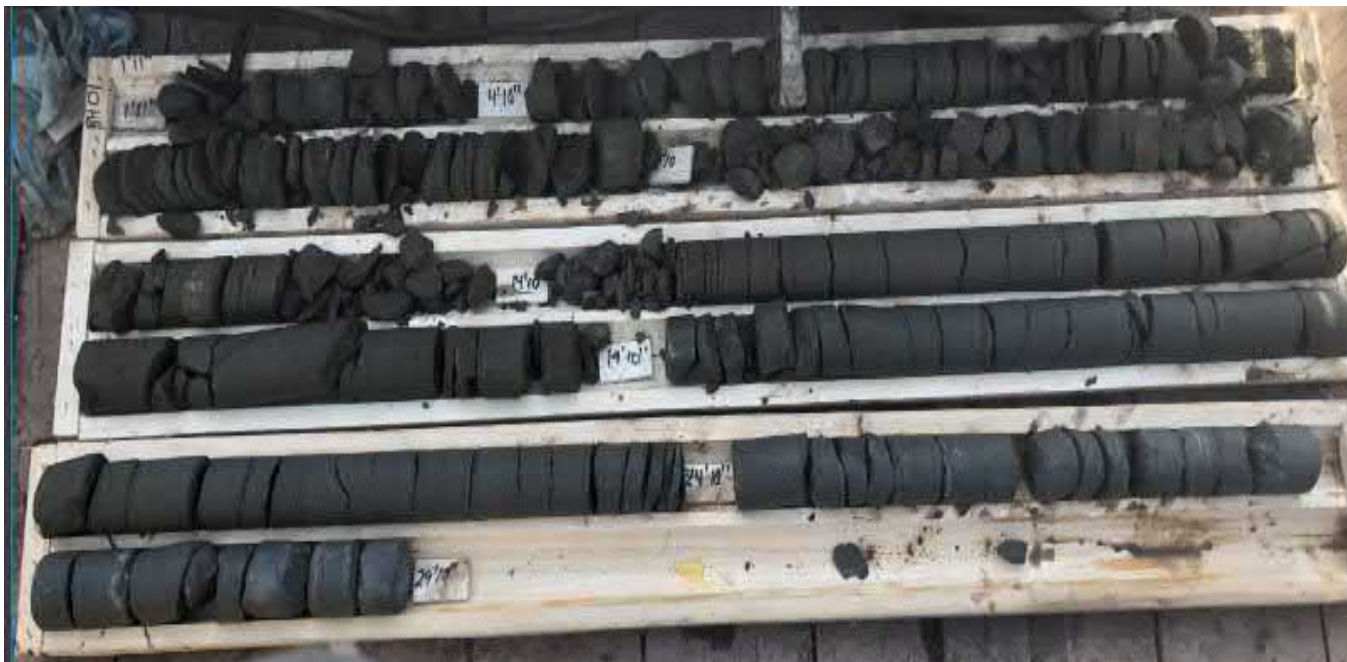
Photo 1: **BH-18-01**
Seabed Elevation : -1.7 meters
Bedrock Elevation : -2.1 meters
Amount cored : 8.6 meters

Sandstone Bedrock was encountered in all five boreholes under the surficial marine sediment. The bedrock was generally described as weathered and transitioning in colour from green-grey to blue-grey with depth. The quality of the bedrock was generally very poor to poor,

based on RQD values ranging from 0 to 44%; averaging 7%. Fracture spacing varied from very close to close, with fractures predominantly horizontally orientated.

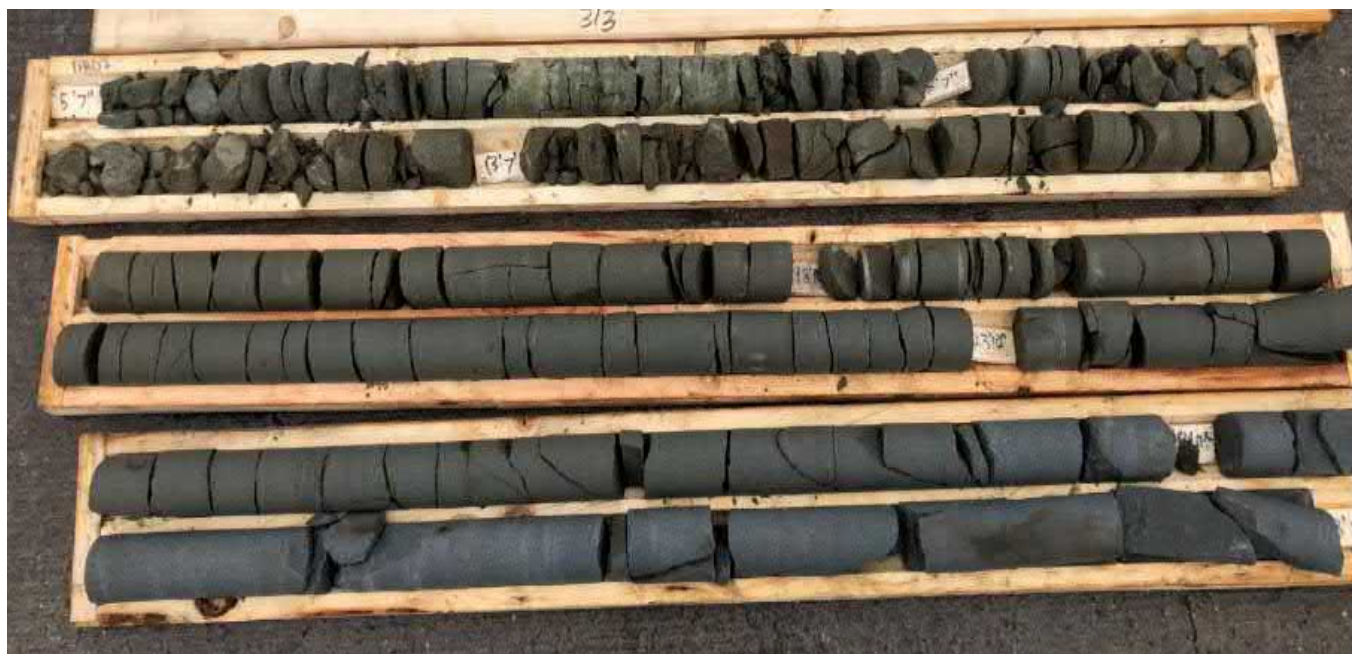
Photo 2: **BH-18-02**
Seabed Elevation : -2.0 meters
Bedrock Elevation : -2.3 meters
Amount cored : 10.1 meters

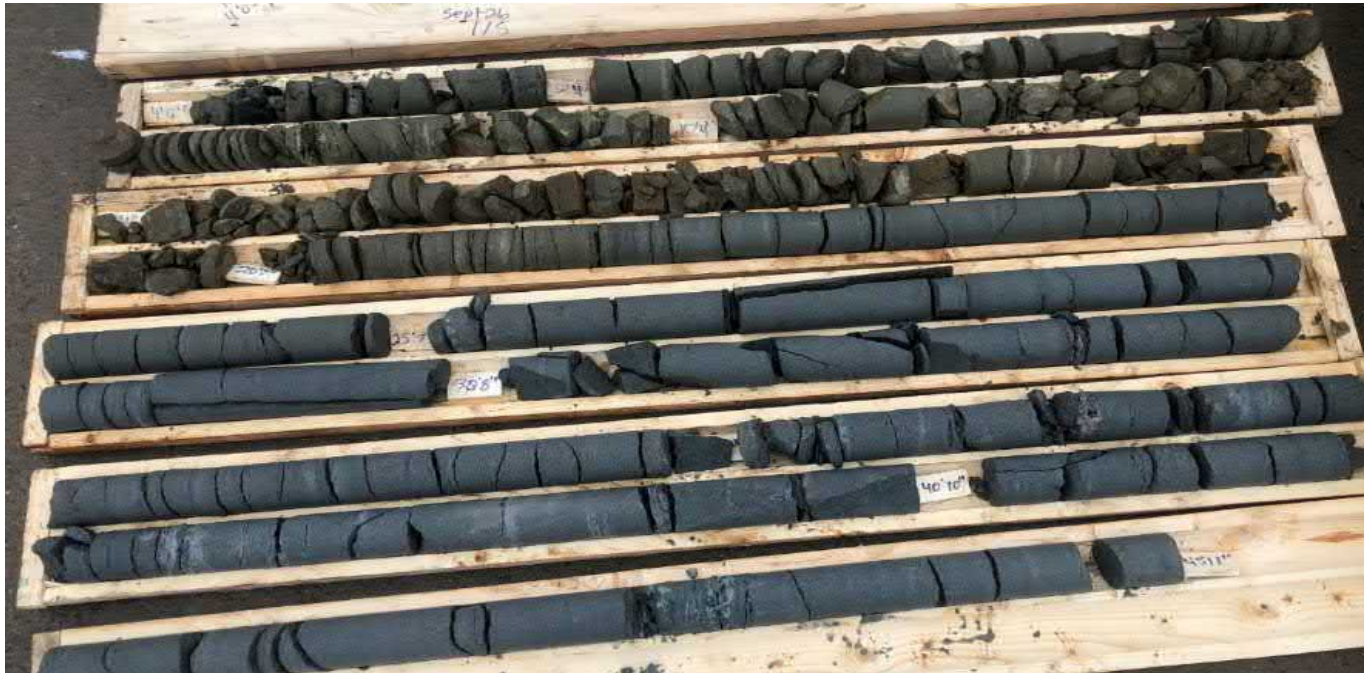
Photo 3: **BH-18-03**
Seabed Elevation : -1.5 meters
Bedrock Elevation : -2.1 meters
Amount cored : 13.4 meters

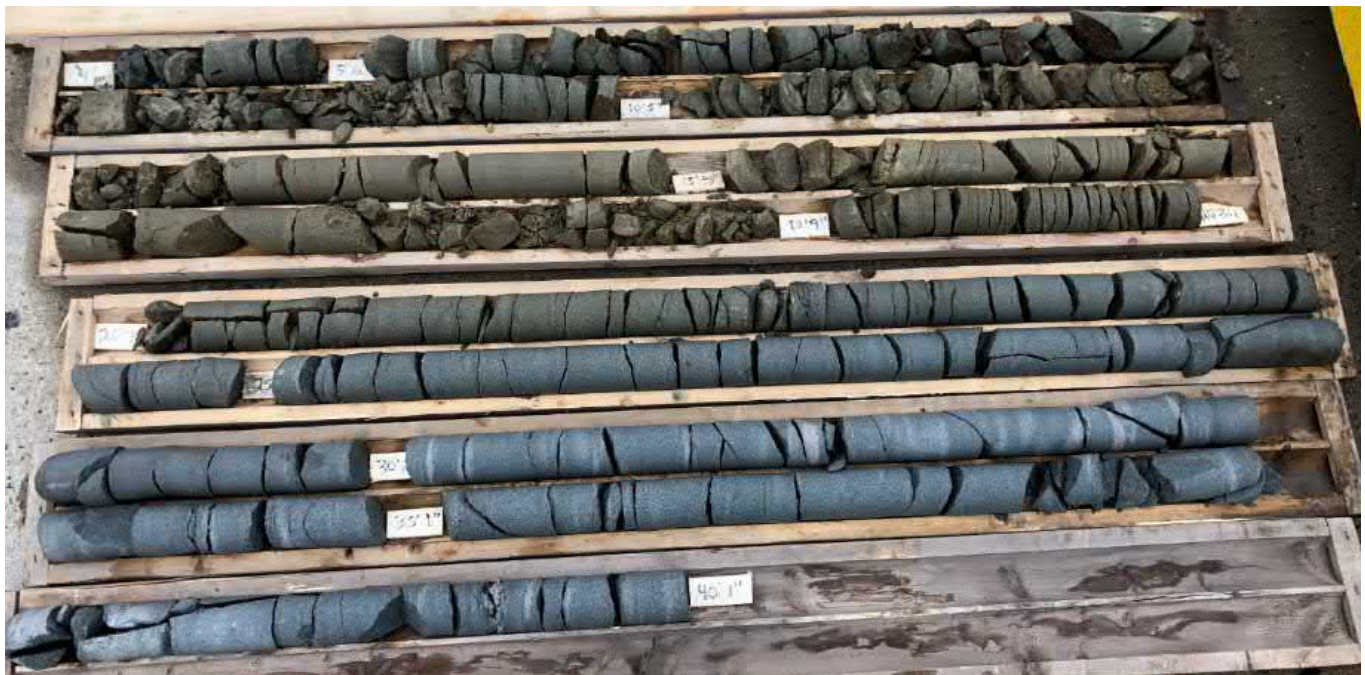
Photo 4: **BH-18-04**
Seabed Elevation : -1.7 meters
Bedrock Elevation : -2.1 meters
Amount cored : 11.8 meters

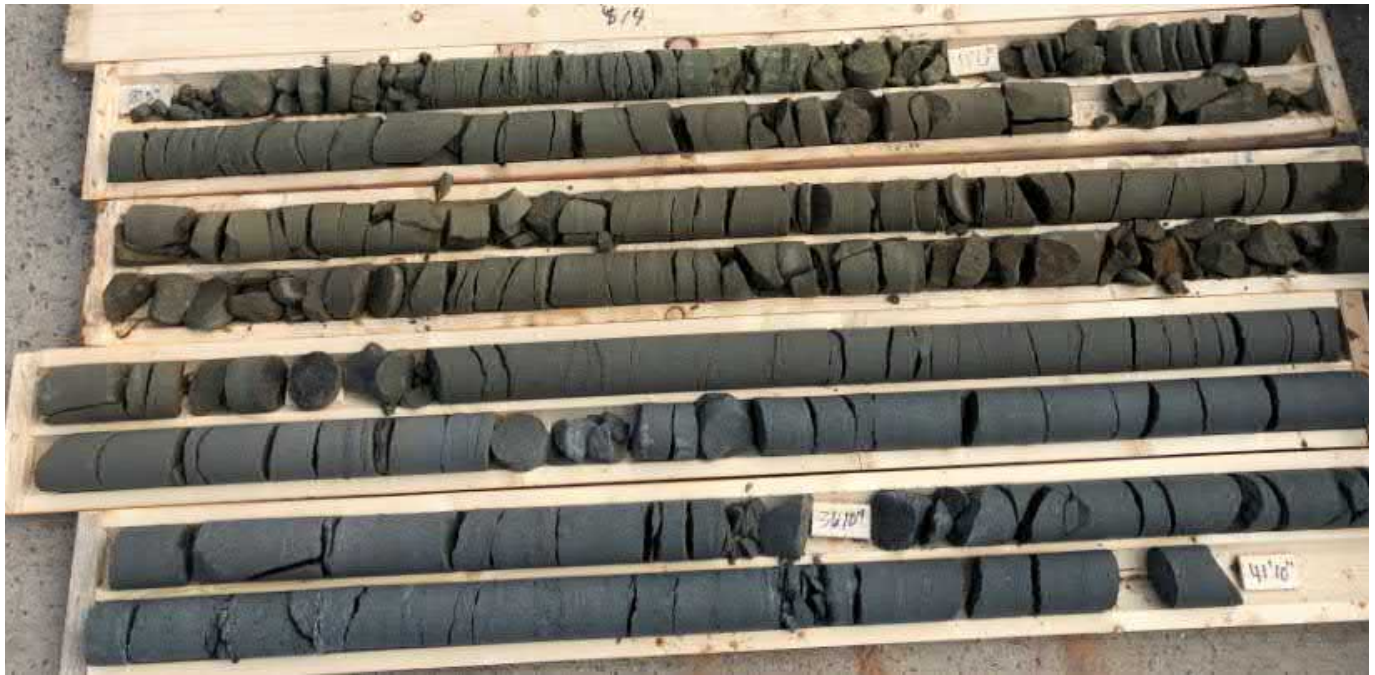
Photo 5: **BH-18-05**
Seabed Elevation :-1.2 meters
Bedrock Elevation : -3.1 meters
Amount cored : 10.9 meters
