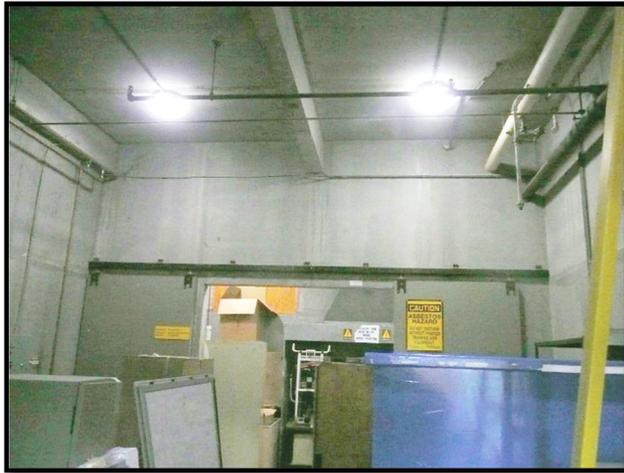
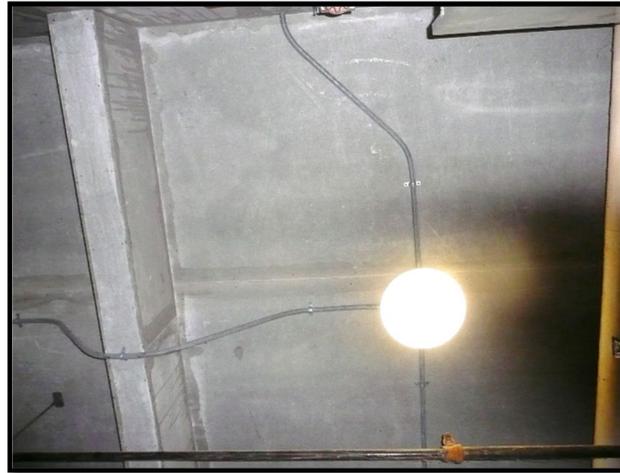
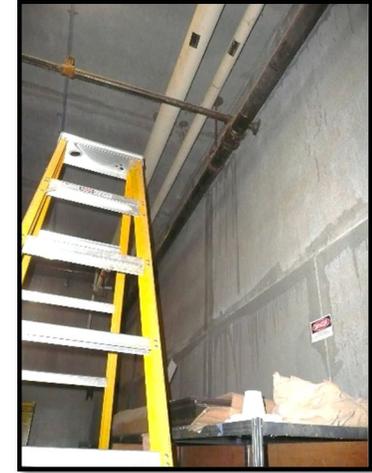
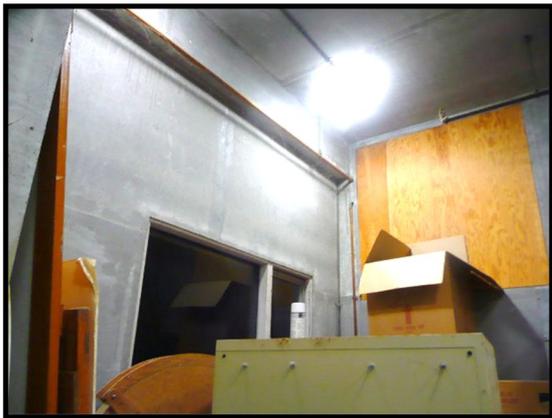
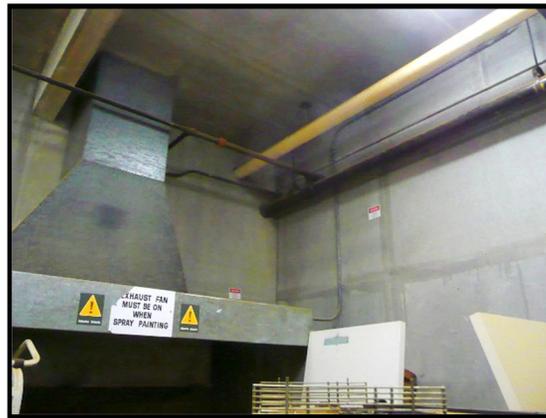
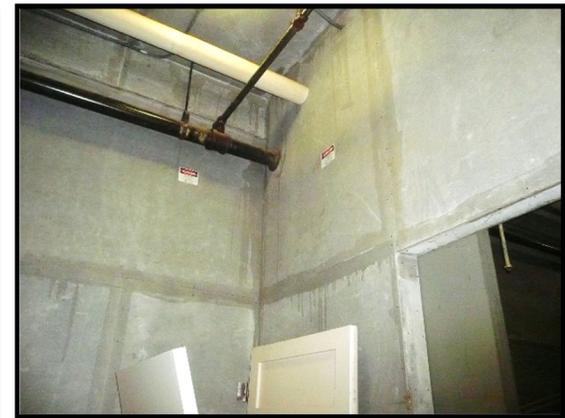
Paint Shop Room # 6 looking south from storage through sliding door to paint booth (upper left), ceiling of storage (upper centre), storage west wall (upper right), paint booth area east wall (lower left), paint booth southwest corner (lower centre), and paint booth northwest corner (lower right).

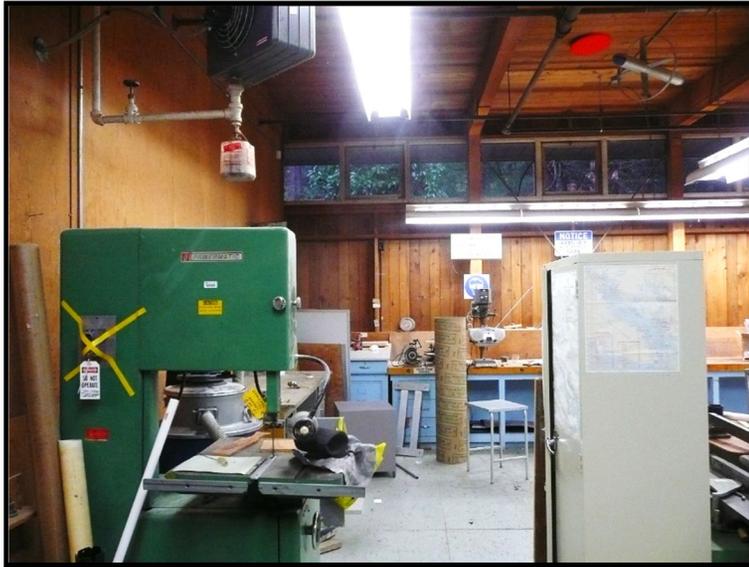
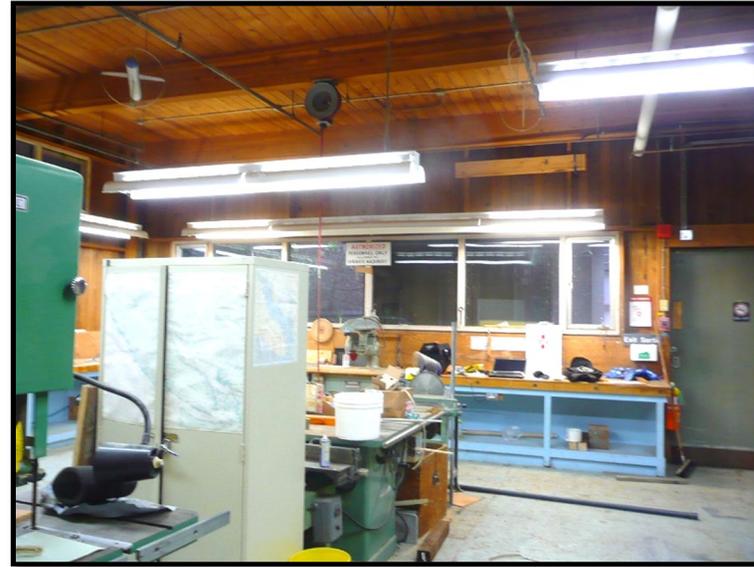
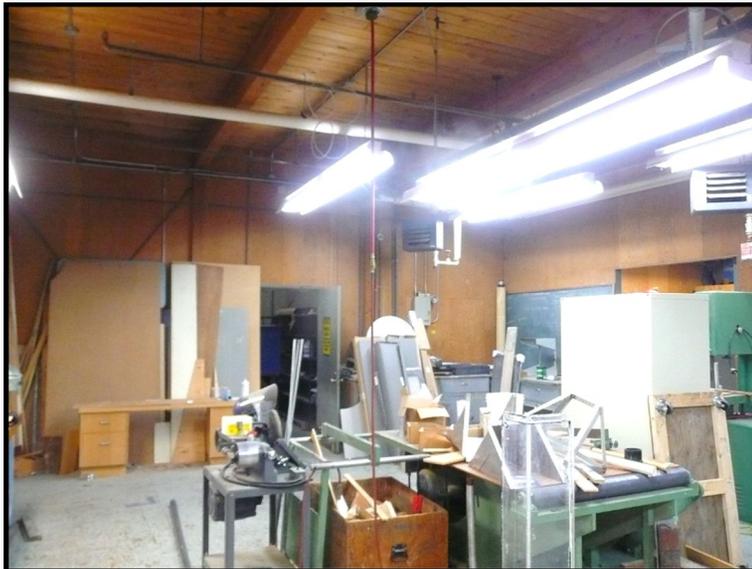
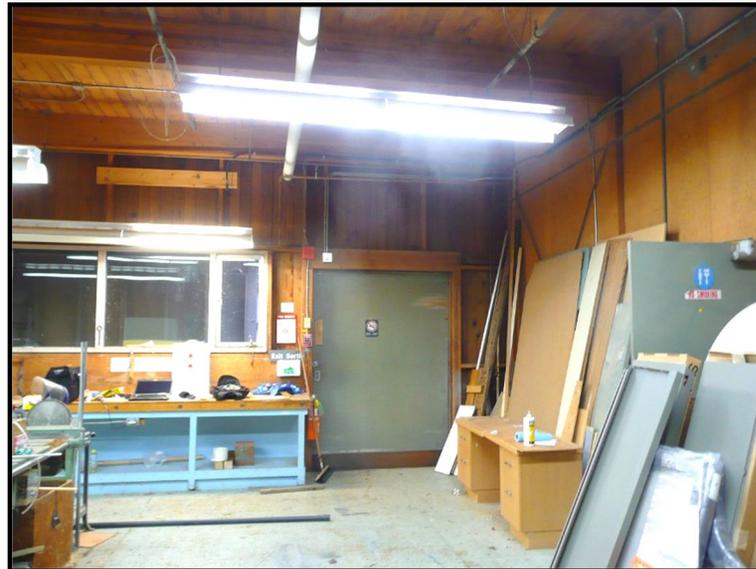
Carpenter Shop Room # 8 looking north (upper left), northeast (upper right), southwest (lower left), and east (lower right).

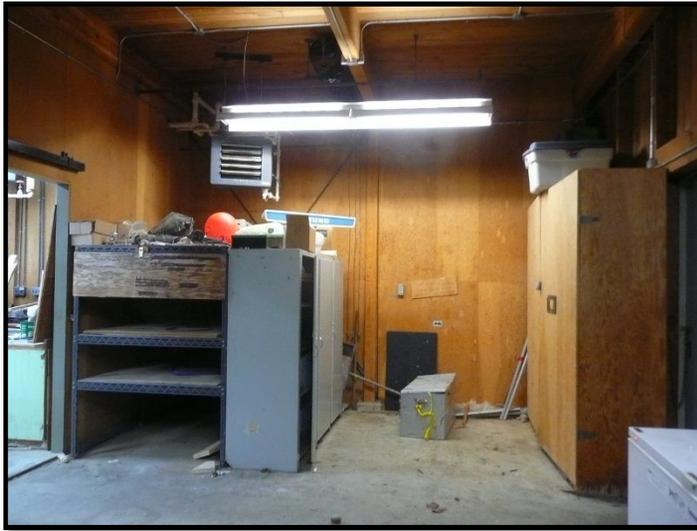
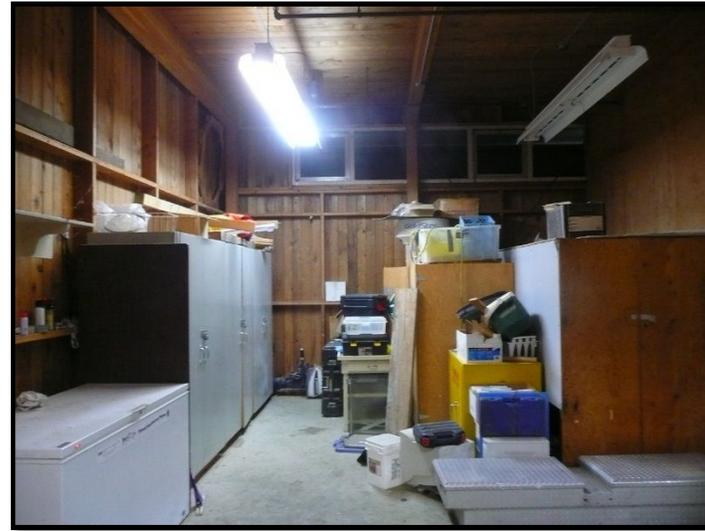
Lumber Storage # 8 looking south (left) and north (right).

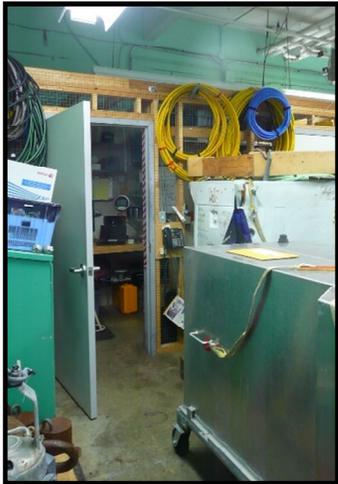
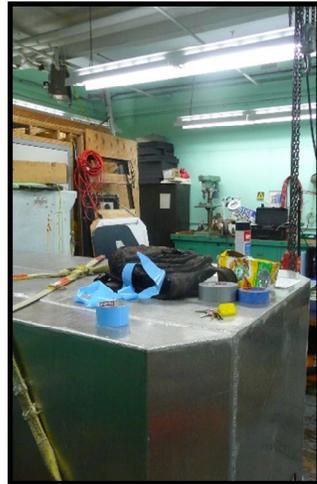
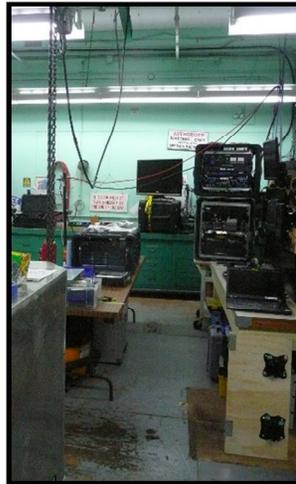
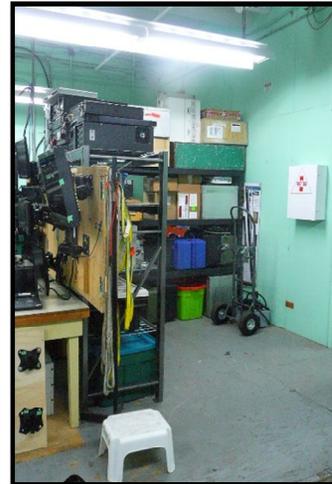
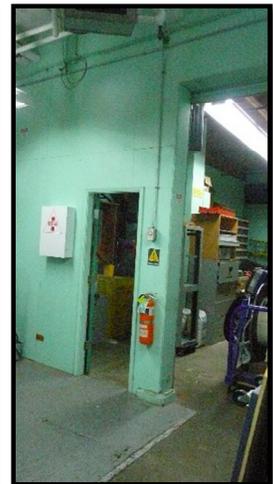
Machine Shop # 9 panorama looking from northeast (left) through to southeast (right).

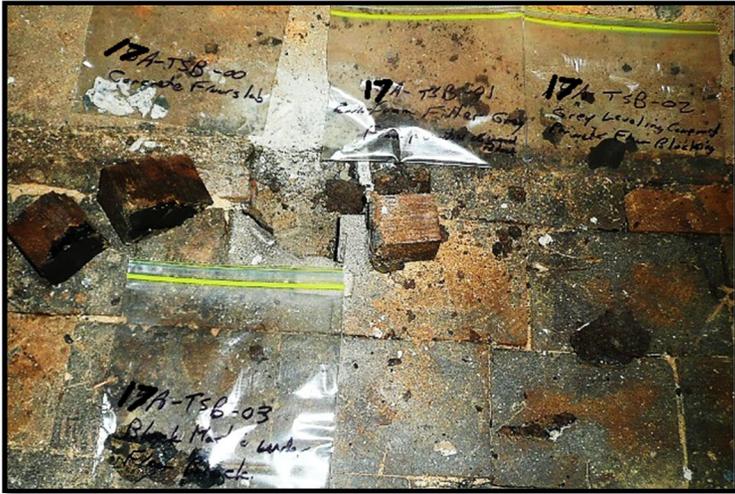
Samples 17A-TSB-00, 01, 02, & 03 associated with the wood block sub-floor in the Carpenters Shop Room # 7.

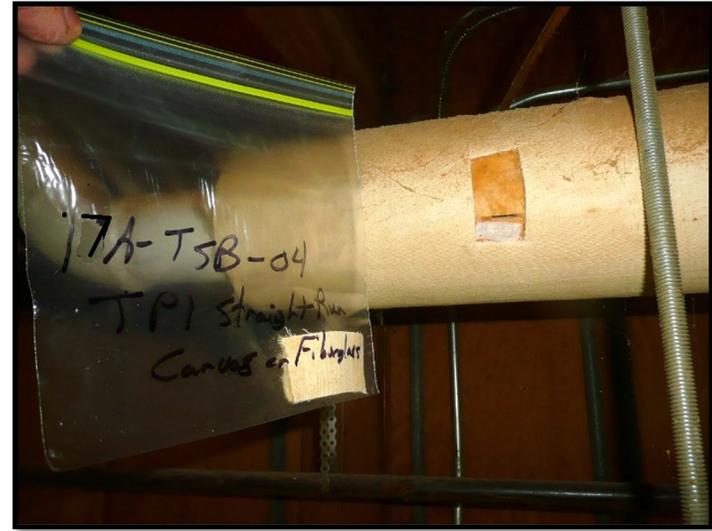
Sample 17A-TSB-04 of thermal pipe insulation straight run canvas over fiberglass from Carpenters Shop Room # 7.

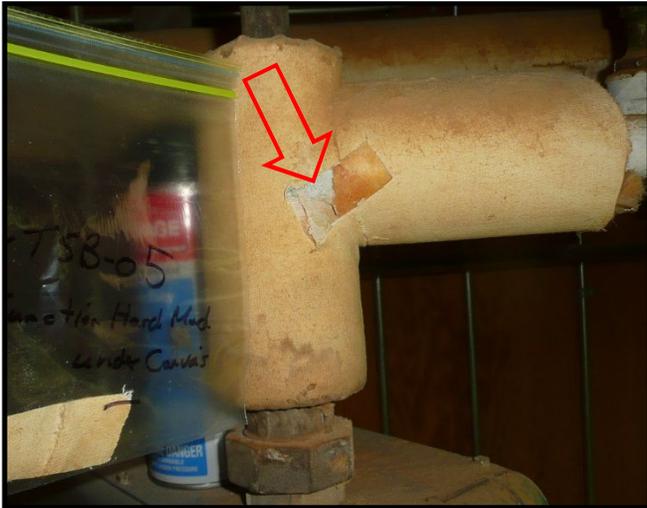
Sample 17A-TSB-05 of thermal pipe insulation at a T-junction with hard mud (65 % Chrysotile) under canvas (None Detected) from Carpenters Shop Room # 7.

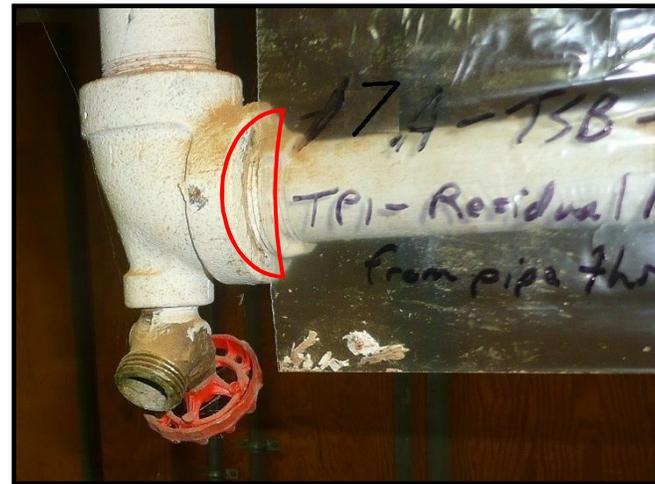
Sample 17A-TSB-06 of thermal pipe insulation residual hard mud from pipe threads (White Insulation 'None Detected', Brown Insulation 'PC 0.5 % Chrysotile') from Carpenters Shop Room # 7.

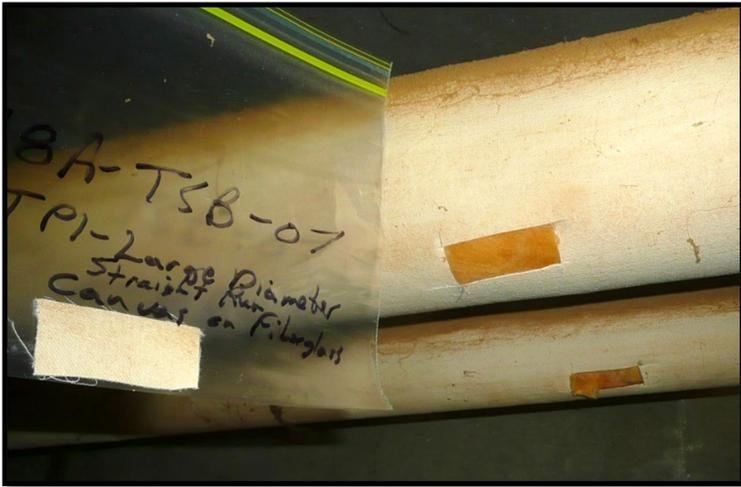
Samples 17A-TSB-07 of large diameter (forward) and 17A-TSB-08 small diameter (back) thermal pipe insulation straight run canvas over fiberglass from Paint Shop Room # 6.

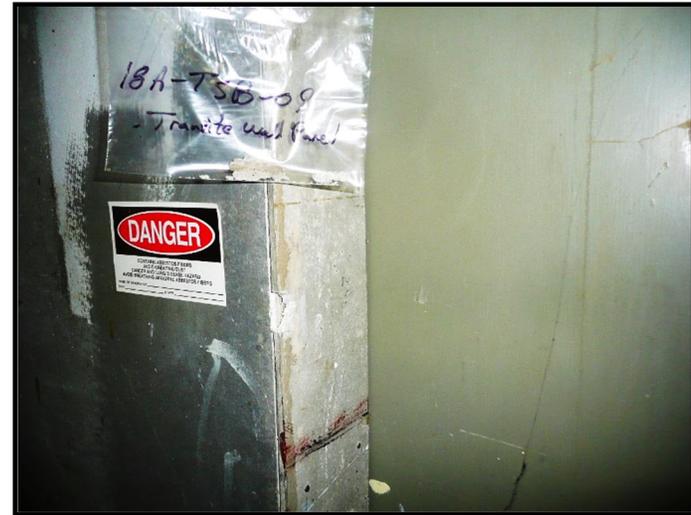
Sample 17A-TSB-09 of hard fireproof composite fibre cement board panelling (Transite Panel) (25 % Chrysotile) from the interior sliding door frame of the Paint Shop Room # 6.

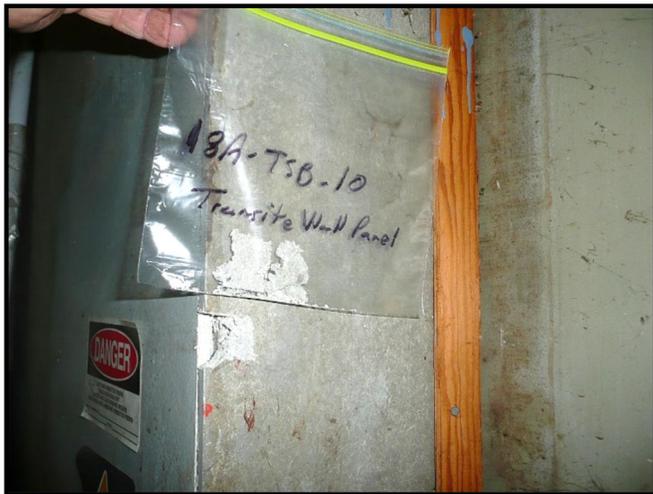
Sample 17A-TSB-10 of hard fireproof composite fibre cement board panelling (Transite Panel) (25 % Chrysotile) from the exterior sliding door frame of the Paint Shop Room # 6.

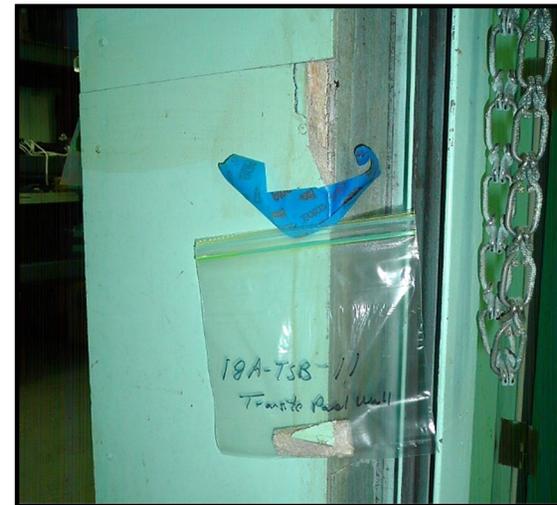
Sample 17A-TSB-11 of hard fireproof composite fibre cement board panelling (Transite Panel) (25 % Chrysotile) from the interior roll-up door frame of the Machine Shop Room # 9.

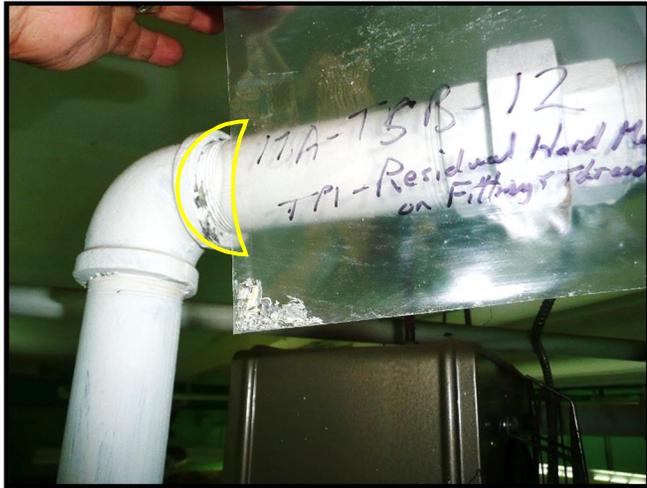
Sample 17A-TSB-12 of thermal pipe insulation residual hard mud on pipe threads in the Machine Shop Room # 9.

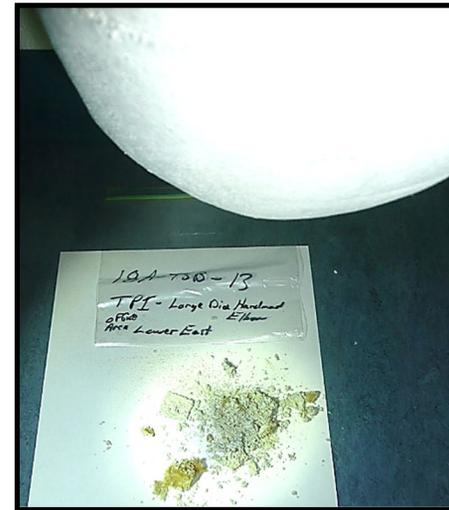
Sample 17A-TSB-13 of thermal pipe insulation from the large diameter, lower east hard mud elbow (65 % Chrysotile) in the Common Room # 5.

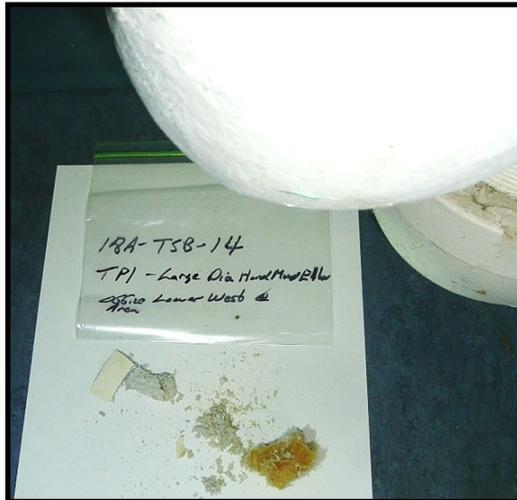
Sample 17A-TSB-14 of thermal pipe insulation from the large diameter, lower east hard mud elbow (Laboratory Reported Portion of Total Sample 25 % Chrysotile) in the Common Room # 5. (Suspect Portion of Sample is the Same as 17A-TSB-05 & 13 or 65 % Chrysotile. See Report Page 9)

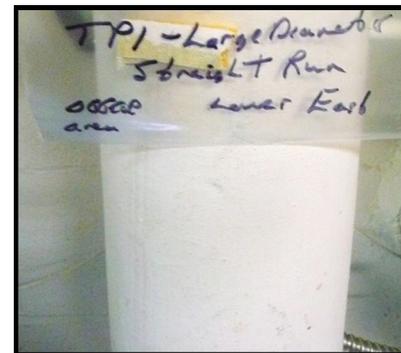
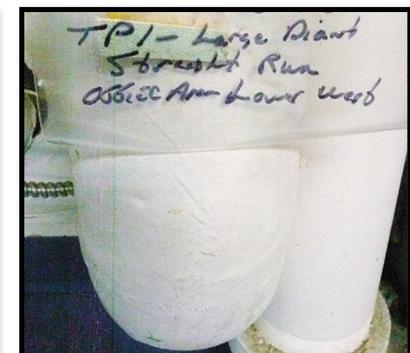
Samples 17A-TSB-15 of large diameter (left) and 17A-TSB-16 large diameter (right) thermal pipe insulation straight run canvas over fiberglass in the Common Room #5.
