0	19/09/09	ISSUED FOR TENDER	DESIGN BY	DESIGN CHECK
NO.	YY/MM/DD	DESCRIPTION	BY	CHECK
REVISIONS / ISSUE				
CLIENT:				
PROJECT: PROJECT:  Parks Canada				
UPPER WEST BANK REHABILITATION PETERBOROUGH LIFT LOCK 21				
DWG. DESCRIPTION: TOPOGRAPHIC SURVEY & EXISTING CONDITIONS SECTIONS, STA. 0+030 TO STA. 0+083				
AUTHENTICATION FOR CURRENT REVISION		DESIGN BY:	SG	DATE: 19/07/30
END. STAMP		DESIGN CHECK:	SK for DA	DATE: 19/09/09
S. GNANASUNTHAR 100060484 SEP 09 10 PROVINCE OF ONTARIO		DRAWN BY:	JTC	DATE: 19/08/01
DWG. NO.		DWG. CHECK:		DATE: 19/09/09
19-1538-003 G110				0

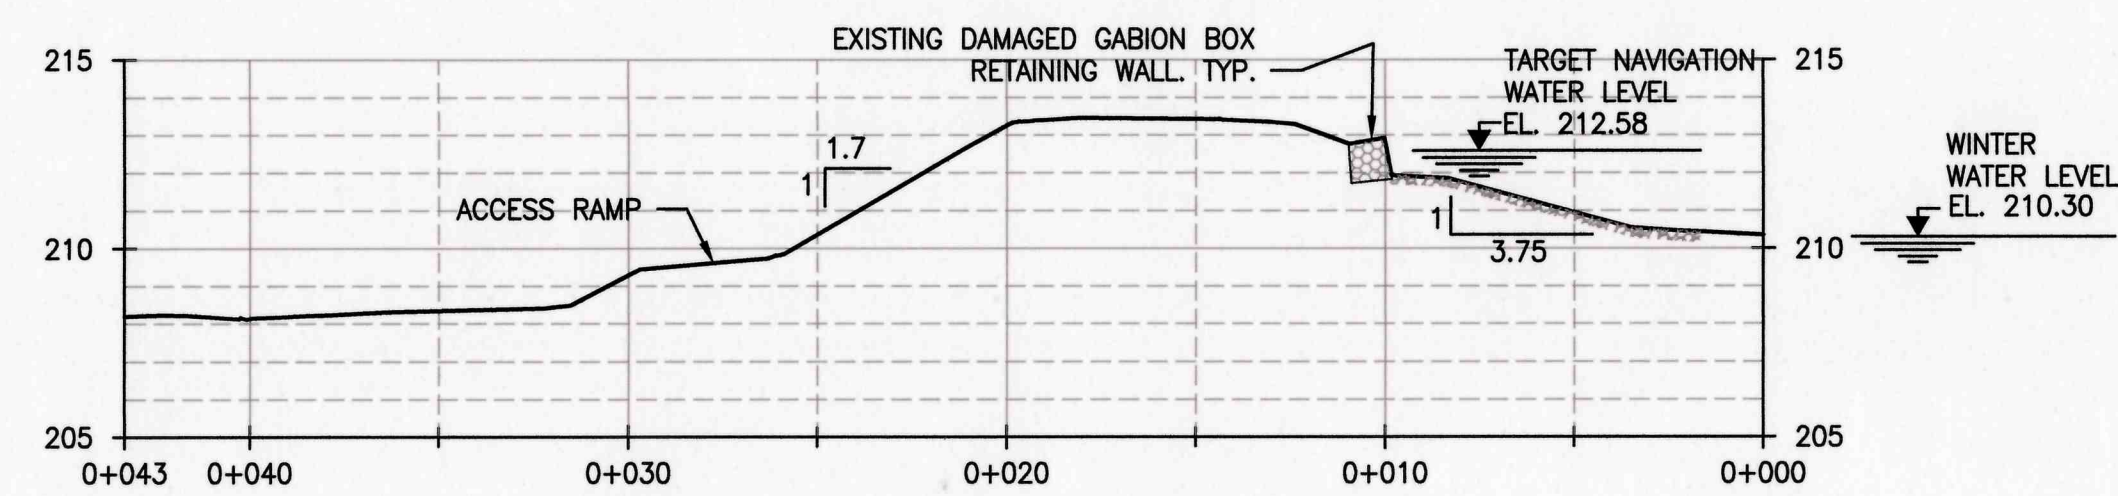
13 STA. 0+083 SECTION  
G104 1:200

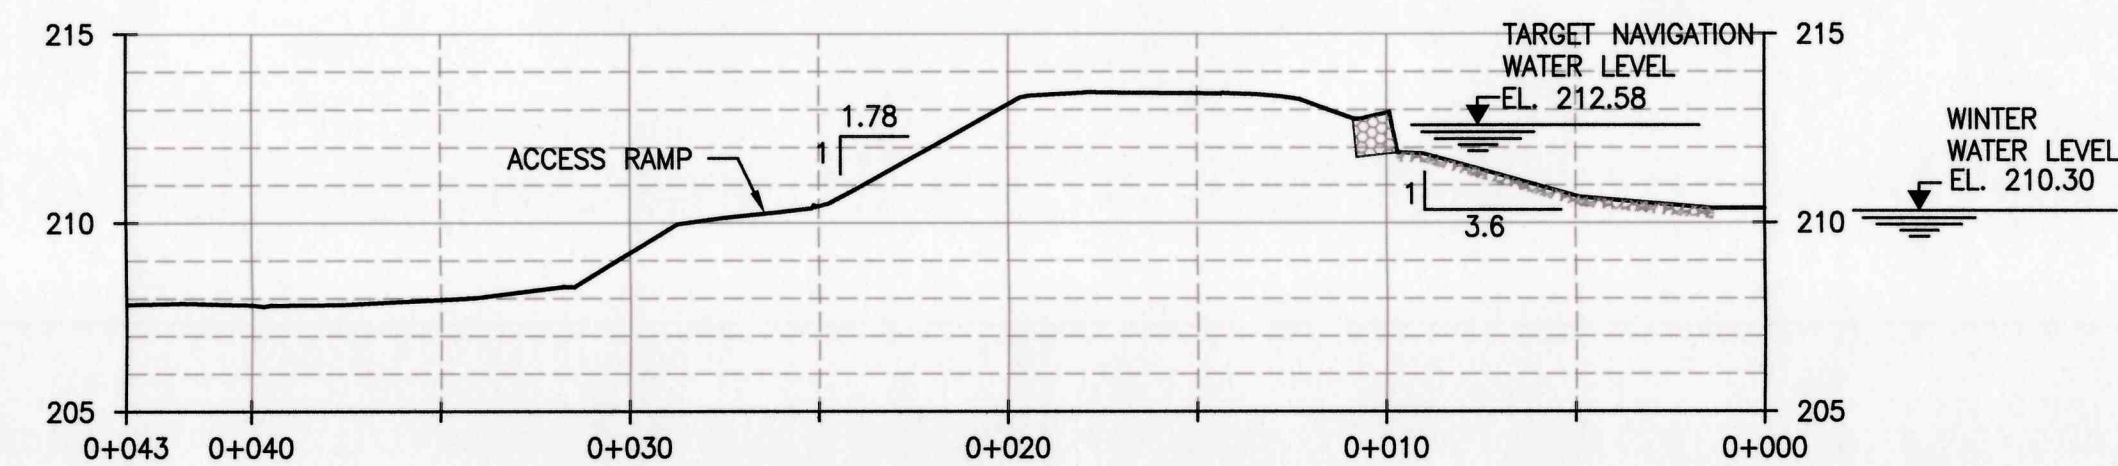
14 STA. 0+077 SECTION  
G104 1:200

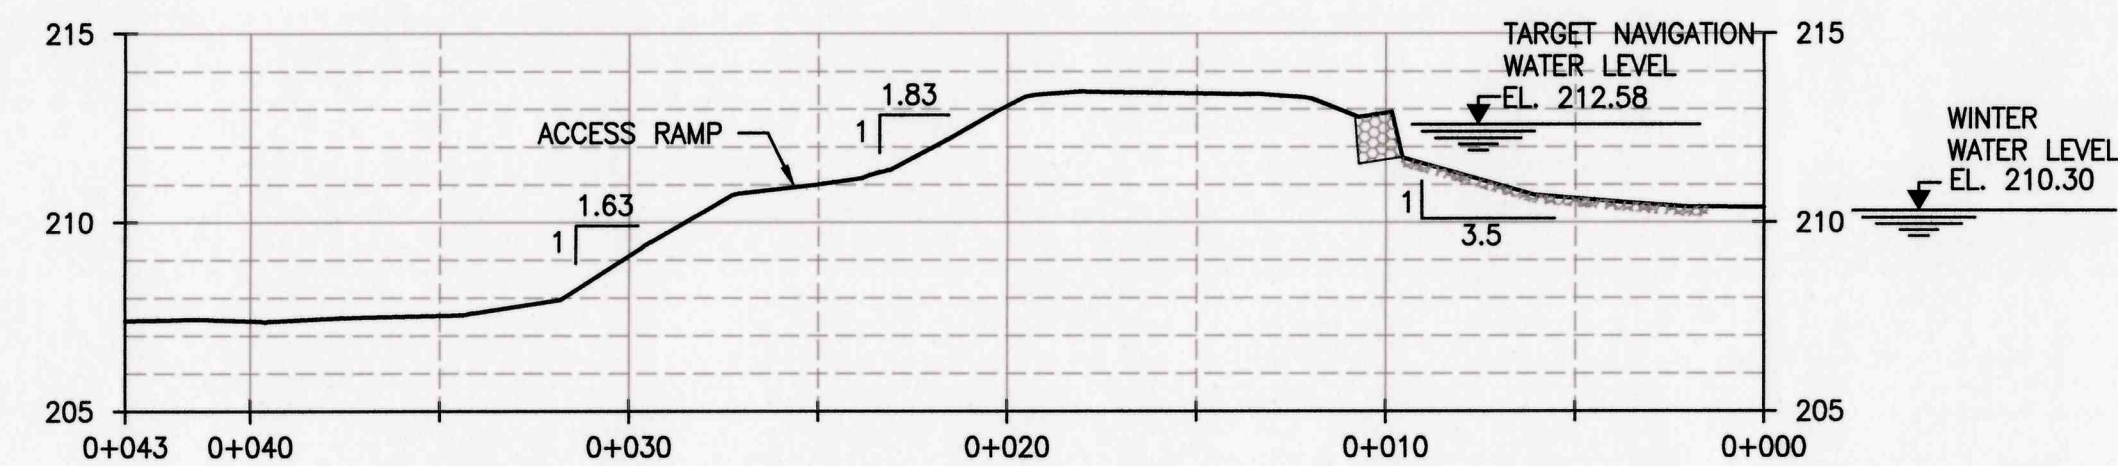
15 STA. 0+070 SECTION  
G104 1:200

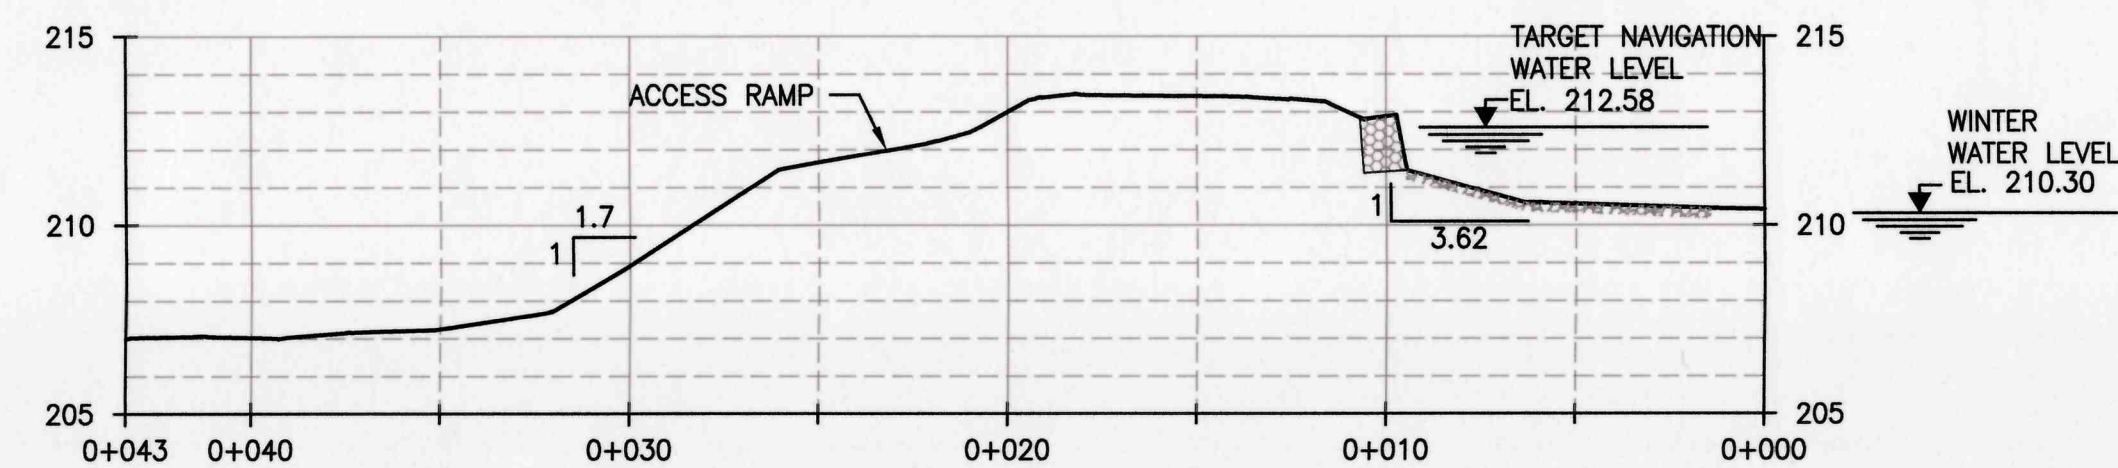
16 STA. 0+064 SECTION  
G104 1:200

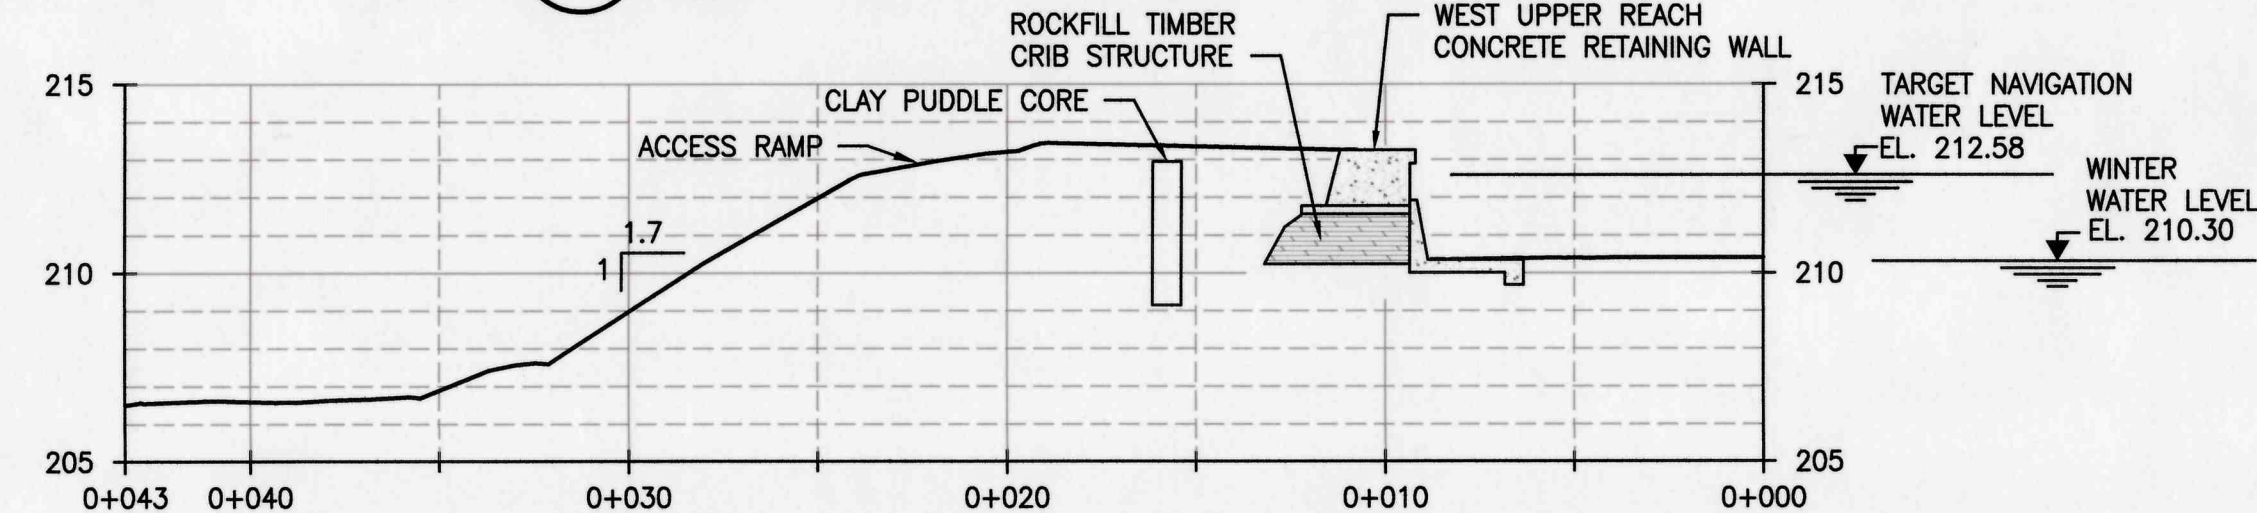
17 STA. 0+057 SECTION  
G104 1:200

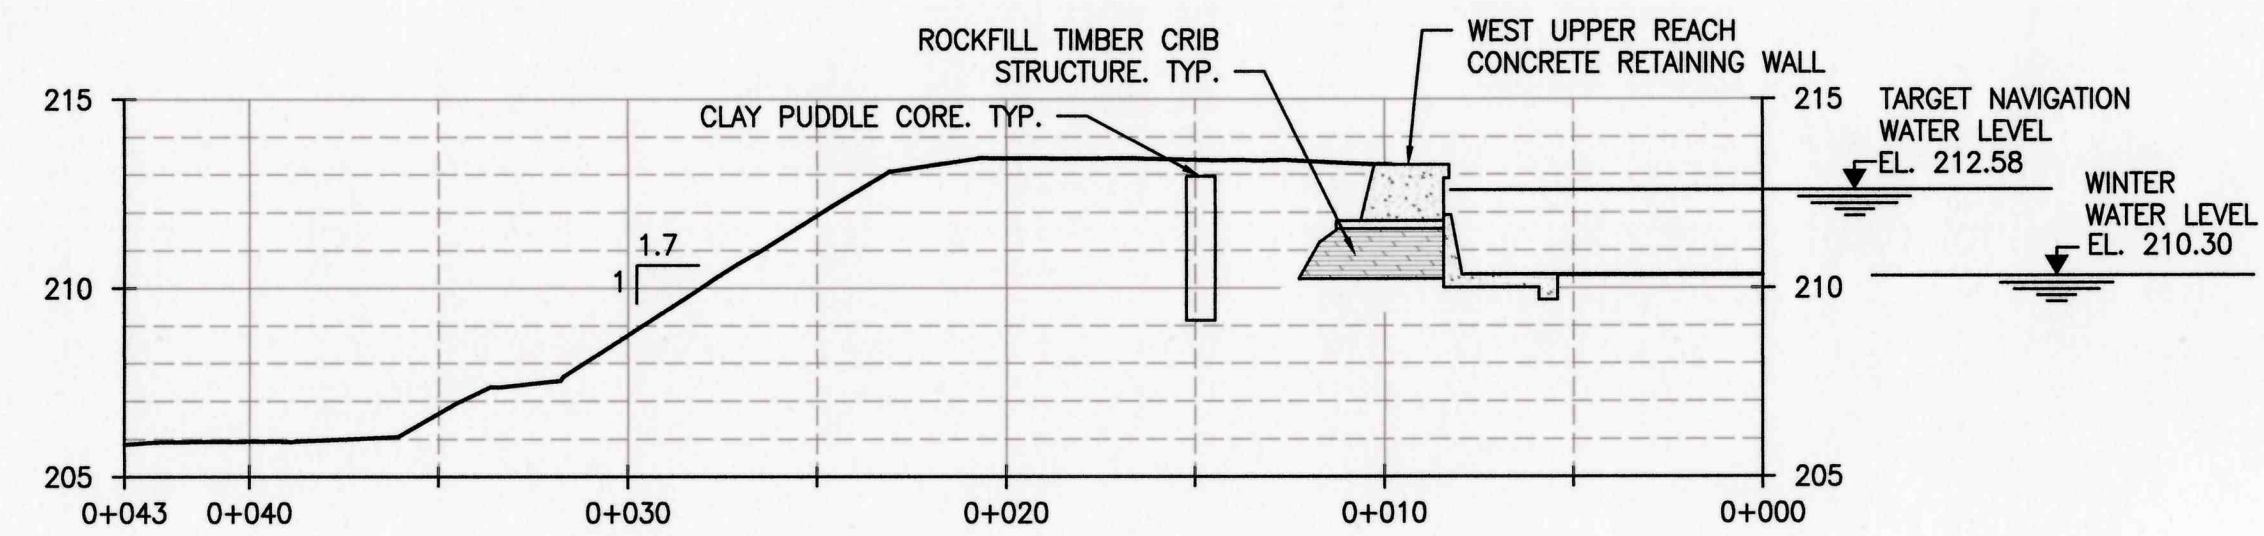
18 STA. 0+048 SECTION  
G104 1:200

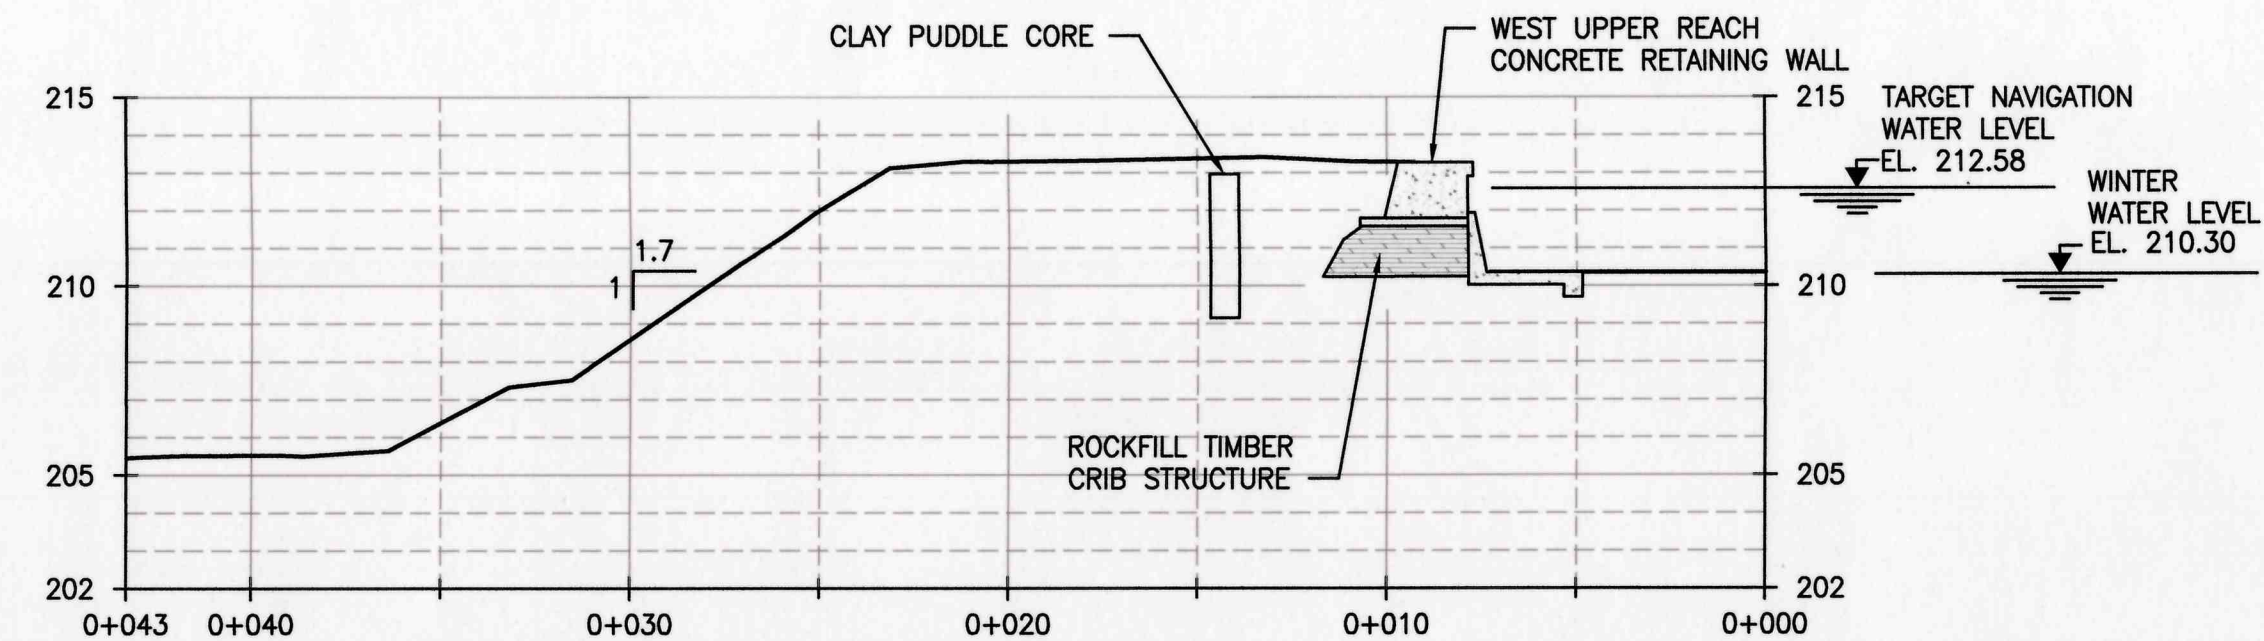
19 STA. 0+042 SECTION  
G104 1:200

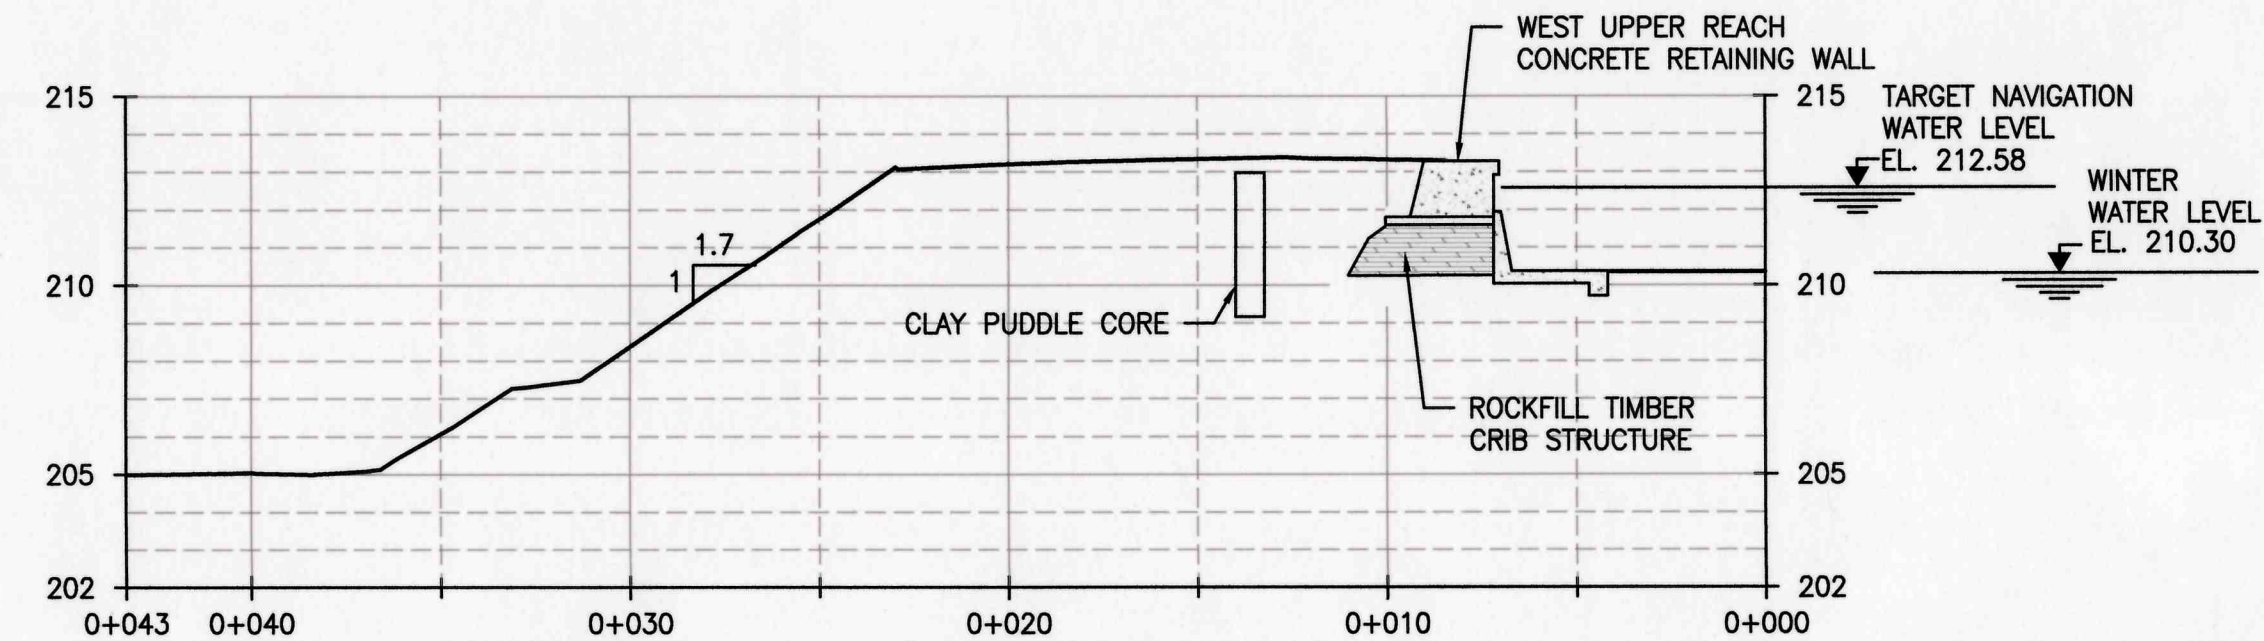
20 STA. 0+035 SECTION  
G104 1:200

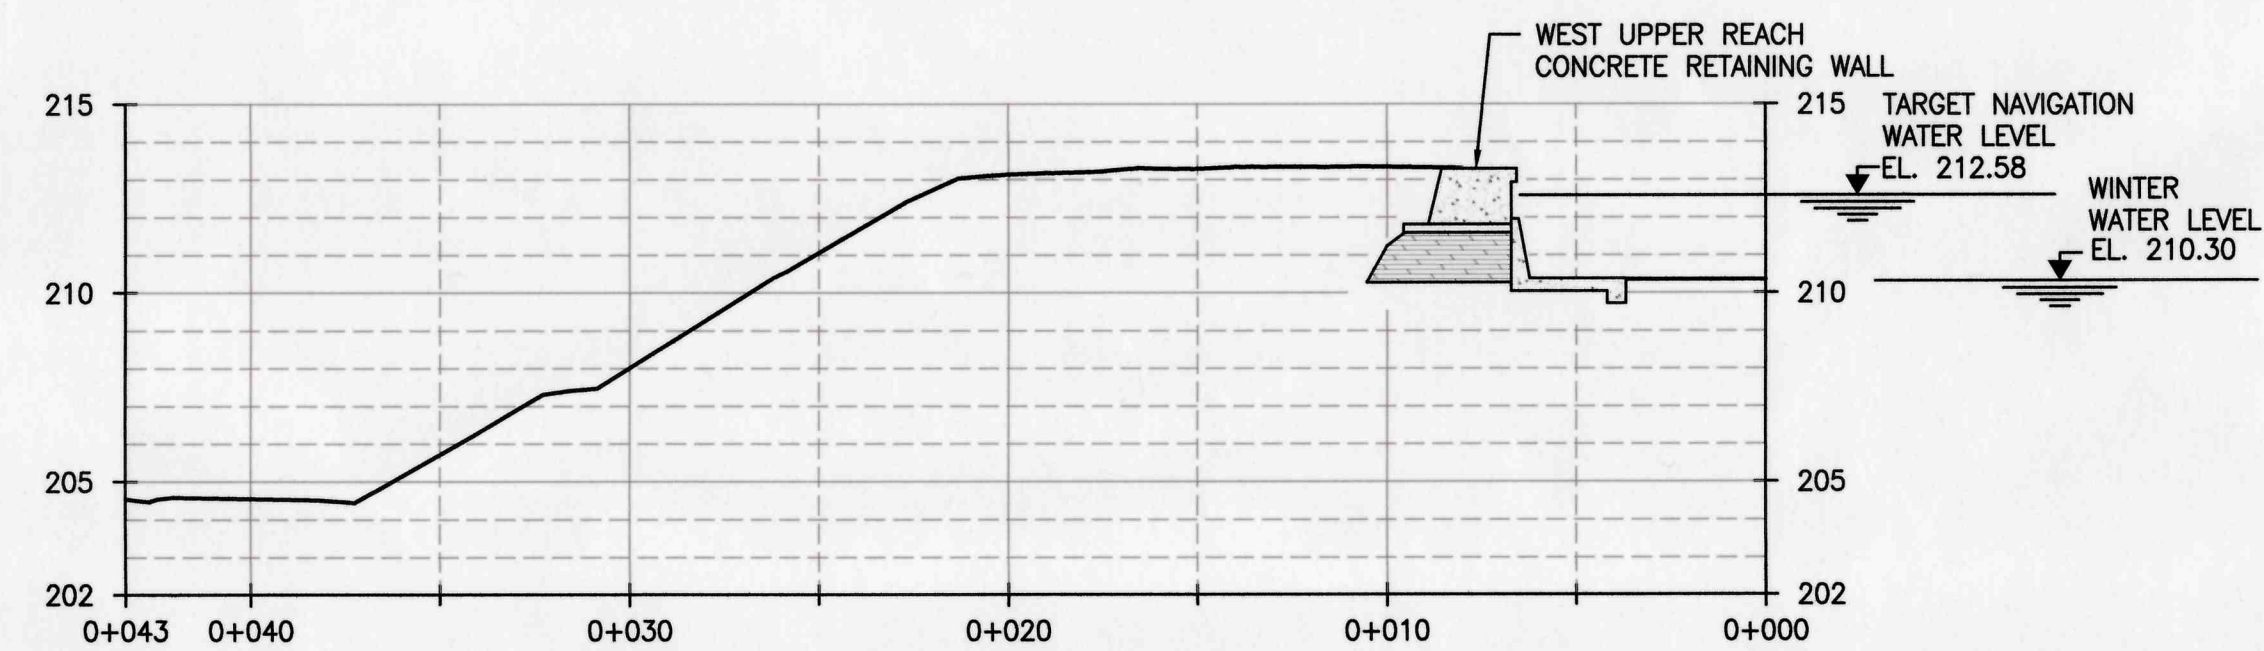
21 STA. 0+030 SECTION  
G104 1:200
