# **Appendix A**

## **Water Flow Test Summary**

**J M FIRE CONSULTING**  
**WATER FLOW TEST SUMMARY**

Type of Area:	Institutional	Property:	Joseph A. Ghiz Building
Location:	275 Pope Road	Test By:	J.A. Maker
Municipality:	Summerside, PE	Date:	07-Aug-18

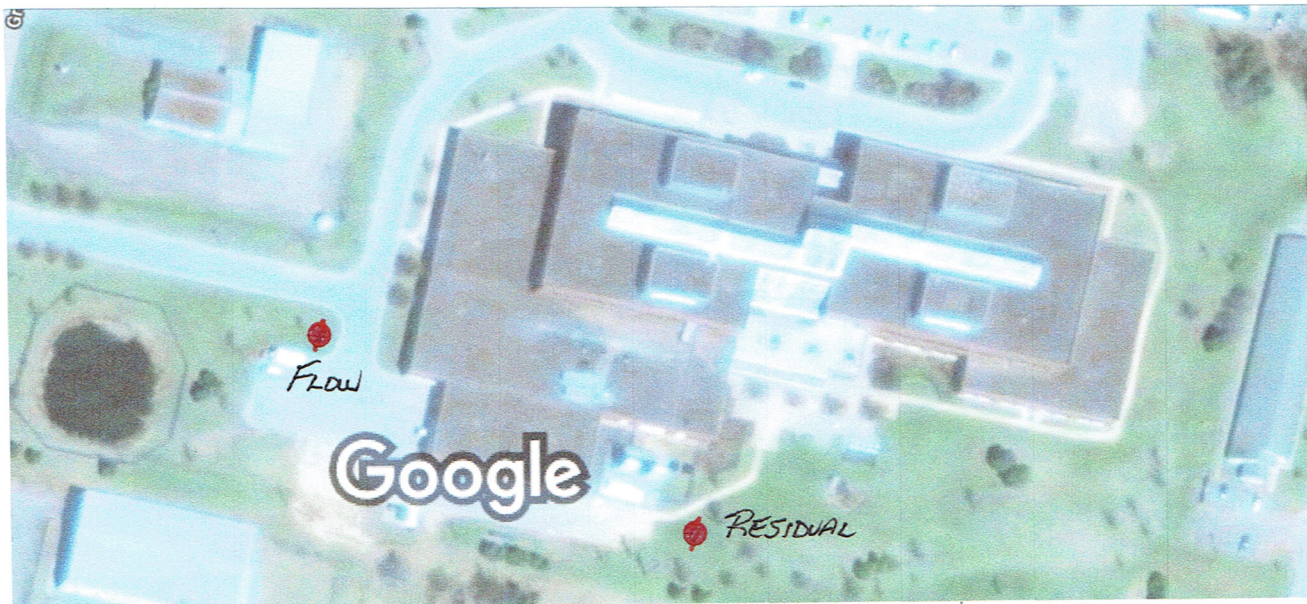
Sketch

Location of Test Hydrants; Residual: **Rear of Complex near underground connections for sprinkler system**

Flow: **Side of Complex near Shipping and Receiving entrance See sketch below**
