**MAINTENANCE GARAGE REHABILITATION ST. ANTHONY AIRPORT**

**MECHANICAL DETAILS**

drawing no. / no. du dessin  
**M12**

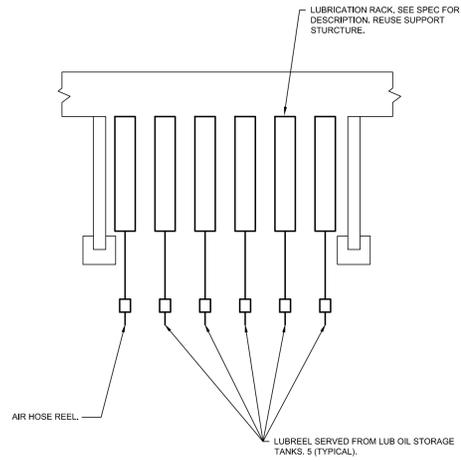
03  
M12

LUBRICATION RACK DETAIL  
N.T.S.

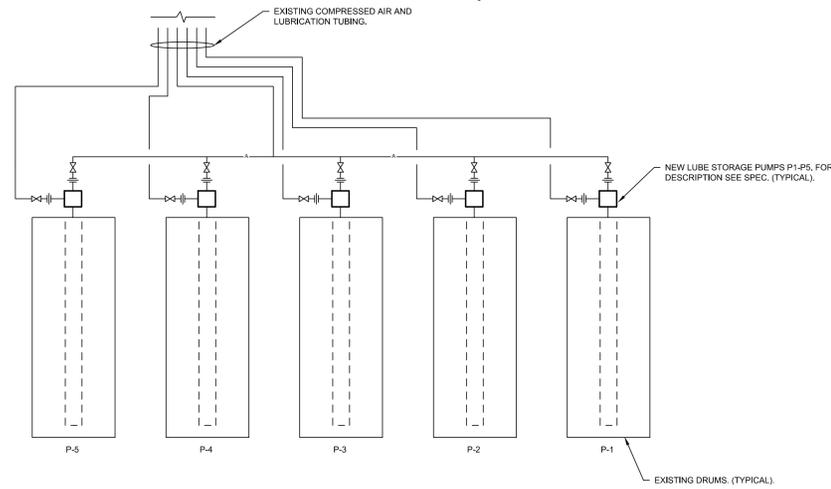
02  
M12

LUBE STORAGE AND PIPING DETAIL  
N.T.S.

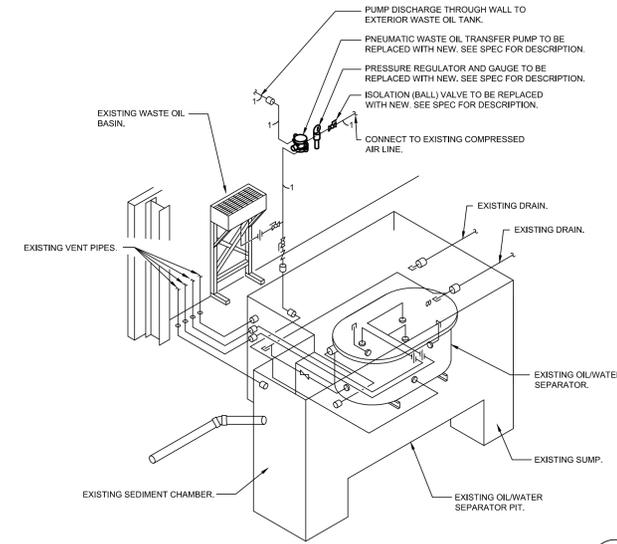
01  
M12

WASTE OIL PIPING ISOMETRIC  
N.T.S.

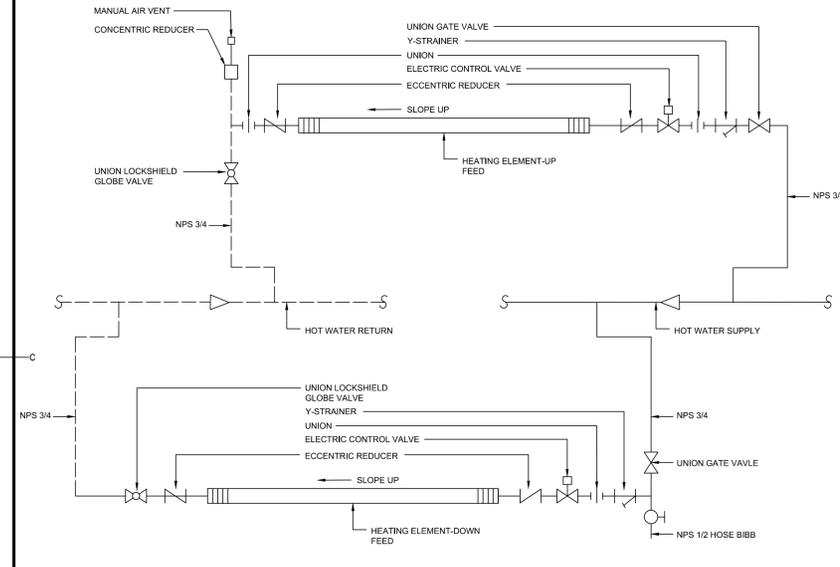
06  
M12

WALL FIN HOT WATER PIPING DETAIL - ONE ROW  
N.T.S.

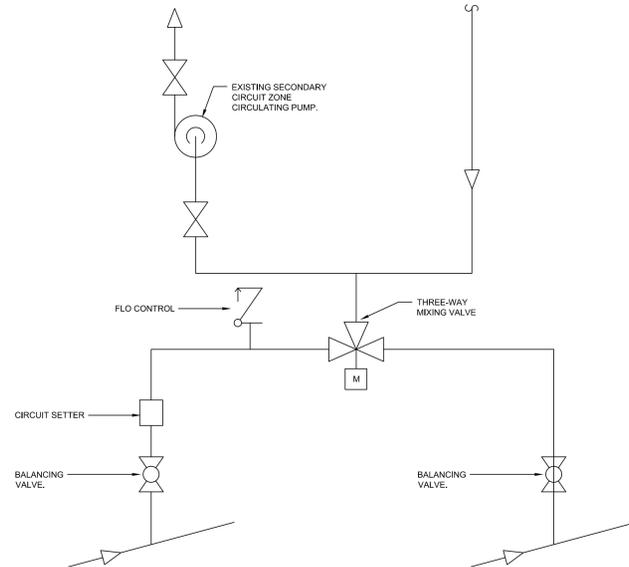
05  
M12

PRIMARY-SECONDARY CROSS-OVER PIPING  
N.T.S.

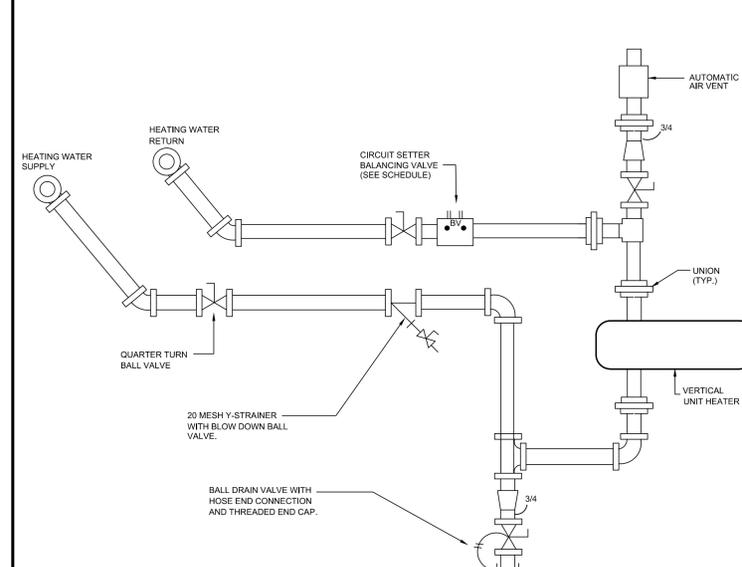
04  
M12

VERTICAL UNIT HEATER DETAIL  
N.T.S.
