Title - Sujet Fuel Storage Tank Repair	
Solicitation No. - N° de l'invitation EP076-201262/A	Amendment No. - N° modif. 004
Client Reference No. - N° de référence du client 20201262	Date 2020-01-09
GETS Reference No. - N° de référence de SEAG PW-\$\$HL-662-77884	
File No. - N° de dossier hl662.EP076-201262	CCC No./N° CCC - FMS No./N° VME
Solicitation Closes - L'invitation prend fin at - à 02:00 PM on - le 2020-02-04	
Time Zone Fuseau horaire Eastern Standard Time EST	
F.O.B. - F.A.B. Plant-Usine: <input type="checkbox"/> Destination: <input type="checkbox"/> Other-Autre: <input type="checkbox"/>	
Address Enquiries to: - Adresser toutes questions à: Munz, Pam	Buyer Id - Id de l'acheteur hl662
Telephone No. - N° de téléphone (613) 296-9133 ()	FAX No. - N° de FAX () -
Destination - of Goods, Services, and Construction: Destination - des biens, services et construction:

Amendment 004 is raised to extend the bid close date, answer questions from the optional site visit and amend the terms and conditions.

STATEMENT OF WORK

Attachment 1 to Annex "A"

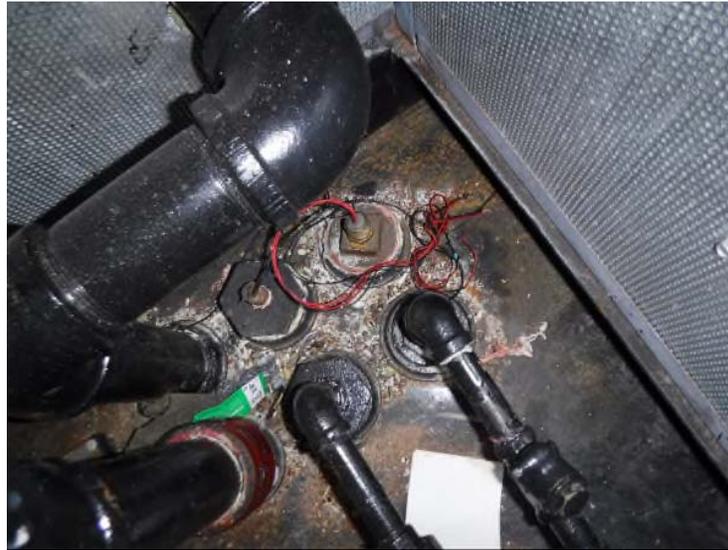
A14 (SV 14) - The twist-on wire connectors shall be added to any remaining loose wires adjacent to the fill, vent, supply and return piping connections. Refer to the photo below.

7. Install twist on wire connectors to prevent damaging wires. The twist-on wire connectors shall be added to any remaining loose wires adjacent to the fill, vent, supply and return piping connections. Refer to the photo below. One of the 2" sealed ports containing the loose wires can be used for the high level float switch.

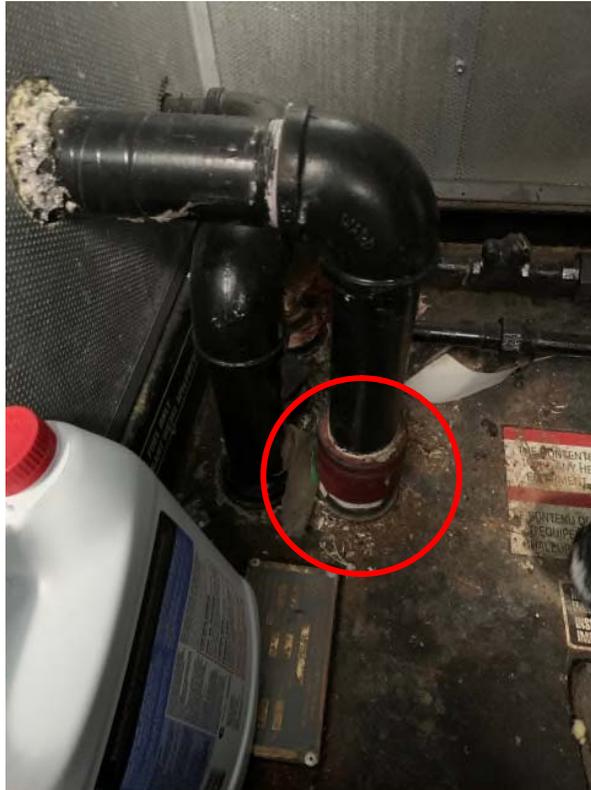
Photo 1: whistle valve (circled) installed on the inside of the fuel storage tank system at Building 91/T82F

A10 (SV10) - Yes, there is an existing vent whistle. However the requirement for this item is to install a ULC approved audible and visual overfill device (example: K-Tech).

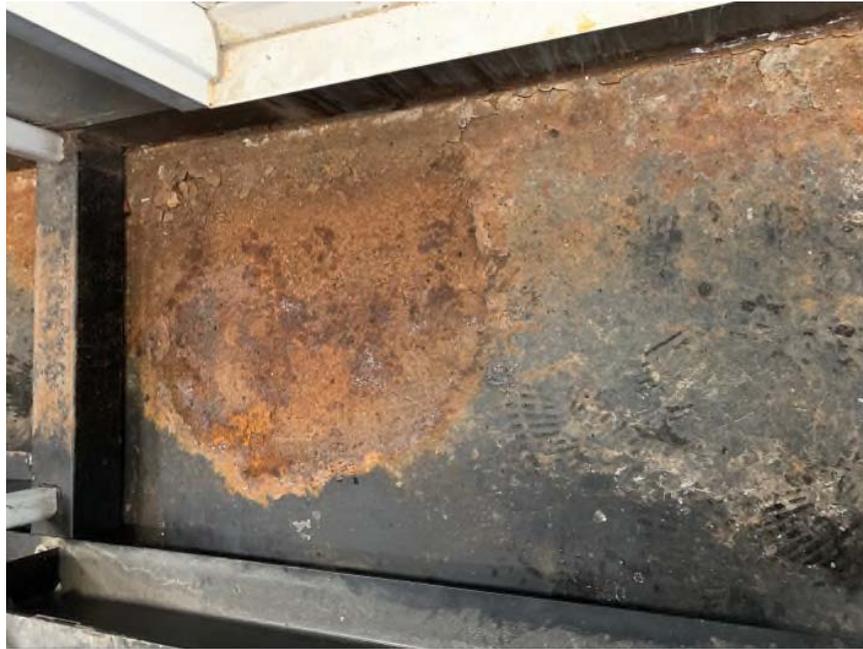
Photo 2: Rust on the floor of the fuel storage tank system at Building 91/T82F

6. Lightly sand tank and repaint tank. The exterior of the tank at the top (inside generator enclosure) and the accessible portions at the exterior (sides) shall be lightly sanded for rust removal and repainting. The fuel containing interior of the tank is excluded. All work shall be completed in accordance with the tank manufacturer's approval. Painting the tank with manufacturer approved primer and paint should be completed as early as it can reasonably be performed.

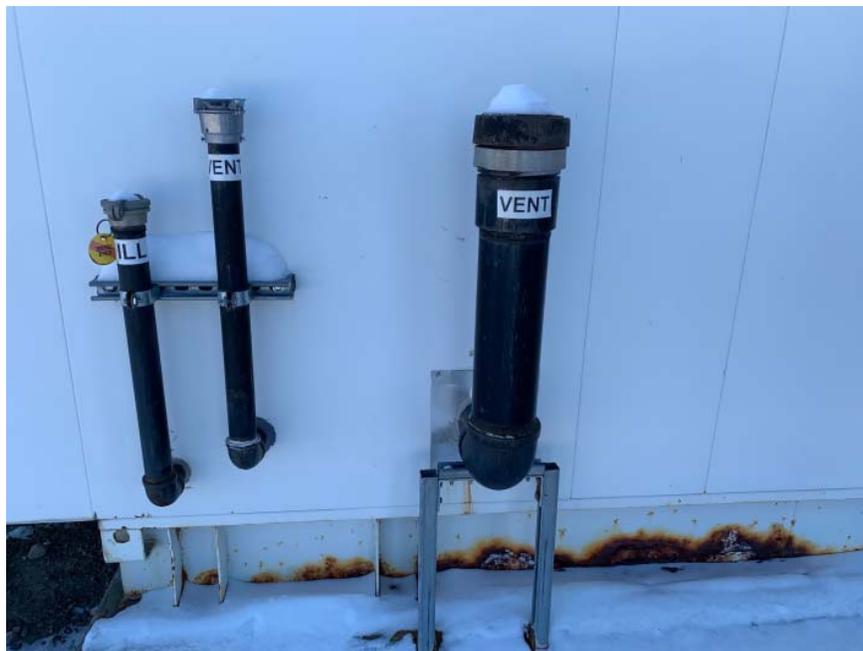
Photo 3: Outside pipe configuration and rust on fuel storage tank system at Building 91/T82F

5. Cut out a larger opening for supply/vent piping penetrating wall and install a sleeve for the piping. The piping shall have weatherproofing and fireproofing, where the piping enters the enclosure.

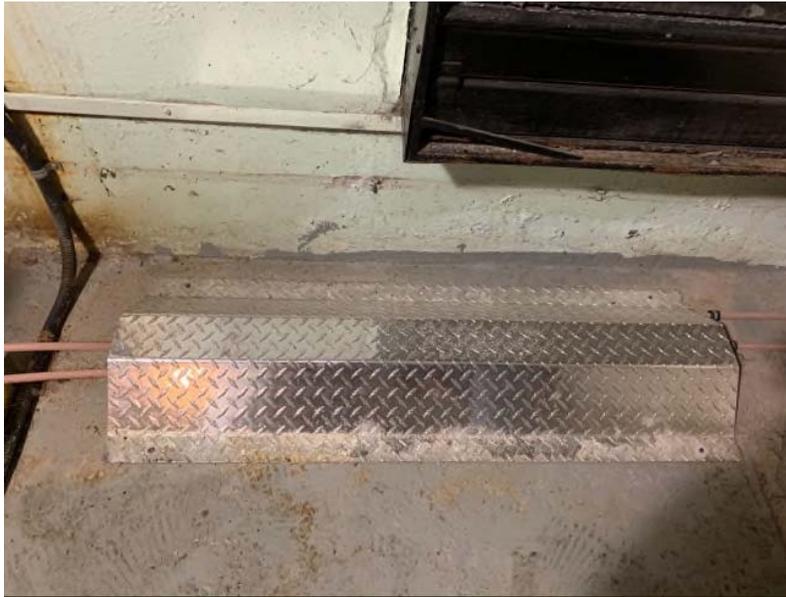
There is already a floor plate installed over the piping where it might be subjected to impact. It is aluminum and not yellow but it's near the wall and wouldn't be a tripping hazard. Is a new floor plate required?

Photo 4: Floor plate installed at Building 5B

A4 (SV 4) - The former piping on the floor to the Markon generator has been removed. This recommendation is amended to adding yellow & black hazard tape to the existing floor plate.

7. Add yellow & black hazard tape to the existing floor plate.
8. Remove valve installed on return line at Perkins generator and replace with pipe nipple

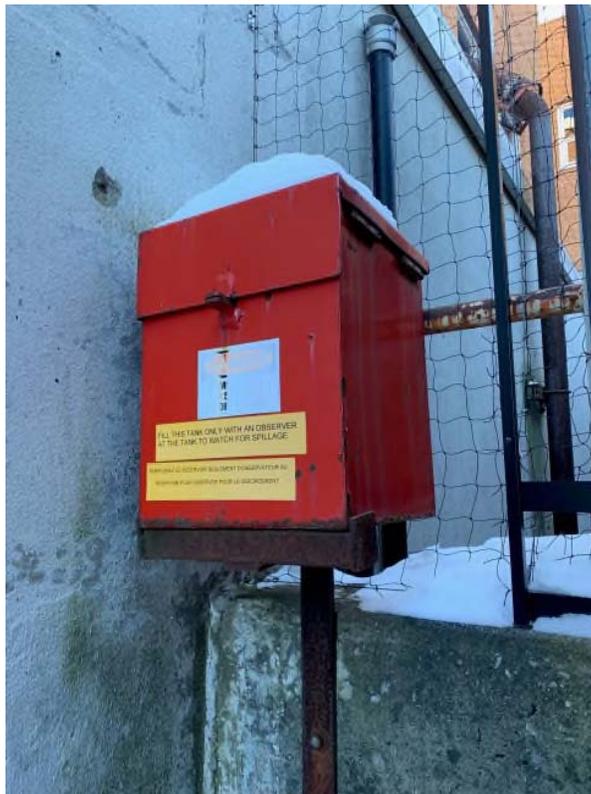
Photo 5: Outside fill pipe spill container at Building 5B

4. Overfill protection:			
<p>There is a non ULC approved spill containment device (approx. 28 L capacity) situated approximately 4 m above the tank. A placard on the spill containment device indicates that an observer must be present at tank for spillage. There no ULC-S661 overfill protection on the system, however a ULC approved level gauge and a vent whistle are present at the main tank.</p>

4. Remove and replace spill containment box and ensure it is ULC approved. A minimum of 68 liters for a reaction time of 2 seconds at the connection point.

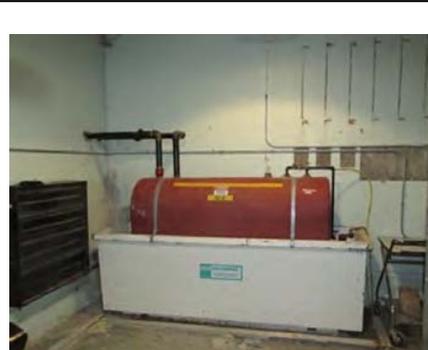
Main Tank

Building Number:	Building 5B		
FSTS Contents:	Diesel	FSTS Capacity:	1,100 L
Location:	3701 Carling Avenue, Nepean, ON		
1. Description of storage tank system:			
<p><u>Main Tank:</u> There is one (1) single-wall shop fabricated tank built in 2000, with a capacity of 1,100 L, ULC-S602, and painted, located inside Building 5B next to the generator. The tank is installed in a secondary containment ULC C142.20 approved.</p> <p><u>Transfer System:</u> A generator is located within 3 m of the main tank inside the building. Piping is run from the fill point directly into the main tank ~4 meters below the fill point. Fuel is delivered through an automatic fuel nozzle directly into the fill port which is contained by a non ULC spill containment box.</p> <p><u>Monitoring System:</u> An operator is present during fueling. There is only a level gauge situated on the tank.</p>

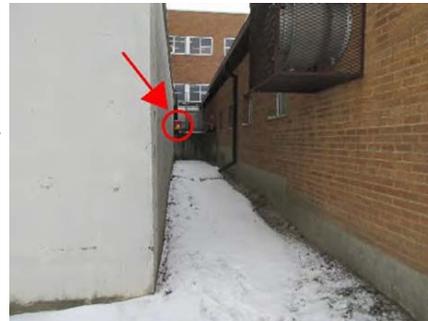
2. PTA, Topography and nearest Receptors:			
<p>The fueling of the main tank happens approximately once per year. The fuel delivery truck parks in the loading dock at Building 29 and runs the fueling hose to the fill point (approx. 30 m). The fuel delivery truck is not visible from the fill point. There is a relatively large slope towards the loading dock.</p> <p>The fill point is located on landscaping therefore the area is susceptible to soil contamination if a spill occurs. The area would not contain a spill at the fill connection, and the fuel would seep into the soil.</p>

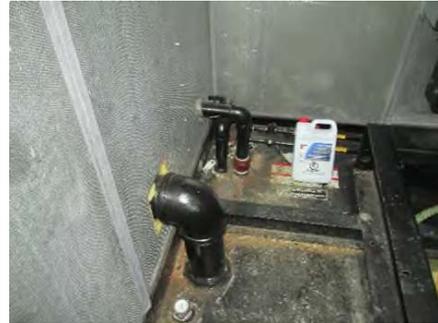
Main Tank

Building Number:	Building 91/T-82F		
FSTS Contents:	Diesel	FSTS Capacity:	1,704 L
Location:	3701 Carling Avenue, Nepean, ON		
1. Description of storage tank system:			
<p><u>Main Tank:</u> There is one (1) painted shop fabricated subbase tank with a secondary containment (ULC-C142.5) built in 2004, with capacity of 1,704 L, located inside Building T-82F below the generator.</p> <p><u>Transfer System:</u> The generator is located above the subbase main tank and piping is run from the tank to the generator. Fuel is delivered through an automatic fuel nozzle directly into the fill port without a spill containment box.</p> <p><u>Monitoring System:</u> There is a level gauge situated inside the building.</p>

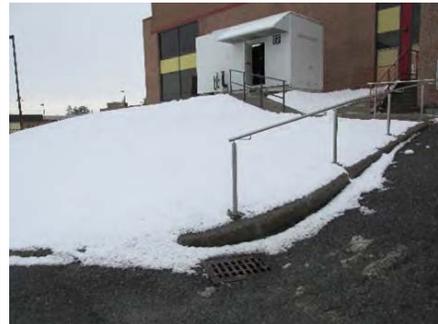
Topographie

2. PTA, Topography and nearest Receptors:			
<p>The fueling of the main tank happens approximately once per year. The fuel delivery truck parks on the road North of Building T-82F and runs the fueling hose up the hill to the fill point (approx. 15 m). The fuel delivery truck is visible from the fill point. There is a significant slope towards the grass and storm drain from the fill point.</p> <p>The tank is installed on a concrete pad surrounded by landscaping therefore, the area is susceptible to soil contamination if a spill occurs. The area would not contain a spill at the fill connection, and the fuel would seep into the soil.</p>

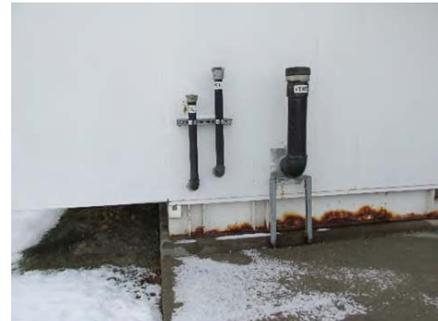
Overfill protection

4. Overfill protection:			
<p>There is no spill containment box and the only overfill protection is a level gauge situated inside Building T-82F. There is a ULC approved vent whistle inside Building T-82F.</p>

1. Install a spill containment box and ensure it is ULC approved. A minimum of 68 liters for a reaction time of 2 seconds at the connection point.
2. Install a ULC-S661 overfill protection device of the audible or combined audible and visual type. There is an existing vent whistle. The requirement for this item is to install a ULC approved audible and visual overfill device (example: K-Tech). Connection of the remote audible and visual overfill alarm to an emergency power source shall be coordinated with the Departmental

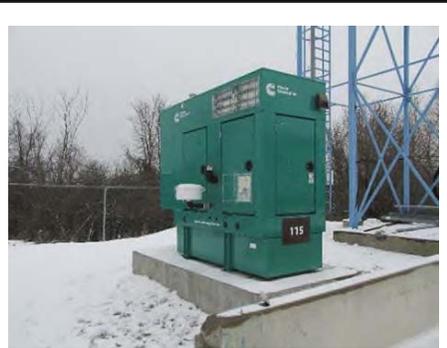
Main Tank

Building Number:	Building T112		
FSTS Contents:	Presume Diesel	FSTS Capacity:	Unknown
Location:	3701 Carling Avenue, Nepean, ON		
1. Description of storage tank system:			
<p><u>Main Tank:</u> There is one (1) shop fabricated tank presumably built in 2016, with unknown capacity, ULC spill containment box and located inside the generator enclosure.</p> <p><u>Transfer System:</u> The system consists of a storage tank and generator as a complete unit. The fuel is supplied by an automatic fuel nozzle into the fill port inside a ULC approved spill containment box.</p> <p><u>Monitoring System:</u> None found.</p>

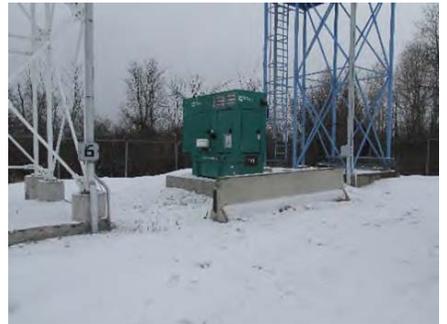
2. PTA, Topography and nearest Receptors:			
<p>The fueling of the main tank happens approximately once per year. The fuel delivery truck parks on the grass south of Building T115 and runs a hose to the fill point (approx. 5 m). The fuel delivery truck is visible from the fill point. There is a minor slope away from the main tank.</p> <p>The storage tank is situated on concrete and surrounded by landscaping therefore, the area is susceptible to soil contamination if a spill occurs. The area would not contain a spill at the fill connection, and the fuel would seep into the soil.</p>

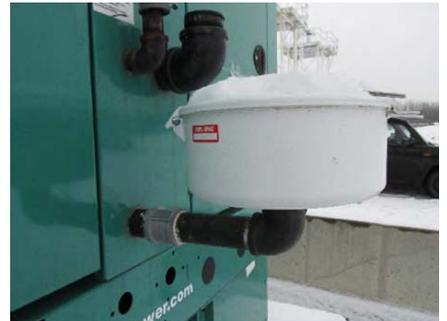
Overfill protection

4. Overfill protection:			
<p>There is a ULC approved spill containment device (approx. 20 L capacity) with no overfill protection was observed.</p>

1. Install a ULC-S661 overfill protection device of the audible or combined audible and visual type. Connection of the remote audible and visual overfill alarm to an emergency power source shall be coordinated with the Departmental Representative.
2. There are no exterior walls on this system, so this recommendation has been withdrawn. However, all new and existing penetrations shall be sealed liquid- and vapour-tight.
3. Install a lock on the spill containment box
