**SOLICITATION AMENDMENT
MODIFICATION DE L'INVITATION**

Title - Sujet Crane Inspections and Repairs	
Solicitation No. - N° de l'invitation ET858-210482/A	Amendment No. - N° modif. 002
Client Reference No. - N° de référence du client PSPC-ET858-210482	Date 2020-09-11
GETS Reference No. - N° de référence de SEAG PW-\$CAL-142-7088	
File No. - N° de dossier CAL-0-43018 (142)	CCC No./N° CCC - FMS No./N° VME
Solicitation Closes - L'invitation prend fin at - à 02:00 PM on - le 2020-09-22	
Time Zone Fuseau horaire Mountain Daylight Saving Time MDT	
F.O.B. - F.A.B. Plant-Usine: <input type="checkbox"/> Destination: <input checked="" type="checkbox"/> Other-Autre: <input type="checkbox"/>	
Address Enquiries to: - Adresser toutes questions à: Blake, Luke J.	Buyer Id - Id de l'acheteur cal142
Telephone No. - N° de téléphone (403) 613-0725 ()	FAX No. - N° de FAX () -
Destination - of Goods, Services, and Construction: Destination - des biens, services et construction:

This amendment is raised to answer the following questions from industry:

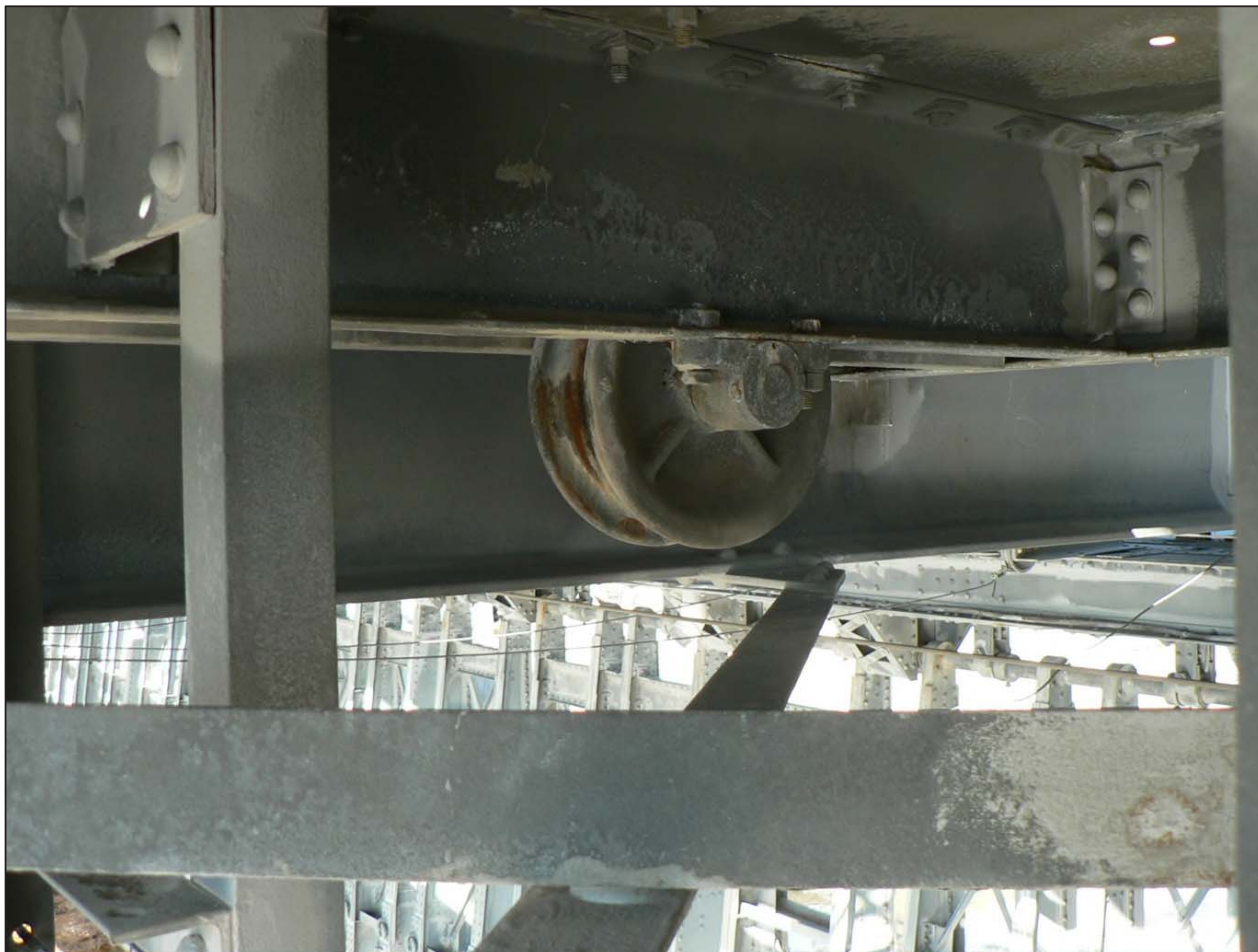
Figure 1: Pulley (chain guide) for frame crane. / / / Poulie (guide de chaîne) pour la grue à cadres.

(a) There are 23 chain guides in each span except last which has 21 (the fish ladder takes the place of last double-frame which would have had 2 guides). This gives a total of 136 chain guides.

(b) Yes, the chain guides are mounted to the underside of the platform. The best access is from the crawl space under the deck or from the top of the frames when these are in the stored ("up") position. This crawl space is visible under the frame crane in Figure 4 of the SOW, but also please see drawing and pictures attached.

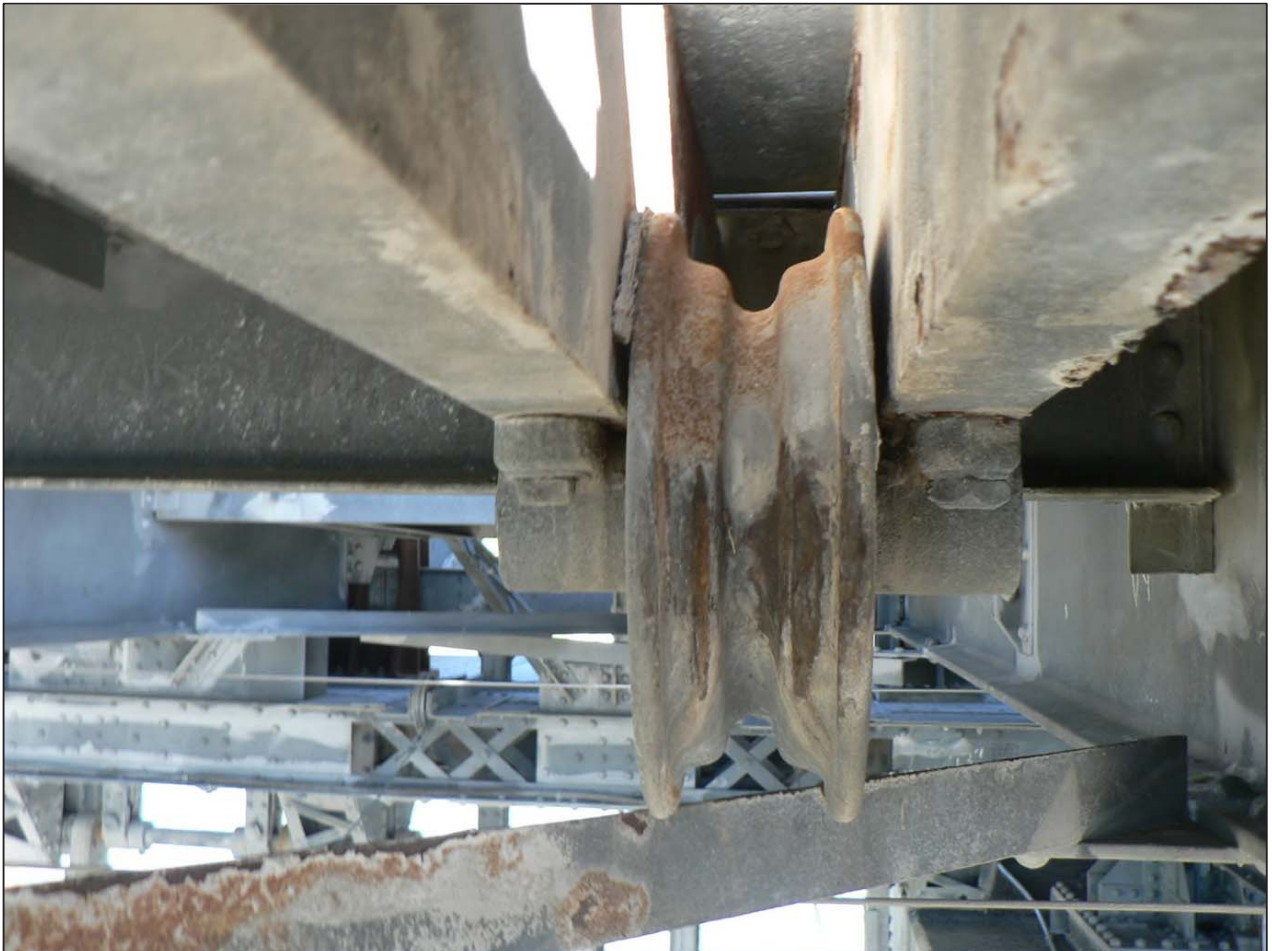
Figure 2 : Pulley (chain guide) for frame crane. / / / Poulie (guide de chaîne) pour la grue à cadres

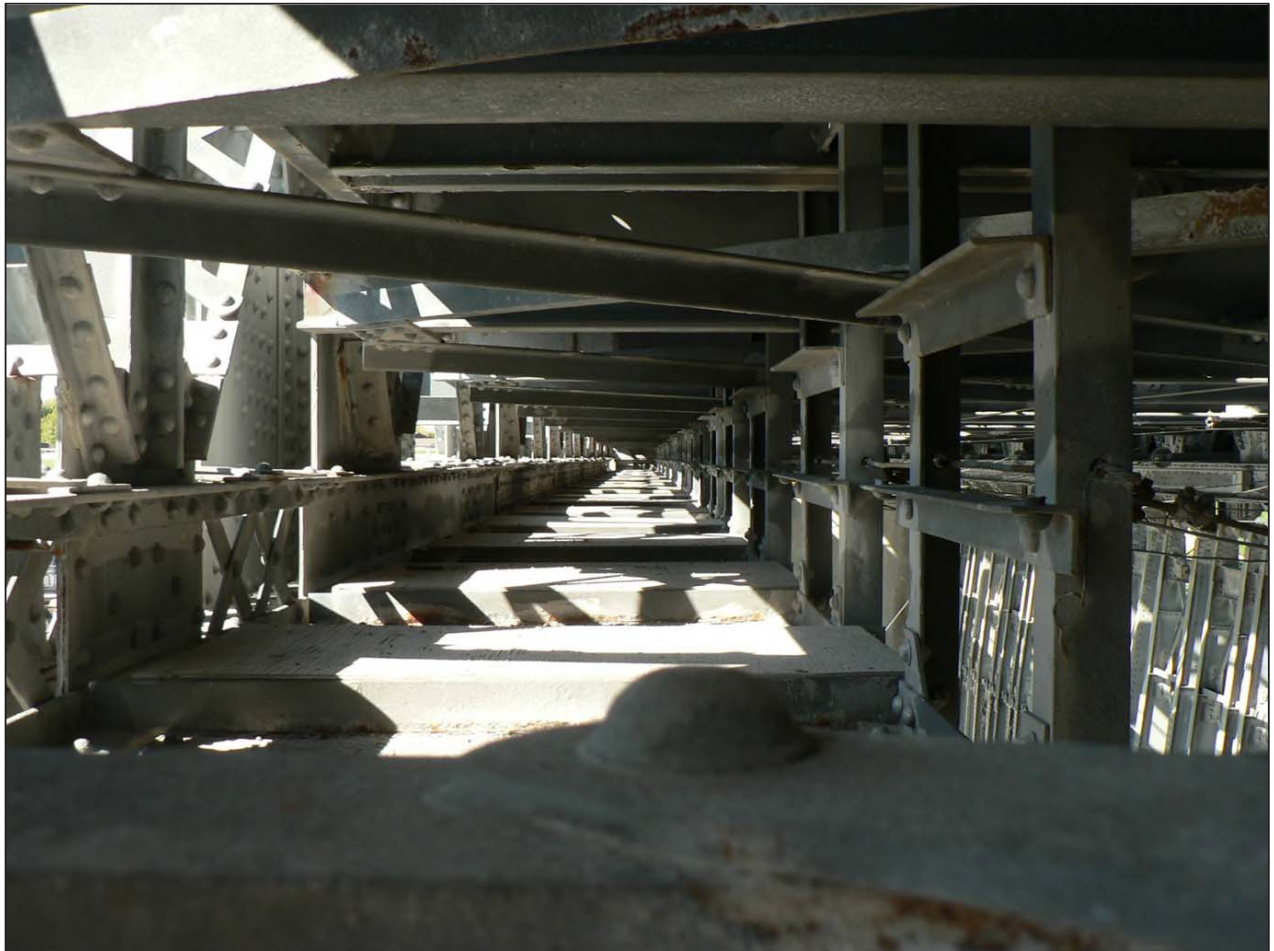
Figure 3 : Crawlspace under operations deck /// Galerie technique sous le tablier opérationnel

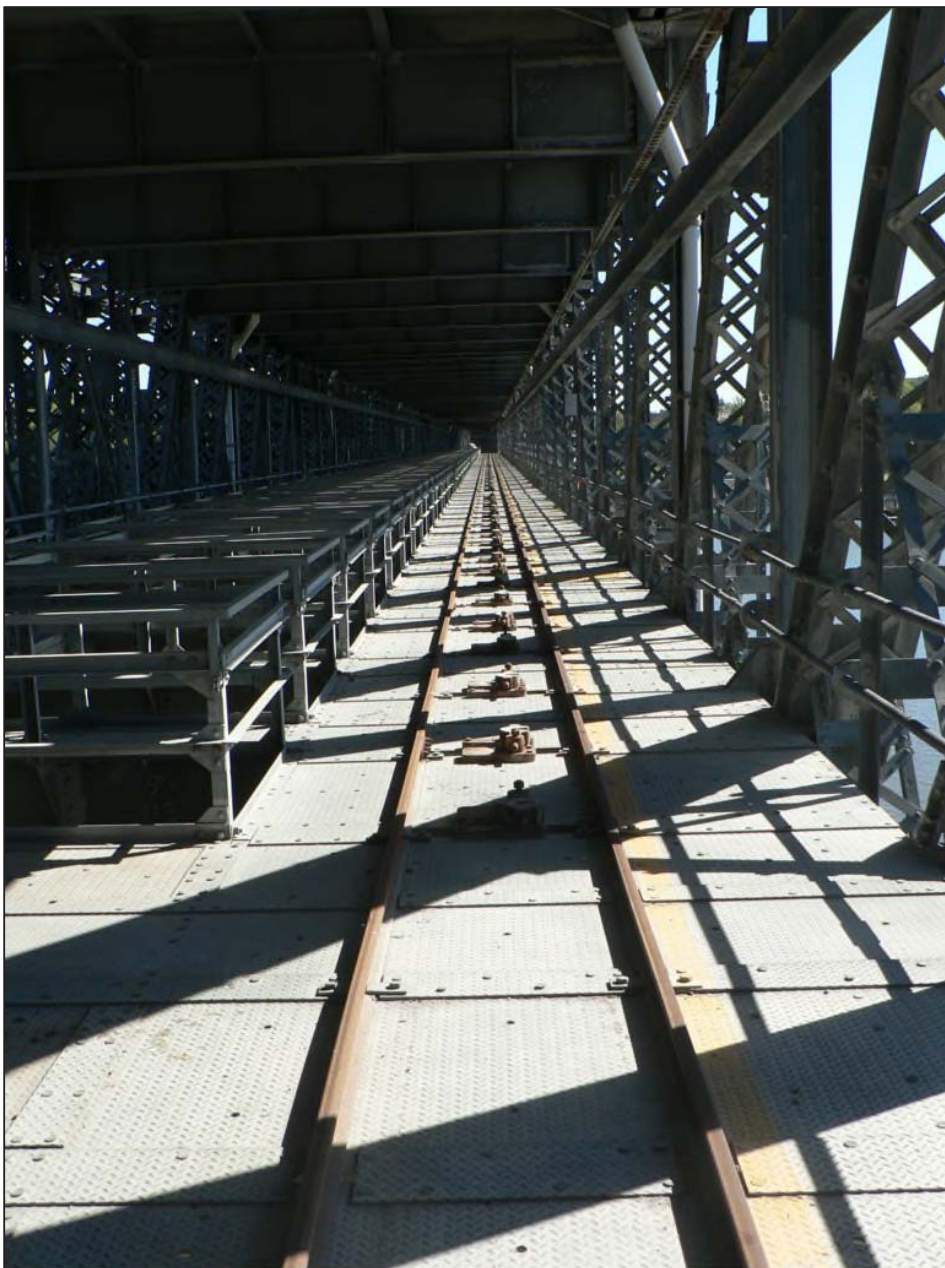
Figure 4: Operating deck showing crane rails for frame crane / / / Tablier opérationnel montrant le rail de grue pour la grue à cadres

(a) The crane rail runs pretty much the full length of the deck, i.e. approximately 864 feet, plus about 30 feet within in the shed.

(b) The rail has the following rolling mark on the web: "30 40 |S|1994". The individual sections thereof are 20 and 30 feet (varies). The rails are joined by fishplates (a.k.a. splice bar, a.k.a. joint bar) with 3 bolts per end.

(c) The number of rail clips per section varies. The rail clips come in clusters of 4, located generally near each of the chain guides and at the ends of sections. It seems to be anywhere from 3 to 6 sets of clips per rail section. The slight turn in the track near the shed has 3 sets. As of 10 September, most clips are in place though a few seem loose.
