**SOLICITATION AMENDMENT
MODIFICATION DE L'INVITATION**

Title - Sujet Heavy Trucks with Crane	
Solicitation No. - N° de l'invitation F7047-200049/A	Amendment No. - N° modif. 004
Client Reference No. - N° de référence du client F7047-200049	Date 2020-09-22
GETS Reference No. - N° de référence de SEAG PW-\$\$HP-927-78951	
File No. - N° de dossier hp927.F7047-200049	CCC No./N° CCC - FMS No./N° VME
Solicitation Closes - L'invitation prend fin at - à 02:00 PM on - le 2020-10-07	
Time Zone Fuseau horaire Eastern Daylight Saving Time EDT	
F.O.B. - F.A.B. Plant-Usine: <input type="checkbox"/> Destination: <input type="checkbox"/> Other-Autre: <input type="checkbox"/>	
Address Enquiries to: - Adresser toutes questions à: Takam(hp927), Maurice	Buyer Id - Id de l'acheteur hp927
Telephone No. - N° de téléphone (613) 297-3516 ()	FAX No. - N° de FAX () -
Destination - of Goods, Services, and Construction: Destination - des biens, services et construction:

AMENDMENT 004

Copper/Brass radiators vs Aluminum Plastic radiators

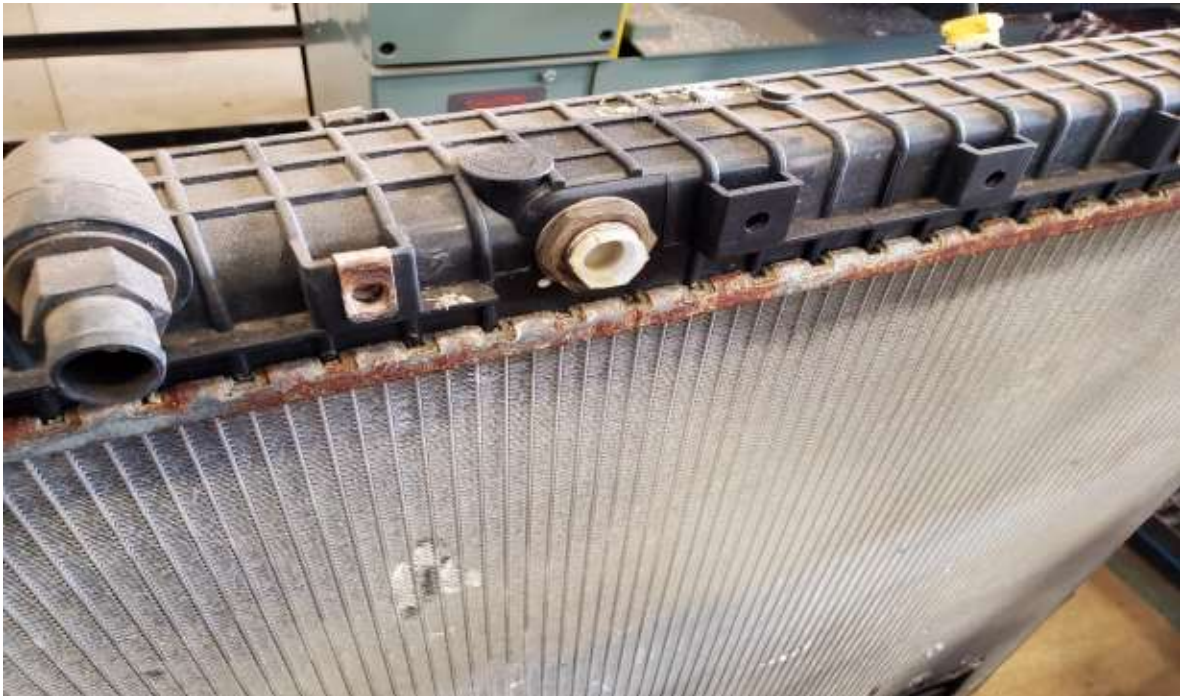
copper brass radiator leak can be repaired. We have attached a photo of the most latest radiator replacement that we have had. Aside from minimal marks on it, it looks fine, except for the fact that it leaks badly and cannot be repaired.

The other issue with this radiator is that there is a cost to Government for disposal as it is aluminum/steel/plastic combined. Not exactly environmentally friendly. Also, please take note of the corrosion. This radiator was in the truck for approximately 14 months and you can notice the obvious corrosion. Another downfall for a vehicle that spends the majority of its life in a salt-water environment.

Usually there is a crack in the plastic, around a joint or fitting, or a hole in the aluminum. Which will result in the entire radiator having to be replaced. On average the repair cost , excluding tows, travel costs, etc. – is \$1,600 - \$2,000. We have also had failures where the hose connection points have failed.

These radiators, due to their assembly and materials and the environment in which they operate, cannot withstand the vibrations that are being put on them. Nor, like a traditional copper/brass radiator, be repaired. Replacement only.
