Project title
**STONY MOUNTAIN
INSTITUTION
BUILDING C12
POWERHOUSE REPAIRS**

Drawing title
SECTIONS
Titre du dessin

Project no./No. du projet	Drawing no./No. du dessin	Revision no.
R.109027	S5.1 of S5.2	0

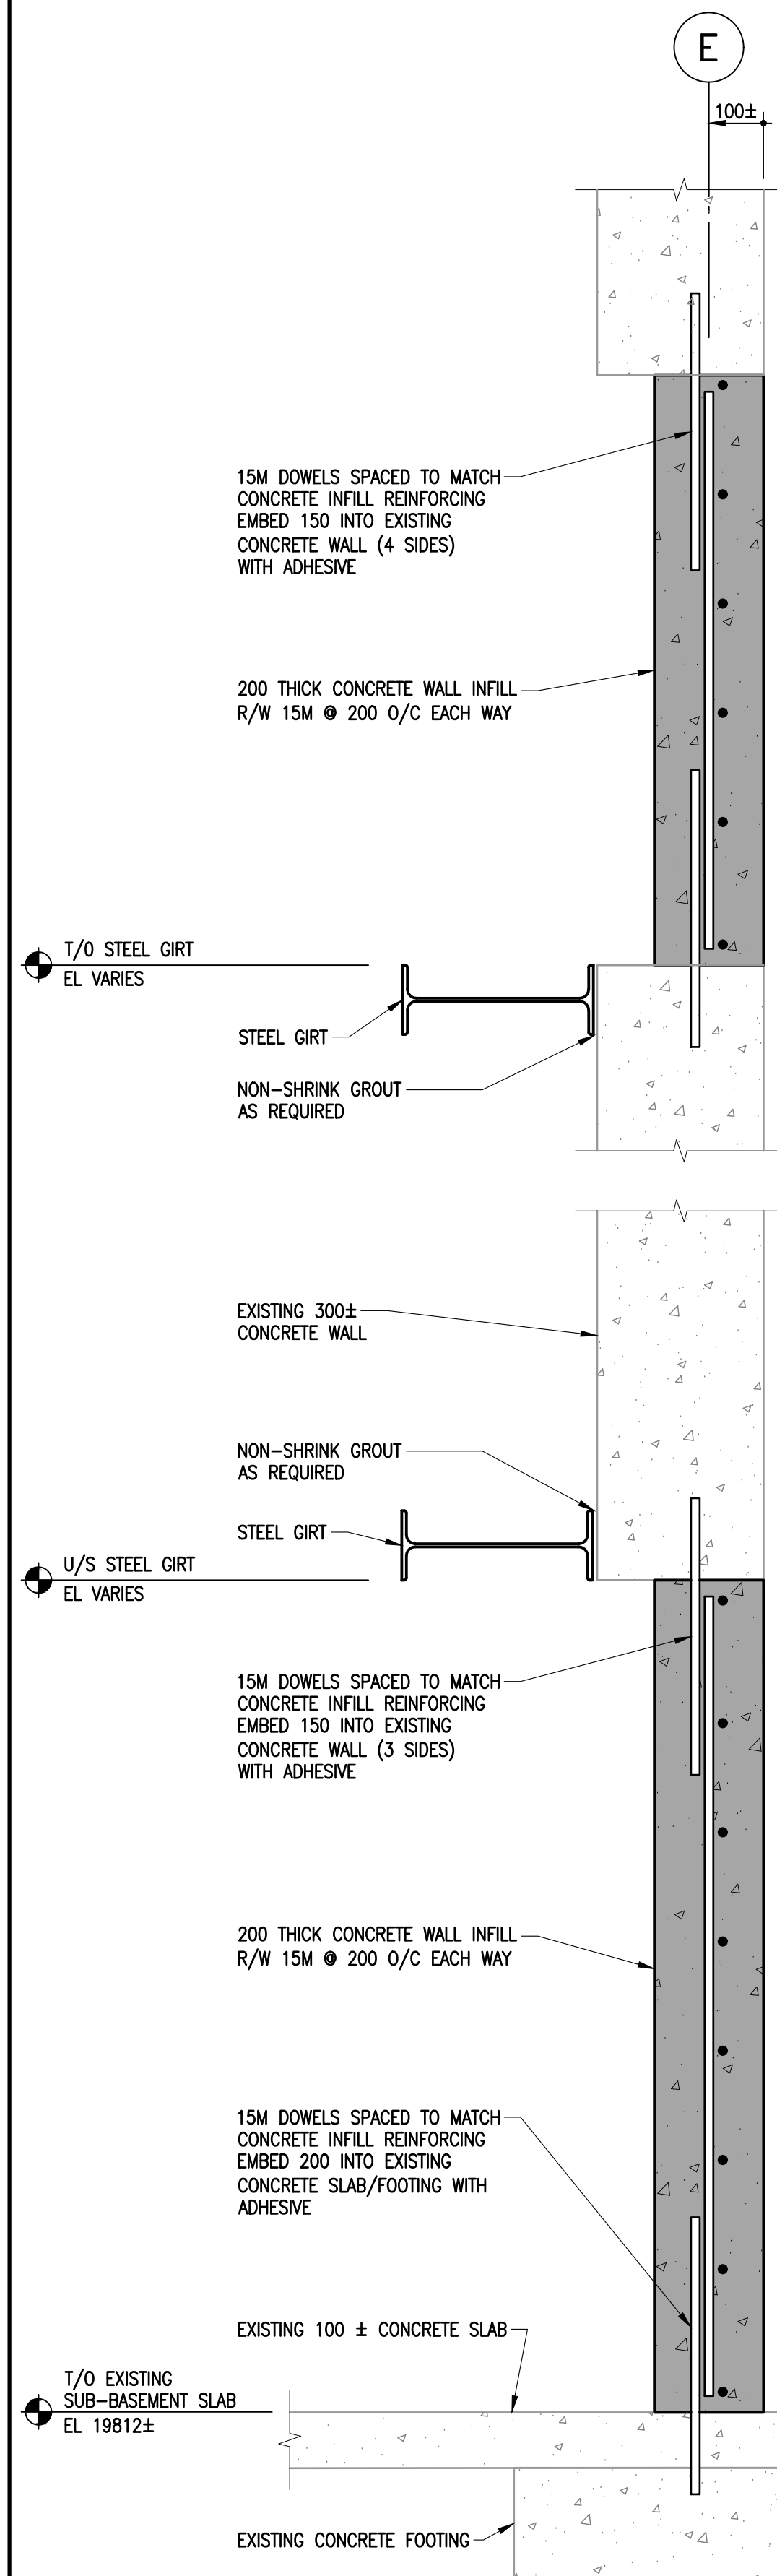
1
S2.1 S5.1 1:10
CONCRETE WALL INFILL SECTION

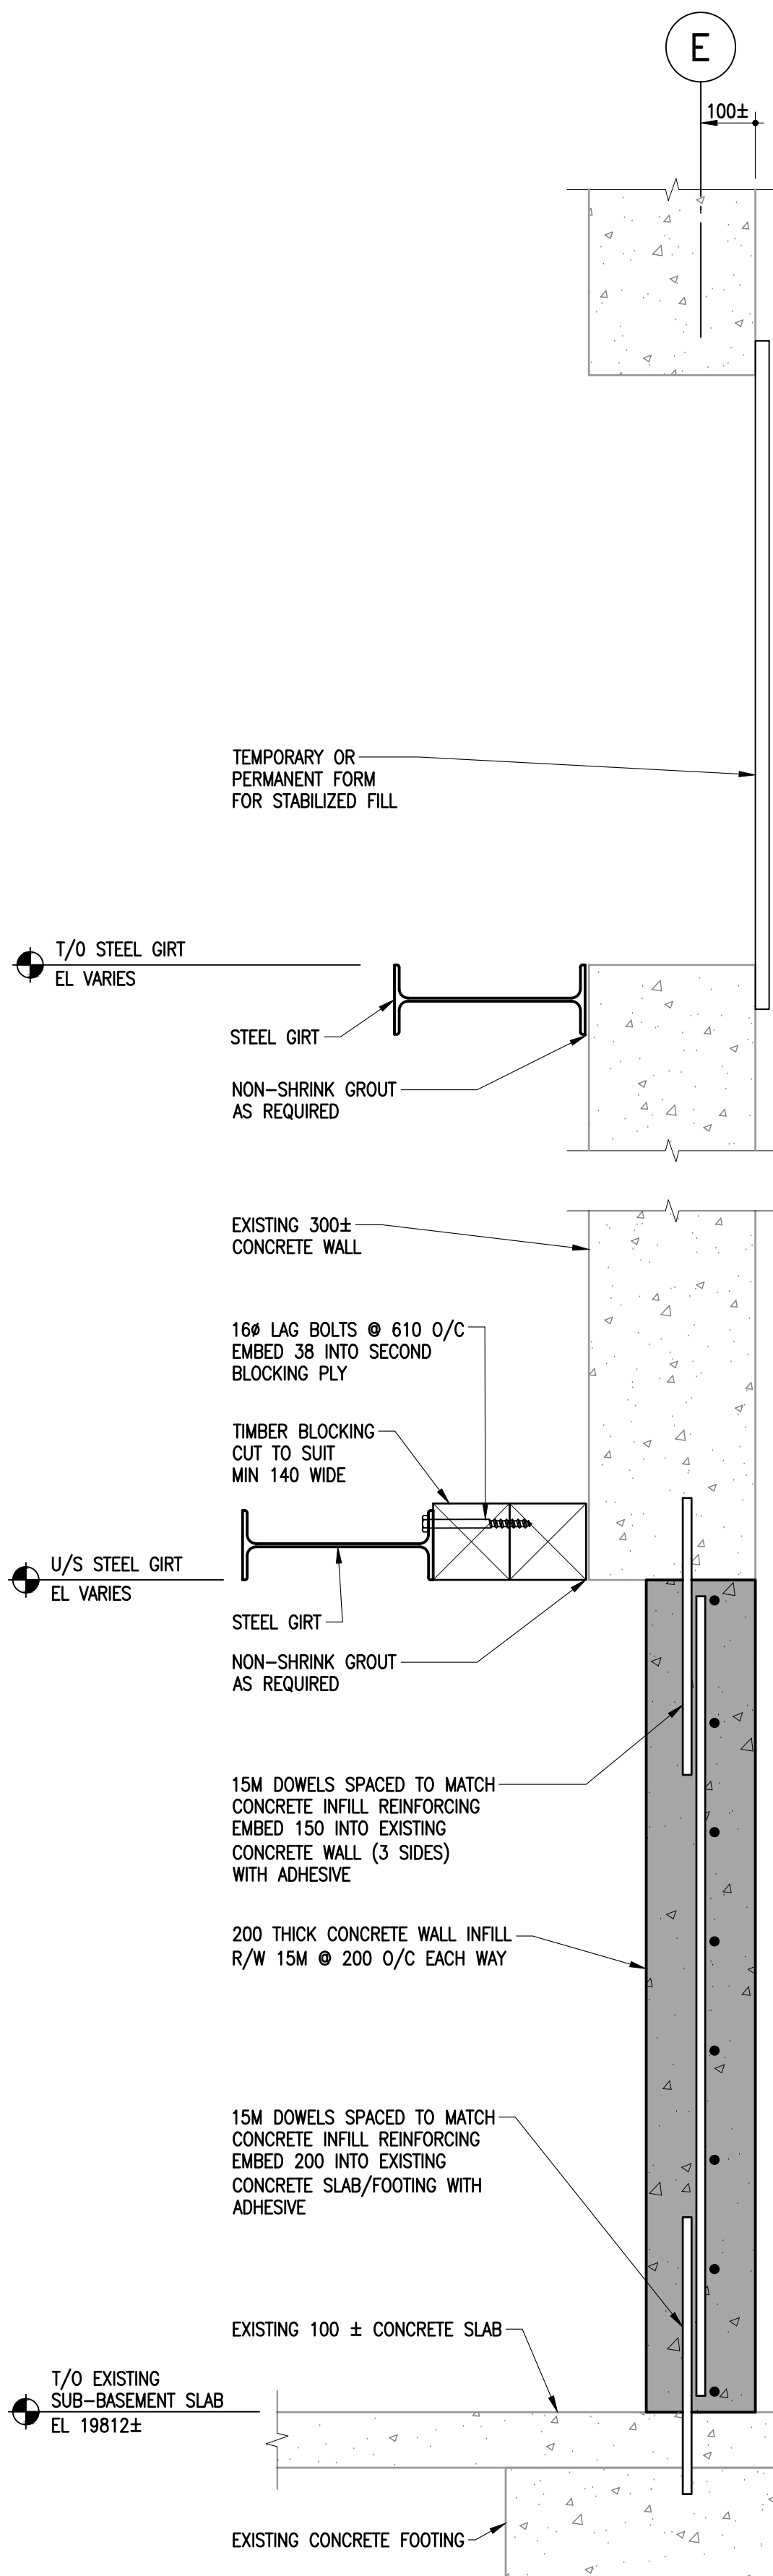
2
S2.1 S5.1 1:10
CONCRETE WALL INFILL
WITH TIMBER BLOCKING SECTION

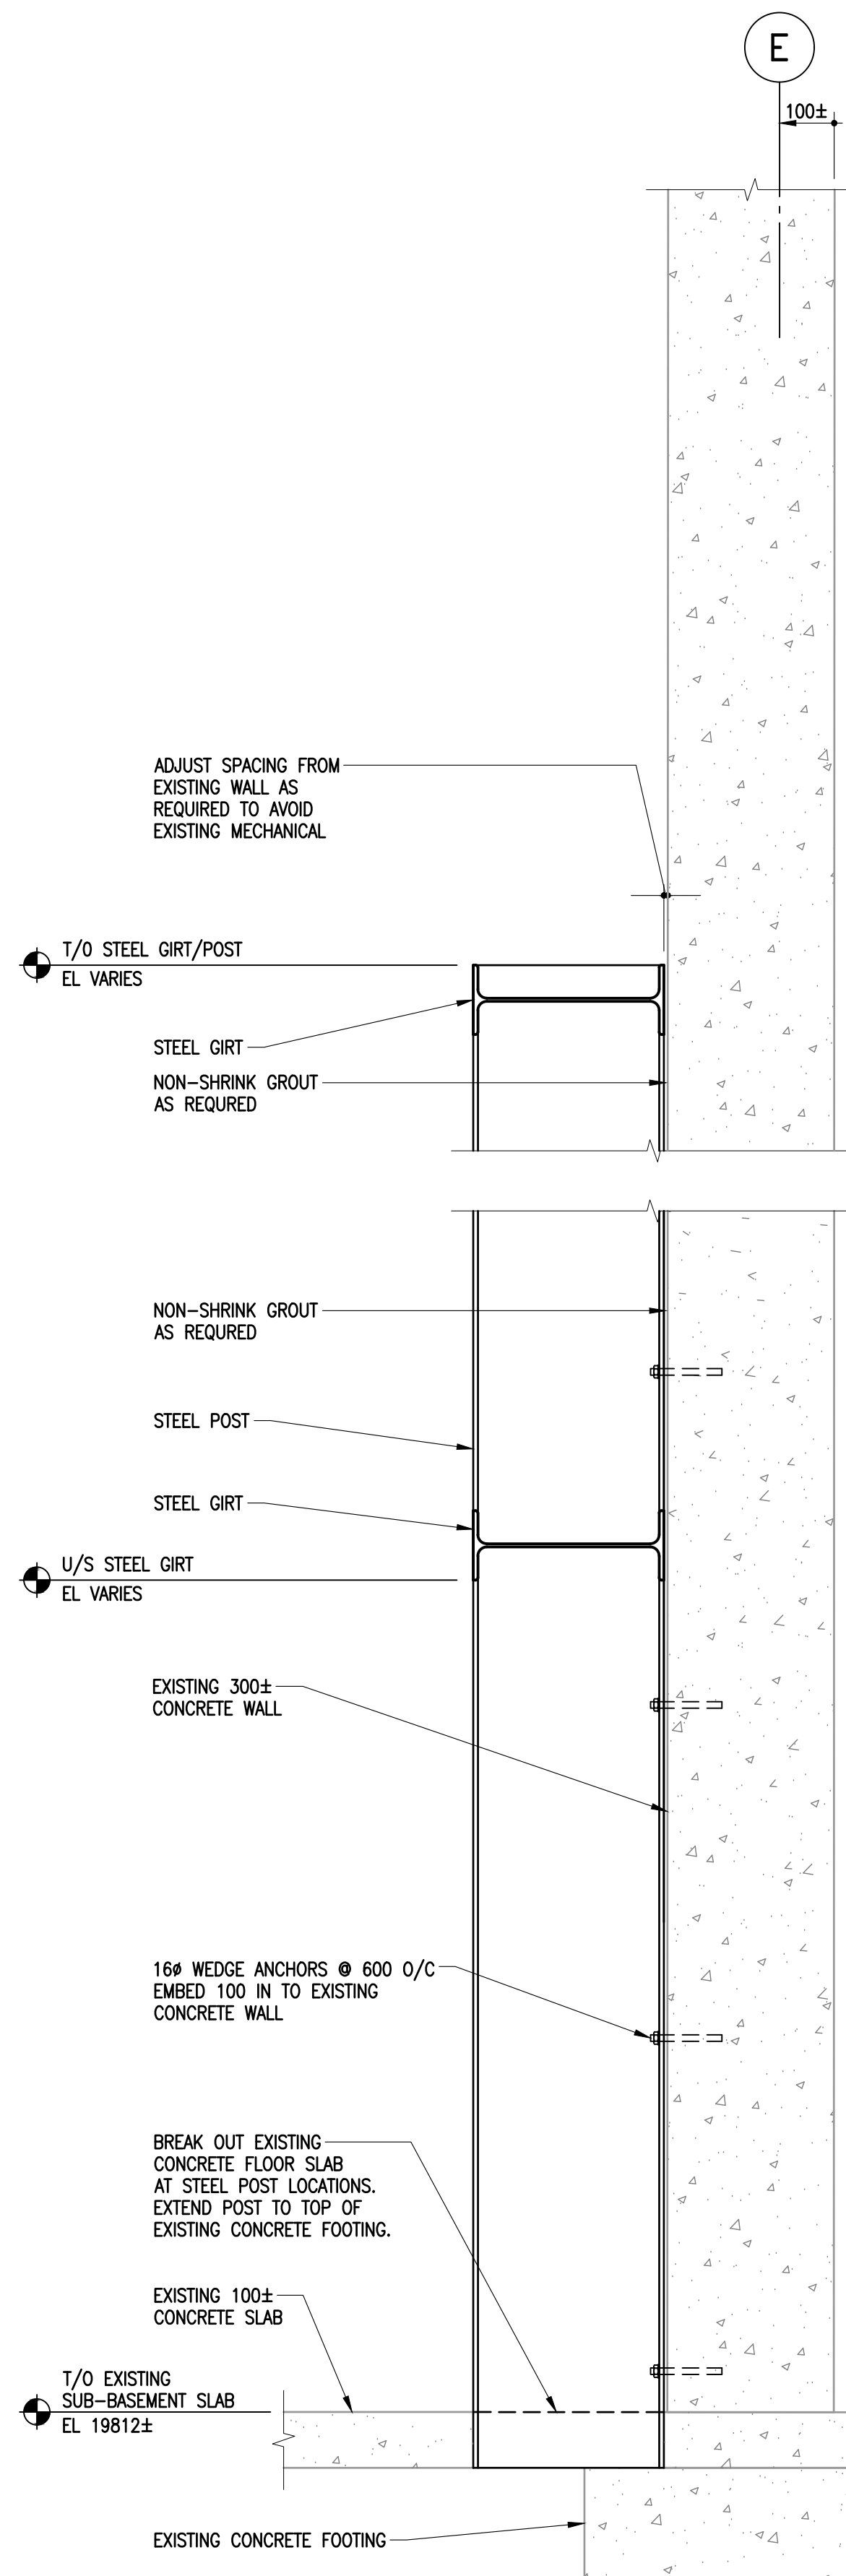
3
S2.1 S5.1 1:10
STEEL POST TIGHT TO
EXISTING CONCRETE WALL SECTION

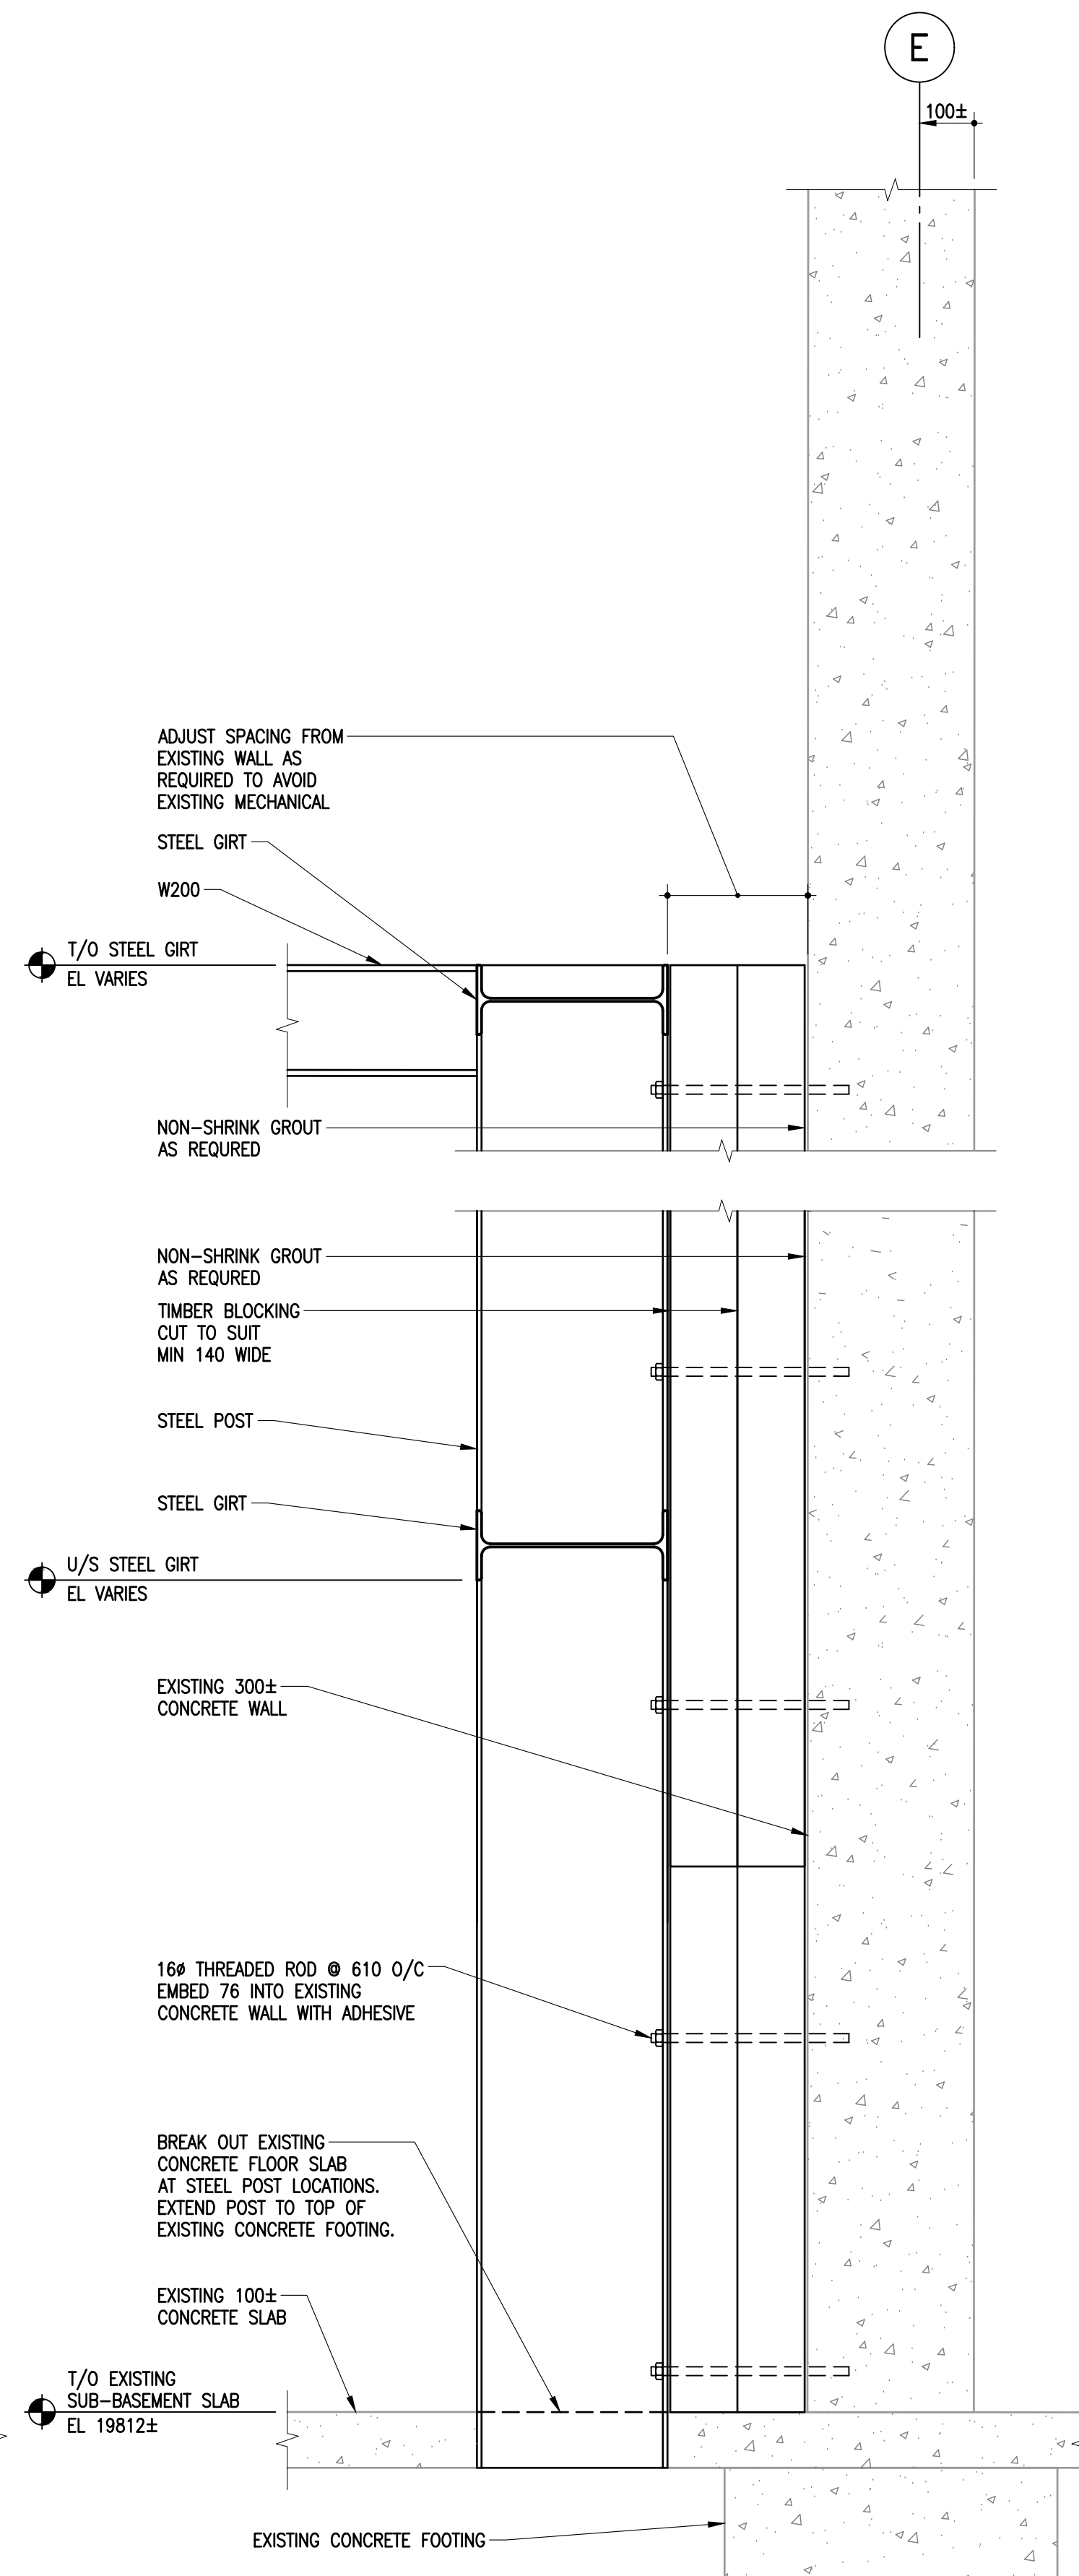
4
S2.1 S5.1 1:10
STEEL POST WITH TIMBER BLOCKING
AT CONCRETE WALL SECTION
