project
BEAVER RIVER BRIDGE
REHABILITATION
T.C.H. - km 9.8
Glacier National Park, B.C.

drawing
AS CONSTRUCTED
DECK JOINT
DETAILS

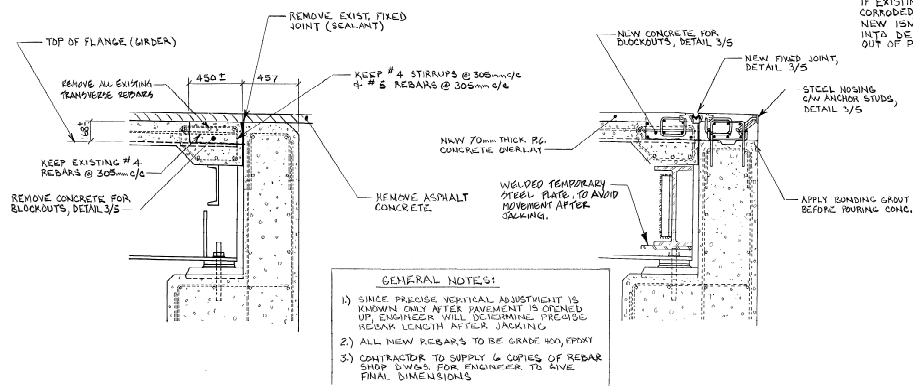
1
5
FIXED JOINT AT EAST & WEST
ABUTMENT (EXISTING) 1:20

2
5
FIXED JOINT AT EAST & WEST
ABUTMENT (REVISED) 1:20

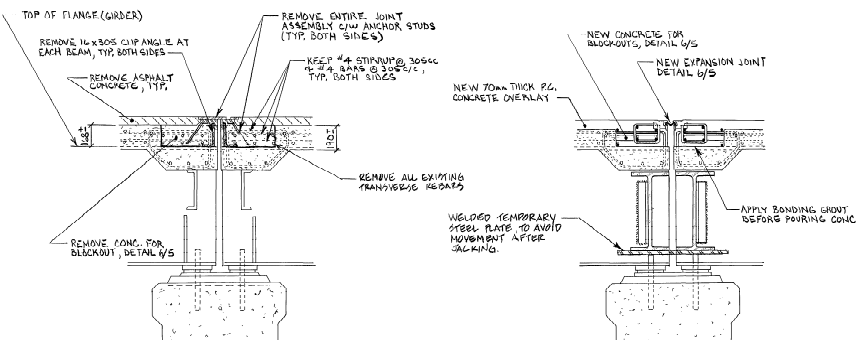
4
5
EXPANSION JOINT AT PIER
(EXISTING) 1:20

5
5
EXPANSION JOINT AT PIER
(REVISED) 1:20

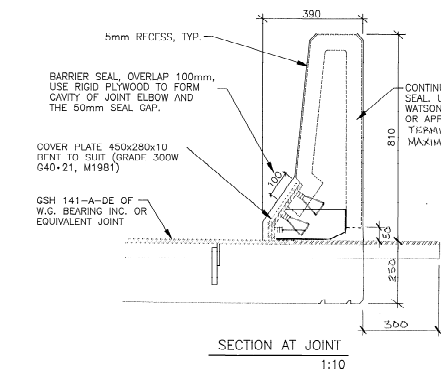
7
5
DECK JOINT COVER PLATE DETAILS

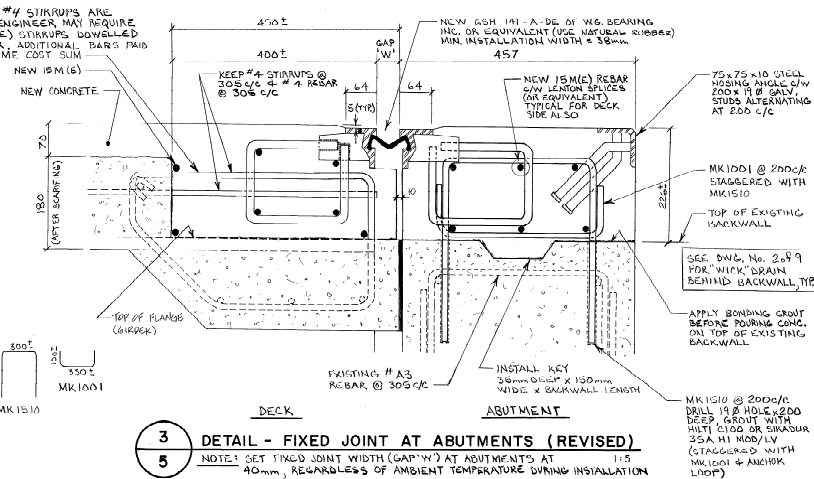
3
5
DETAIL - FIXED JOINT AT ABUTMENTS (REVISED)
NOTE: SET FIXED JOINT WIDTH (GAP 'W') AT ABUTMENTS AT 40mm, REGARDLESS OF AMBIENT TEMPERATURE DURING INSTALLATION 1:5

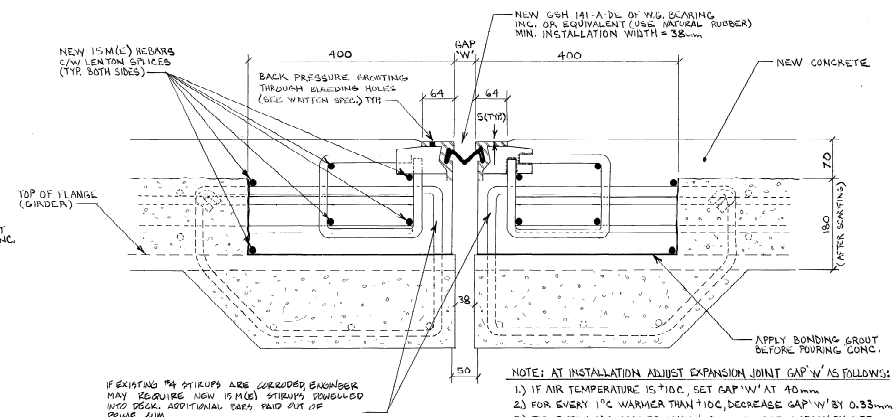
6
5
DETAIL - EXPANSION JOINT AT PIER (REVISED) 1:5
