FISHERIES & OCEANS CANADA INSTITUTE OF OCEAN SCIENCES STAGE 1 - ROOFING REMEDIATION

PACIFIC GEOSCIENCE CENTRE

SHEET	TITLE
1-1	Title Sheet
1-2	Pacific Geoscience Centre - Plan
1-3	Pacific Geoscience Centre - Plan
1-4	Pacific Geoscience Centre - Details
1-5	Pacific Geoscience Centre - Details

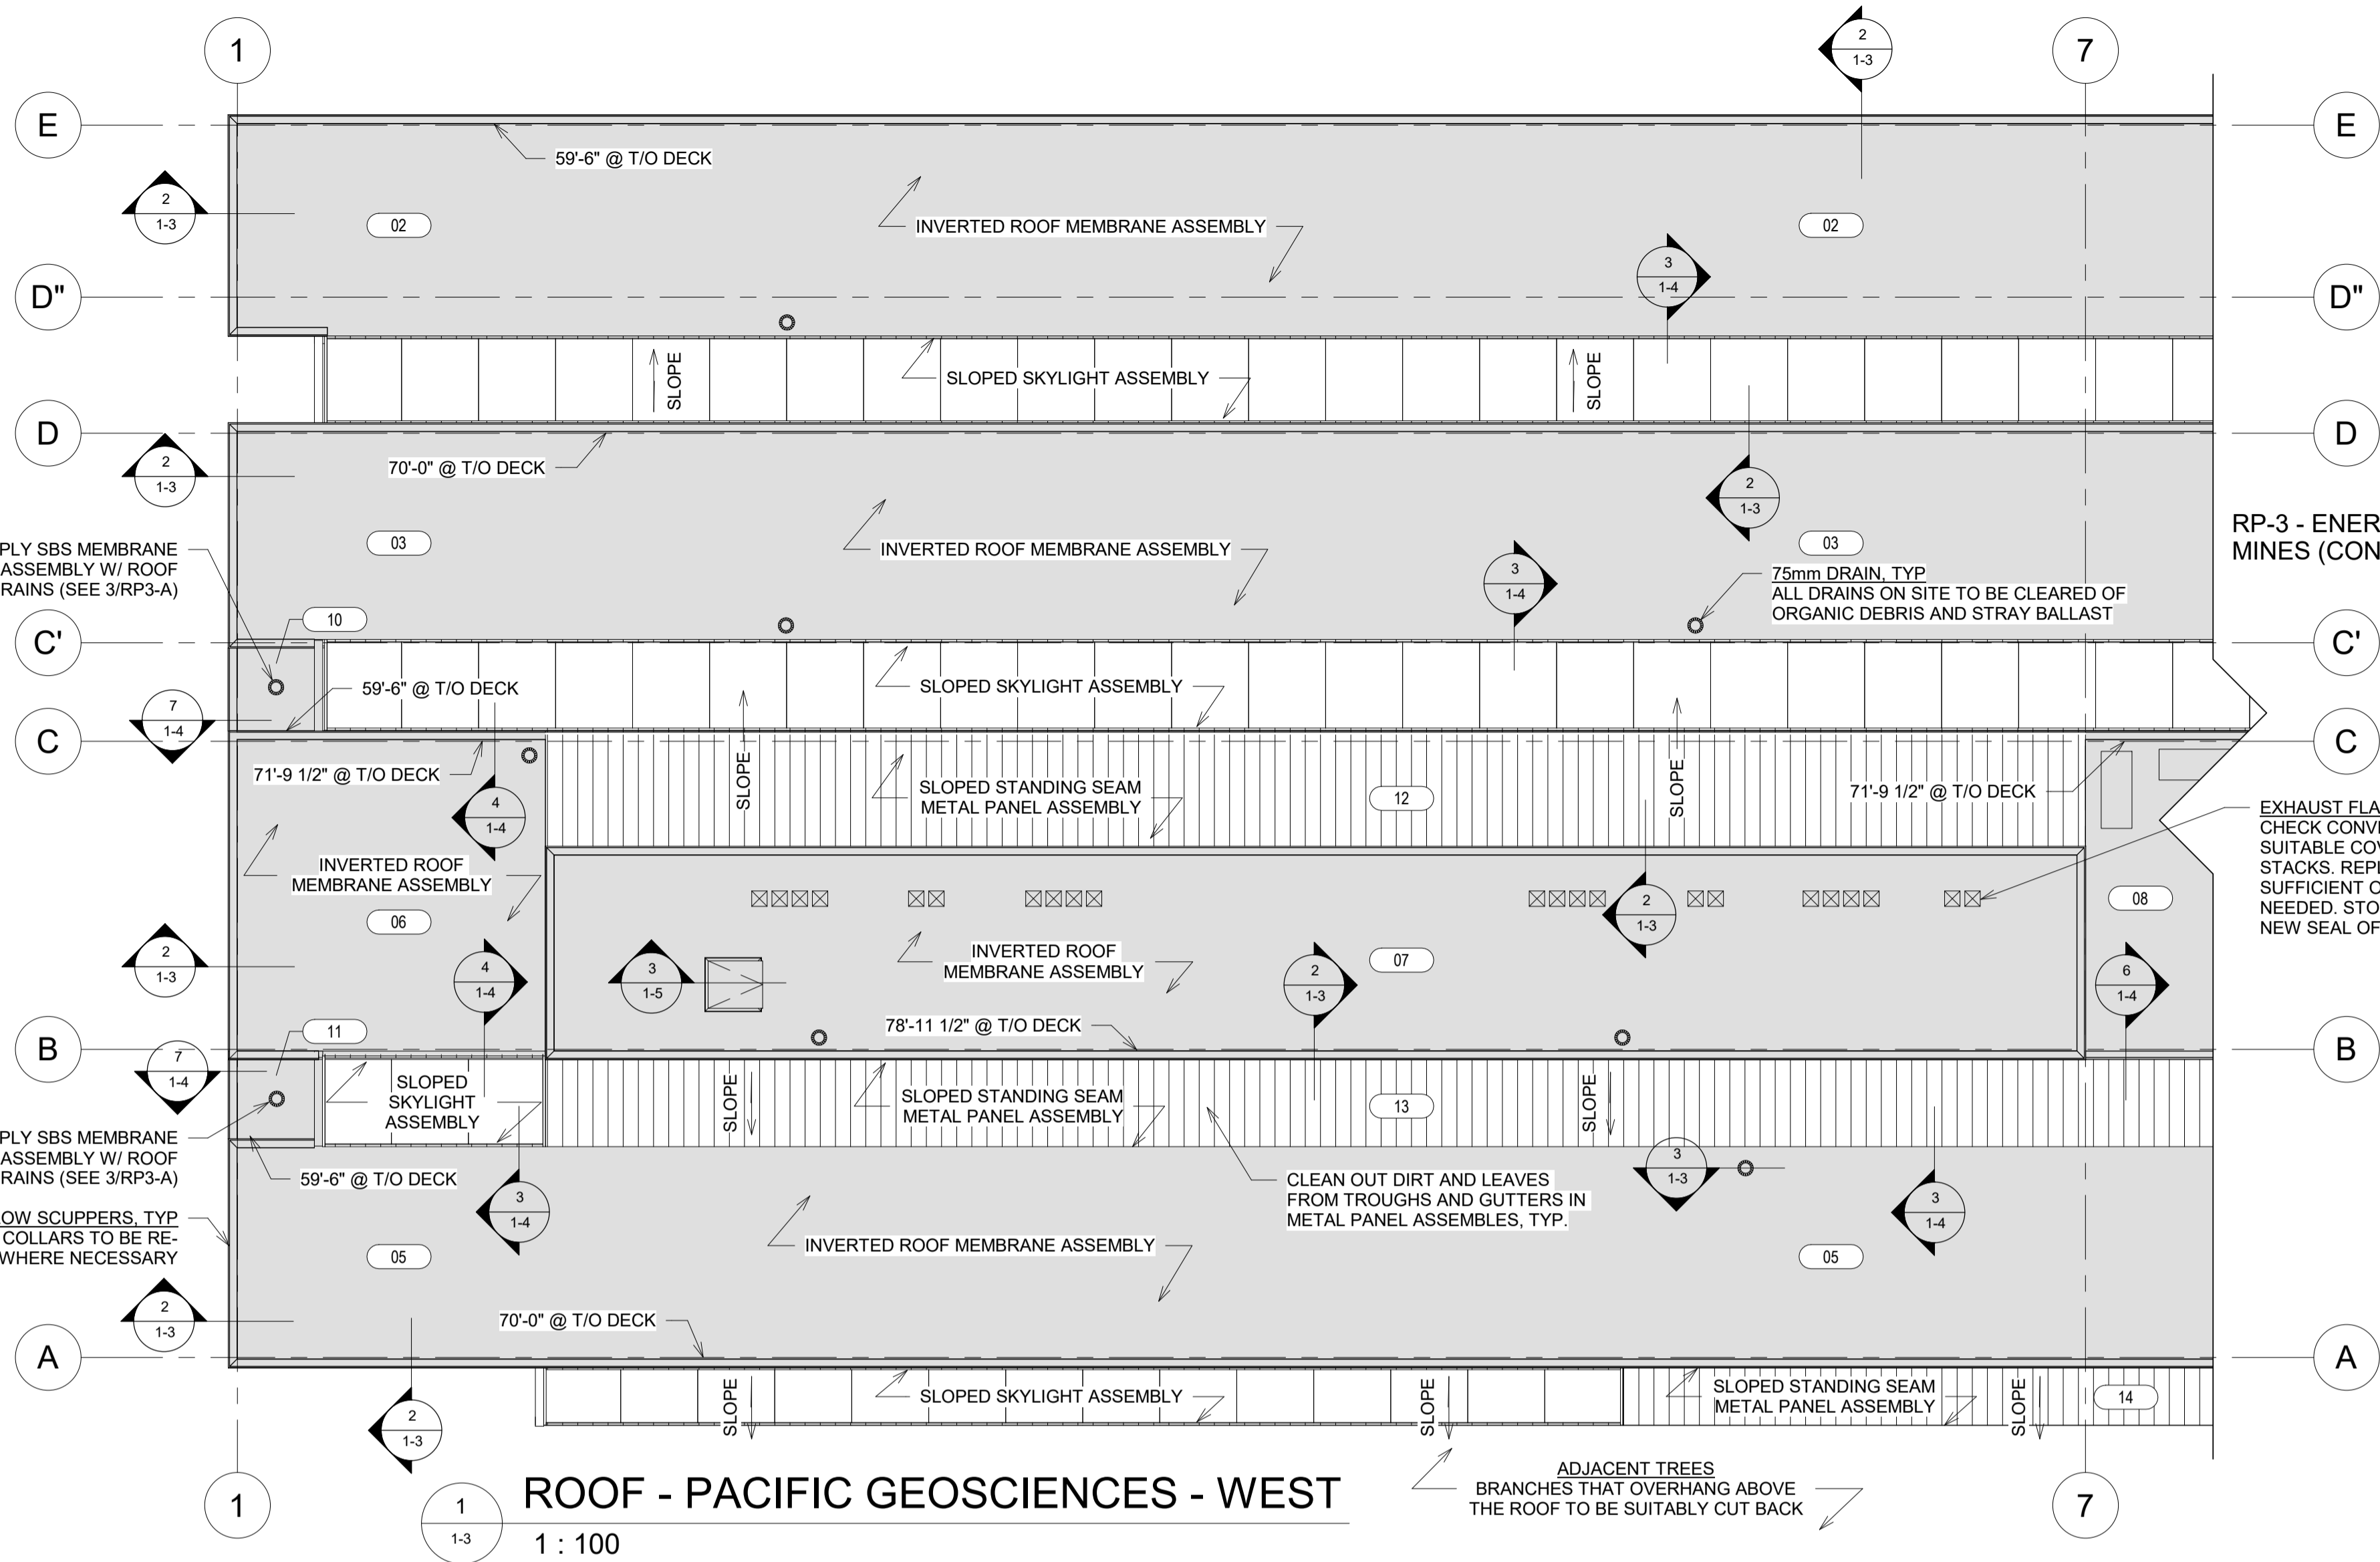
ROOF - PACIFIC GEOSCIENCES - WEST
1 : 100

EXHAUST FLANGES, TYP. CHECK CONVERTED FLANGES FOR SUITABLE COVERING OVER ORIGINAL STACKS. REPLACE WITH FLANGES WITH SUFFICIENT OVERLAPPING COVERAGE IF NEEDED. STORM COLLARS TO RECEIVE NEW SEAL OF POLYURETHANE CAULKING

2-PLY SBS MEMBRANE ASSEMBLY W/ ROOF DRAINS (SEE 3/RP3-A)

OVERFLOW SCUPPERS, TYP. STEM COLLARS TO BE RE-SEALED WHERE NECESSARY

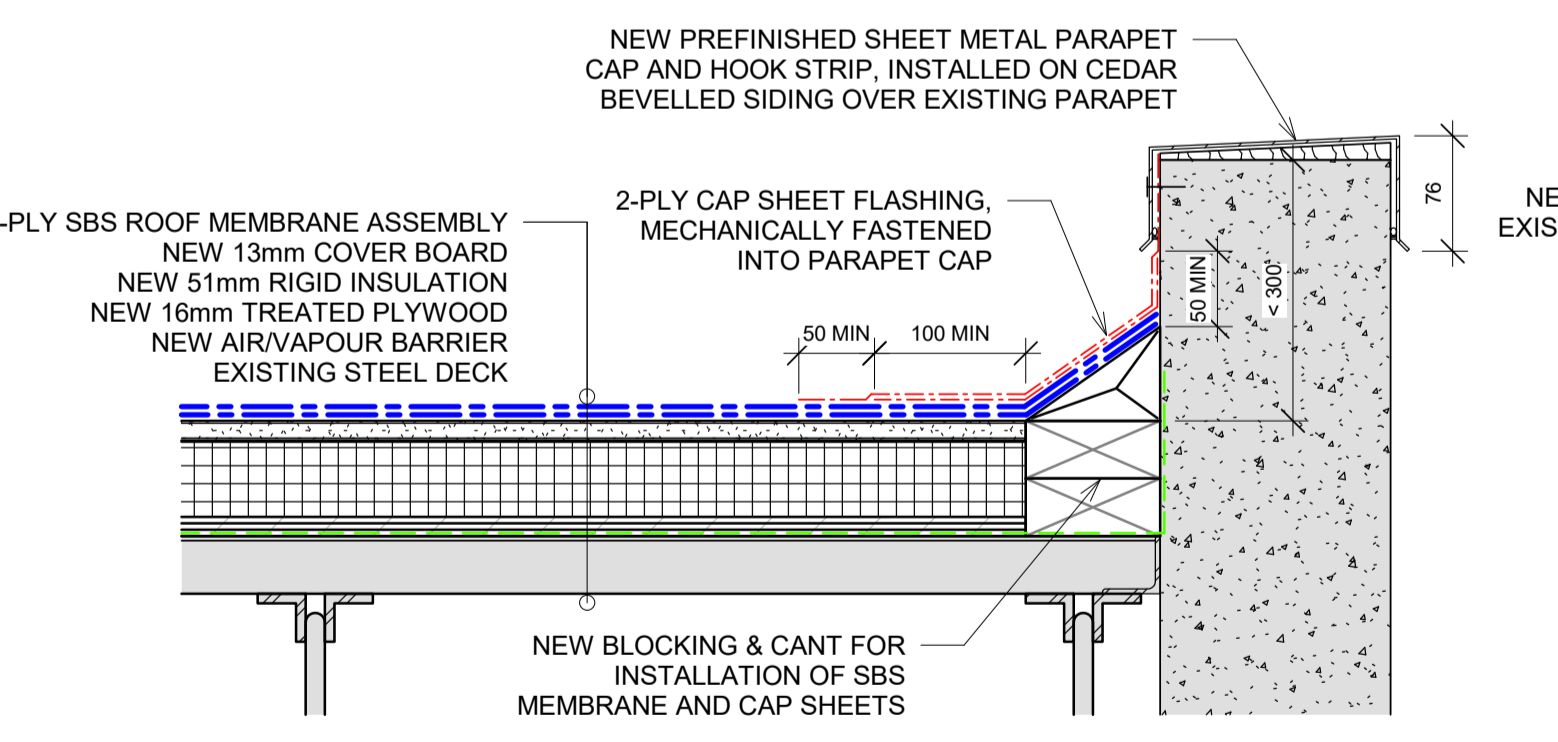
PARAPET HEIGHT < 300mm
