# Bridge Inspection Manual

Structures, Marine and Transportation

December 2010

Public Works and  
Government Services  
Canada

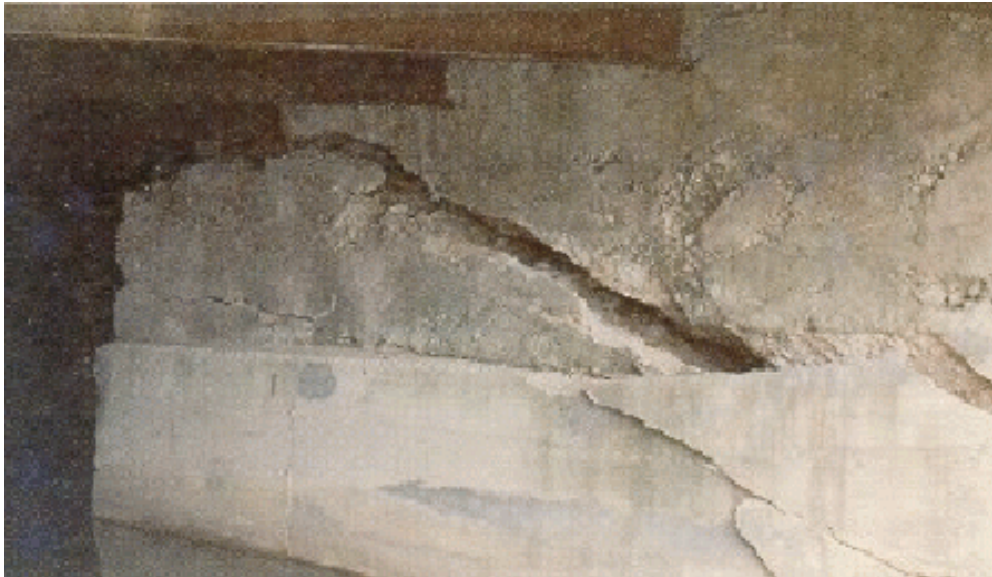
**Figure 2.2.7(d) Very Wide Movement Crack in an Abutment**

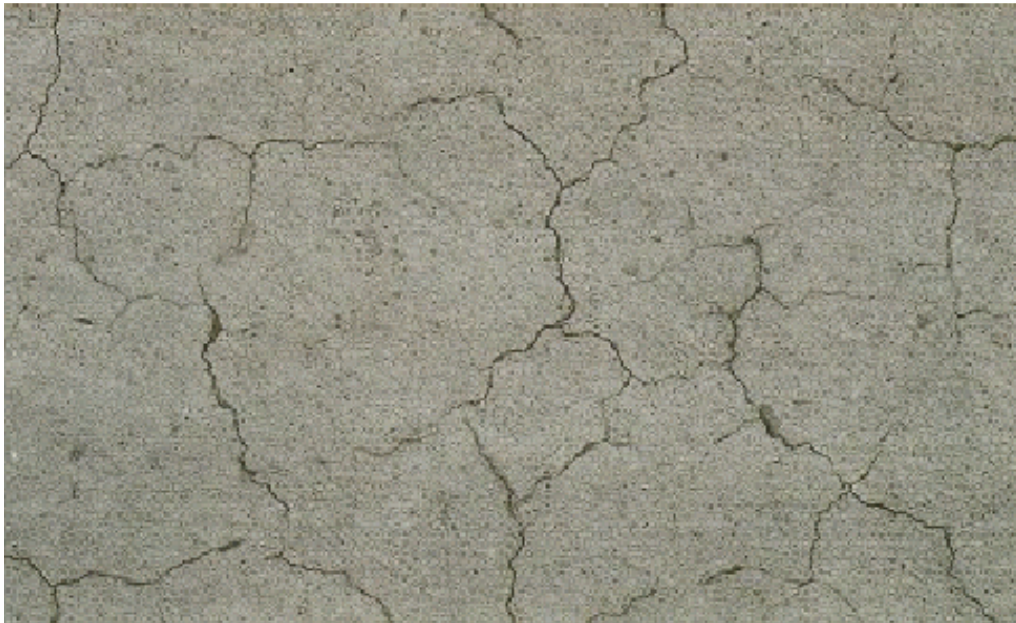
**Figure 2.2.8 Severe Alkali-Aggregate Reaction**

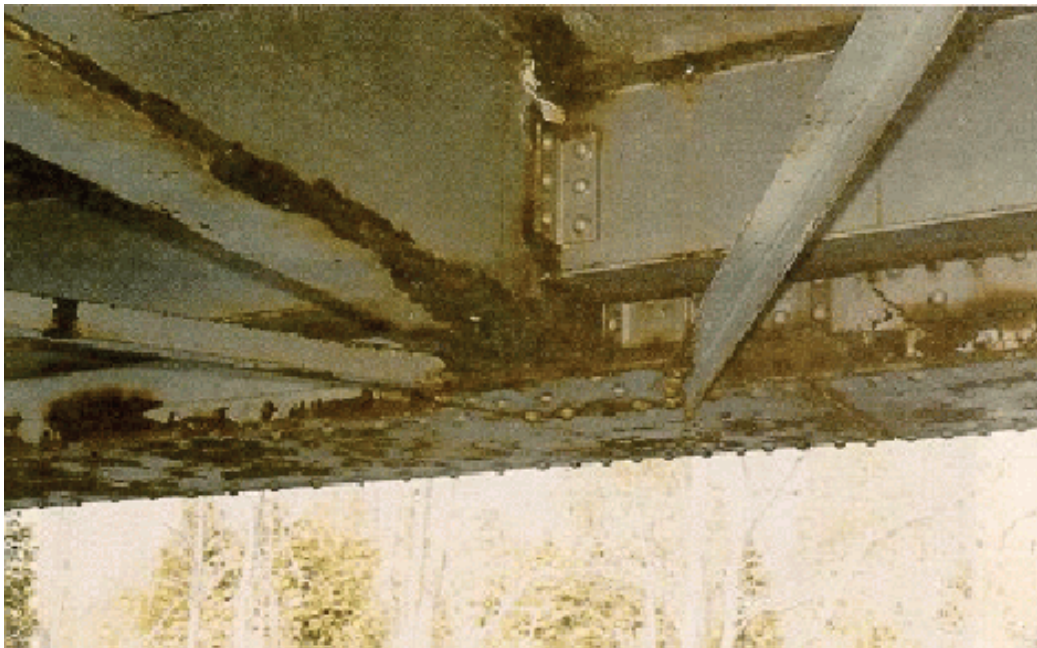
**Figure 2.3.1 Medium Corrosion of Steel Beams**

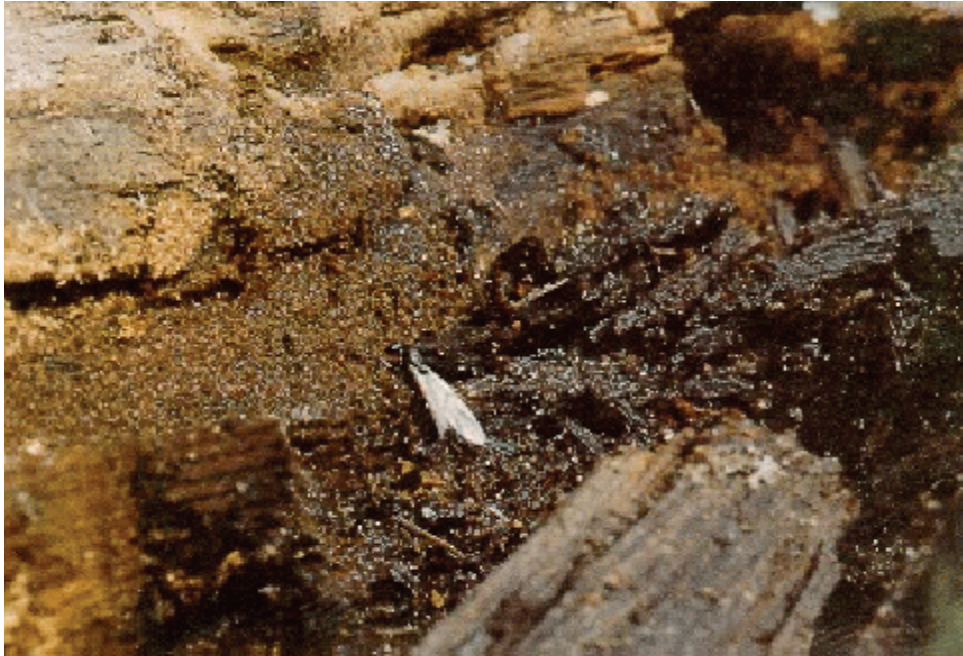
**Figure 2.4.3(b) Very Severe Insect Damage in Wood**

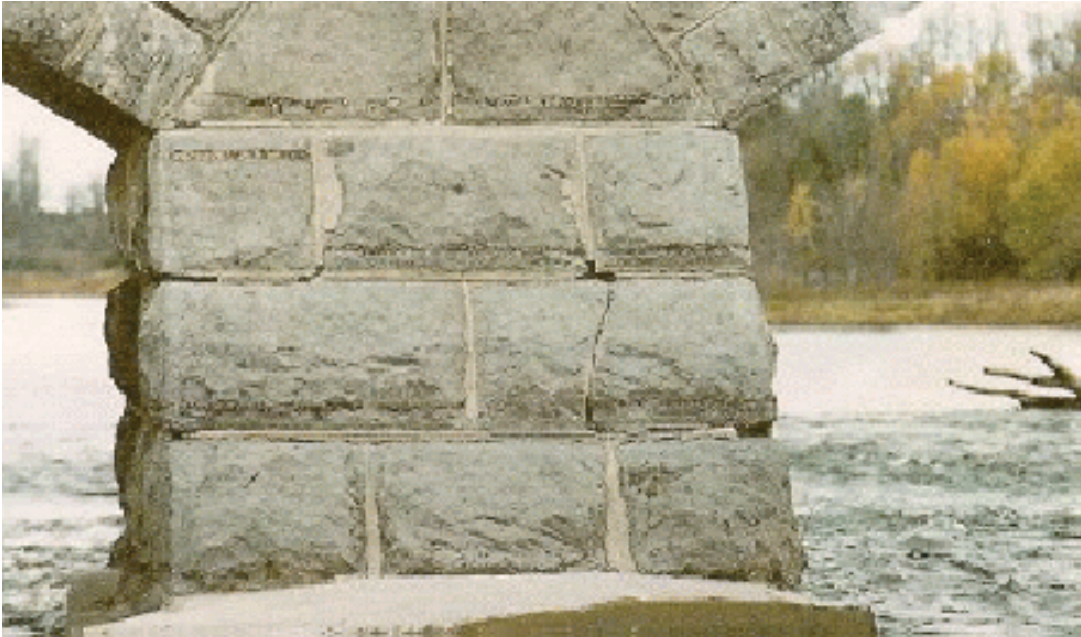
**Figure 2.5.1 Wide Crack Through a Stone in a Masonry Pier**

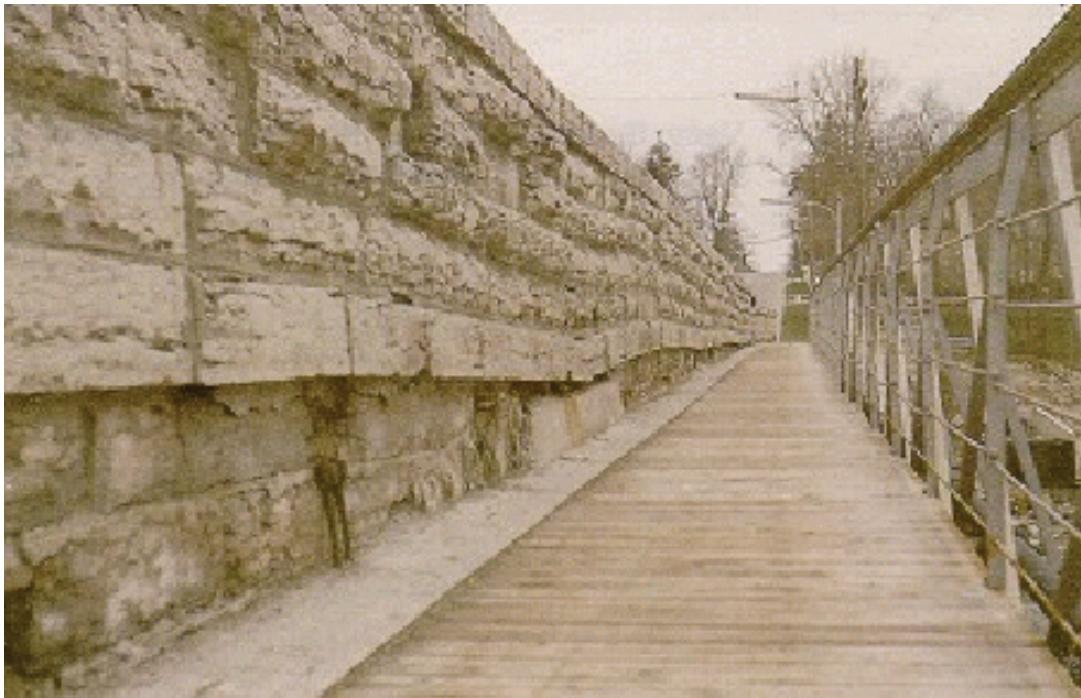
**Figure 2.5.2 Very Severe Splitting, Spalling and Deterioration in Masonry**

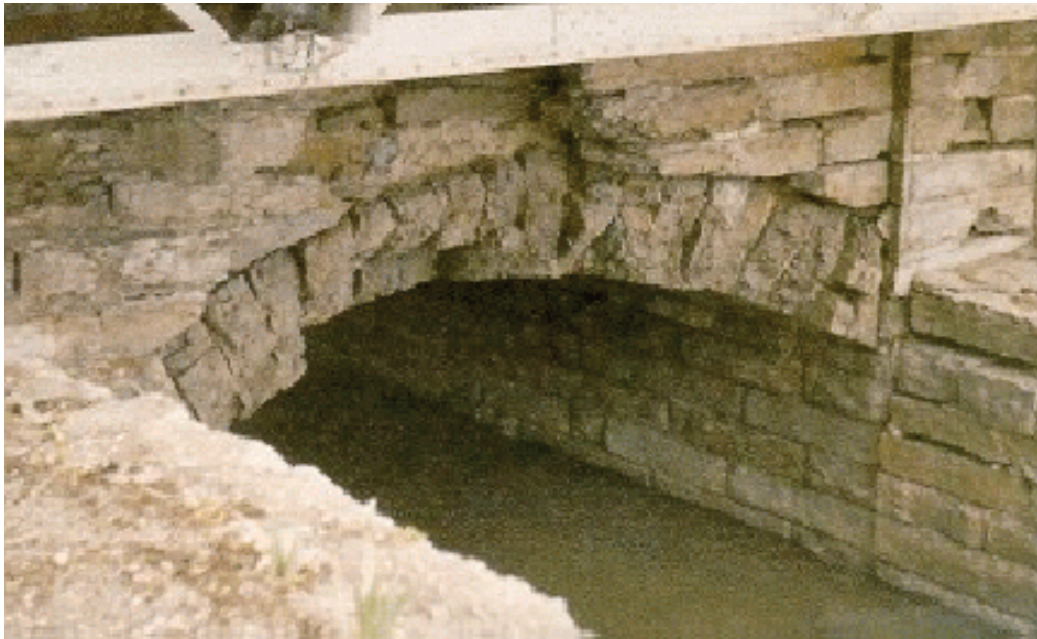
**Figure 2.5.3** Very Severe Loss of Mortar and Stone in a Masonry Arch

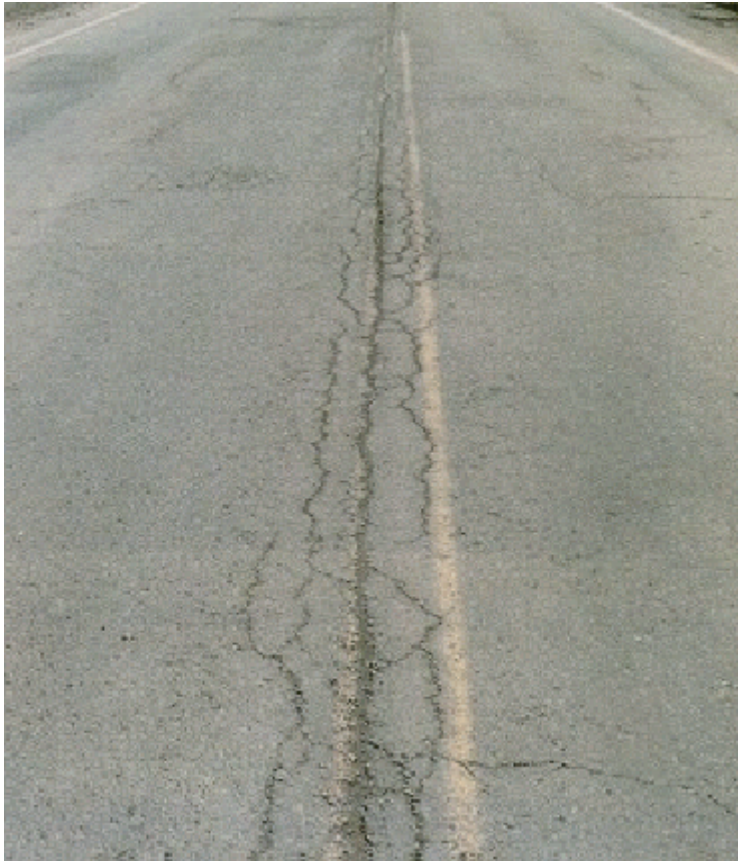
**Figure 2.7.1(a) Medium Longitudinal Crack**

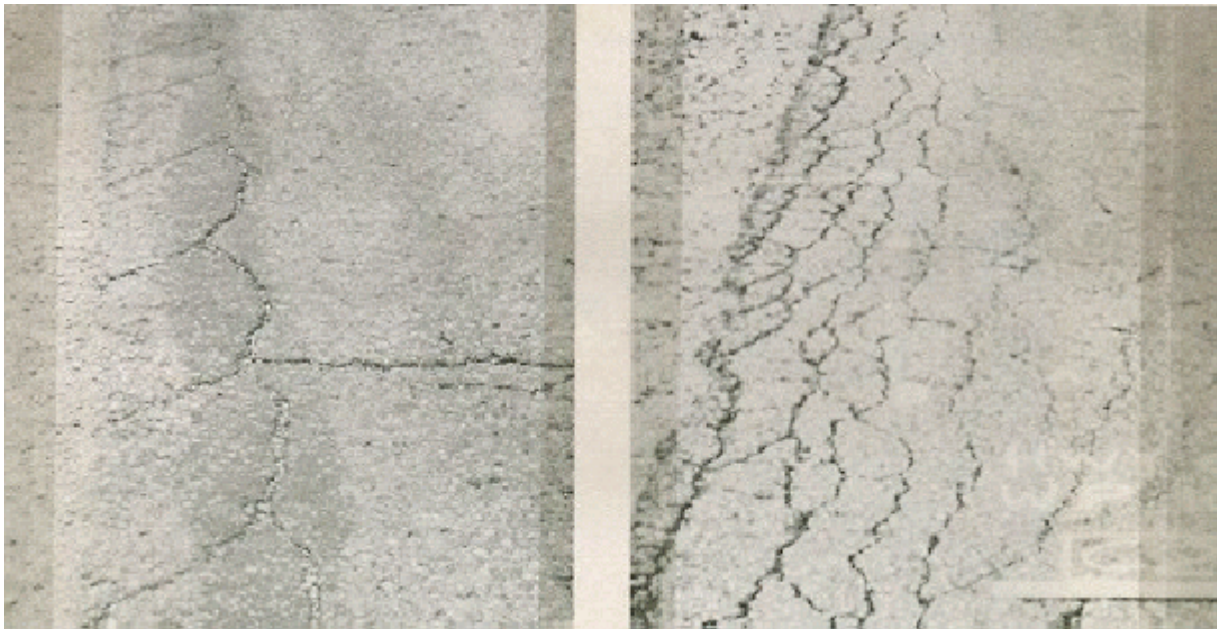
**Figure 2.7.1(e) Medium Progressive Edge Cracks**

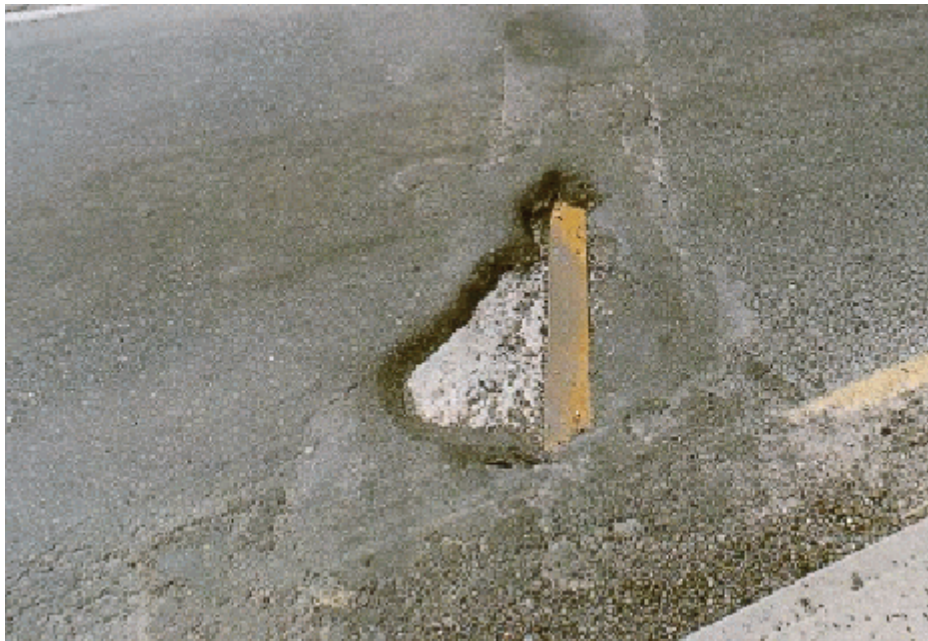
**Figure 2.7.4 Severe Pothole**

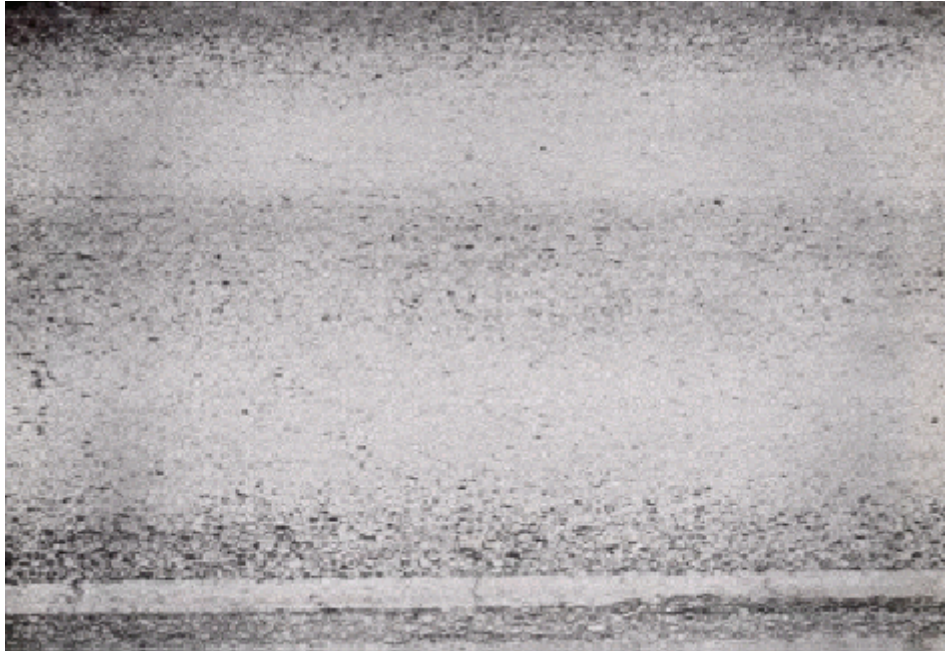
**Figure 2.7.7 Severe Flushing**

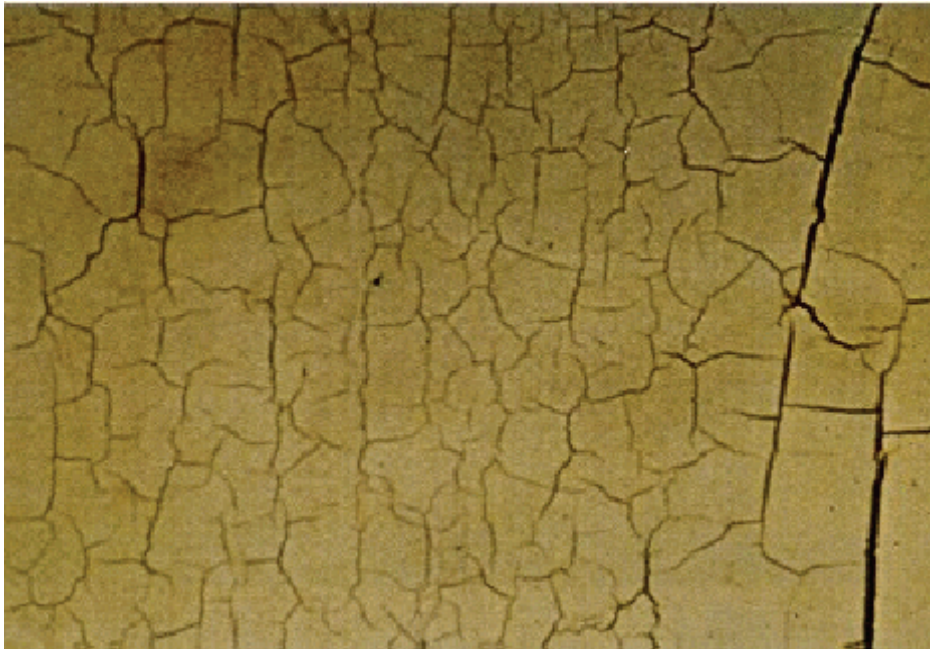
**Figure 2.8.1(a) Checking**

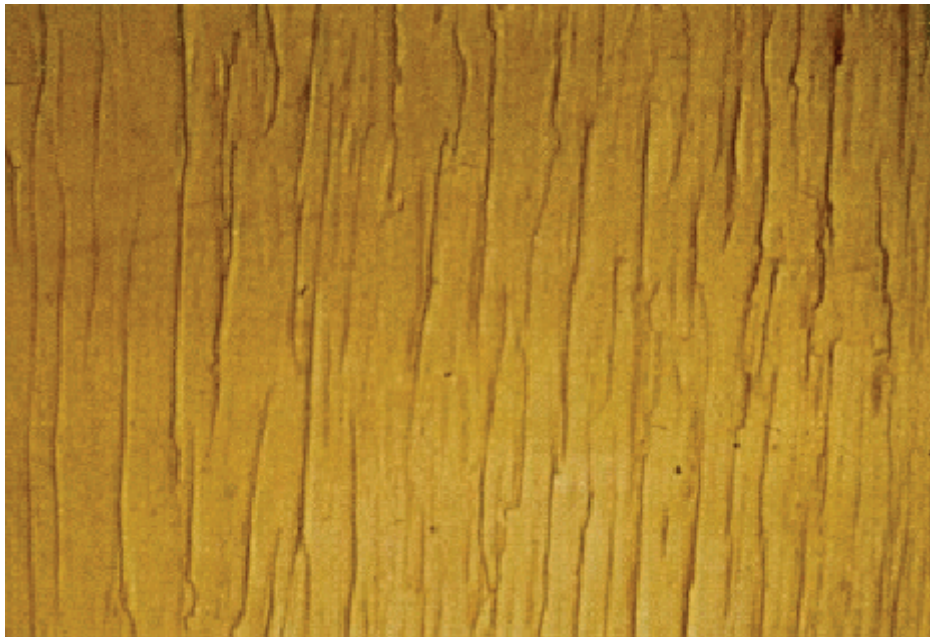
**Figure 2.8.1(b) Cracking**

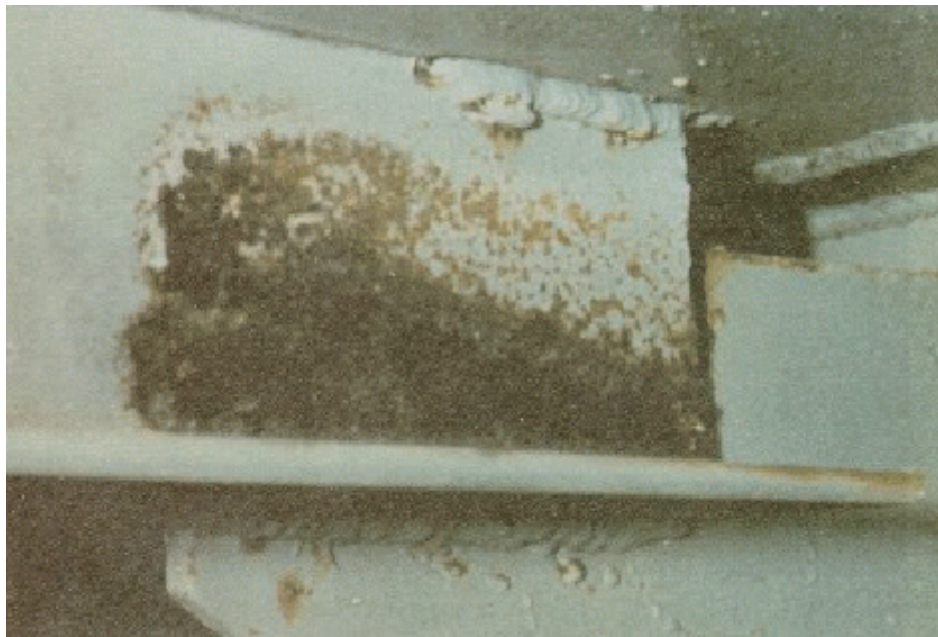
**Figure 2.8.1(d) Chemical Attack**

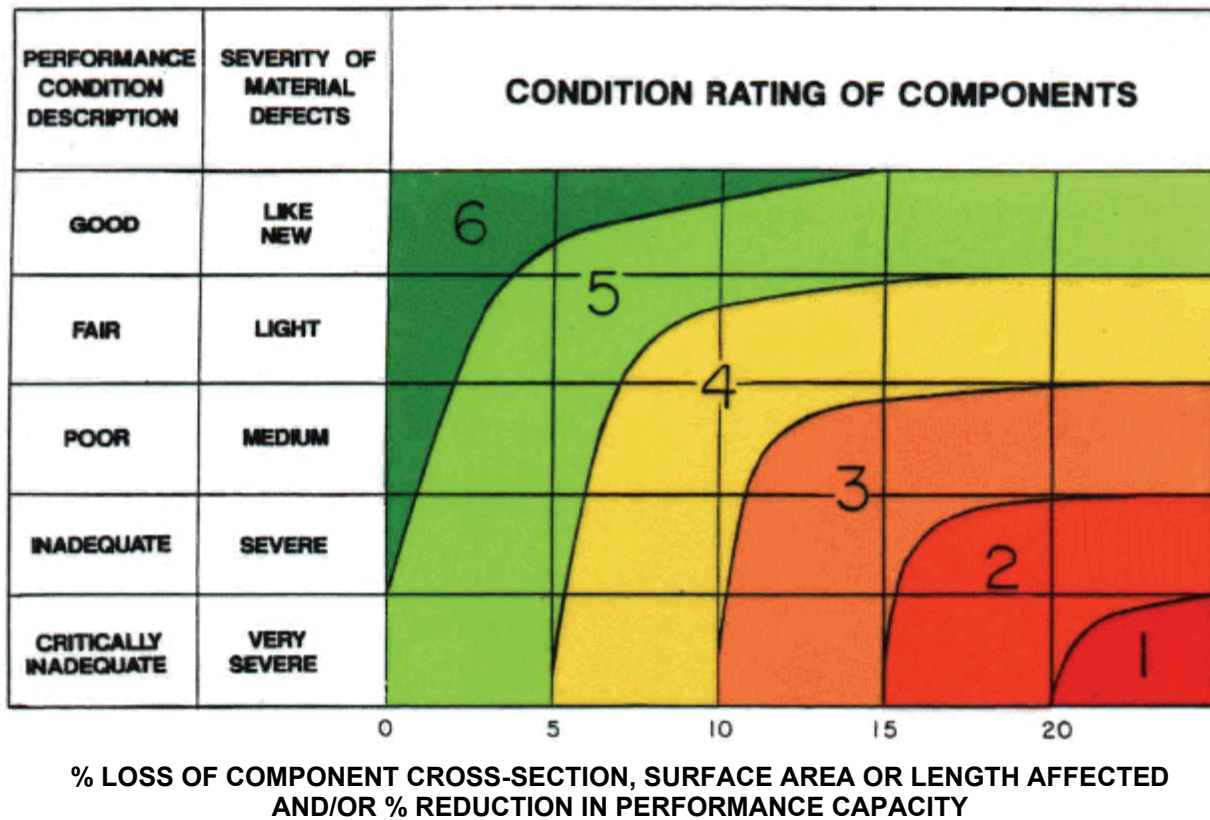
**Figure 2.2 Condition Rating of Components**

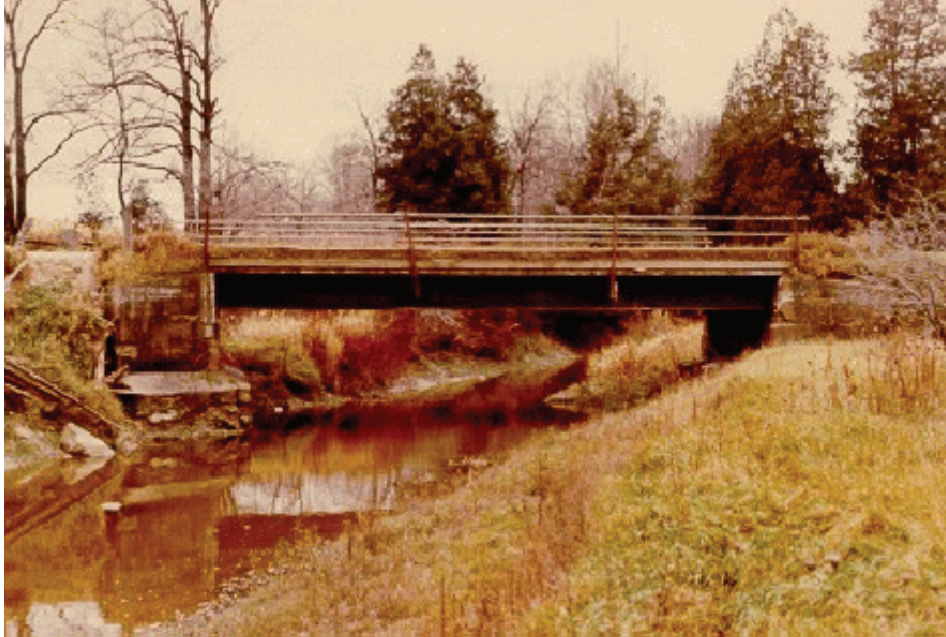
**Figure A1.1.2(a) Waterways**

- MCR 1 – Degradation of waterway bed to bottom of footing.
- PCR 3 – Maximum high water marks above soffit of beams.
- PC B – Monitor structure closely during extended periods of rain and after spring run-off.

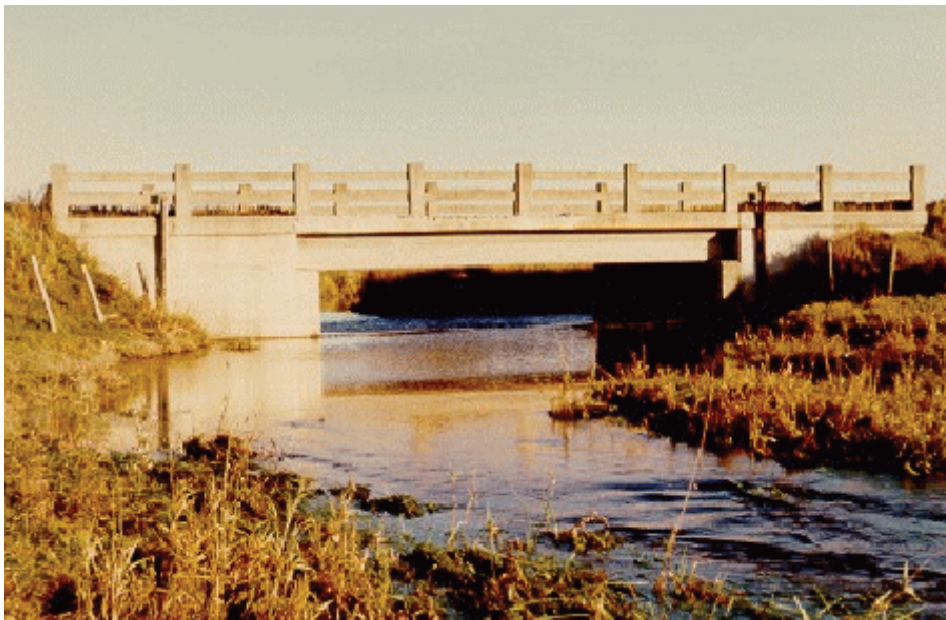
**Figure A1.1.2(b) Waterways**

- MCR 2 – Aggradation of right bank and erosion of left bank resulting in severe change in waterway alignment and flow at the structure.
- PCR 3 – Waterway encroaching against wingwall and substructure with severe erosion of embankment and scour under more than 10% of the foundation.
- PC B – Monitor structure closely during extended periods of rain and after spring run-off.

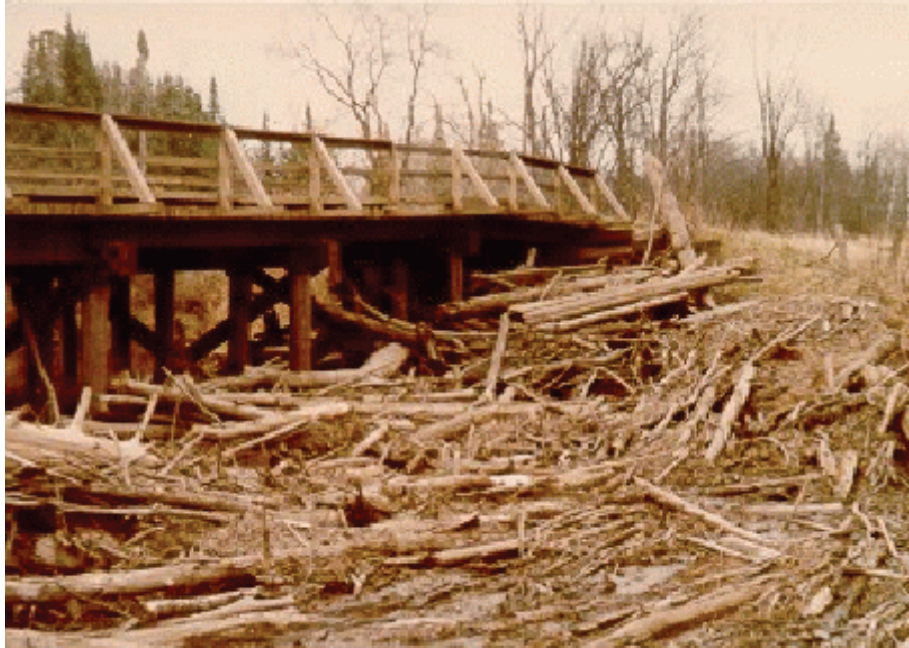
**Figure A1.1.2(e) Waterways**

- MCR 1 – Very severe deposition of debris and siltation of the waterway bed after a flood.
- PCR 3 – Debris carried and deposited against structure after a flood causing substantial damage to piles, and blocking waterway flow.
- PC M – Waterway bed easily accessible to maintenance crews.

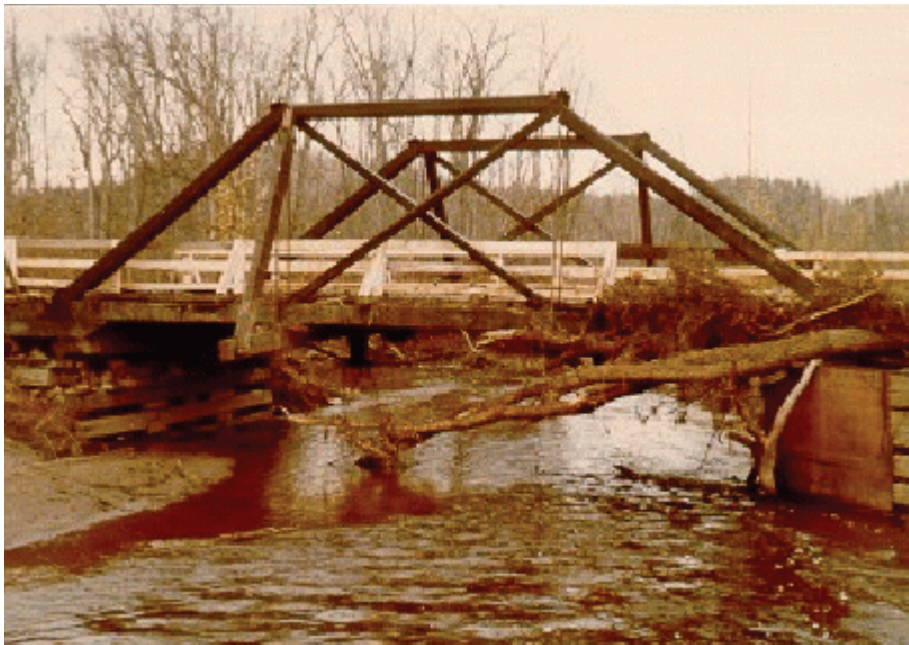
**Figure A1.1.2(f) Waterways**

- MCR 3 – Medium local aggradation of the waterway bed.
- PCR 1 – Very severe damage to structure by debris carried during flood.
- PC U – Initiate emergency inspection procedure. Upstream truss has failed.

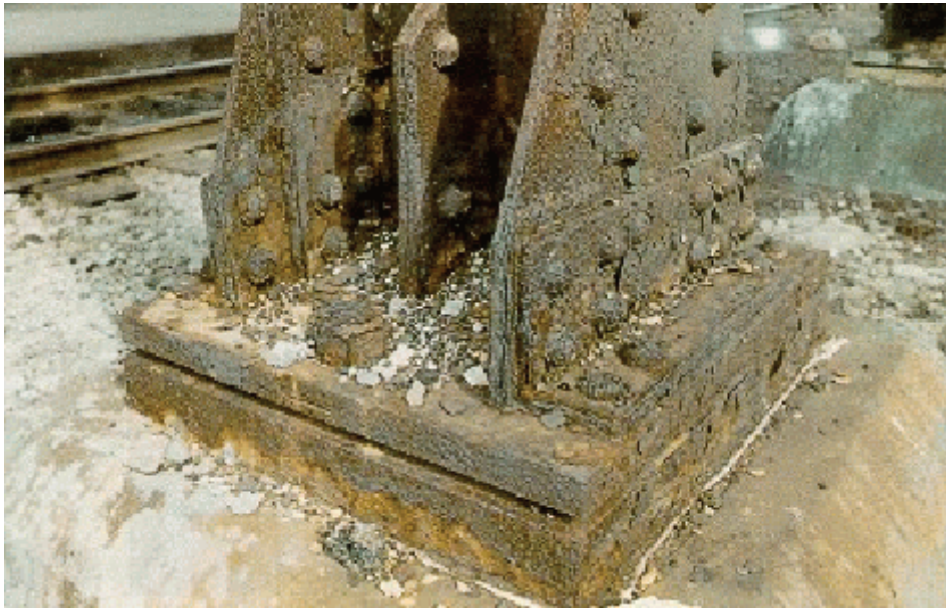
**Figure A3.1.2(k) Steel Pier Bent Base**

- MCR 4 – Medium corrosion; 5% to 10% loss of section locally.
- PCR 5 – Component capacity marginally affected by loss of section.
- PC B – Refinishing may prevent further loss of section.

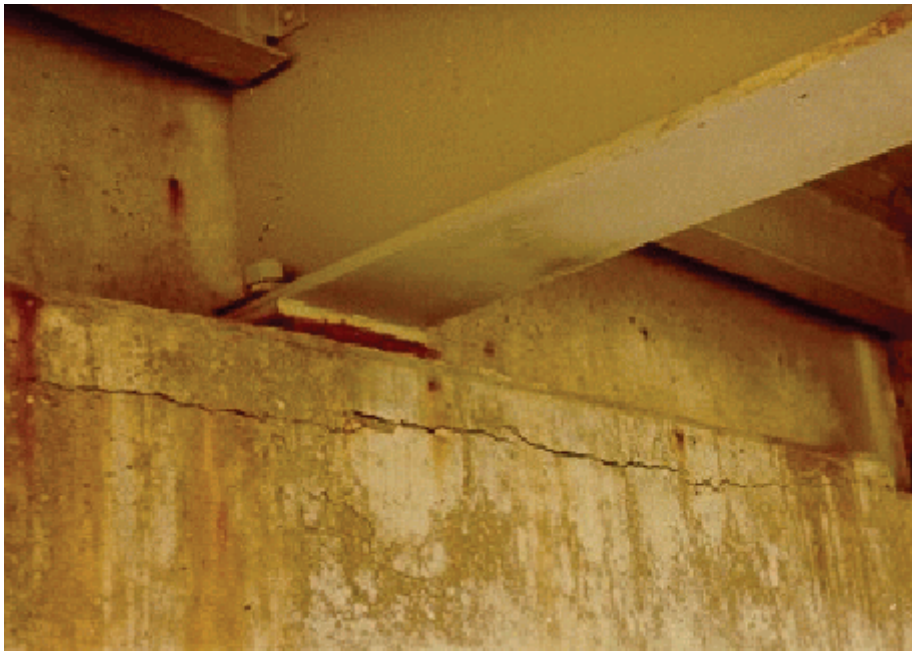
**Figure A3.1.2(p) Concrete Ballast Walls**

- MCR 5 – Light surface scaling.
- PCR 6 – No performance defects.
- PC D – No repairs recommended at this time.

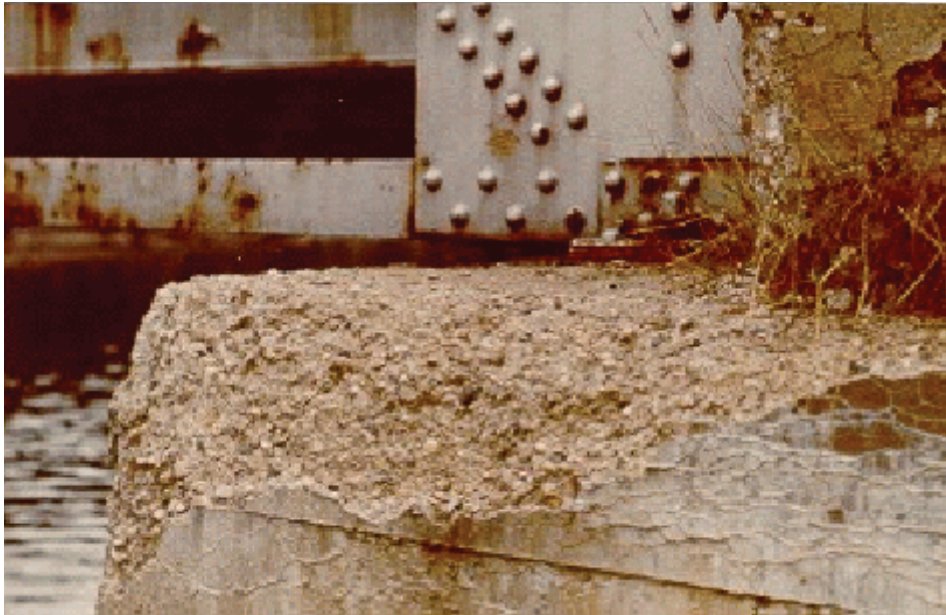
**Figure A3.1.2(u) Concrete Bearing Seat**

- MCR 4 – Medium cracking under the bearing seat.
- PCR 6 – No loss of bearing area.
- PC D – No loss of performance.

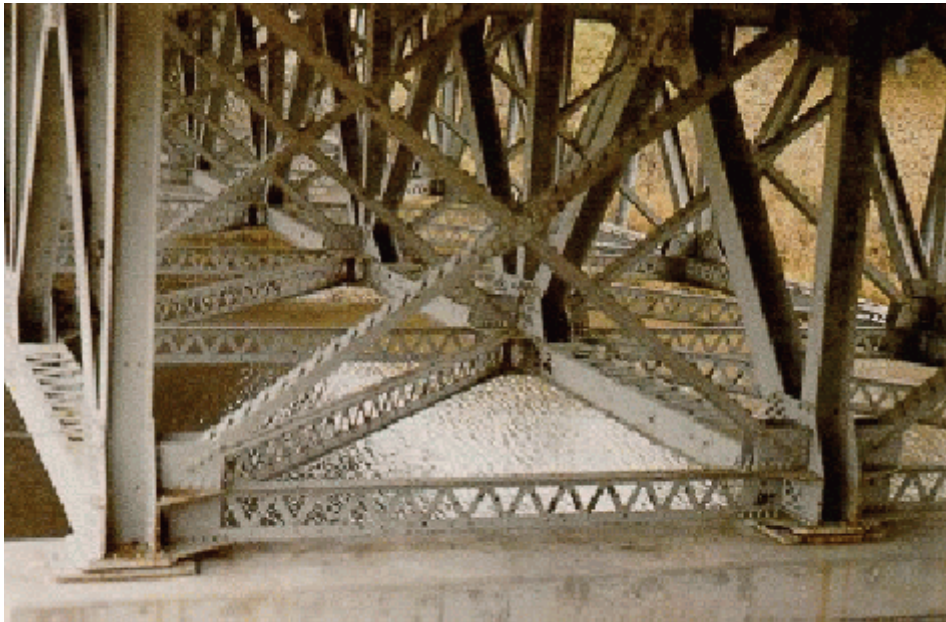
**Figure A6.1.2(o) Sway Bracing and Bottom Lateral Bracing**

- MCR 5 – Light corrosion of both bracing systems.
- PCR 6 – Bracings appear to provide satisfactory lateral support.
- PC D – No recommended repairs to bracing systems at this time. See coating recommendations.

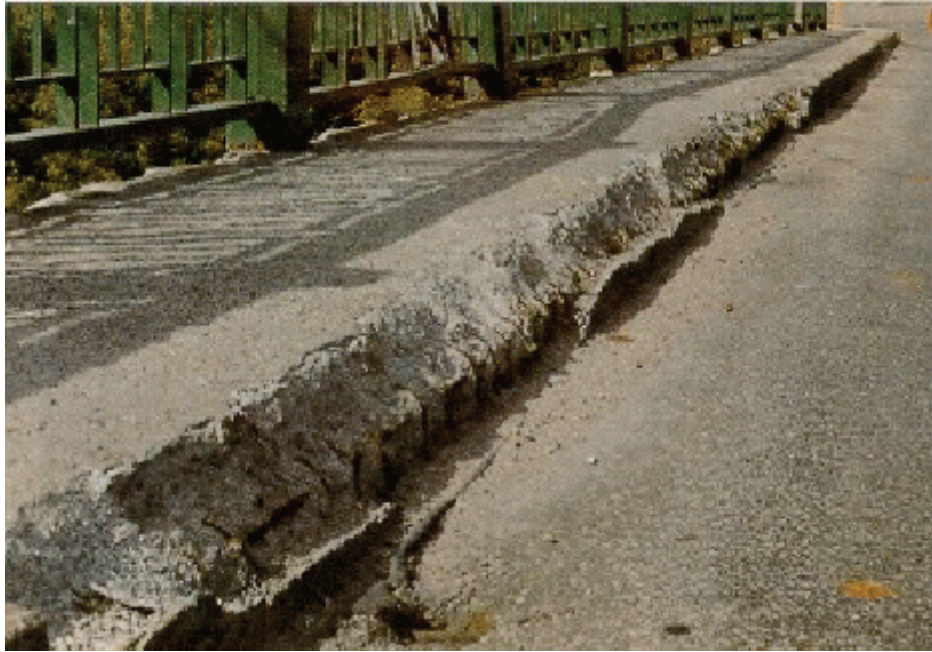
**Figure A7.1.2(g) Concrete Curb**

- MCR 1 – Very severe spalling over more than 75% of curb length.
- PCR 2 – Curb inadequate to prevent vehicles from climbing curb.
- PC B – Curb is only secondary component.

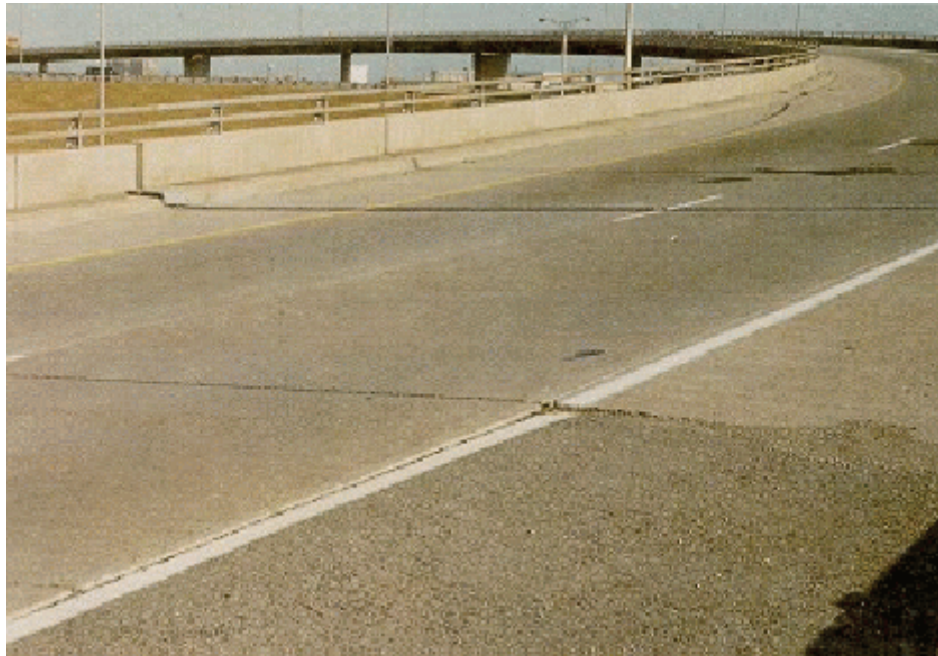
**Figure A7.1.2(k) Concrete Approach Slab**

- MCR 6 – No visible defects.
- PCR 4 – Approach has settled by 20 mm adjacent to the bridge, and provides a rough transition onto the bridge.
- PC C – Only minor loss of performance of secondary component.

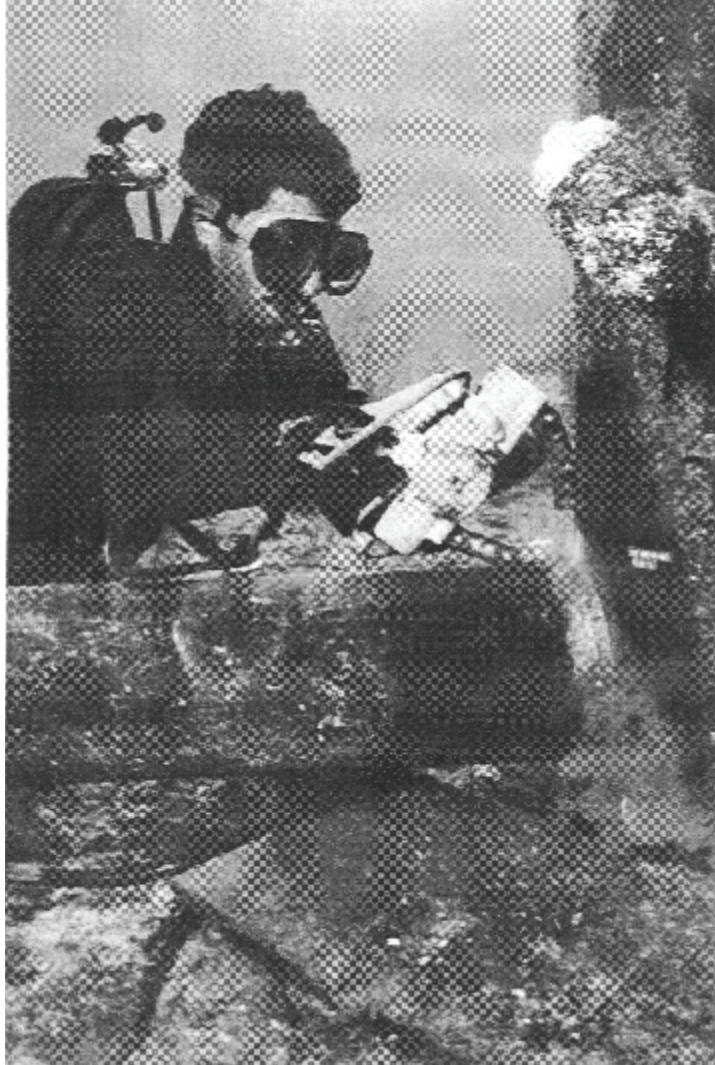
Magnetic particle testing techniques are also used underwater for cracks or discontinuities in the surface of components. The process is the same as used on the surface except the magnetic particles are in a water suspension of fluorescent dye (Figure E1.4.2). The flux leakage at the defect creates an accumulation of the coloured particles indicating location and size. This deposit can be measured and photographed to create a permanent record. The surface is then cleaned with a wire brush or a water-jet.

**Figure E1.4.2 Underwater Magnetic Particle Inspection**
