Statement of Work - Decommission Project 2021

To secure under a global Decommission Project Contract, a demolition contractor to perform the demolition of residential building and associated debris on property at 1986 Woodview Avenue, Pickering; 2262 Meadowvale Road, Markham; 3 Reesor Road, Toronto; 4 Reesor Road, Toronto; and 1149 Concession Road 2, Stouffville.

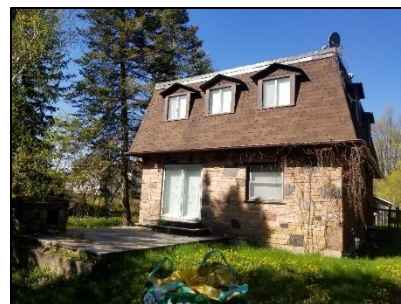
1968 Woodview Ave. is a residential property with a 2.0 storey bungalow with major roof damage. The property also has a 1.0 storey garage/shop in the back yard

1. Removal and disposal of main residential building, concrete patio structures.
2. Remove and dispose of garage/shop structure and concrete floor
3. Supporting foundation of main residential building to be removed 200mm below existing grade, backfilling of the foundation cavity to include the create a hibernaculum (refer to Appendix 2).

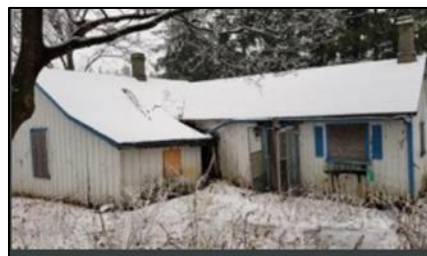
2262 Meadowvale is a small cabin structure with 2 small additions. The residential building is considered unsafe for access into interior. 5 accessory building exist on the property, 1 small collapsed cabin, 3 driving sheds and cabin/shed structure located close to road. The property is littered with unfit vehicles, abandon equipment and debris

- 1 **Secure main residential building perimeter with 33m of 6' high construction fencing (Heritage review – not available for demolition)**
- 2 Removal of accessory buildings and structural foundations, footings and concrete floors

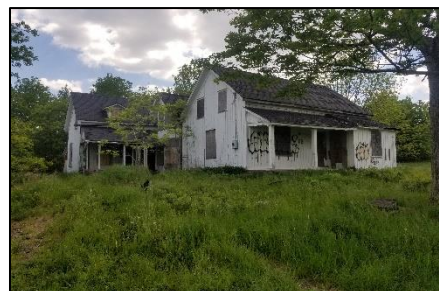
3 Reesor Road is a residential/agricultural property, with a single residential building. The site is a well forested property with grown up farm fields. Remains of an old stone foundation is the only sign of agriculture on the property.

1. Removal and disposal of main residential building, additions and attached structures.
2. The remains of the barn foundation are grown over with native vegetation and will remain a cultural feature on landscape, debris within the foundation will be removed and disposed

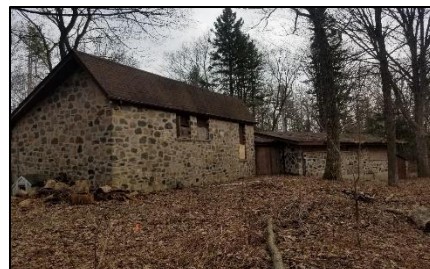
This is a remote property with 2- 1.5 storey main building sections joined with 1.0 storey breezeway residential building. The building site is barely visible from Reesor Road. 100m + driveway supporting minimal granular base.

1. Removal and disposal of main residential building/addition structures.
2. Supporting foundation to be removed 200mm below existing grade, backfilling of the foundation cavity to include the create a hibernaculum (refer to Appendix 2).

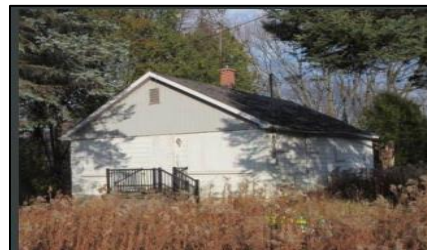
1149 Concession Road 2 is a 1-storey bungalow residential building located adjacent to a small creek on a larger residential Property, the residential building was renovated on the exterior within the last 10-15 years, with, aluminum siding, soffit, fascia and flashing on windows. Asphalt roof is partially collapsed and appears to have the presence of wildlife in attic area. The building is considered unsafe for access into interior.

1. Removal and disposal of main residential building/addition structures.
2. Supporting foundation to be removed 200mm below existing grade, backfilling of the foundation cavity to include the create a hibernaculum (refer to Appendix 2).
