3		
2		
1	ISSUED FOR TENDER	2021/05/17
revisions	description	date

SHIRLEY'S BAY
B91
ROOF REPLACEMENT

DETAILS
BUILDING B91

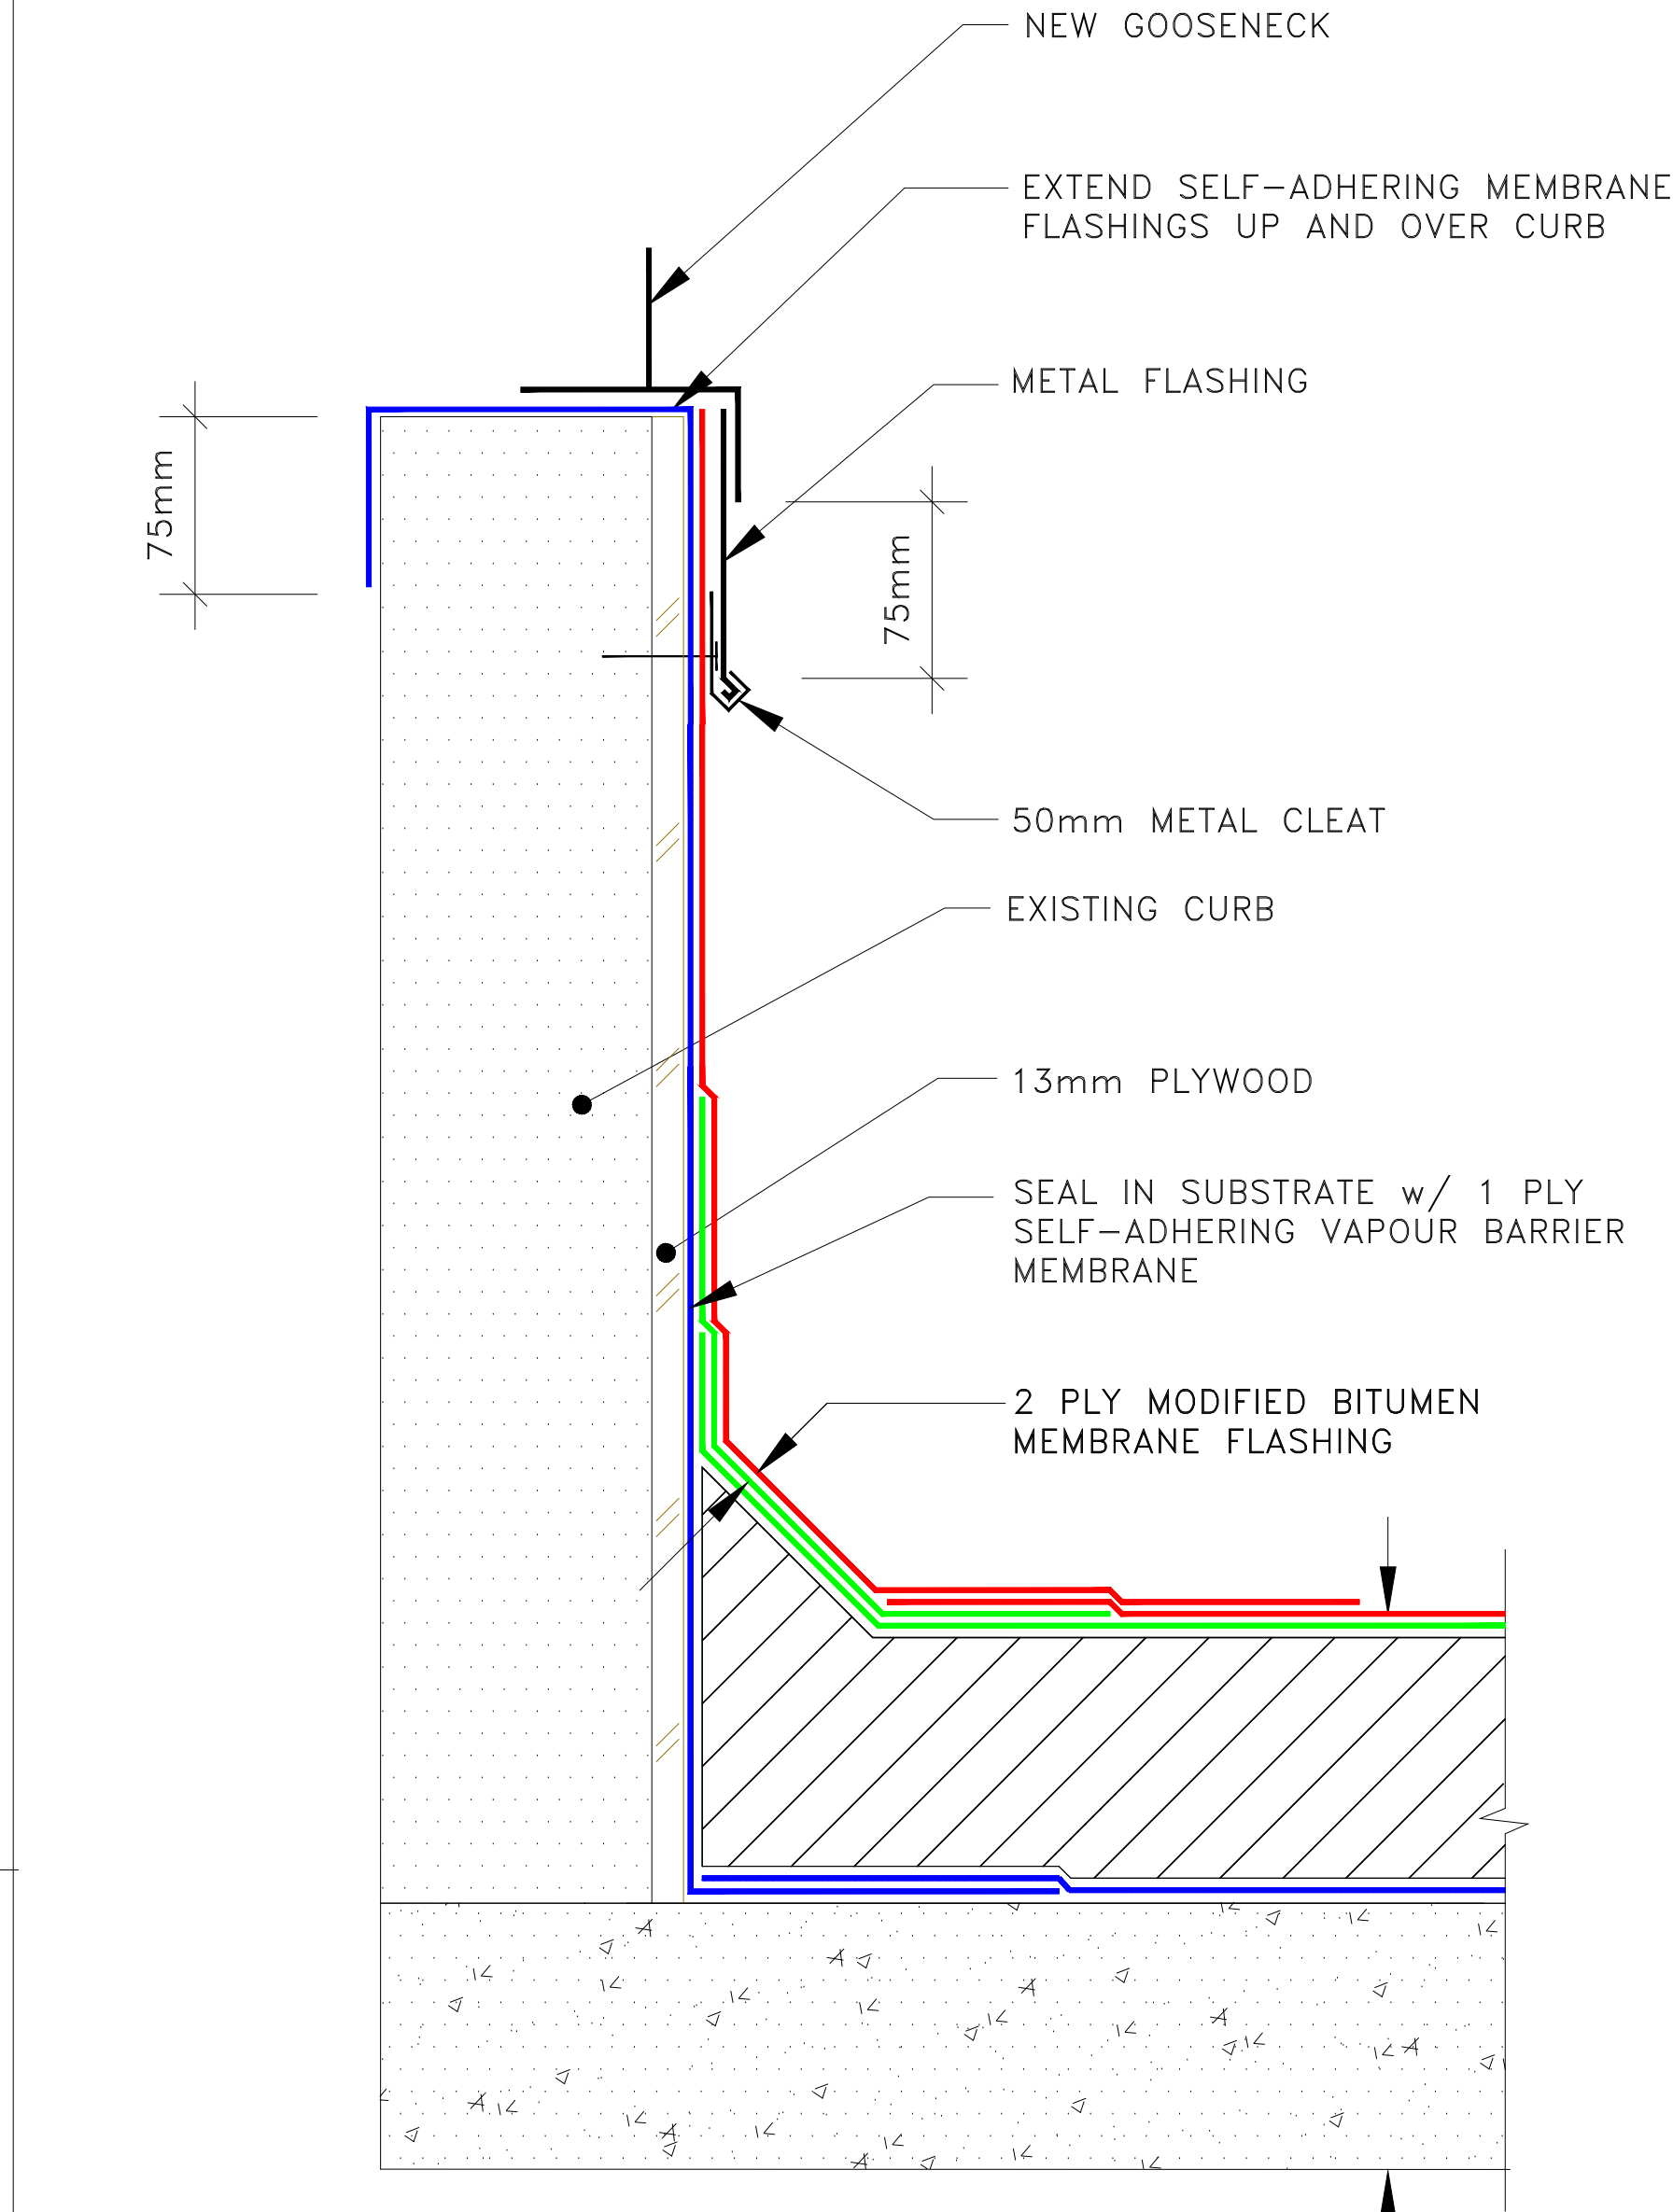
1
A11

TYPICAL ROOF ASSEMBLY
SEE DETAIL No. 1/A3
