Title - Sujet Washroom Renovations, MBF, FV, NB Washroom Renovations, Mactaquac Biodiversity Facility, French Village, NB	
Solicitation No. - N° de l'invitation EC015-221644/A	Amendment No. - N° modif. 002
Client Reference No. - N° de référence du client EC015-221644	Date 2021-12-02
GETS Reference No. - N° de référence de SEAG PW-SPWJ-024-6079	
File No. - N° de dossier PWJ-1-44103 (024)	CCC No./N° CCC - FMS No./N° VME
Solicitation Closes - L'invitation prend fin at - à 02:00 PM Atlantic Standard Time AST on - le 2021-12-07 Heure Normale de l'Atlantique HNA	
F.O.B. - F.A.B. Plant-Usine: <input type="checkbox"/> Destination: <input checked="" type="checkbox"/> Other-Autre: <input type="checkbox"/>	
Address Enquiries to: - Adresser toutes questions à: Doucette (PWJ), Trisha	Buyer Id - Id de l'acheteur pwj024
Telephone No. - N° de téléphone (506) 343-7645 ()	FAX No. - N° de FAX (506) 851-6759
Destination - of Goods, Services, and Construction: Destination - des biens, services et construction:

Hazardous Materials Assessment Report Fish Culture Centre Mactaquac, NB

Project No. NB0499

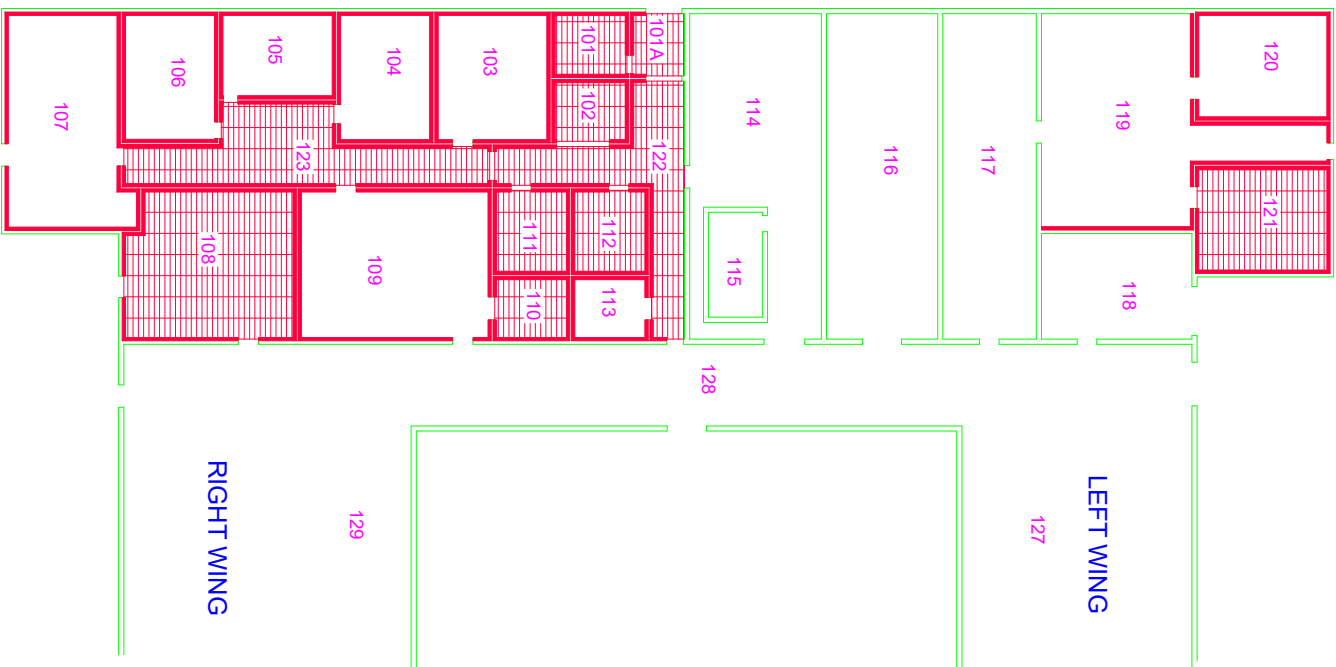
ASBESTOS CONTAINING MATERIAL SAMPLE INDEX

SAMPLE #	ROOM #	MATERIAL DESCRIPTION	ASBESTOS PRESENT
01	122	CEILING TILE	NO
02	122	GLASS	NO
03	122	SPRAY FIREPROOFING	NO
04	122	JOINT COMPOUND	NO
05	102	FLOOR TILE	NO
06	106	JOINT COMPOUND	YES
07	110	VINYL SHEET FLOORING	NO
08	110	VINYL SHEET FLOORING	NO
09	119	JOINT COMPOUND	NO
10	122	PLASTER	NO
11	128	VERMICULITE	NO
12	122	VINYL SHEET FLOORING	NO
13	122	WASTE ON STRUCTURE	NO
14	EXT	TRANSIT PANEL	YES
15	EXT	WINDOW CALULING	NO
16	105	JOINT COMPOUND	NO
23	107	JOINT COMPOUND	YES
24	104	JOINT COMPOUND	NO
25	109	JOINT COMPOUND	NO
26	120	JOINT COMPOUND	NO

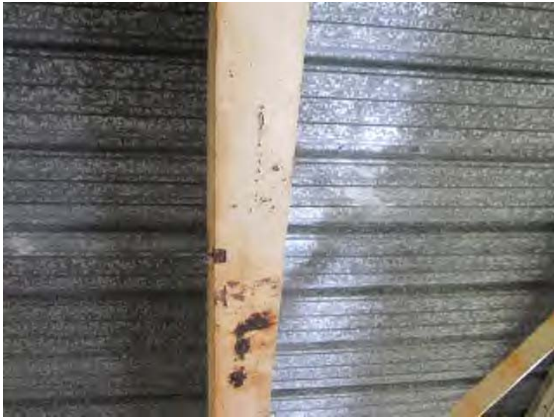
Figure 1 - Off-white paint on the metal structure in the Rearing Ponds areas is lead-containing (Samples LP-01 and LP-04) and is peeling in many locations.

5. Lead containing metal items such as doors / door frames can be recycled as per Appendix 7.
- Regarding the above five bullets, the lead-containing paint sampled from the metal structure in the Rearing Pond area was observed to be flaking/chipping/peeling in many locations (most likely due to age and exposure to weather/temperature). Good Condition lead paint can be retained long-term without danger to employees, but not much of the metal structure was observed to have Good Condition paint. If the metal structure is being replaced soon, the abatement contractor must scrape the loose paint (which would be disposed of as a lead-containing material) and then the metal could go for recycling. However, if this metal structure is planned to be retained long-term, it is recommended to have an abatement contractor scrape the loose paint to limit the chances of exposure. The structure should then be re-painted so that the exposed rust/edges do not cause the paint to continue to lift.

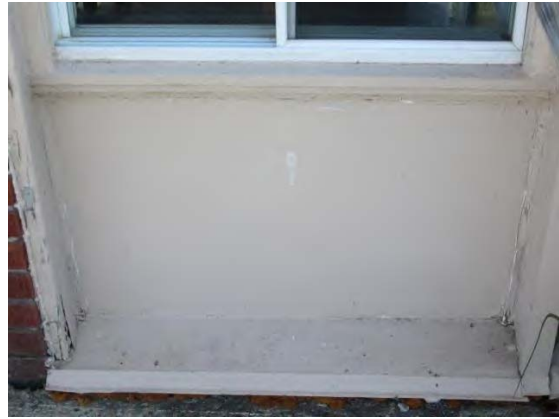
Figure 4 - Transite panels were observed under and over exterior windows of the Administration Building. This material contains asbestos according to Sample 14.

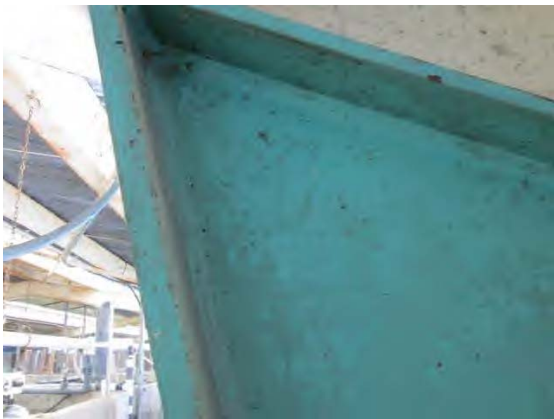
Figure 2 - Green paint on metal structure in the Rearing Ponds areas also contains lead (Sample LP-02) and is peeling in some locations.

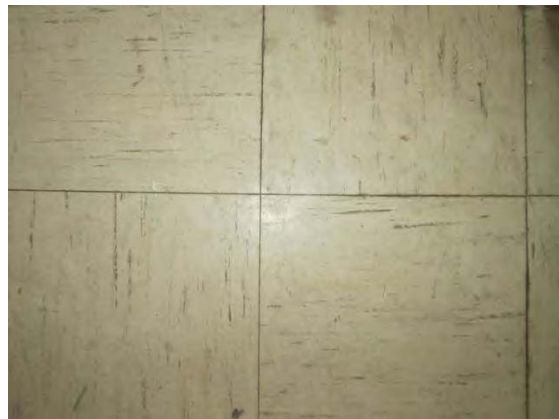
Figure 5 - The 12"x12" floor tiles in the office on the 2nd floor of the Main Garage Building contain asbestos (Sample 17).

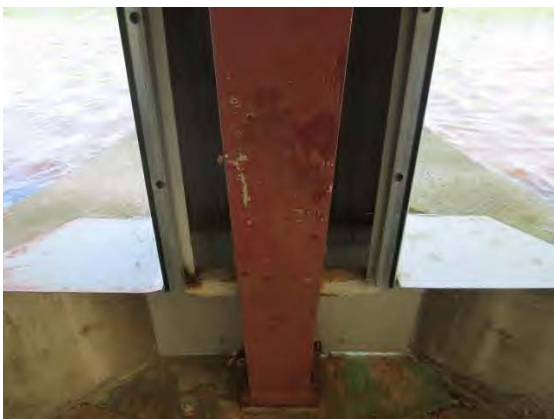
Figure 3 - Red-Brown metal structure paint was also observed in the Rearing Ponds areas, also contains lead according to Sample LP-03, and was also observed to be peeling in several locations.

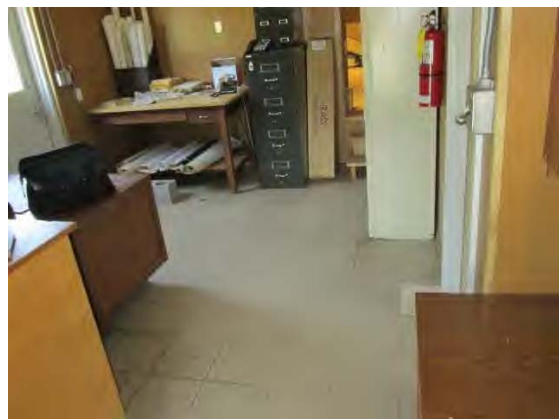
Figure 6 - Another view of the ACM floor tiles in the Garage Office.
