ADDENDUM No. 1

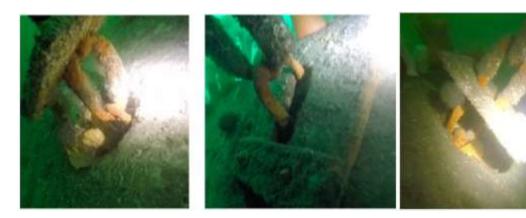
Answer: Refer to Annex B - Description of Items, Mandatory Items .2 Replace Mooring Chain at Kellets. The main mooring chain does pass through the kellets. No additional drawings are available, however, we have included three more photos showing the main mooring chain passing through the kellets.
