**SOLICITATION AMENDMENT
MODIFICATION DE L'INVITATION**

Title - Sujet Mechanical System Upgrade for North Modernisation du système mécanique des ailes nord et sud	
Solicitation No. - N° de l'invitation EZ899-222066/A	Amendment No. - N° modif. 005
Client Reference No. - N° de référence du client	Date 2022-04-28
GETS Reference No. - N° de référence de SEAG PW-SPWY-031-9116	
File No. - N° de dossier PWY-1-44210 (031)	CCC No./N° CCC - FMS No./N° VME
Solicitation Closes - L'invitation prend fin at - à 02:00 PM Pacific Daylight Saving Time PDT on - le 2022-05-12 Heure Avancée du Pacifique HAP	
F.O.B. - F.A.B.	
Plant-Usine: <input type="checkbox"/> Destination: <input checked="" type="checkbox"/> Other-Autre: <input type="checkbox"/>	
Address Enquiries to: - Adresser toutes questions à: Leung, Janie	Buyer Id - Id de l'acheteur pwy031
Telephone No. - N° de téléphone (778) 919-3273 ()	FAX No. - N° de FAX () -
Destination - of Goods, Services, and Construction: Destination - des biens, services et construction: CSC - Kent Institution - Agassiz, BC

This Amendment 005 is raised to issue Addendum #3.

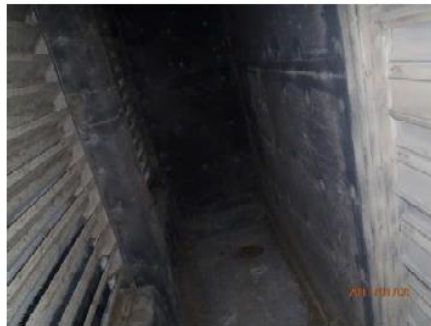
PHOTO-2

NOTE:
REMOVE ALL EXISTING ACOUSTIC LINERS INSIDE ROOM. PATCH & REPAIR FIRE SPRAYED TO U/S OF ROOF WITH NEWSPRAY APPLIED FIREPROOFING, MANUFACTURER'S STANDARD, FACTORY-MIXED, LIGHTWEIGHT, DRY FORMULATION, COMPLYING W/ INDICATED FIRE-RESISTANCE DESIGN, ULC CERTIFIED CEMENTITIOUS FIREPROOFING LISTED FOR USE IN ULC DESIGNS.
ACCEPTABLE MANUFACTURERS:
1. W.R. GRACE CONSTRUCTION PRODUCTS
2. ISOLATEK INTERNATIONAL, CARBOLINE A/D FIREPROOFING.
CLEAN AND PAINT EXISTING WALL, REFER TO PHOTOS 1 AND 2.

Response: The photos 1 & 2 including the fire spray note are irrelevant to Room N202. Those are intended for Partial Mezzanine Floor Plan-North Equipment Room (AHU-N1). Patch and repair of fire spray coating applies to whole North Mechanical Room, including AHU-N1 room.
