Title - Sujet Mechanical System Upgrade for North Modernisation du système mécanique des ailes nord et sud	
Solicitation No. - N° de l'invitation EZ899-222066/A	Amendment No. - N° modif. 005
Client Reference No. - N° de référence du client	Date 2022-04-28
GETS Reference No. - N° de référence de SEAG PW-\$PWY-031-9116	
File No. - N° de dossier PWY-1-44210 (031)	CCC No./N° CCC - FMS No./N° VME
Solicitation Closes - L'invitation prend fin at - à 02:00 PM Pacific Daylight Saving Time PDT on - le 2022-05-12 Heure Avancée du Pacifique HAP	
F.O.B. - F.A.B. Plant-Usine: <input type="checkbox"/> Destination: <input checked="" type="checkbox"/> Other-Autre: <input type="checkbox"/>	
Address Enquiries to: - Adresser toutes questions à: Leung, Janie	Buyer Id - Id de l'acheteur pwy031
Telephone No. - N° de téléphone (778) 919-3273 ()	FAX No. - N° de FAX () -
Destination - of Goods, Services, and Construction: Destination - des biens, services et construction: CSC - Kent Institution - Agassiz, BC

This Amendment 005 is raised to issue Addendum #3.

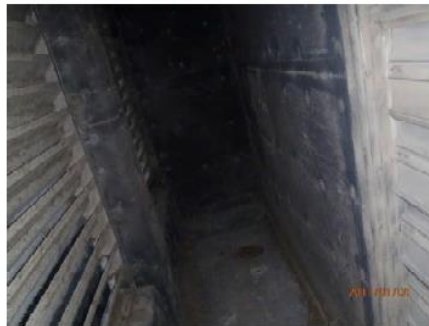
PHOTO-2

NOTE:
REMOVE ALL EXISTING ACOUSTIC LINERS INSIDE ROOM. PATCH & REPAIR FIRE SPRAYED TO U/S OF ROOF WITH NEWSPRAY APPLIED FIREPROOFING, MANUFACTURER'S STANDARD, FACTORY-MIXED, LIGHTWEIGHT, DRY FORMULATION, COMPLYING W/ INDICATED FIRE-RESISTANCE DESIGN, ULC CERTIFIED CEMENTITIOUS FIREPROOFING LISTED FOR USE IN ULC DESIGNS.
ACCEPTABLE MANUFACTURERS:
1. W.R. GRACE CONSTRUCTION PRODUCTS
2. ISOLATEK INTERNATIONAL, CARBOLINE A/D FIREPROOFING.
CLEAN AND PAINT EXISTING WALL, REFER TO PHOTOS 1 AND 2.

Response: The photos 1 & 2 including the fire spray note are irrelevant to Room N202. Those are intended for Partial Mezzanine Floor Plan-North Equipment Room (AHU-N1). Patch and repair of fire spray coating applies to whole North Mechanical Room, including AHU-N1 room.
