Client: RCMP	City: REGINA	Project: RCMP TRAINING CENTRE	Date: NOV 22/2011
Inspection no.: DM1	Address: SHAW ST/LOWRY PL [GYMNASE] E SIDE	Sewer: DM1	Video Tape no.: 0
Contract no.:	Reason of insp.:	Start Manhole: MH1A	Total length: 31.20 m
Operator: Frank McBride	Direction: Downstream	End Manhole: MH2A	Page: 1
Profile: Circle 200 / 200 mm	Sewer type: DOMESTIC	Material: VCT Vitrified Clay T	Condition:

sewer inspection

Project: RCMP TRAINING CENTER
Date: 15/12/2011
Description: CAMERA AND CLEAN SANITARY AND STORM
Remark: 5907 DEWDNEY AVE

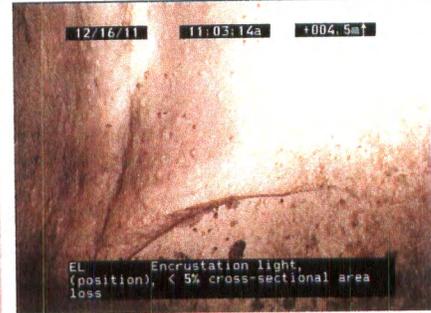
Photo : 55 Distance: 4.50 m
Code : EL

Start	End	Code	Description	Score	DC	Video	Photo
1.30	1.30	ST	Start of survey			00:00:00	54 54_b
4.50	4.50	EL	Encrustation light, (position), < 5% cross-sectional area loss	1	1	00:00:00	55
12.20	12.20	FX	Broken Pipe	80	4	00:00:00	56
18.10	18.10	MC	Pipe material changes to PVC Polyvinylchloride Pipe			00:00:00	57
31.20	31.20	FH	End of survey			00:00:00	58

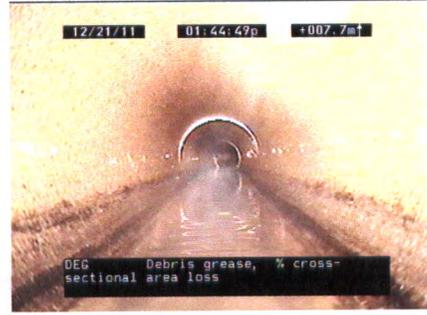
Photo : 147 Distance: 7.70 m
Code : DEG

Start	End	Code	Description	Score	DC	Video	Photo
0.00	0.00	ST	Start of survey			00:00:00	146 146_b
7.70	7.70	DEG	S1 Debris grease, % cross-sectional area loss	2	1	00:00:00	147
13.20	13.20	JM	Joint displaced (moderate), > 1* pipe wall thickness	2	1	00:00:00	148
21.00	21.00	DEG	F1 Debris grease, % cross-sectional area loss. DEFECT ENDS	2	1	00:00:00	149
23.30	23.30	DEG	S2 Debris grease, % cross-sectional area loss	2	1	00:00:00	150
41.20	41.20	JM	Joint displaced (moderate), > 1* pipe wall thickness	2	1	00:00:00	151
45.70	45.70	DEG	F2 Debris grease, % cross-sectional area loss. DEFECT ENDS	2	1	00:00:00	152
46.10	46.10	FH	End of survey			00:00:00	153

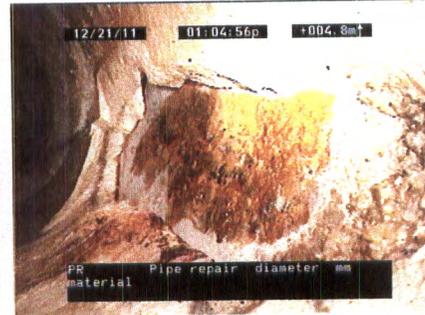
Photo : 136 Distance: 4.80 m
Code : PR

Start	End	Code	Description	Score	DC	Video	Photo
1.30	1.30	ST	Start of survey			00:00:00	135 135_b
4.80	4.80	PR	Pipe repair diameter mm material			00:00:00	136

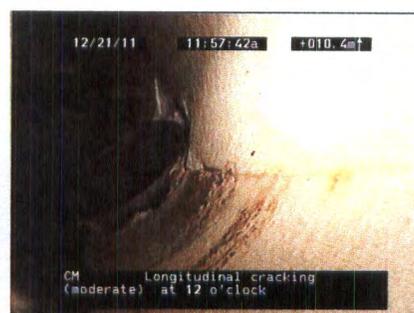
Start	End	Code	Description	Score	DC	Video	Photo
0.00	0.00	ST	Start of survey			00:00:00	117 117_b
10.40	10.40	CM	Longitudinal cracking (moderate) at 12 o'clock	10	1	00:00:00	118

Photo : 118 Distance: 10.40 m
Code : CM

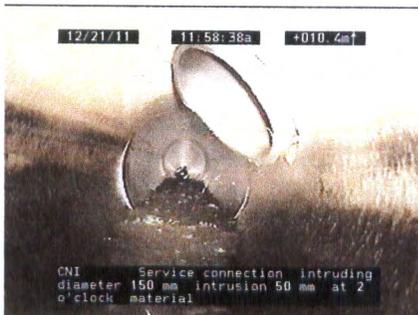
Photo : 119 Distance: 10.40 m
Code : CNI

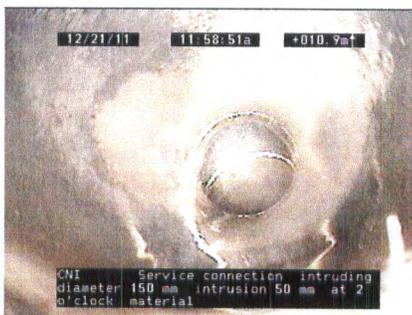
Photo : 119_b Distance: 10.40 m
Code : CNI

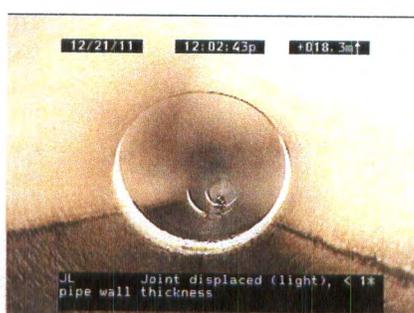
Photo : 123 Distance: 18.30 m
Code : JL

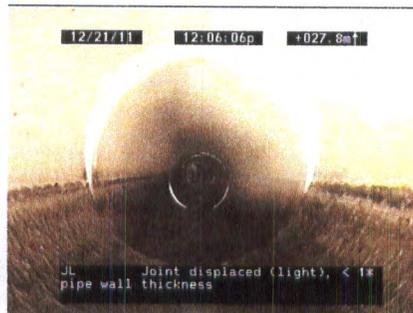
Photo : 125 Distance: 27.80 m
Code : JL

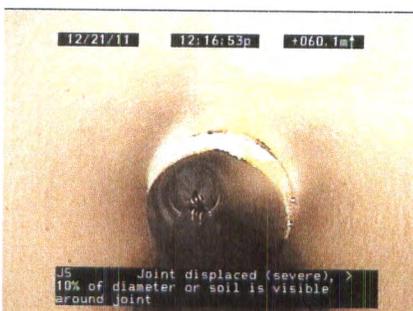
Photo : 131 Distance: 60.10 m
Code : JS

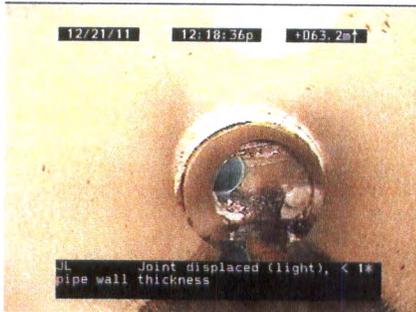
Photo : 133

Distance: 63.20 m

Code : JL

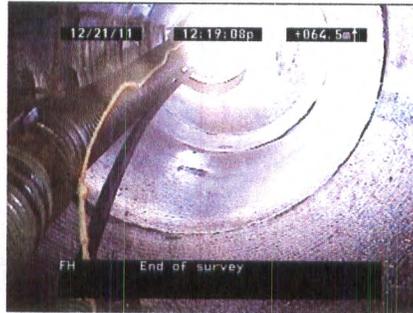
Photo : 134

Distance: 64.50 m

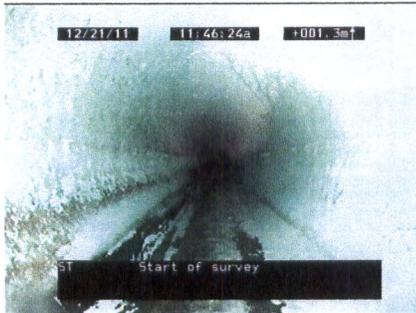
Photo : 115 Distance: 1.30 m
Code : ST

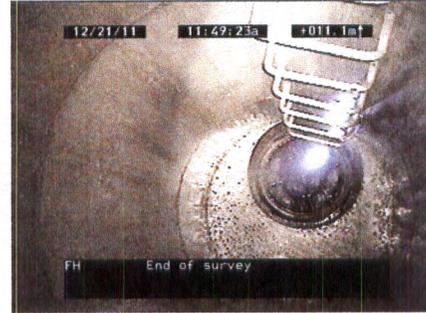
Photo : 116 Distance: 11.10 m
Code : FH

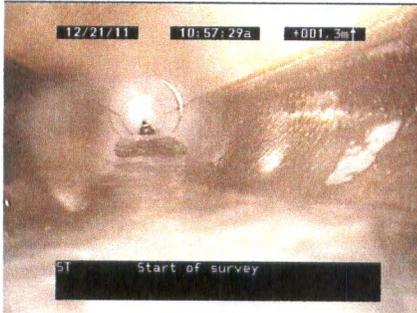
Photo : 101 Distance: 1.30 m
Code : ST

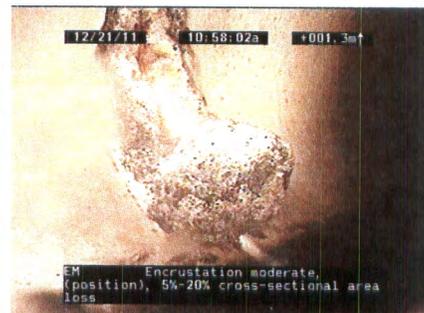
Photo : 102 Distance: 1.30 m
Code : EM

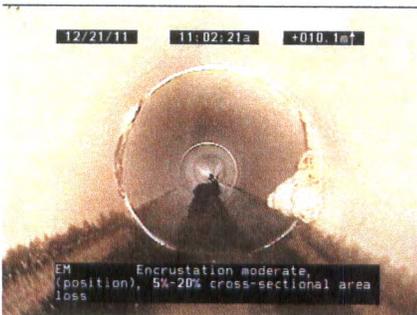
Photo : 103 Distance: 10.10 m
Code : EM

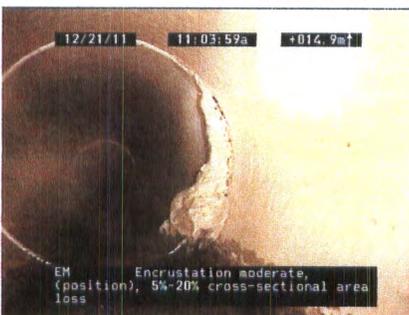
Photo : 104 Distance: 14.80 m
Code : EM

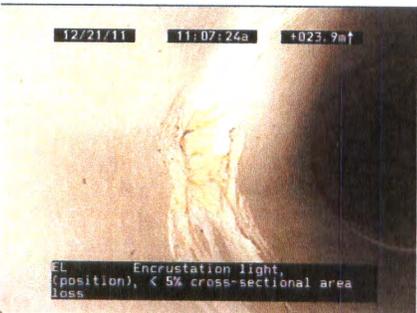
Photo : 106 Distance: 23.90 m
Code : EL

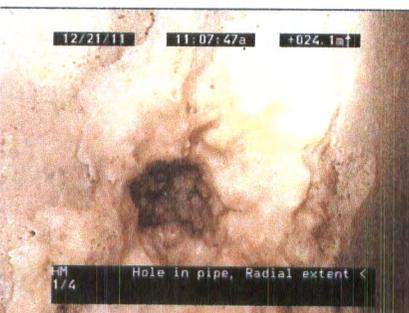
Photo : 107 Distance: 24.10 m
Code : HM

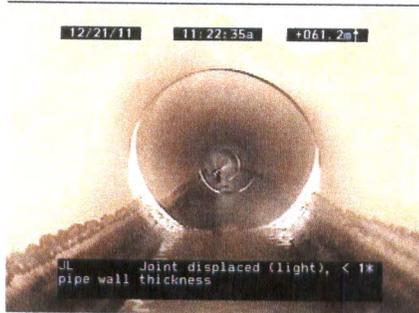
Photo : 113 Distance: 61.20 m
Code : JL

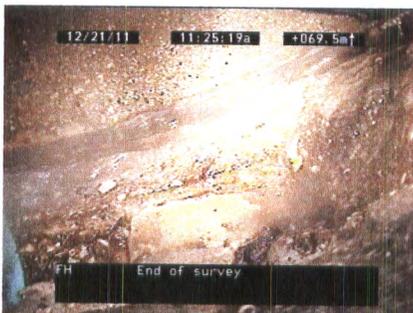
Photo : 114 Distance: 69.50 m
Code : FH

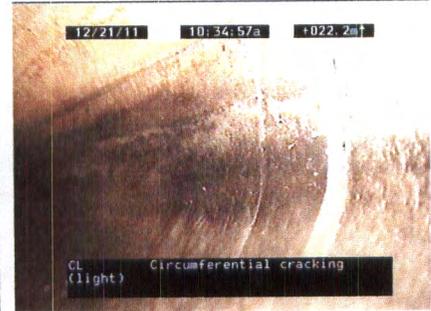
Photo : 97 Distance: 22.20 m
Code : CL

Start	End	Code	Description	Score	DC	Video	Photo
1.30	1.30	ST	Start of survey			00:00:00	96 96_b
22.20	22.20	CL	Circumferential cracking (light)	10	2	00:00:00	97
51.70	51.70	GO	General Observation: MH IS NOT ON MAP			00:00:00	98
56.70	56.70	EM	Encrustation moderate, (position), 5%-20% cross-sectional area loss	2	1	00:00:00	99
56.70	56.70	SA	Survey abandoned. AT ENCRUSTATION, NO ACCESS TO UP STEAM MH, CONSTRUCTION			00:00:00	100

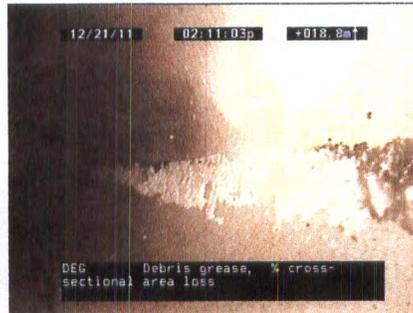
Photo : 156 Distance: 17.10 m
Code : DEG

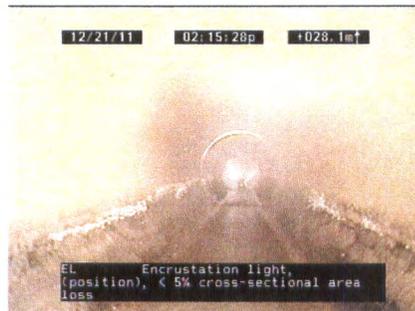
Photo : 158 Distance: 24.30 m
Code : DEG

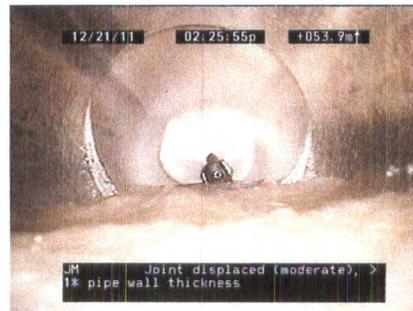
Photo : 159 Distance: 28.00 m
Code : EL

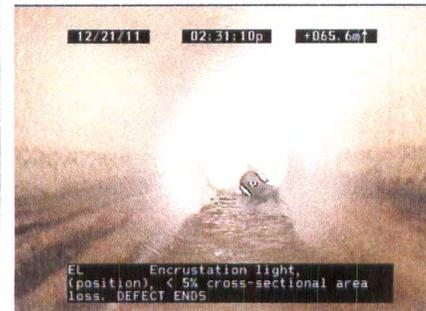
Photo : 160 Distance: 53.90 m
Code : JM

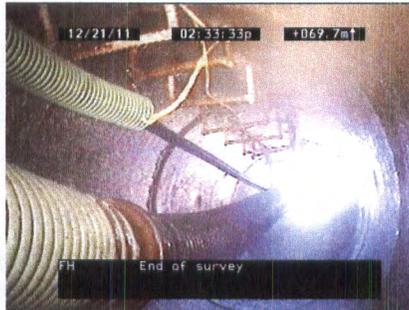
Photo : 162 Distance: 69.30 m
Code : CL

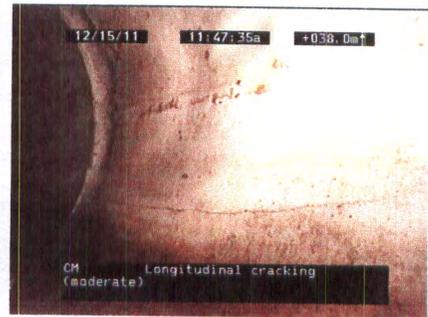
Photo : 13 Distance: 38.00 m
Code : CM

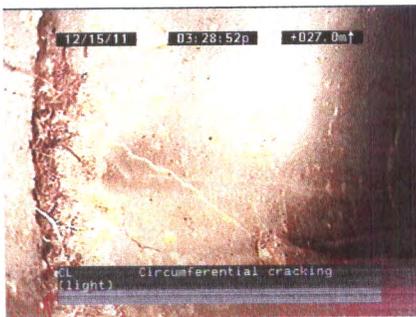
Photo : 38 Distance: 27.00 m
Code : CL

27.00	27.00	CL	Circumferential cracking (light)	10	2	00:00:00	38
27.00	27.00	RMS	Root mass (severe), > 50% cross-sectional area loss, from ... to ... o'clock	20	2	00:00:00	39

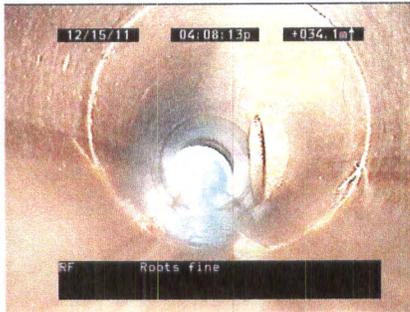
Photo : 45 Distance: 34.00 m
Code : RF

32.90	32.90	RF	Roots fine	1	1	00:00:00	43
33.50	33.50	CL	Circumferential cracking (light)	10	2	00:00:00	44
34.00	34.00	RF	Roots fine	1	1	00:00:00	45
34.60	34.60	CN	Service connection diameter 200 mm material			00:00:00	46 46_b

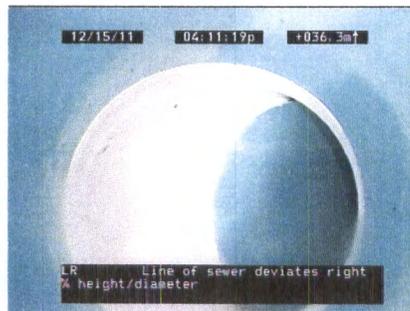
Photo : 50 Distance: 36.30 m
Code : LR

36.30	36.30	LR	Line of sewer deviates right % height/diameter			00:00:00	50
36.80	36.80	GO	General Observation: MH CAN BE SEEN			00:00:00	51
36.80	36.80	EL	F1 Encrustation light, (position), < 5% cross-sectional area loss. DEFECT ENDS	1	1	00:00:00	52

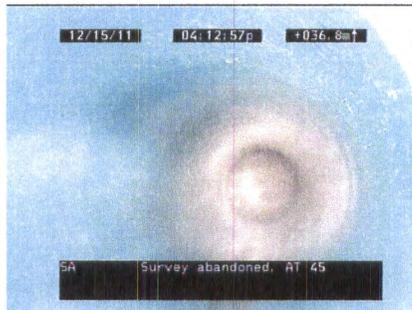
Photo : 52
Code : EL

36.30	36.30	LR	Line of sewer deviates right % height/diameter			00:00:00	50
36.80	36.80	GO	General Observation: MH CAN BE SEEN			00:00:00	51
36.80	36.80	EL	F1 Encrustation light, (position), < 5% cross-sectional area loss. DEFECT ENDS	1	1	00:00:00	52
