PRE-DESIGN REPORT

AAFC - Highfield Dam Rehabilitation

Report Number: 12-1345-0020

**FINAL REPORT – HIGHFIELD DAM SERVICES CONTRACT NO. 6:
PROJECT REHABILITATION PRE-DESIGN STUDY**

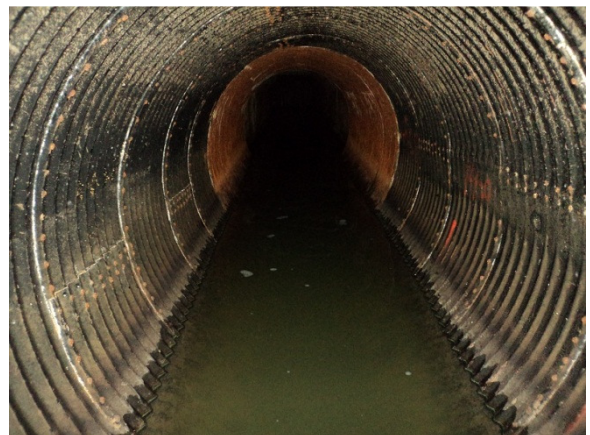
Riveted and coated CMP w/

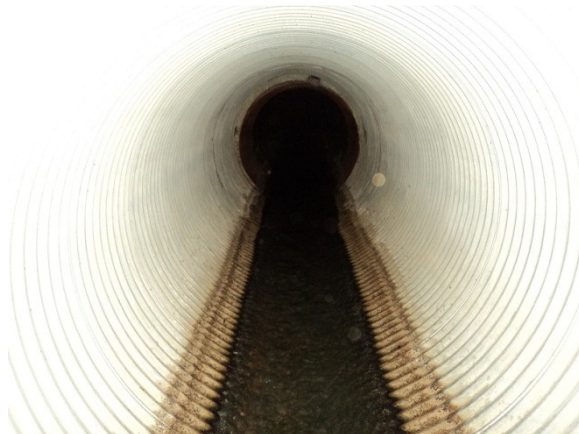
View upstream to 1.5 m to 1.6 m diameter CMP.

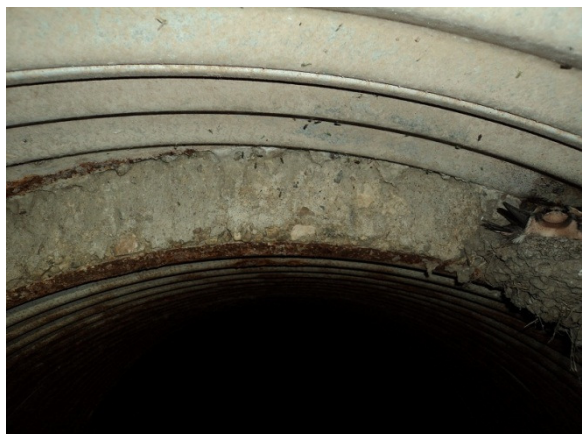
Transition from 1.5 m dia. to 1.6 m dia. CMP. Note swallow nest.

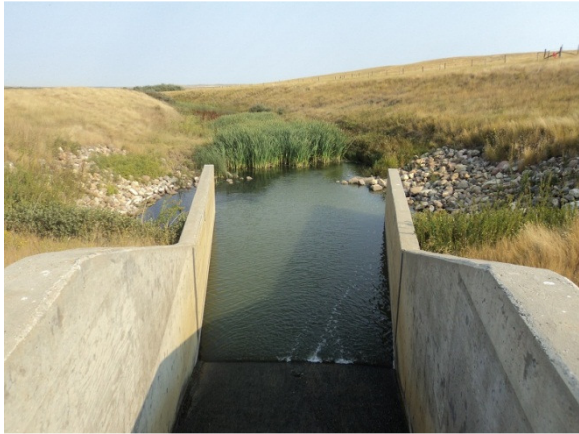
View looking downstream along stilling basin. No protective fence.

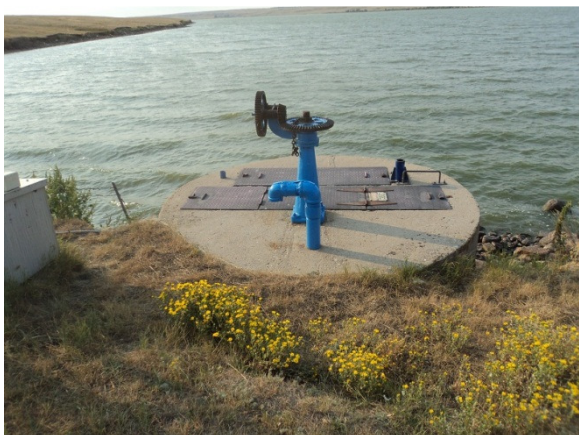
East LLO gatewell at existing dam crest.

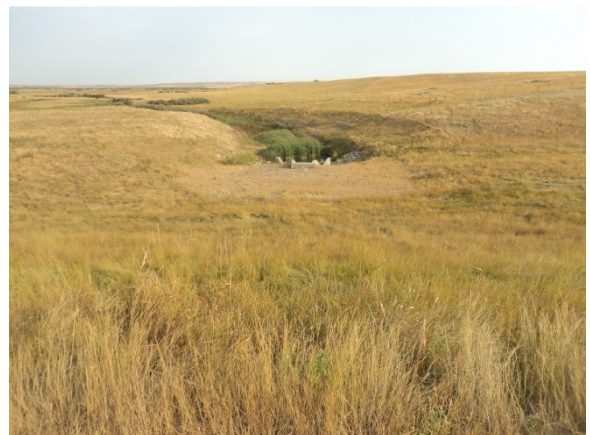
View from crest looking downstream along Rush Lake Creek and the East LLO outlet structure.

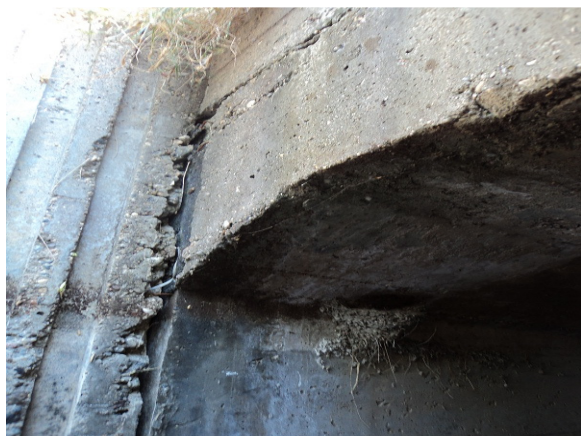
Waterface transition from box culvert pipe section to West LLO stilling basin.

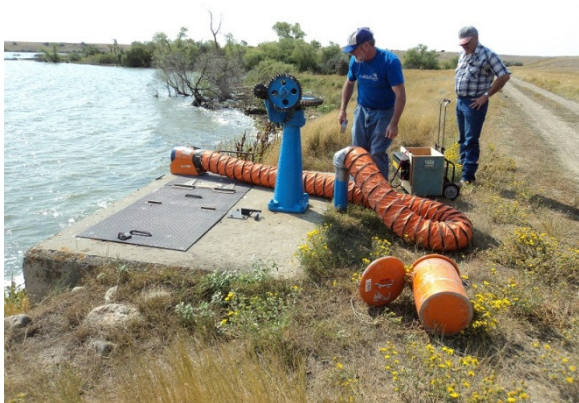
West LLO gatewell w/gate actuator lockout. Shows vent pipe and confined space entry ventilation.

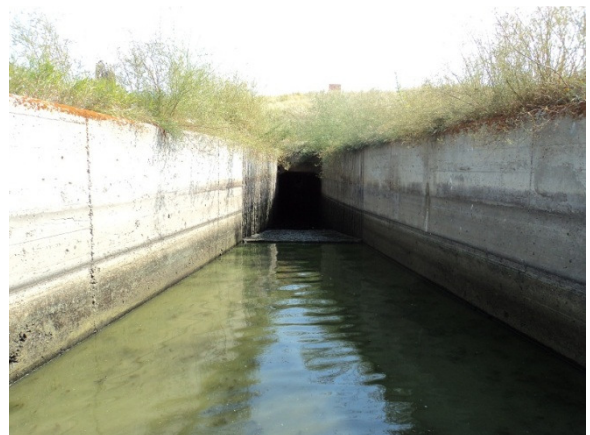
View towards West LLO transition section. Note existing ground to top of wall. No protective fence.

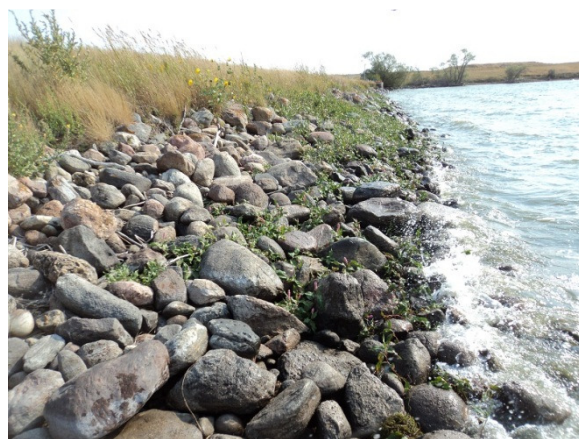
General view of armor looking east toward the East LLO area. Note rounded field stone armor 3-400 mm

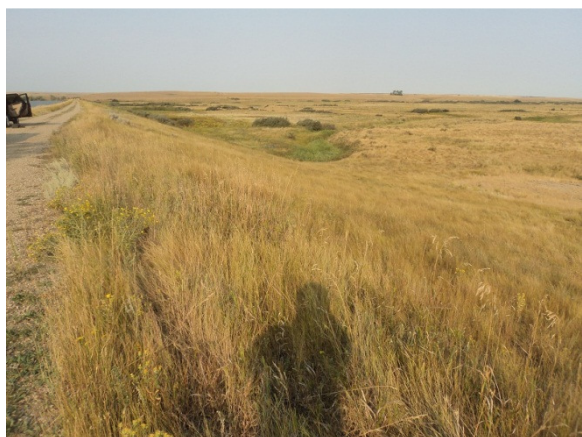
General view looking west from east abutment and existing East LLO alignment to wet dam toe area.

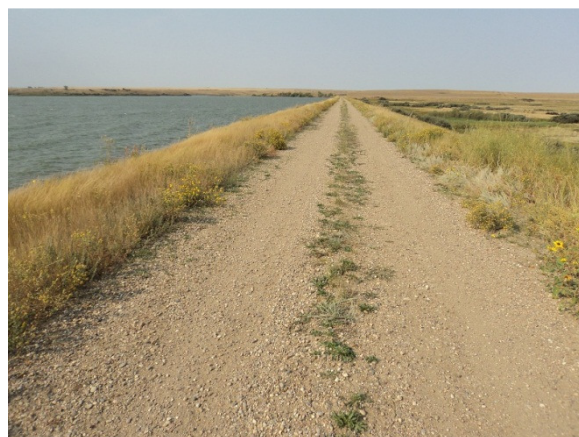
General view looking west across Highfield dam crest. Note granular topping and very flat terrain.

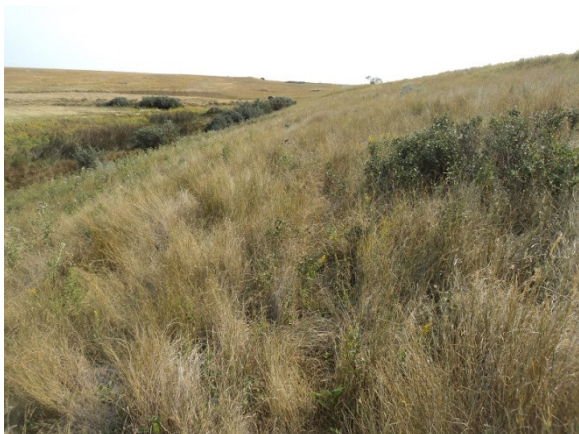
General view looks east at downstream slope and toe area vegetation cover.

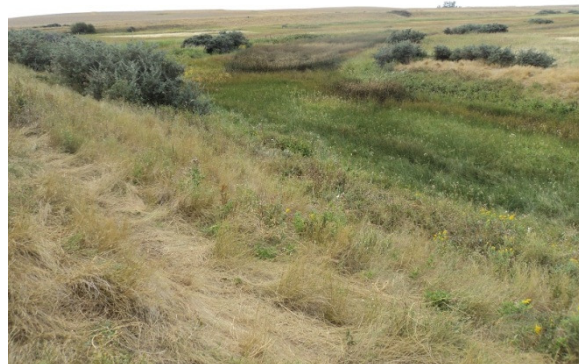
General view of downstream toe area of the Highfield dam w/oxbows, vegetation and standing water.

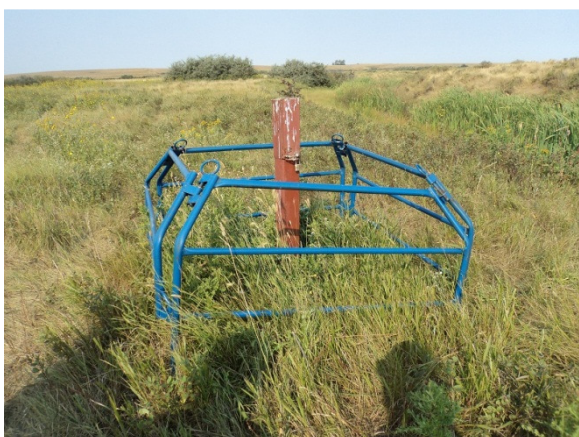
Newly installed instrumentation and protection from cattle interaction.

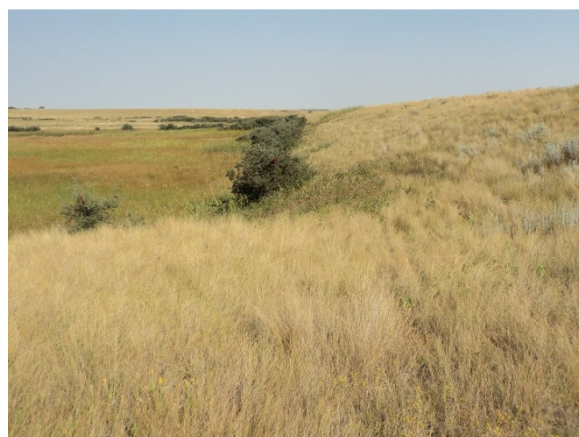
General view looking east from the West LLO and Herbert canal access trail. Note toe area vegetation.

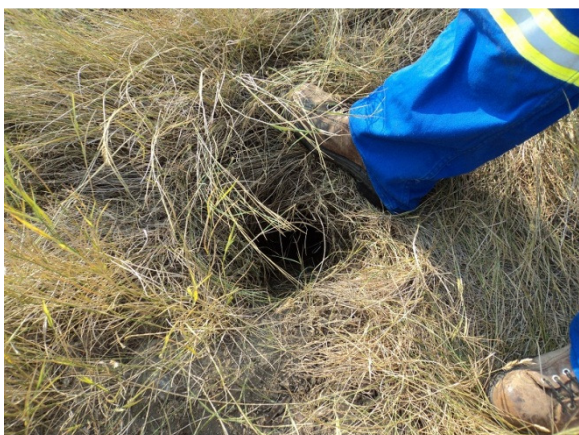
Evidence of borrowing animals in the downstream dam face.

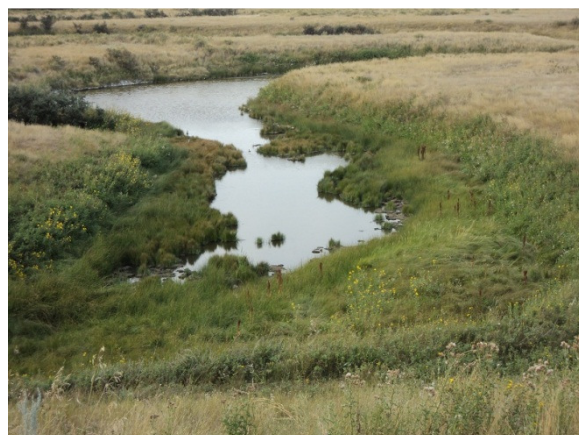
Standing water in oxbows abutting to the toe of the Highfield dam.

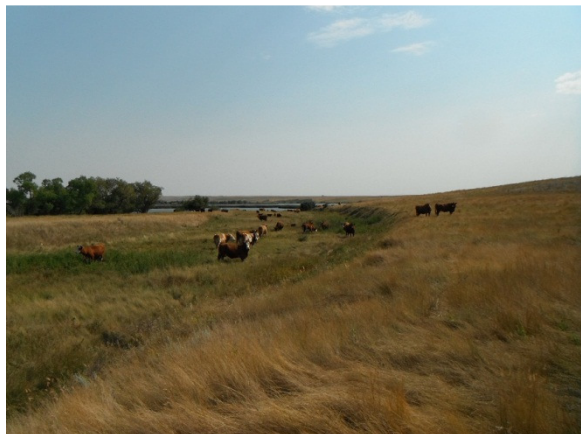
West Spillway looking toward the Highfield reservoir. Free roaming cattle.

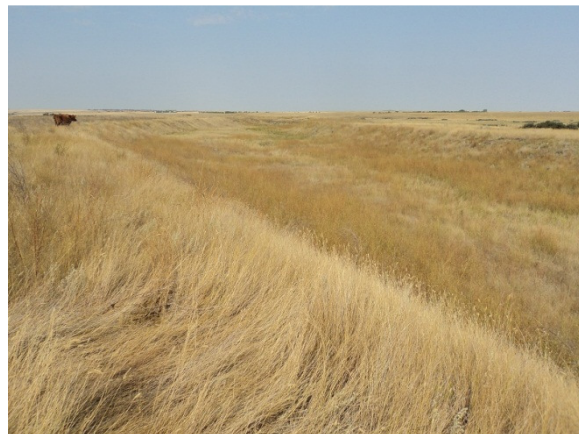
General view looking downstream along West Spillway noting vegetation cover and trapezoid shape.

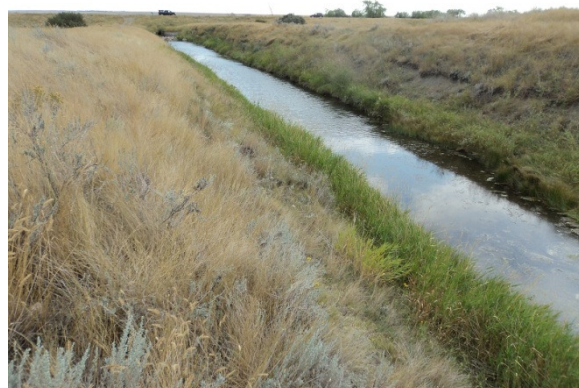
View looking back toward the West LLO from right embankment overbuild and confluence w/spillway.

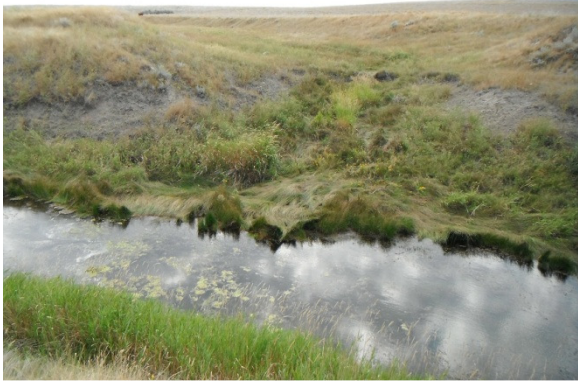
View looking west toward West Spillway confluence with the Herbert Canal. Note erosion and scour at point of entry.
