## APPENDIX B

**GEOTECHNICAL INVESTIGATION REPORT  
PROPOSED BRIDGE REPLACEMENT  
HASTINGS SWING BRIDGE  
TRENT – SEVERN CANAL  
TORONTO, ONTARIO**

Project: 1842-910  
October 1, 2014

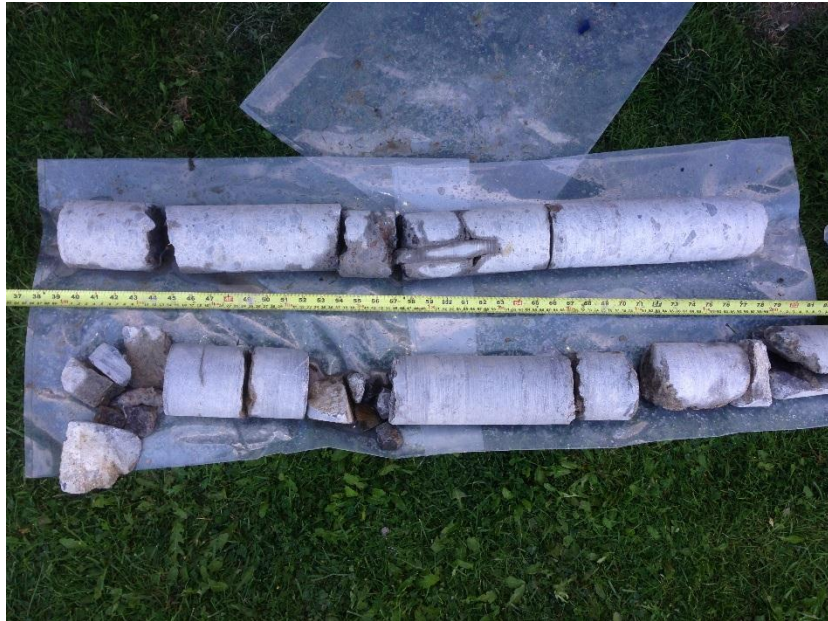
**Photograph 1: Corehole CH 13-1 Concrete Cores and partial Rock Cores**

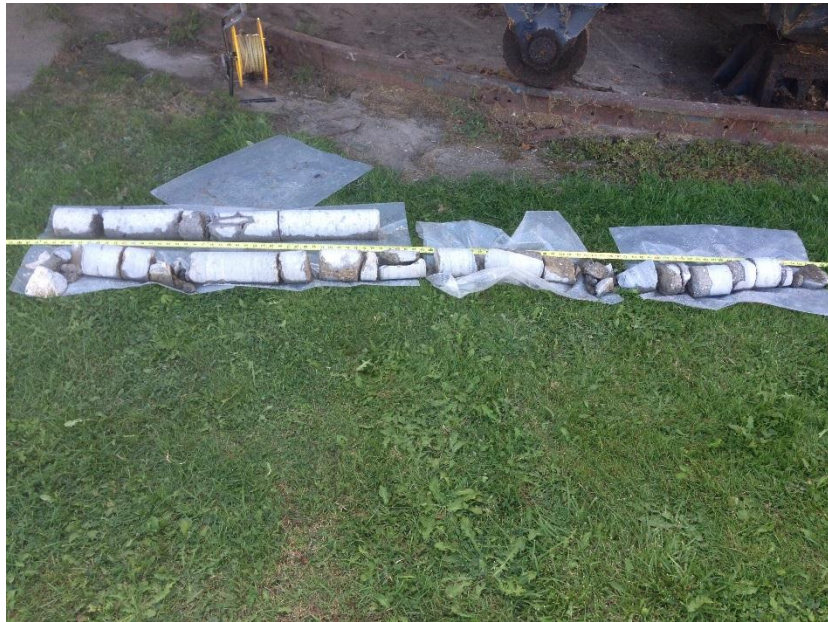
**Photograph 2: Corehole CH 13-1 Concrete Cores and full depth Rock Cores**

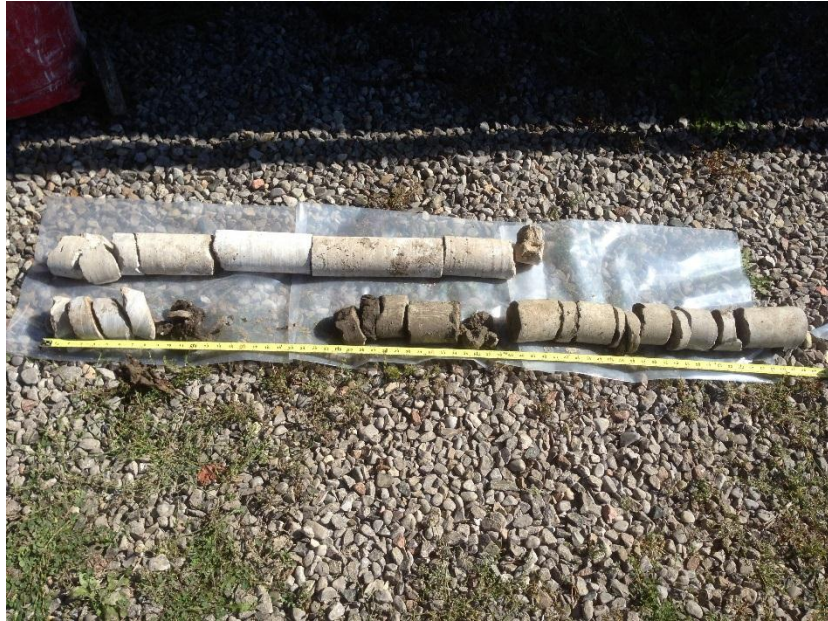
**Photograph 3: Corehole CH 13-2 Concrete Cores and full depth Rock Cores**

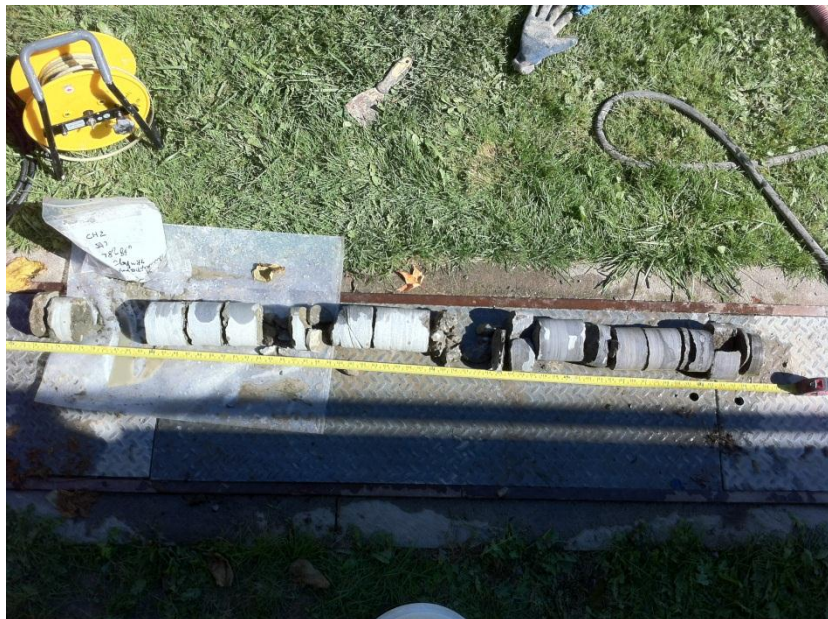
**Photograph 8: Corehole CH 13-4 Rock Cores**

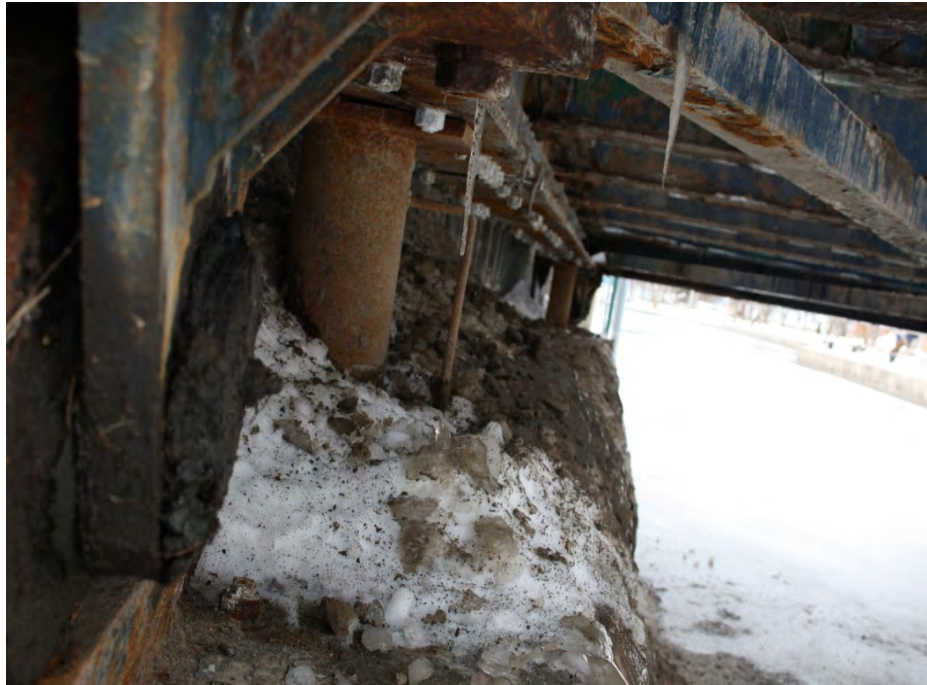
No.13: The south abutment underneath the bridge deck, looking west; note the snow, salt and sands or soils falling from the steel grate deck; note two steel posts used to support the bridge during the non-operational seasons.

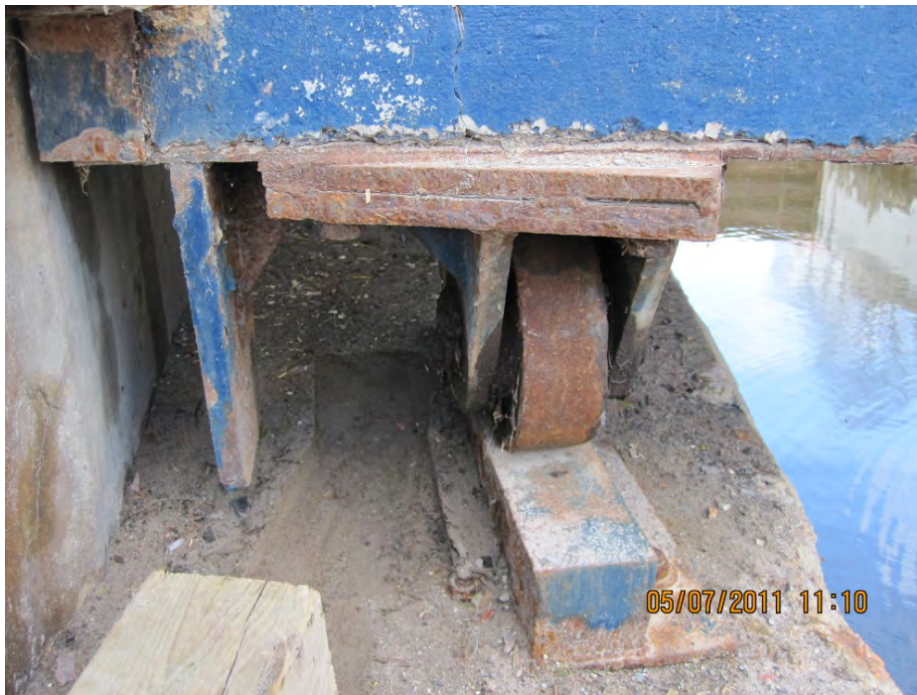
No.14: The south abutment, looking west; note the steel wheel sitting on top of the steel plate to support the bridge during the operational seasons.

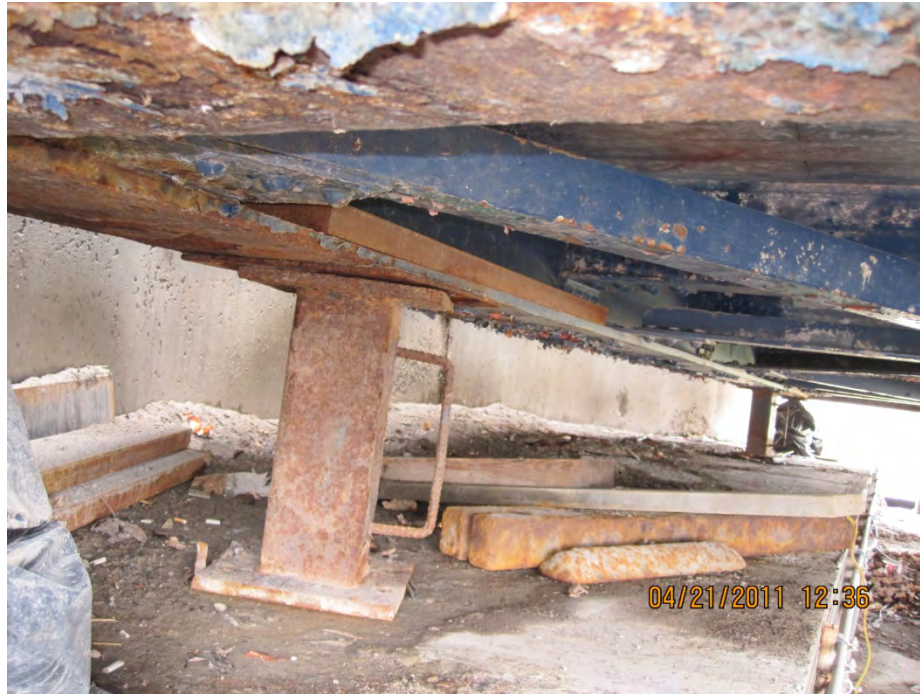
No.15: The north abutment underneath the bridge deck, looking east; note two steel posts used to support the bridge during the non-operational seasons.

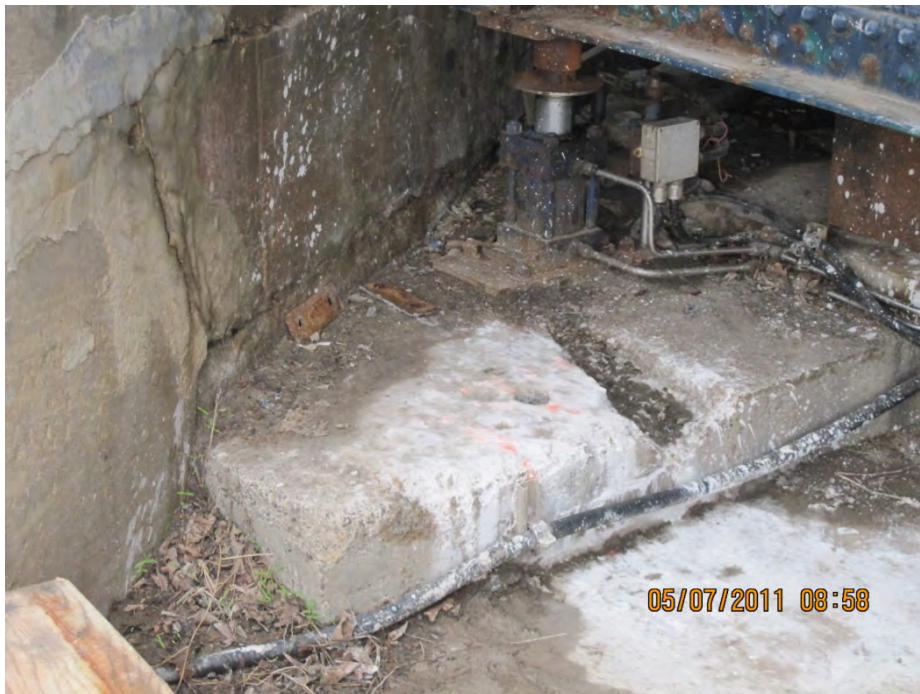
No. 16: The north abutment west side of the bridge, looking northeast; note the support hydraulic jack used to support the bridge during the operational seasons.

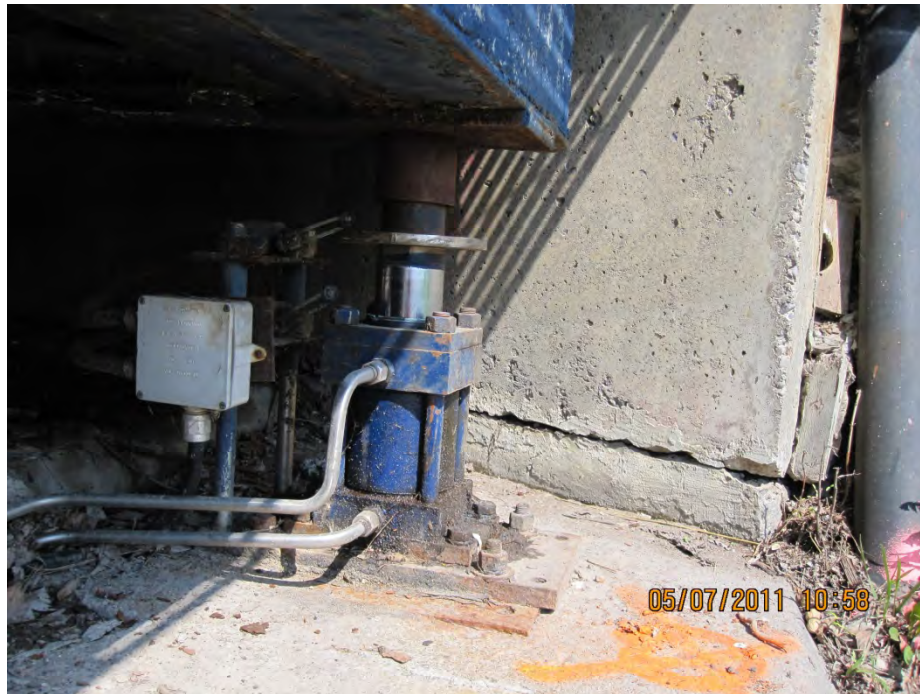
No.17: The north abutment east side of the bridge, looking northwest; note the support hydraulic jack used to support the bridge during the operational

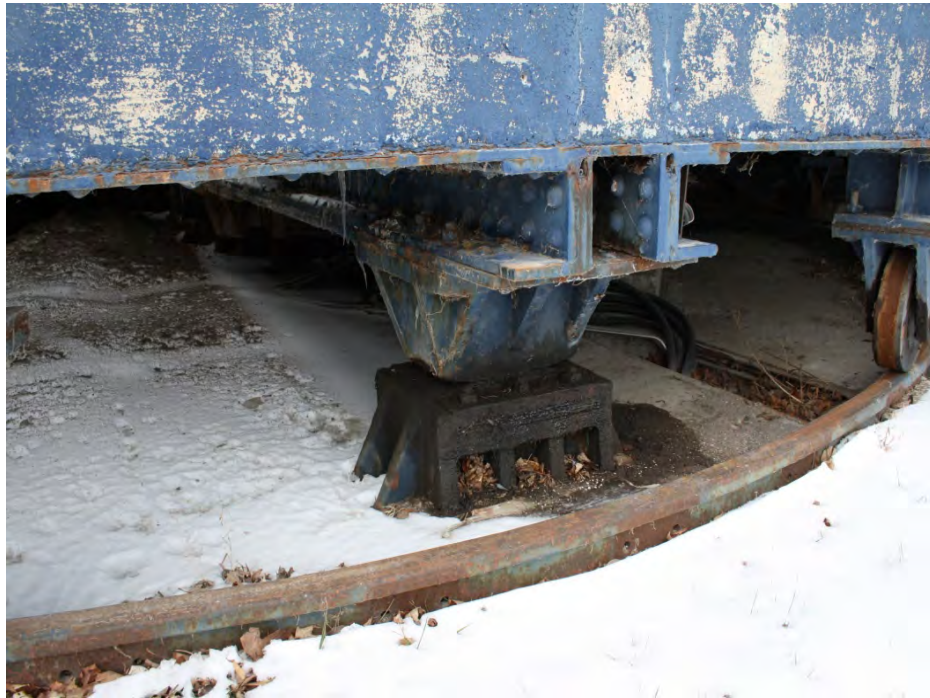
No.19: The central concrete pier; note the circular steel track on top of the concrete pier, the balance wheel on the track and steel pillow block rest to support the transverse beam of the swing bridge.

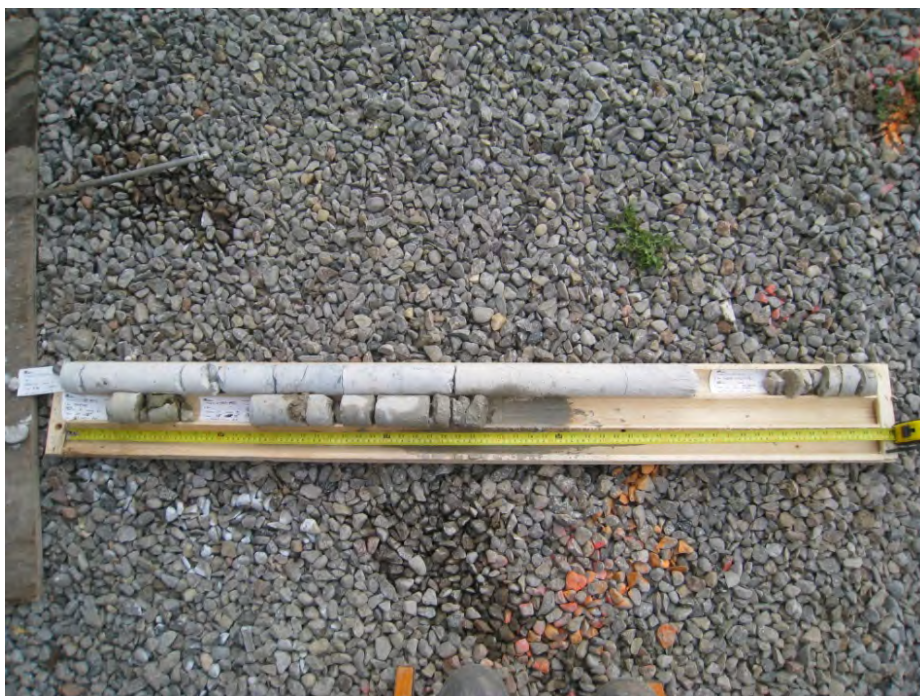
No.30: Photograph of the Corehole 2 cores.

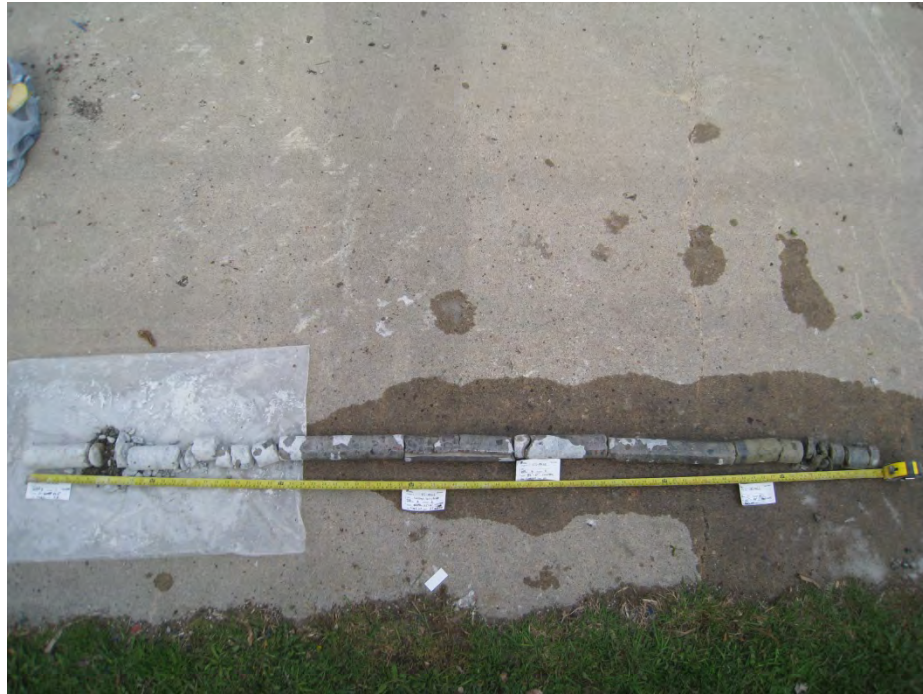
No.31: Photograph of the Corehole 3 cores.

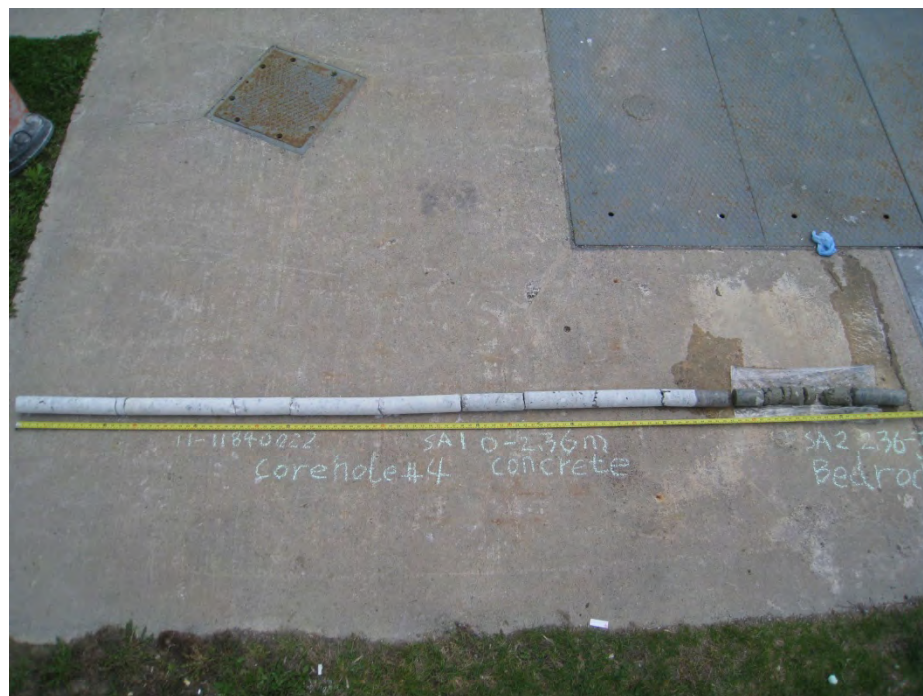
No.32: Photograph of the Corehole 4 cores.

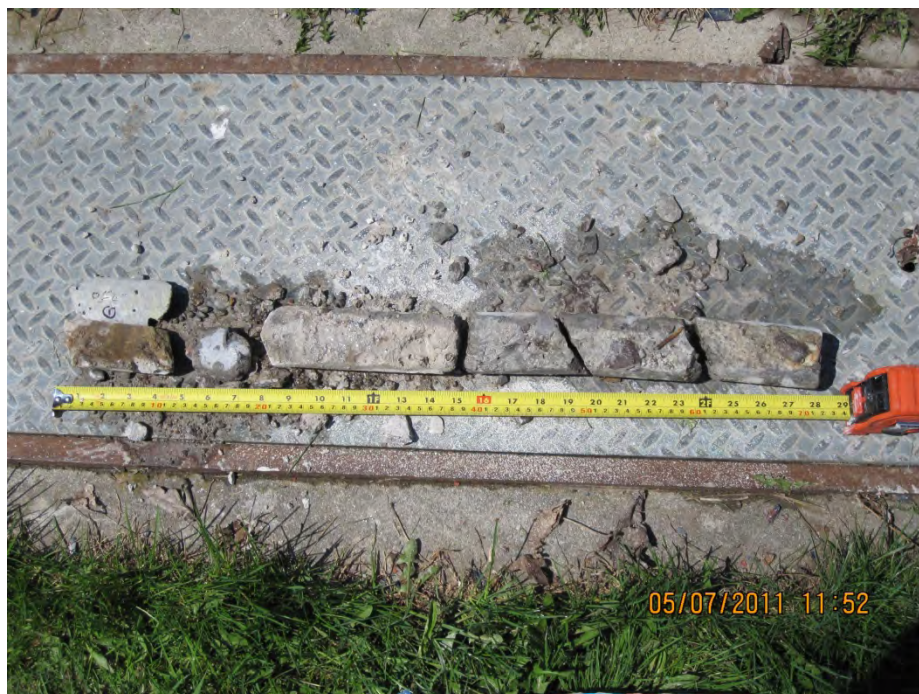
No.33: Photograph of the Corehole 5 cores.

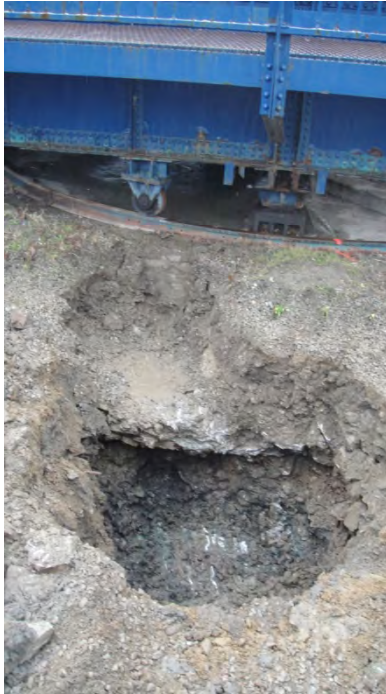
No.35: Photograph of the Test Pit 1.

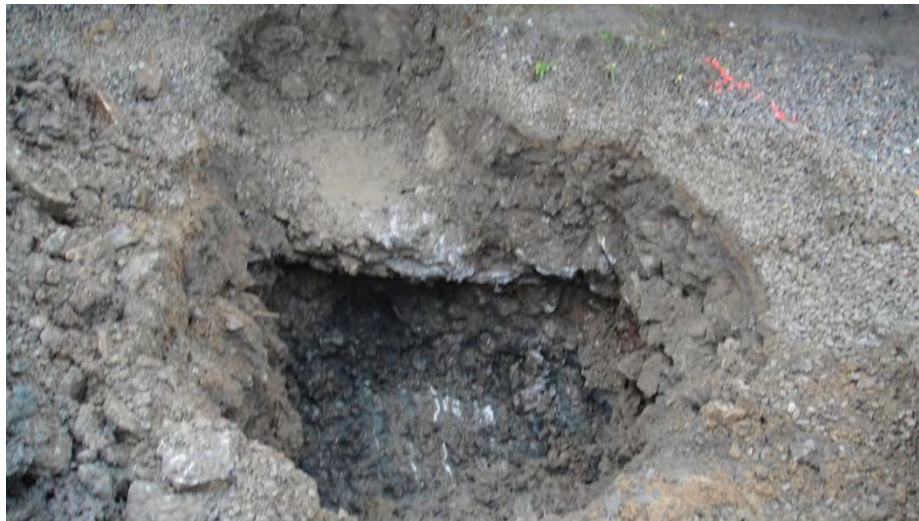
No.36: Photograph of the Test Pit 1. The limestone bedrock exposed at the bottom of the test pit.
