Pachena Light Tower Photos - WSP Inspection Trip Aug 2014

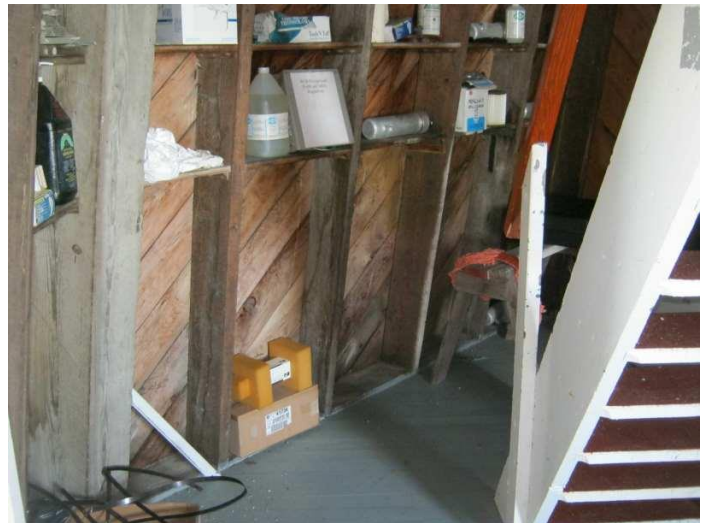
#34 - Main Floor Typical Wall Framing

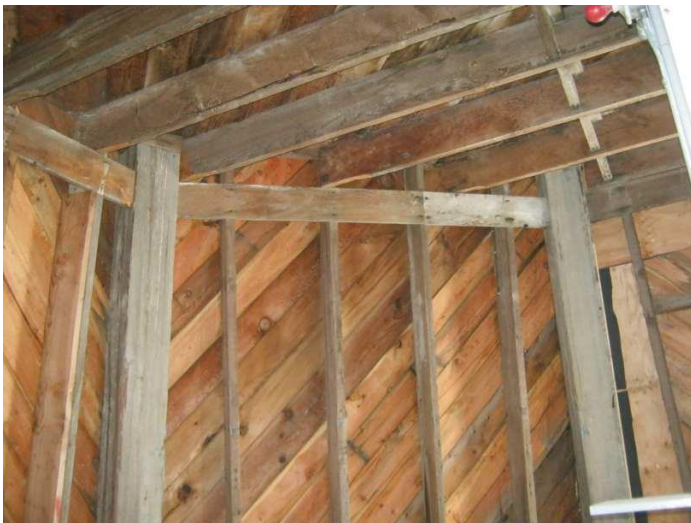
#35 - Main Floor Typical Wall Framing

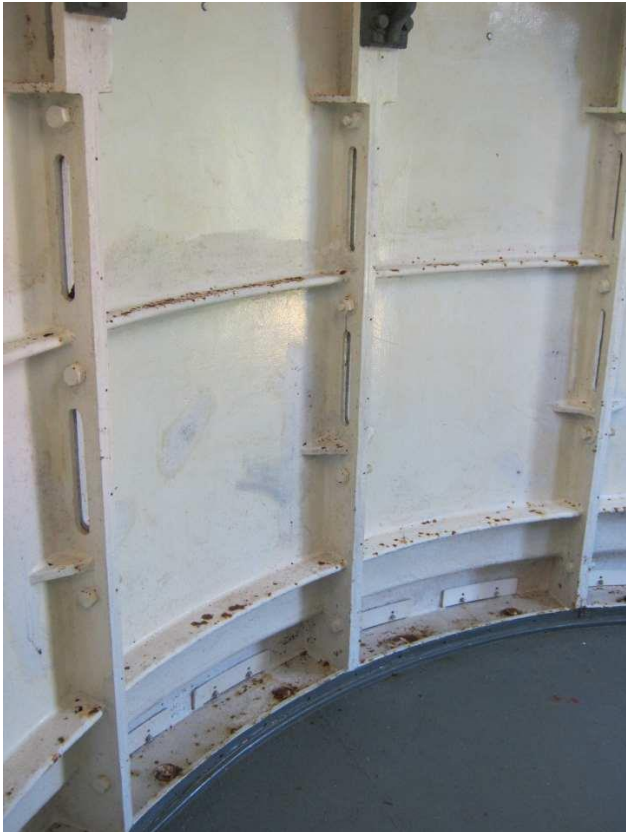
#57 - Lantern Room Interior Wall Assembly

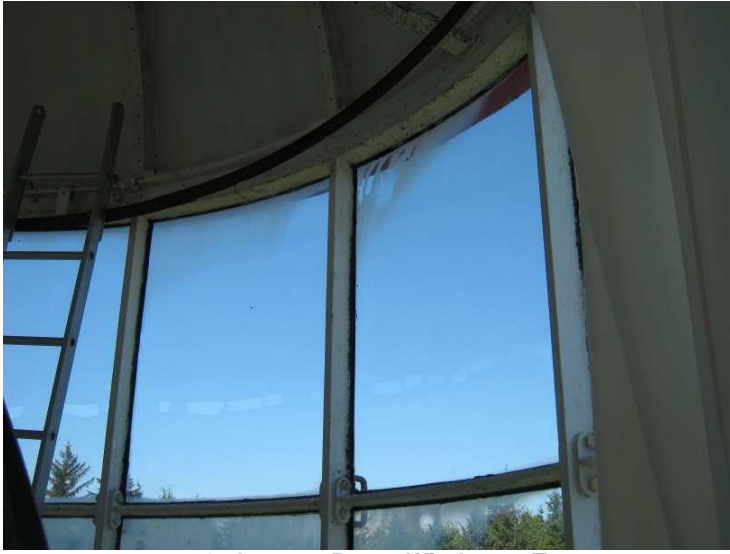
#61 - Lantern Room Window at Top

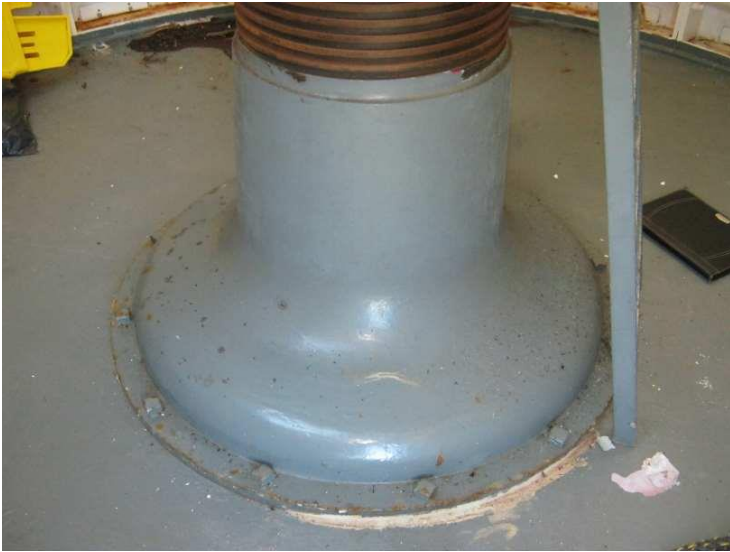
#67 - Lens Pedestal Base

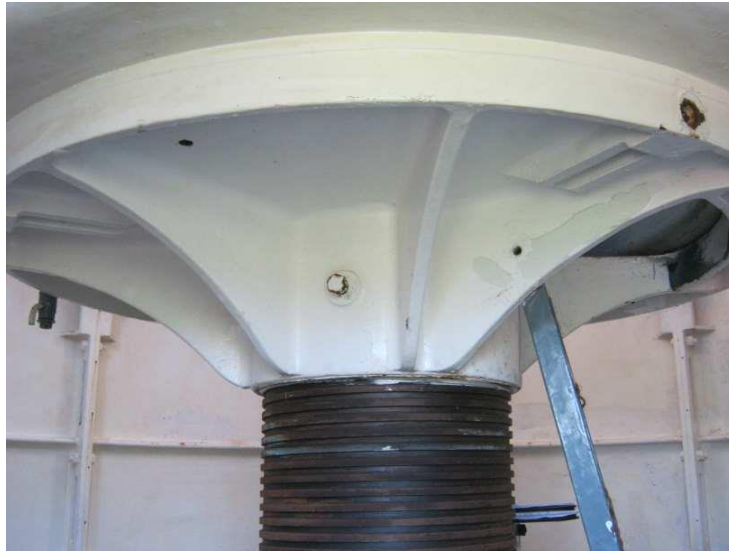
#68 - Lens Pedestal

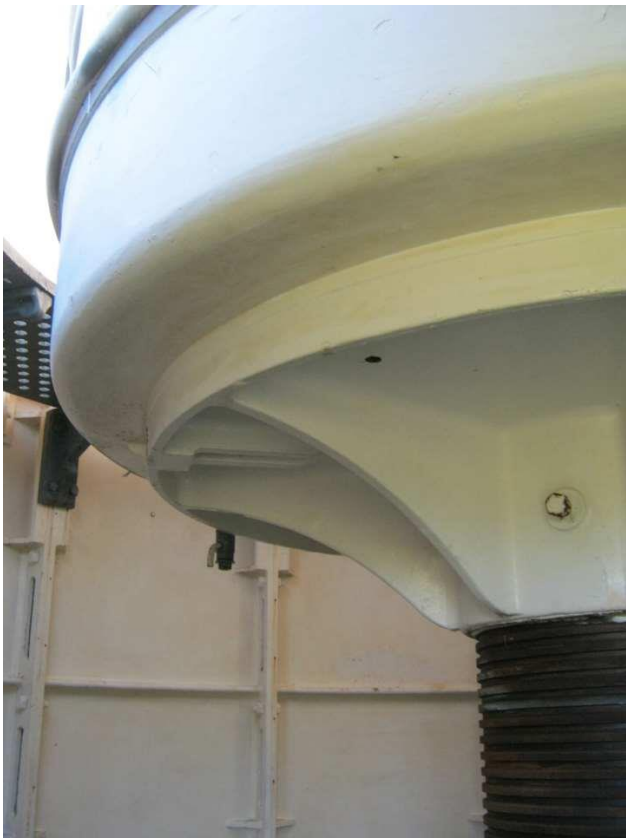
#69 - Lens Pedestal

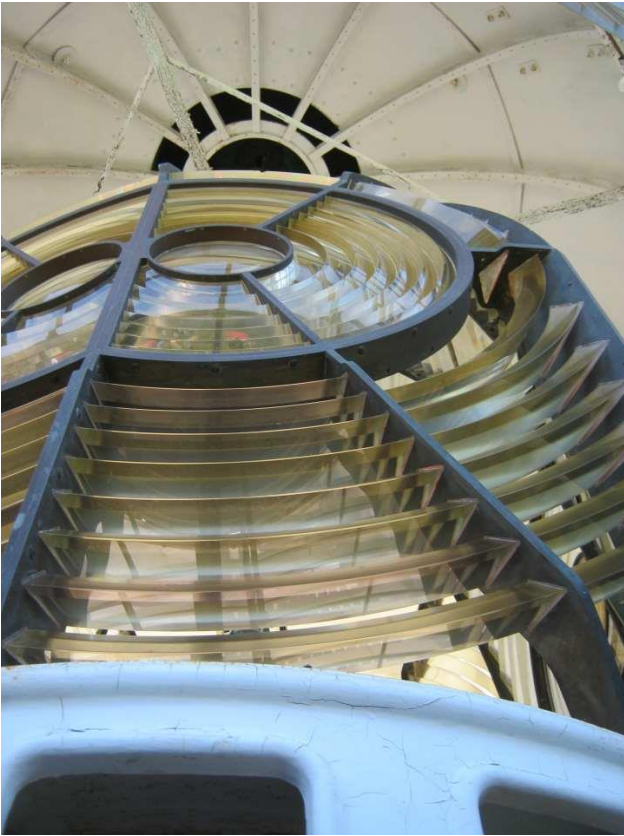
#71 - Fresnel Lens Exterior

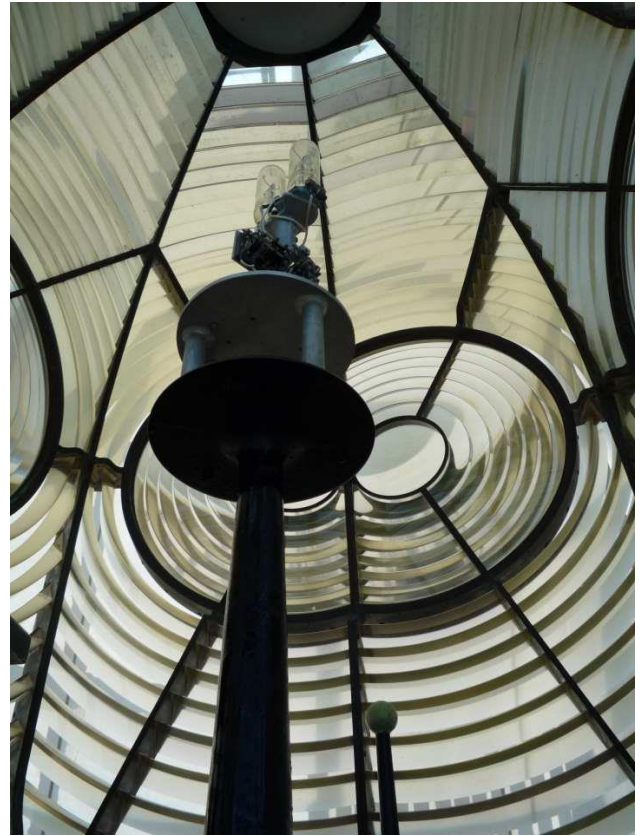
#72 - Fresnel Lens Interior
