Prepared for:
National Research Council Canada

Hazardous Materials Survey

**1916 Wing Building
Victoria, BC
NWEG Project 20120**

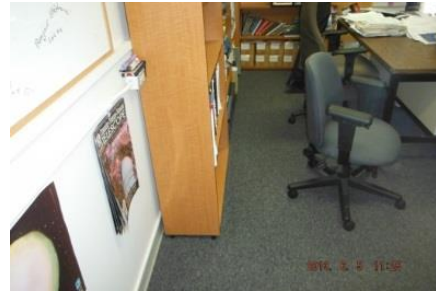
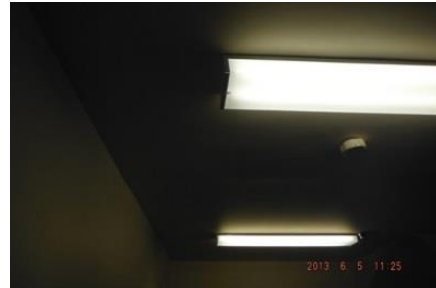
Building: Floor 4, Room 403

- **PCB:**
Fluorescent light ballasts may contain PCBs, prior to modification, check ballast to determine if PCBs are present.
- **Mercury containing:** Fluorescent light tubes contain mercury.

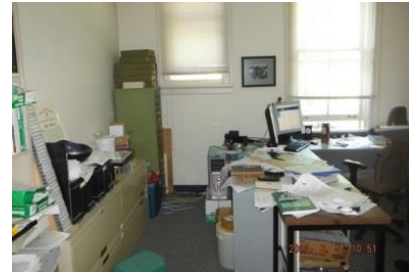
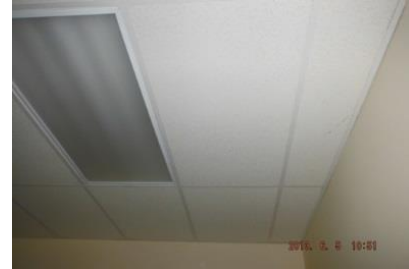
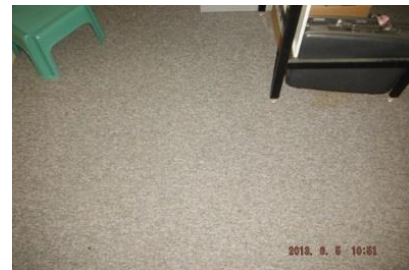
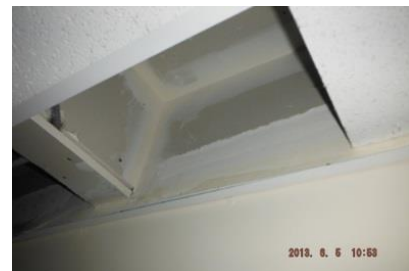
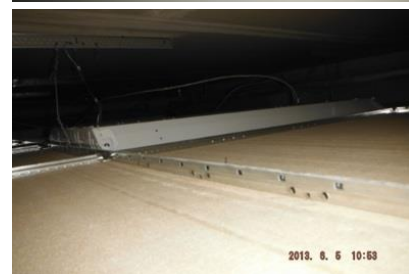
Building: Floor 3, Room 303

- **PCB:**
Fluorescent light ballasts may contain PCBs, prior to modification, check ballast to determine if PCBs are present.
- **Mercury containing:** Fluorescent light tubes contain mercury.

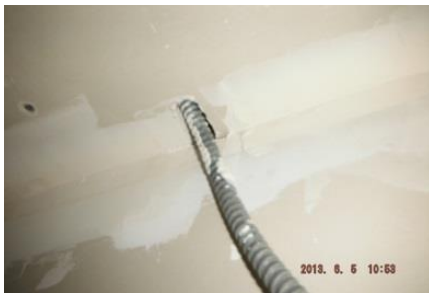
20120-17 Drywall with Joint Compound Above Ceiling

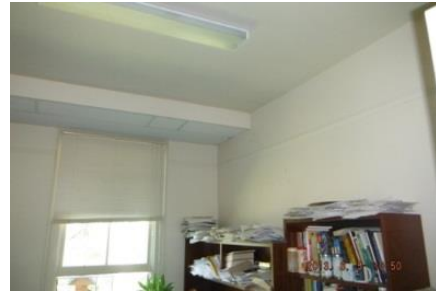
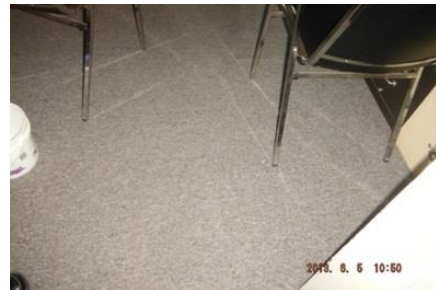
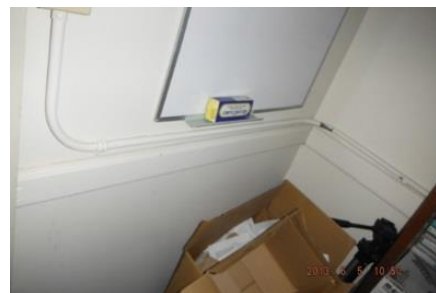
- **PCB:**
Fluorescent light ballasts may contain PCBs, prior to modification, check ballast to determine if PCBs are present.
- **Mercury containing:** Fluorescent light tubes contain mercury.

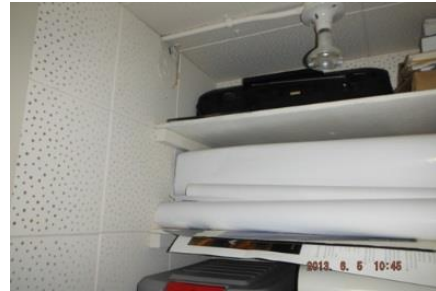
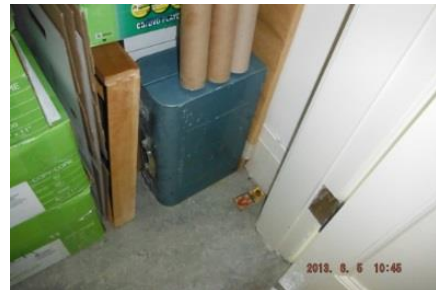
20120-16 Donna Conna Tile 2(no asbestos detected)

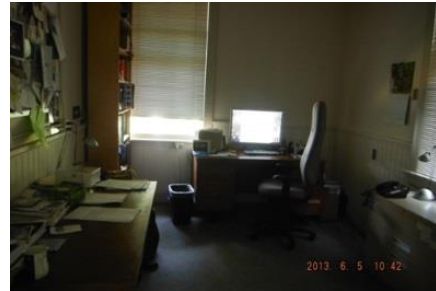
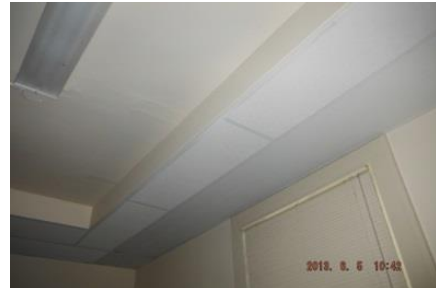
- **PCB:**
Fluorescent light ballasts may contain PCBs, prior to modification, check ballast to determine if PCBs are present.
- **Mercury containing:** Fluorescent light tubes contain mercury.

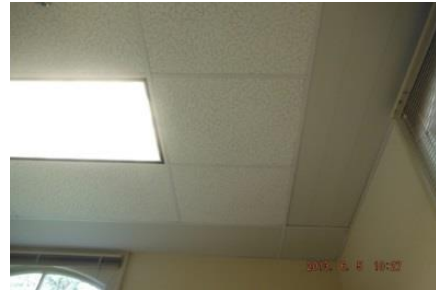
Fibreglass pipe insulation

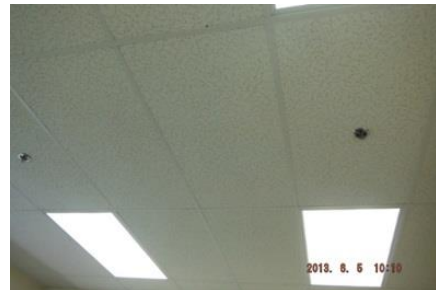
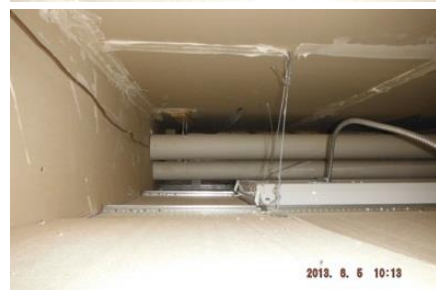
Fibreglass pipe insulation above ceiling

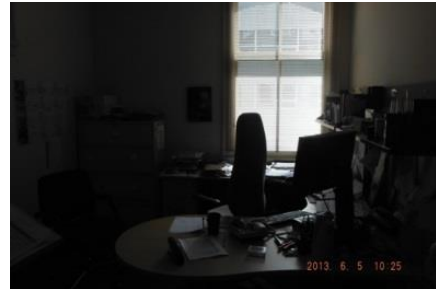
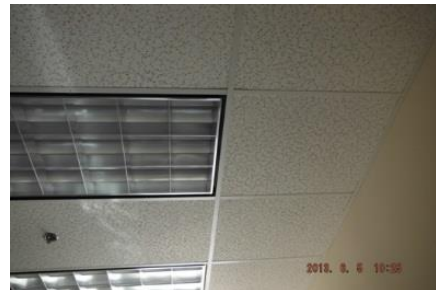
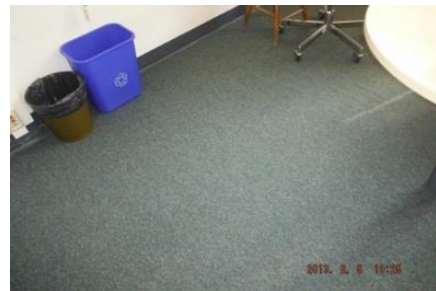
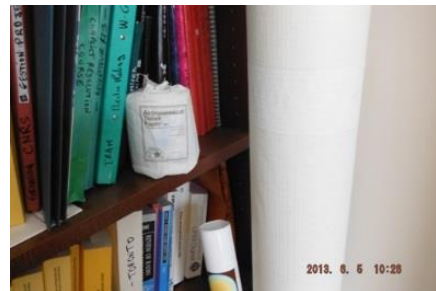
Fibreglass pipe insulation

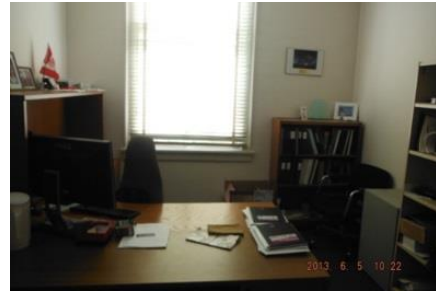
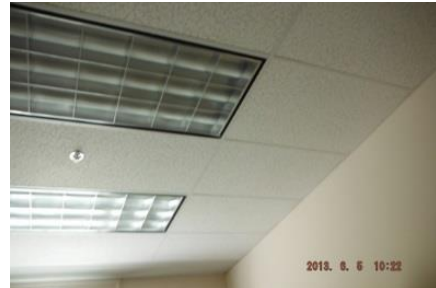
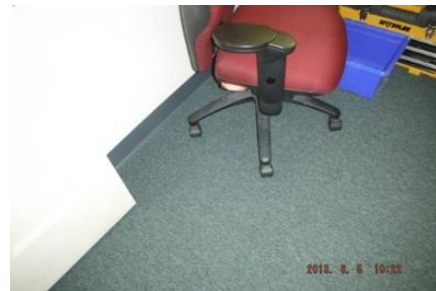
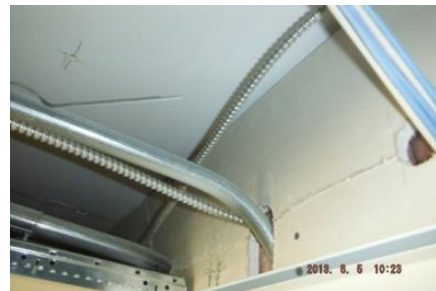
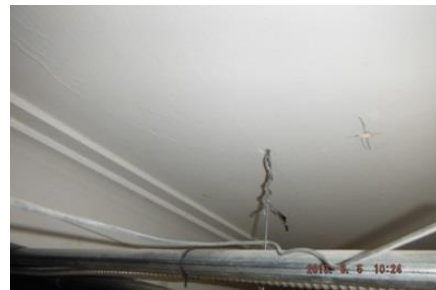
- **PCB:**
Fluorescent light ballasts may contain PCBs, prior to modification, check ballast to determine if PCBs are present.
- **Mercury containing:** Fluorescent light tubes contain mercury.

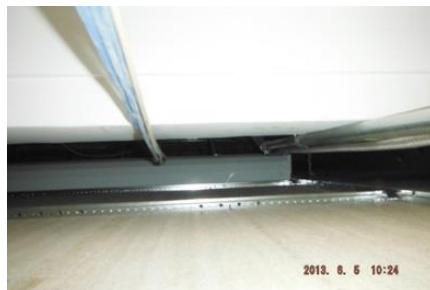
Fibreglass Insulation (wall cavity)

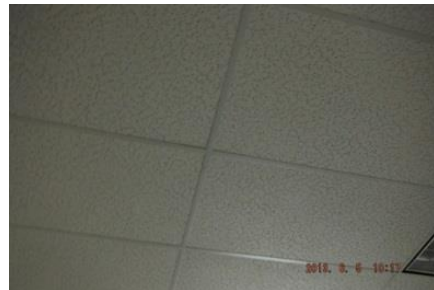
Fibreglass pipe insulation

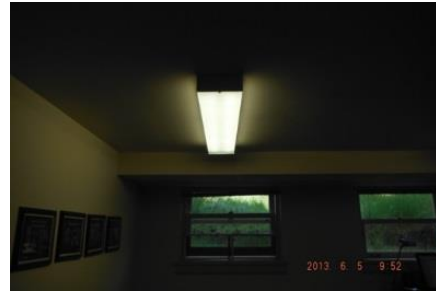
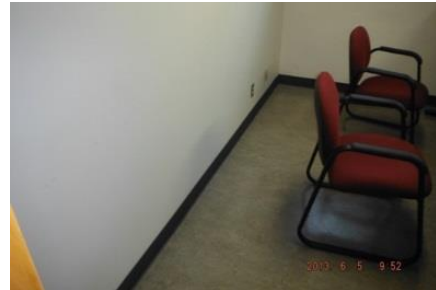
- **PCB:**
Fluorescent light ballasts may contain PCBs, prior to modification, check ballast to determine if PCBs are present.
- **Mercury containing:** Fluorescent light tubes contain mercury.

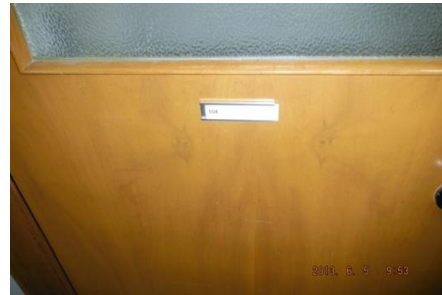
20120-09 Ceiling Texture Coat 1 (no asbestos detected)

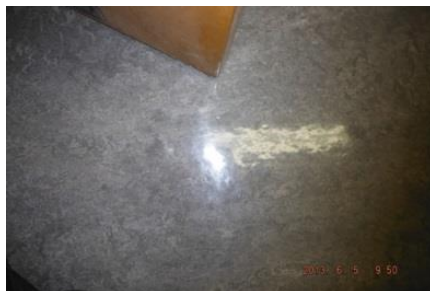
- 20120-07 Layer 1, Plaster, Skim Coat (no asbestos detected)
- 20120-07 Layer 2, Plaster, Base Coat (no asbestos detected)
- 20120-08 Sheet Flooring (no asbestos detected)

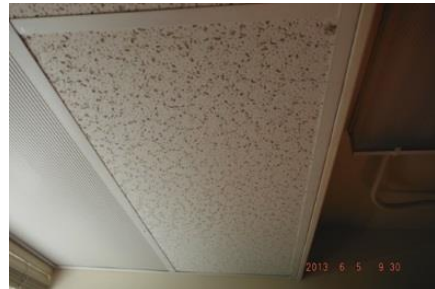
- 20120-04 Drywall Joint Compound (no asbestos detected)
20120-05 Acoustic Ceiling Tile (no asbestos detected)

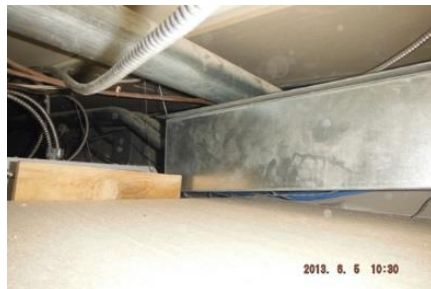
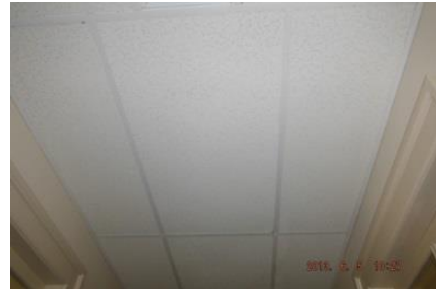
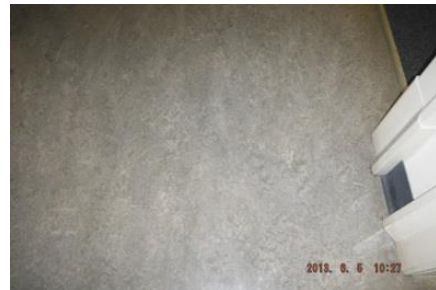
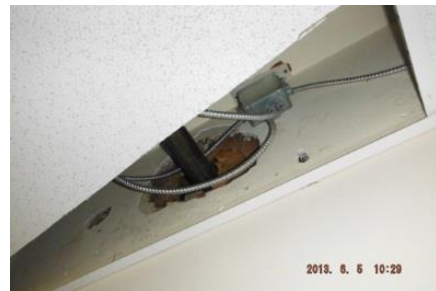
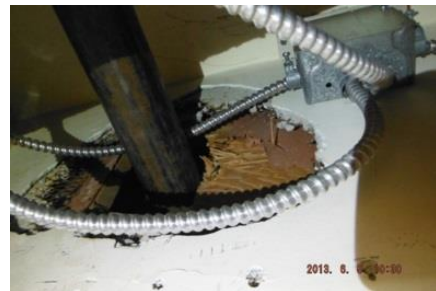
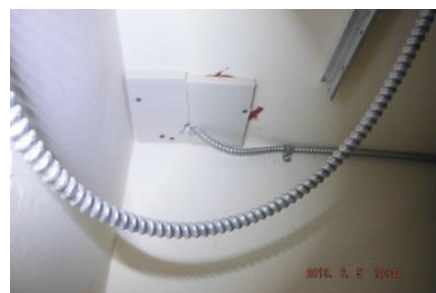
20120-26

Wood behind plaster
