Hamlet Bridge (Bridge 57) Comprehensive Detailed Inspection and Structure Evaluation Report (PCA Project No. 2011-4650-20027340)

Comprehensive Detailed Inspection and Structure Evaluation Report

Parks Canada Project No. 2011-4650-20027340

Delcan Corporation

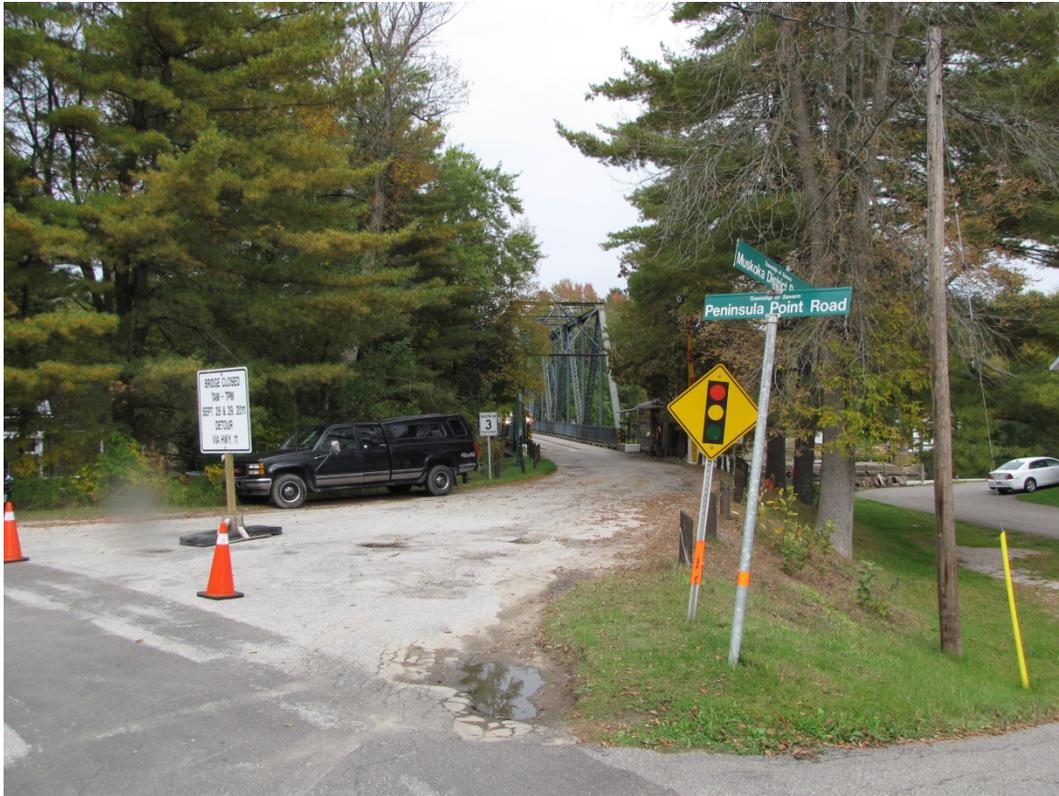
Photo S5: West approach. Note leaning traffic light and road signs.

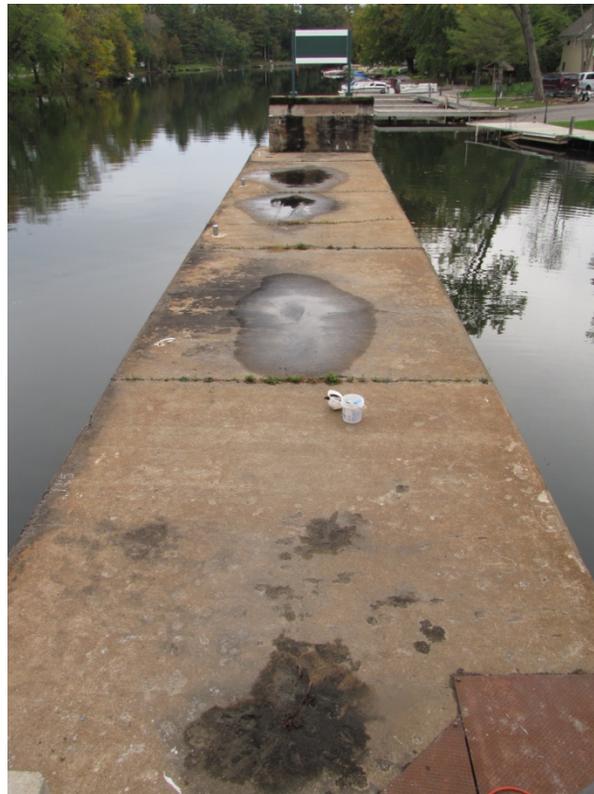
Photo S10: Top of the south section of the rest pier. Note the areas of ponding water.

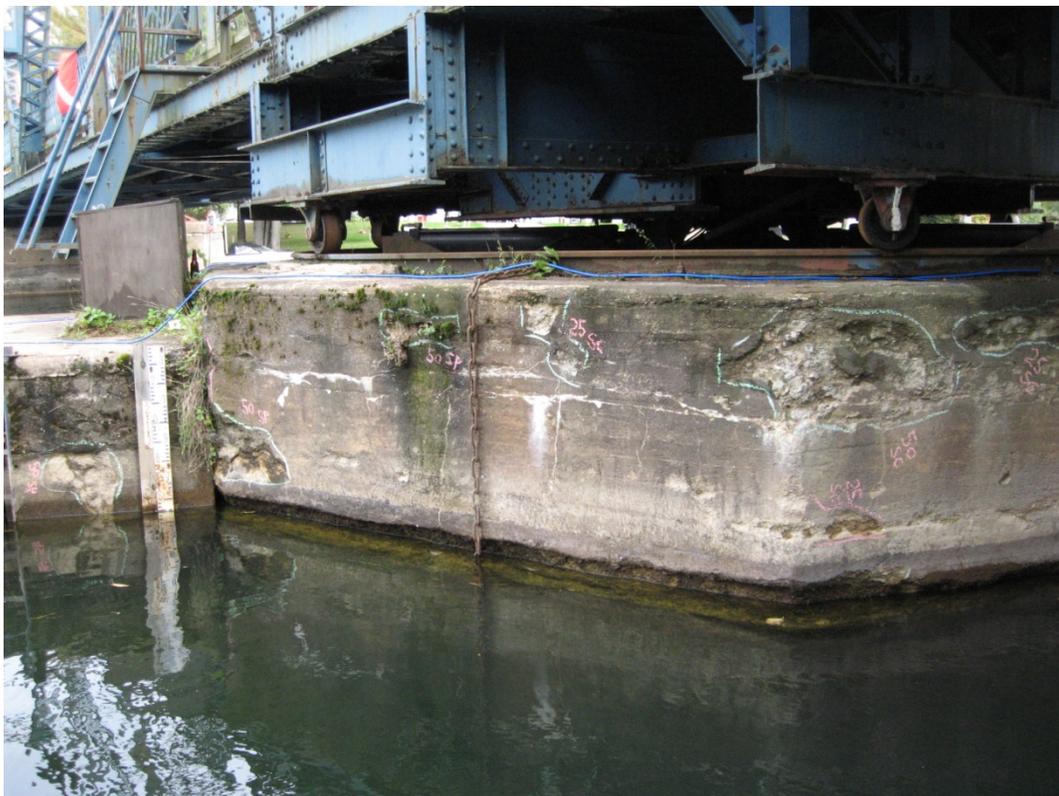
Photo S18: North-west corner of the central swing pier. Very severe erosion of the walls at the waterline, and several large areas of disintegration.

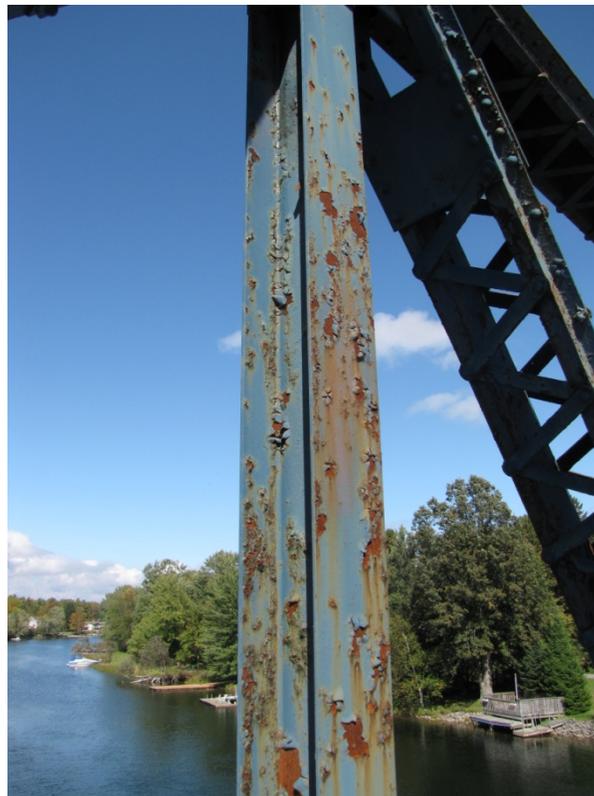
Photo S22: V6N – typical condition of vertical truss members with extensive areas of coating failure and light corrosion.

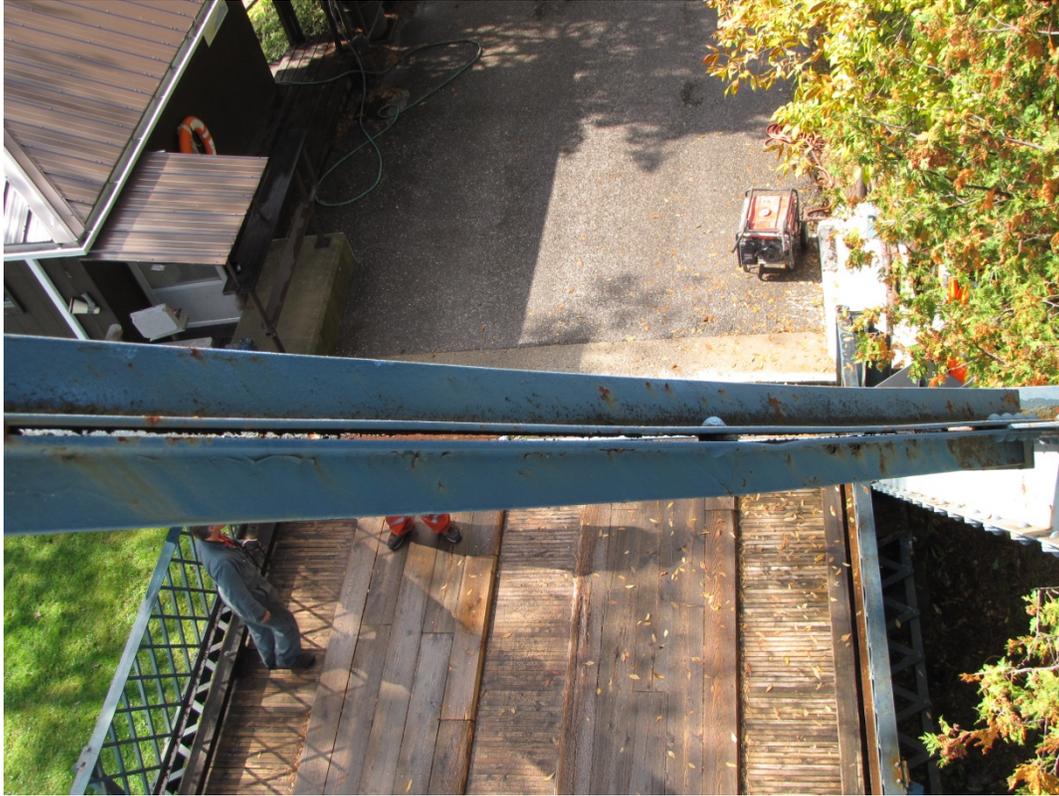
Photo S25: The north diagonal member in the west portal frame is bent.

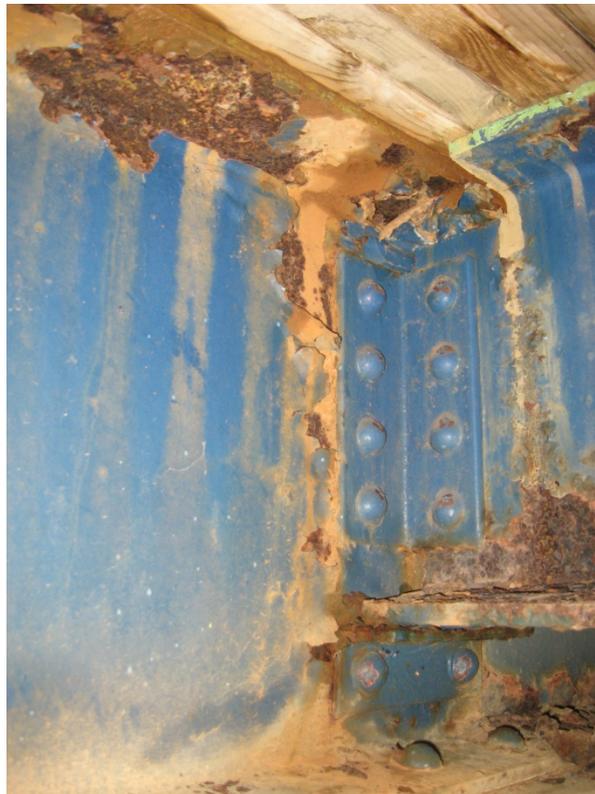
Photo S28: Typical light to medium corrosion of floor beams and stringers at floor system connections.

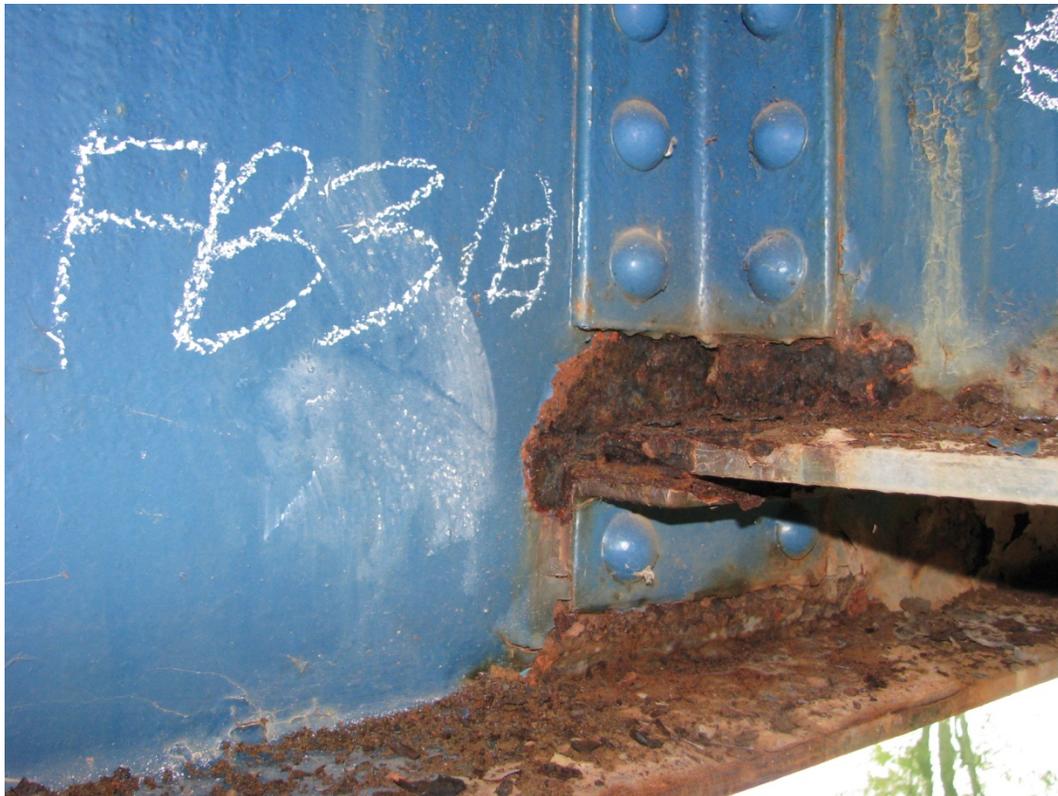
Photo S30: The east side of the web of FB3 has severe localized section loss at the connection with stringer S3-2.

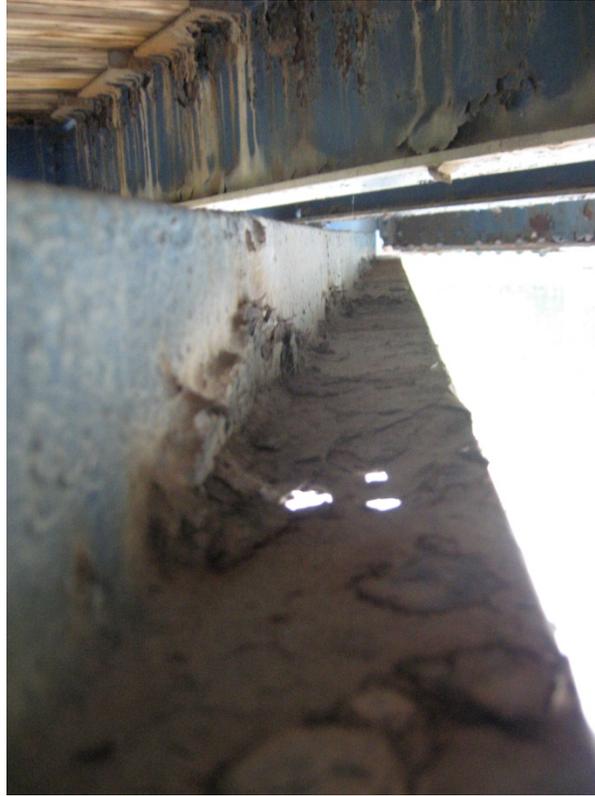
Photo S31: The south-east section of bracing member 6N-7S has severe pitting and three small perforations.

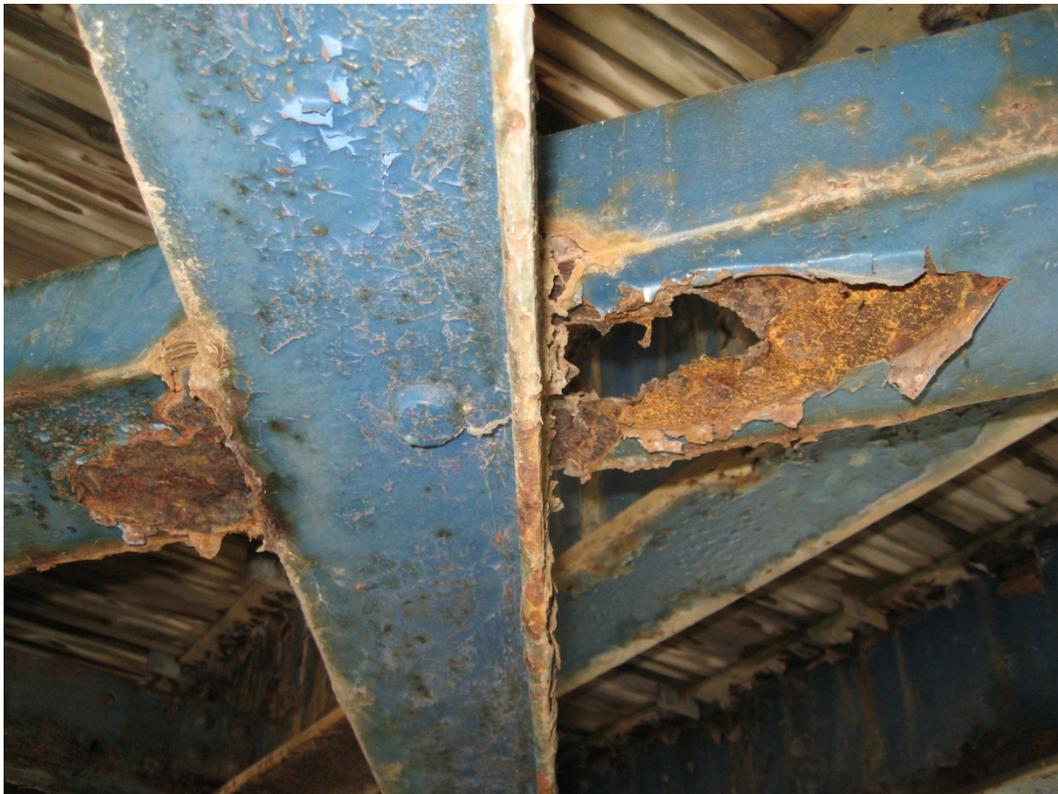
Photo S32: Bracing member 5S-6N has a long perforation in the horizontal leg.

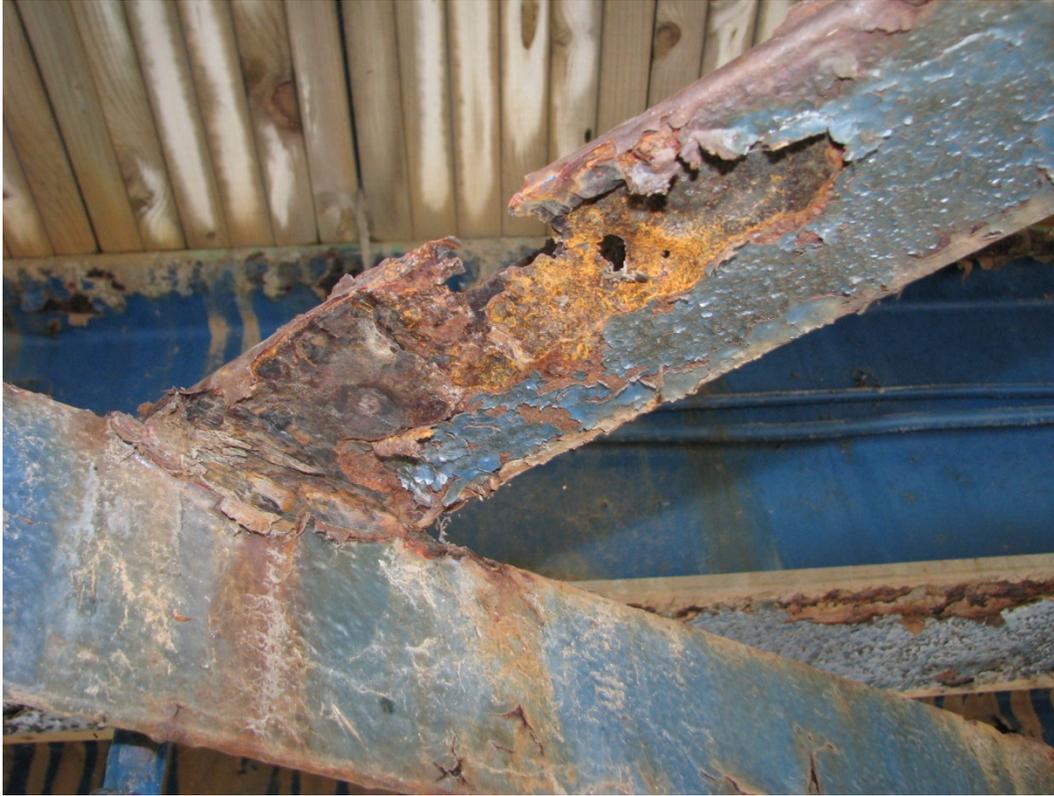
Photo S33: Very severe section loss and 75 mm x 50 mm perforation in bracing member 2N-3S.

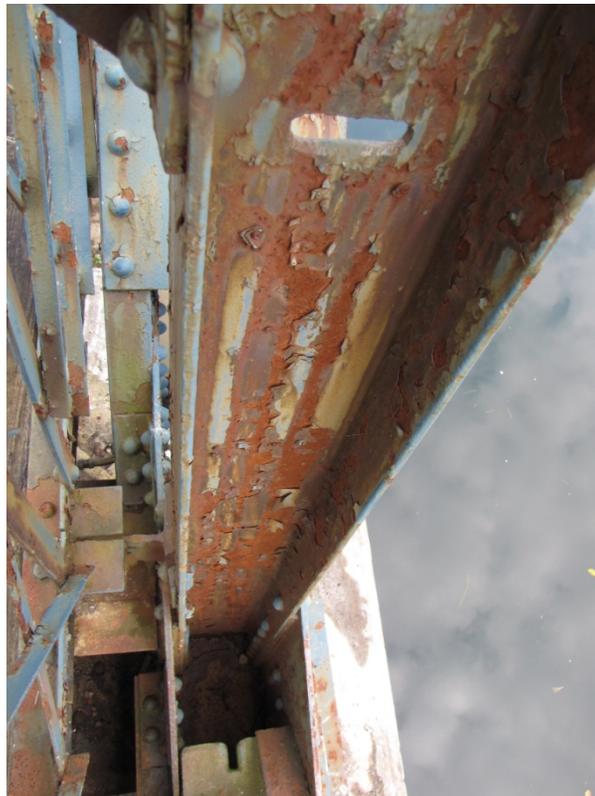
Photo S36: West side of V5S with extensive coating loss.

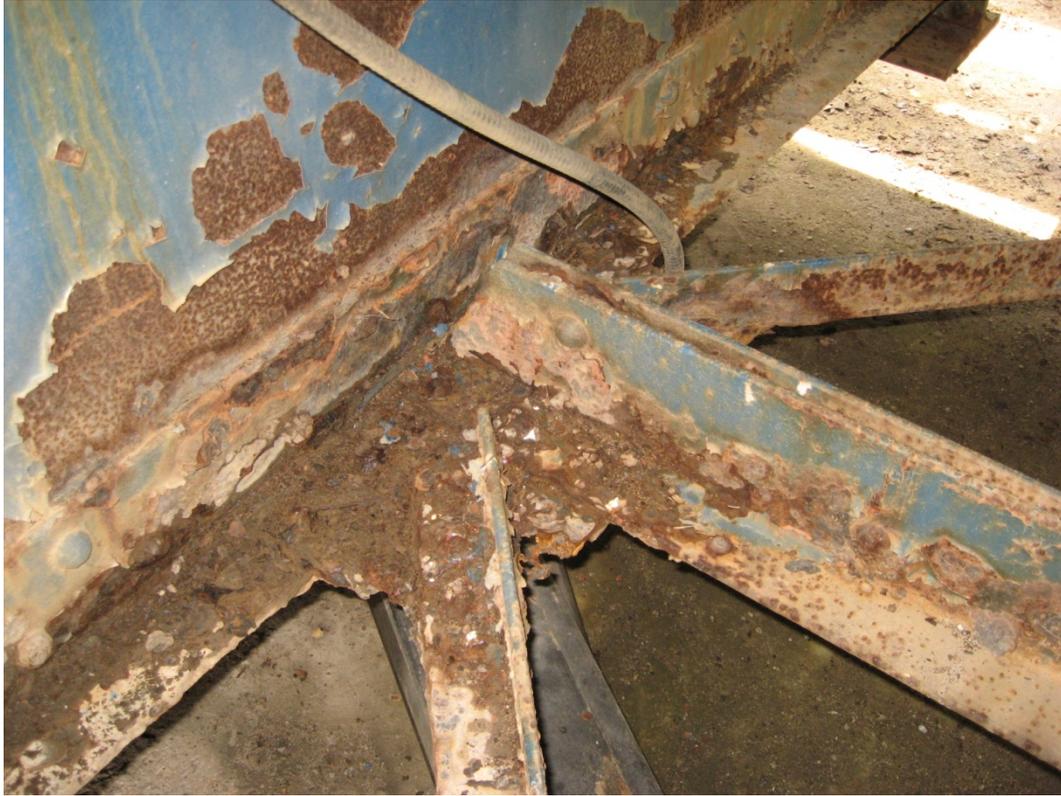
Photo S37: The steel members in the central pivot area typically have severe section loss, including perforations in gusset plates.

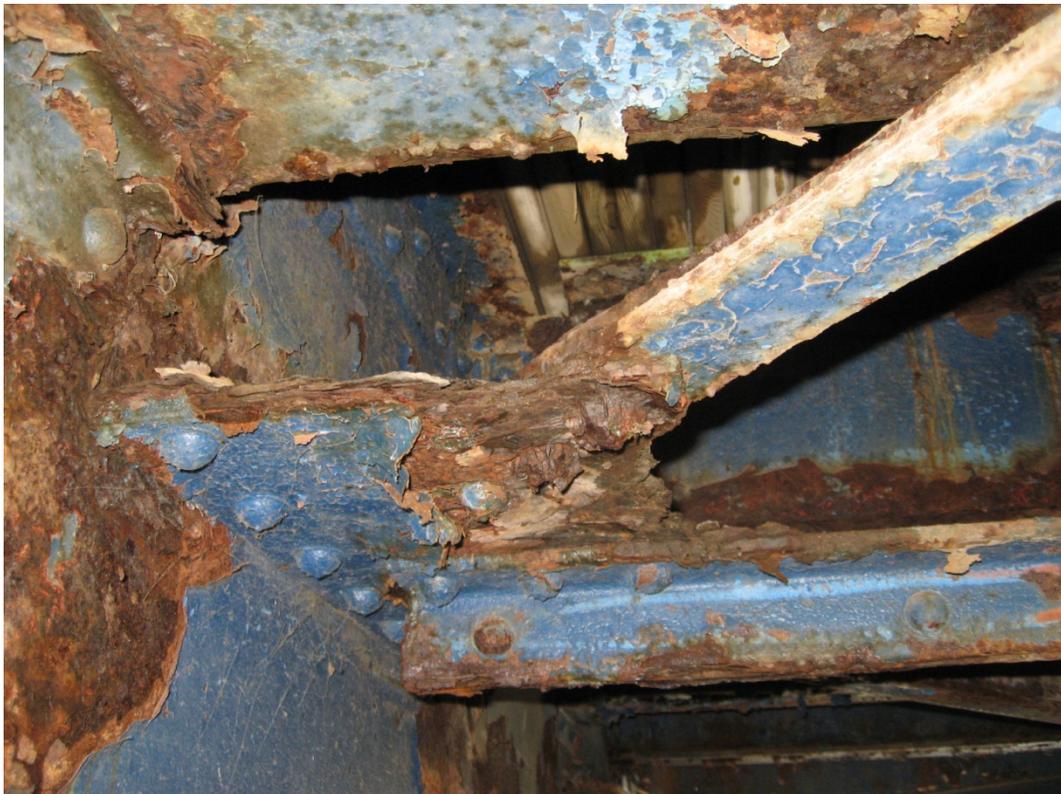
Photo S38: The steel members in the central pivot area typically have severe section loss, including perforations in gusset plates.

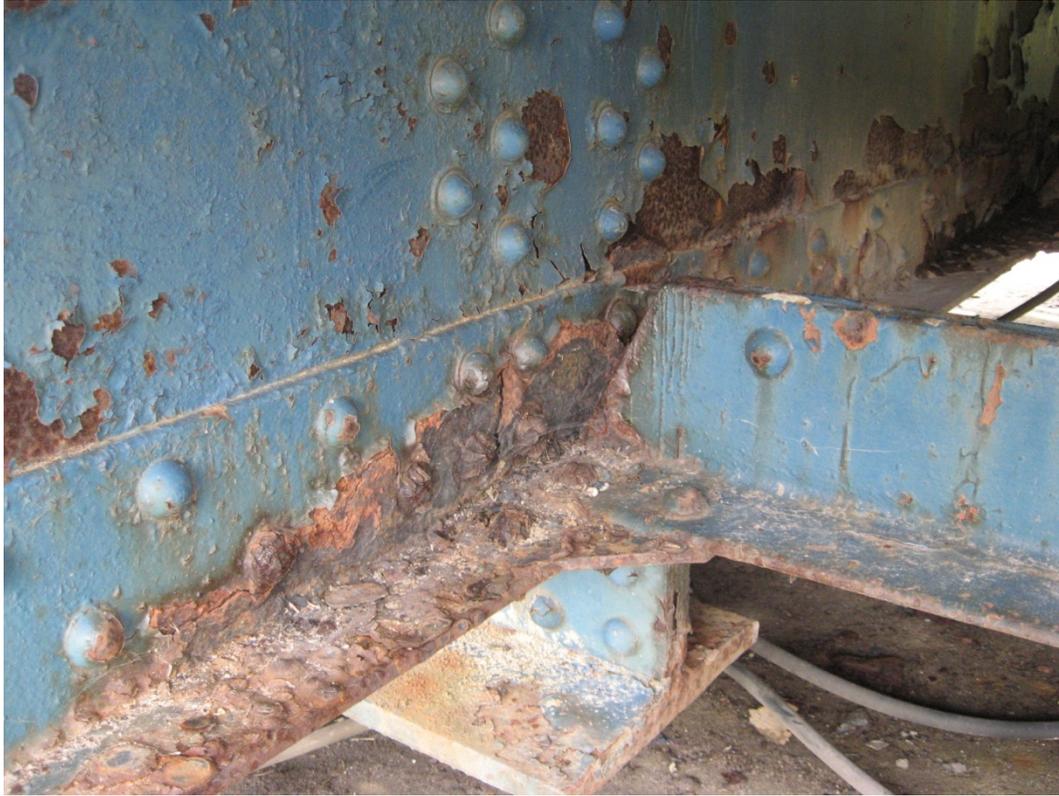
Photo S39: Typical severe section loss of pivot girder bottom flange.

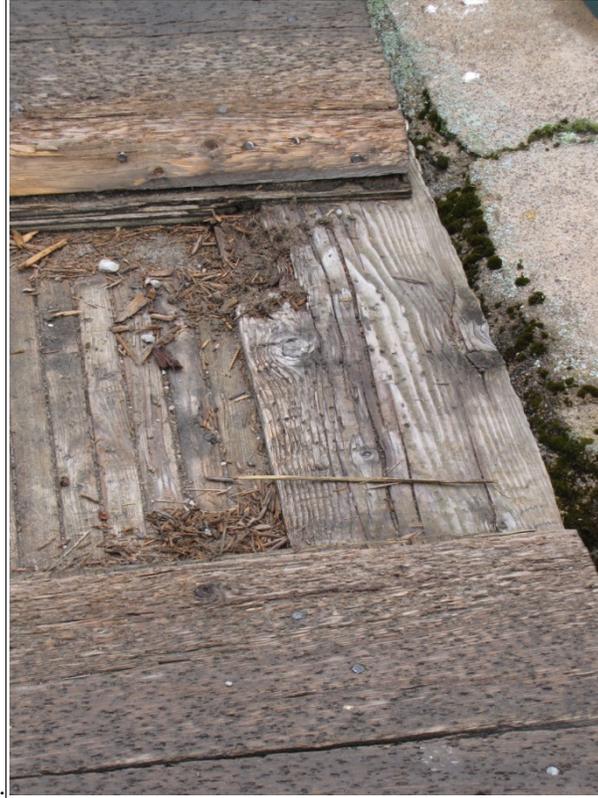
Photo S41: East end of central exposed section of deck. The end deck member is rotten and splitting. The plywood shims beneath the wearing surface members are also rotten.

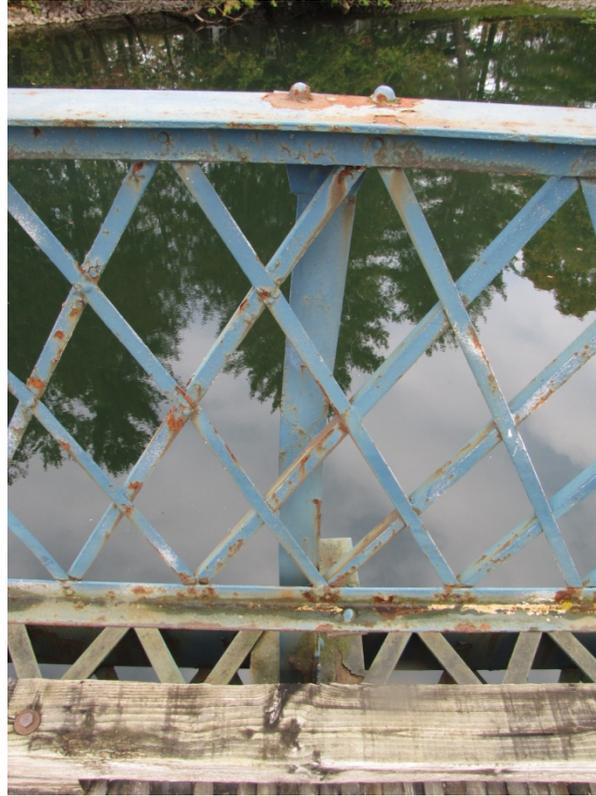
Photo S47: The north railing post between FB3 and FB4 is bent.

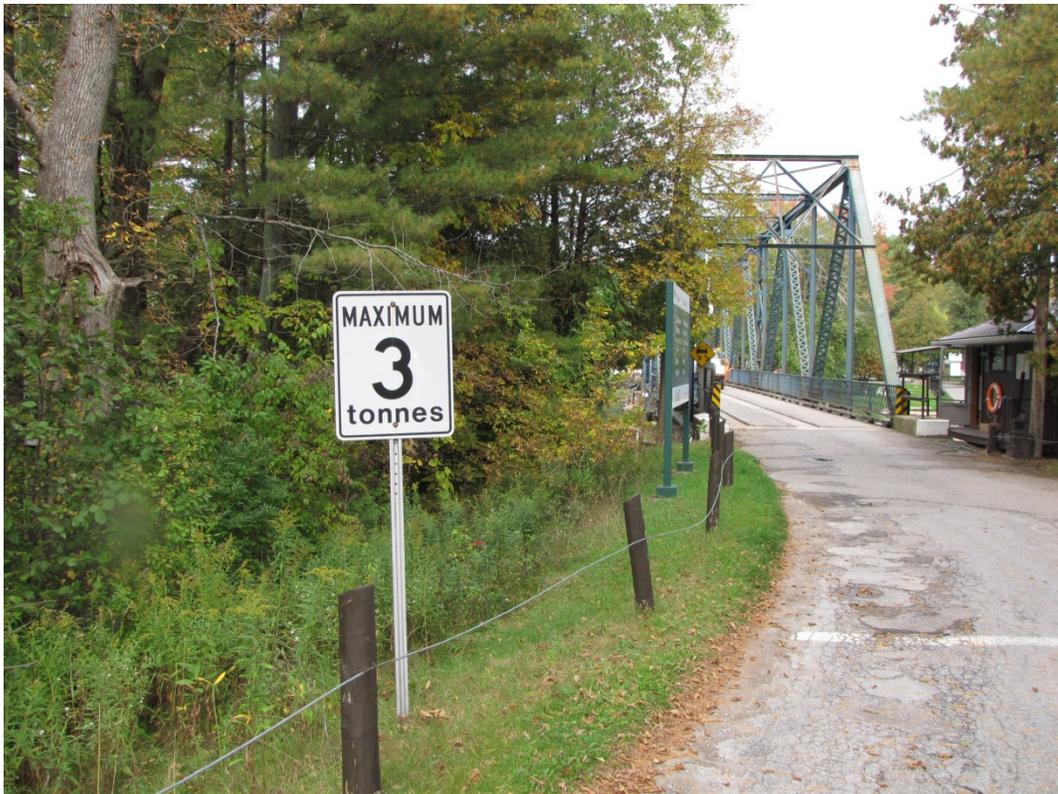
Photo S48: The steel cable in the north-west approach guide rail has tension loss.

Recommended short-term remedial work (within two years) on the span includes: Replacement of the steel cable guide rails in the west approach with MTO-approved guiderail; Maintenance of the bridge railing connections; and maintenance of approach signage.

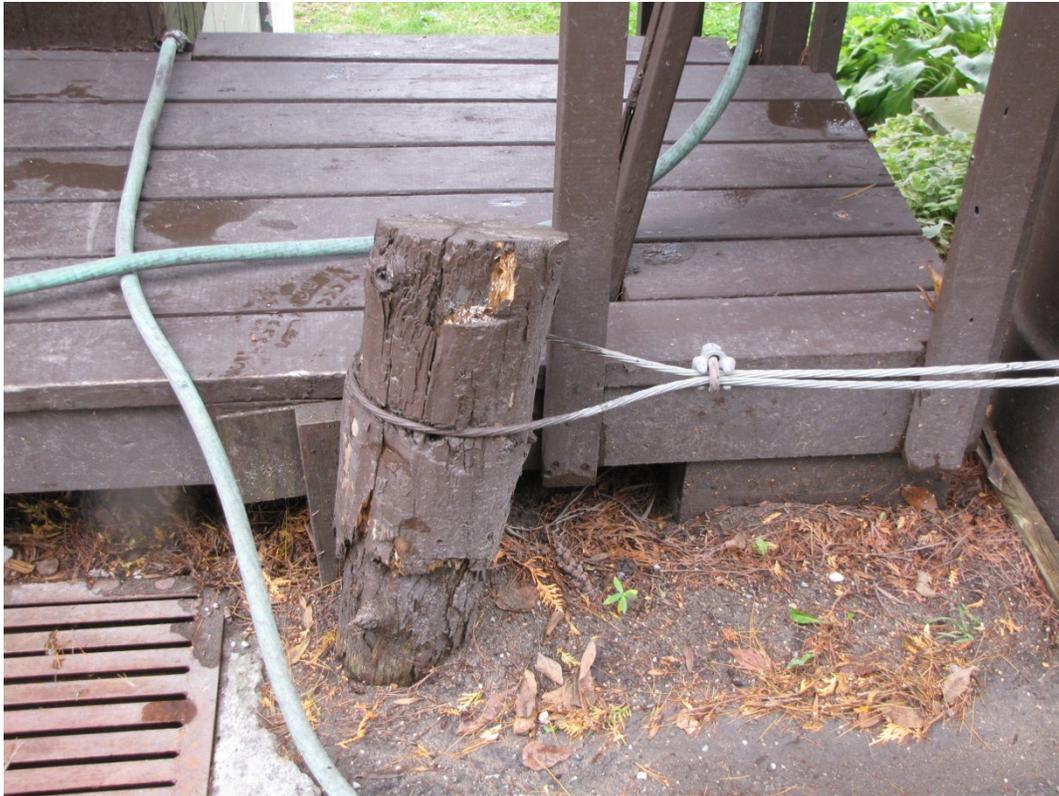
Photo S49: The first ten posts at the east end of the south-west guiderail are rotten (east post shown).

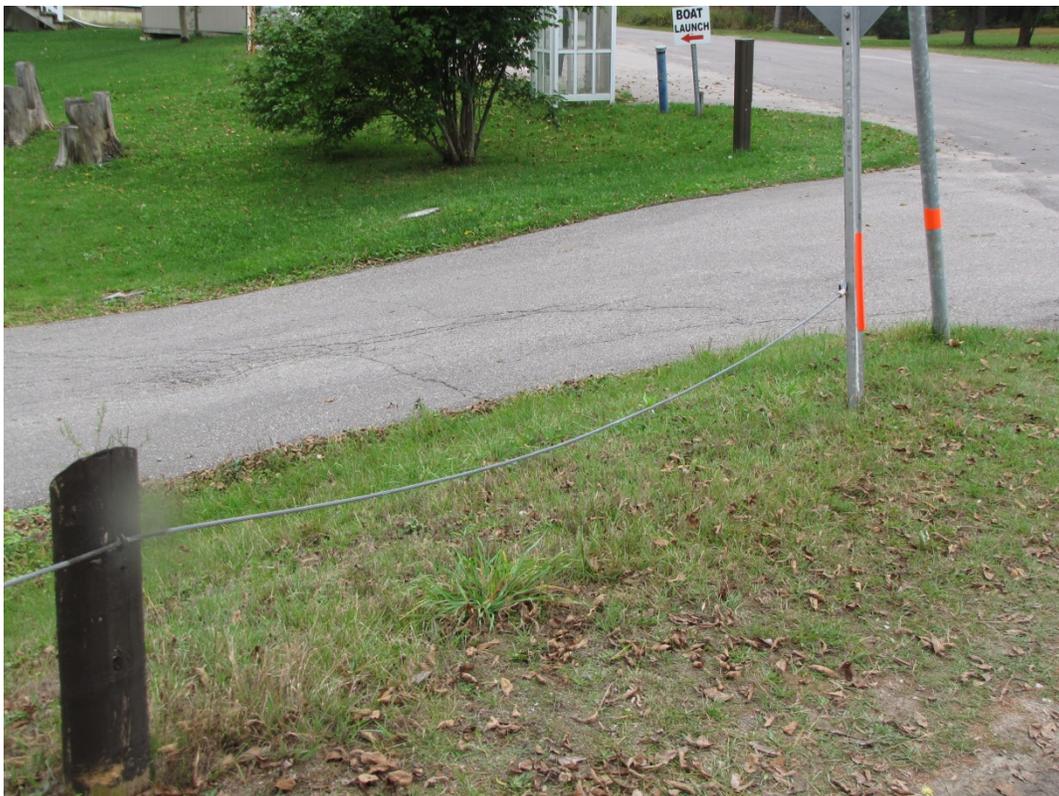
Photo S50: The west end of the steel cable of the south-west guiderail is attached to a road sign post.

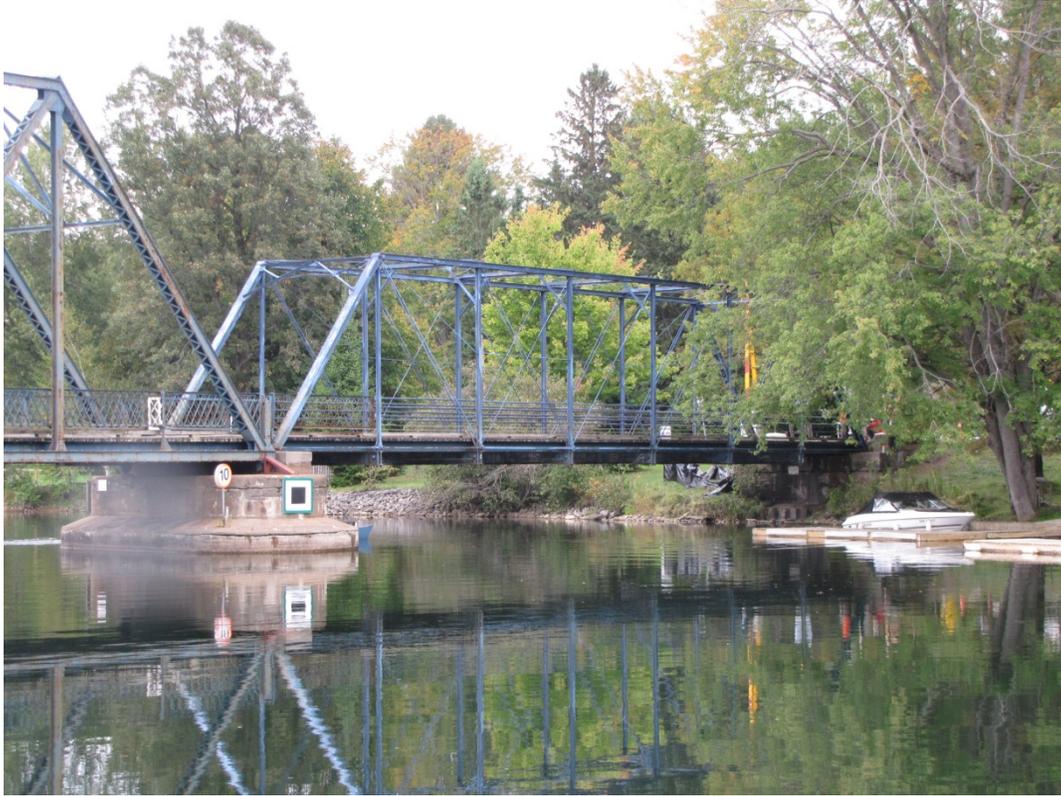
Photo F1: South elevation.

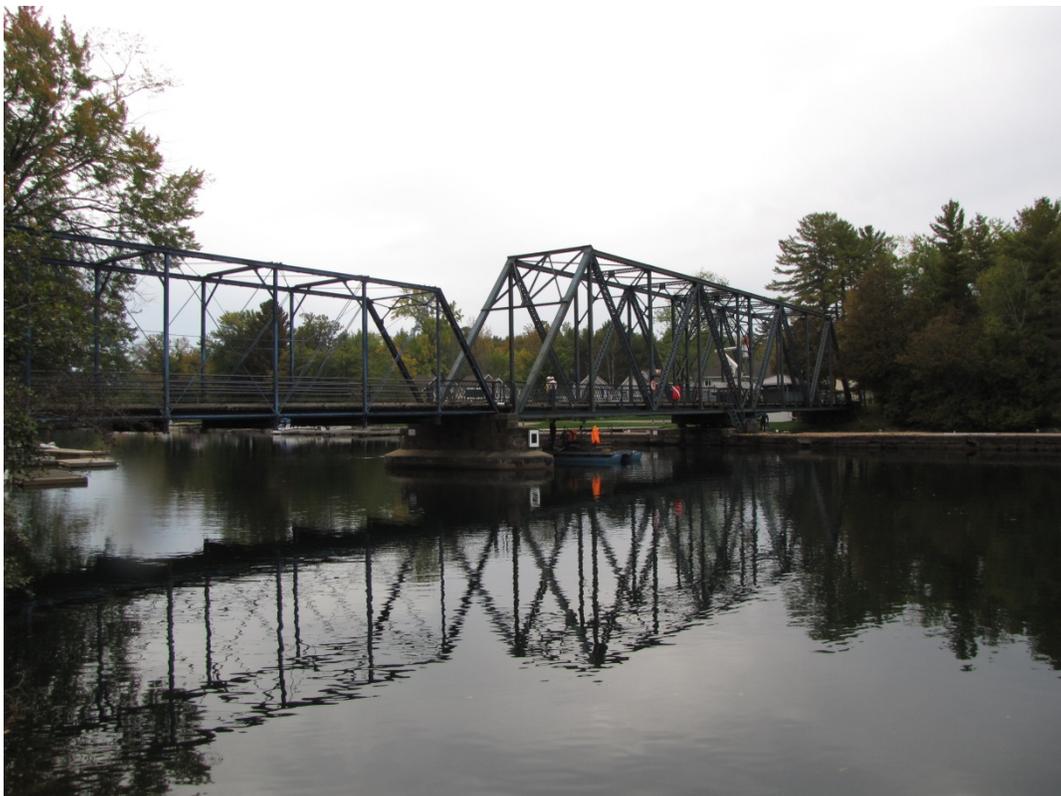
Photo F2: Partial north elevation showing both bridge spans.

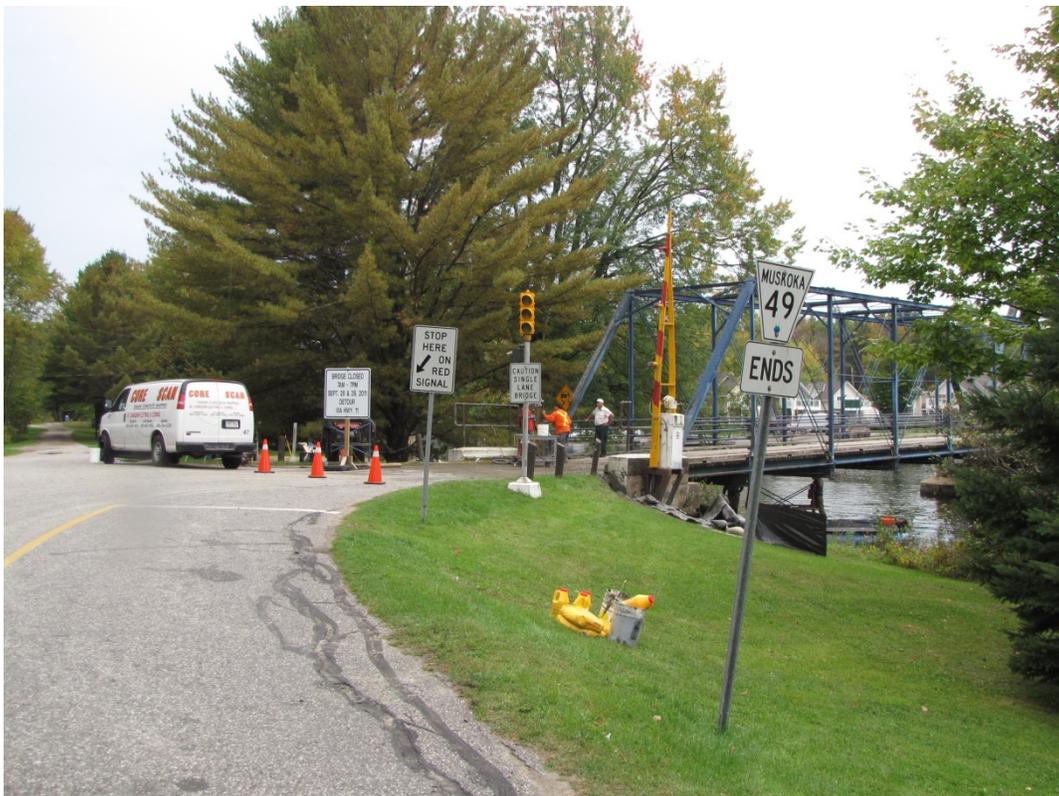
Photo F4: East approach.

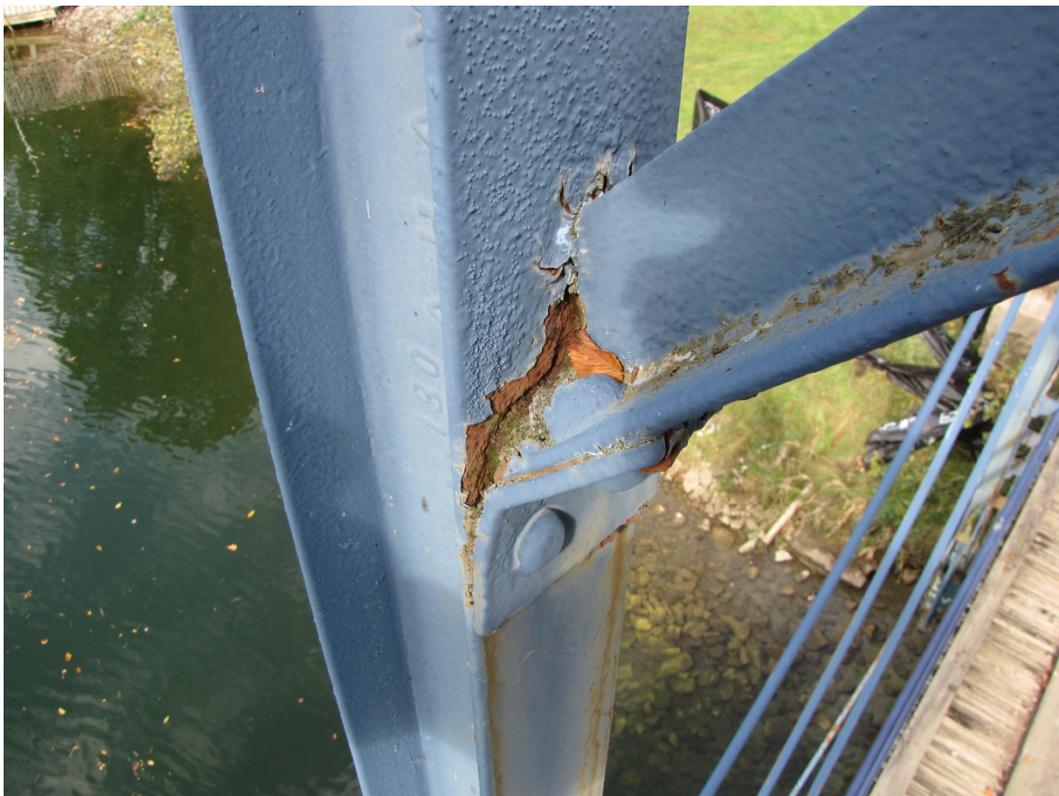
Photo F14: V5N – typical localized section loss of the interior flange of the vertical members at the connection to the vertical bracing.

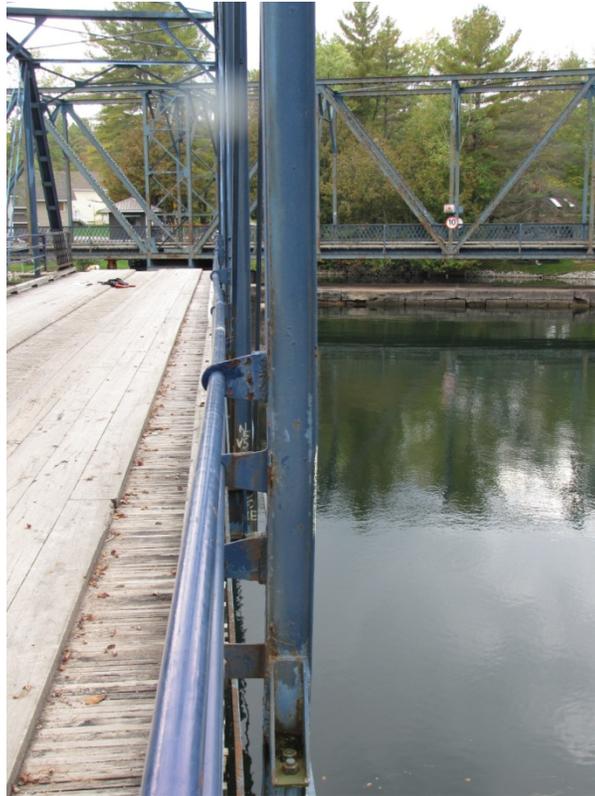
Photo F15: V6N is bent at the base.

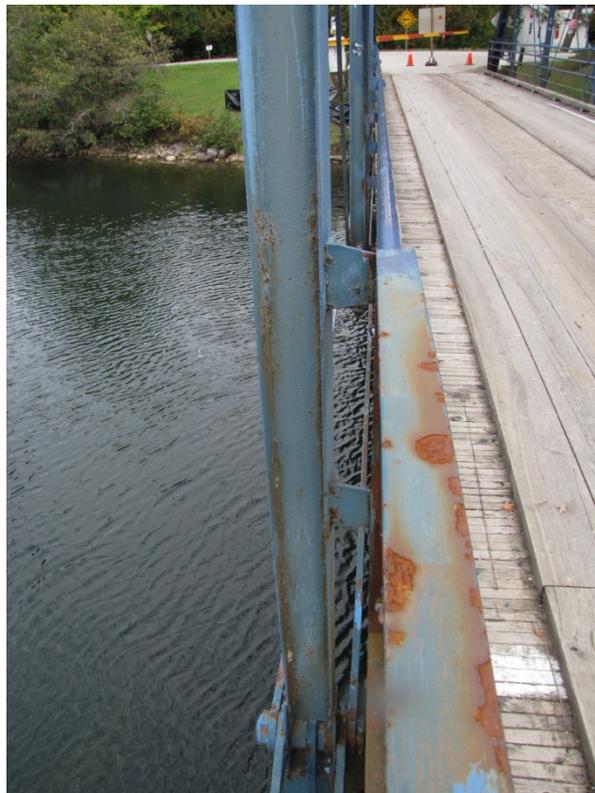
Photo F16: V1N is twisted about its longitudinal axis.

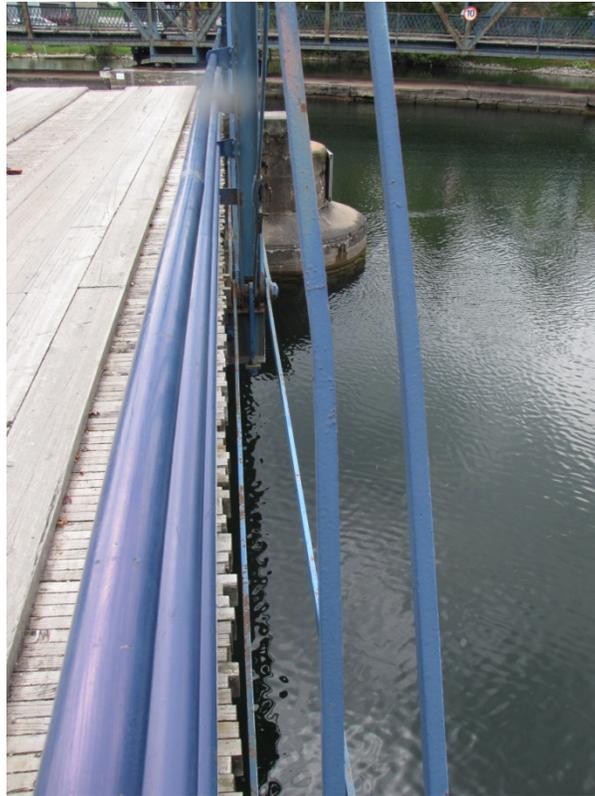
Photo F17: Inside member of U2N-L3N is bent.

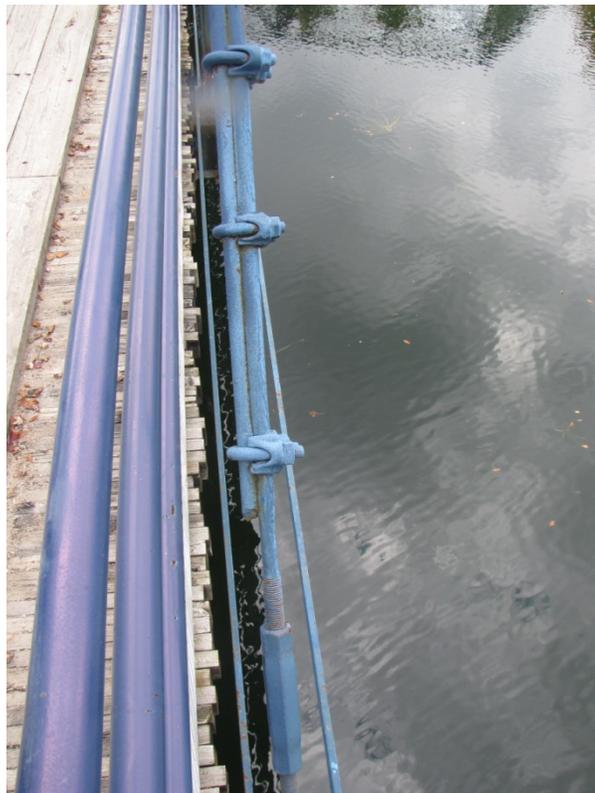
Photo F18: Splice in member U4N-L5N.

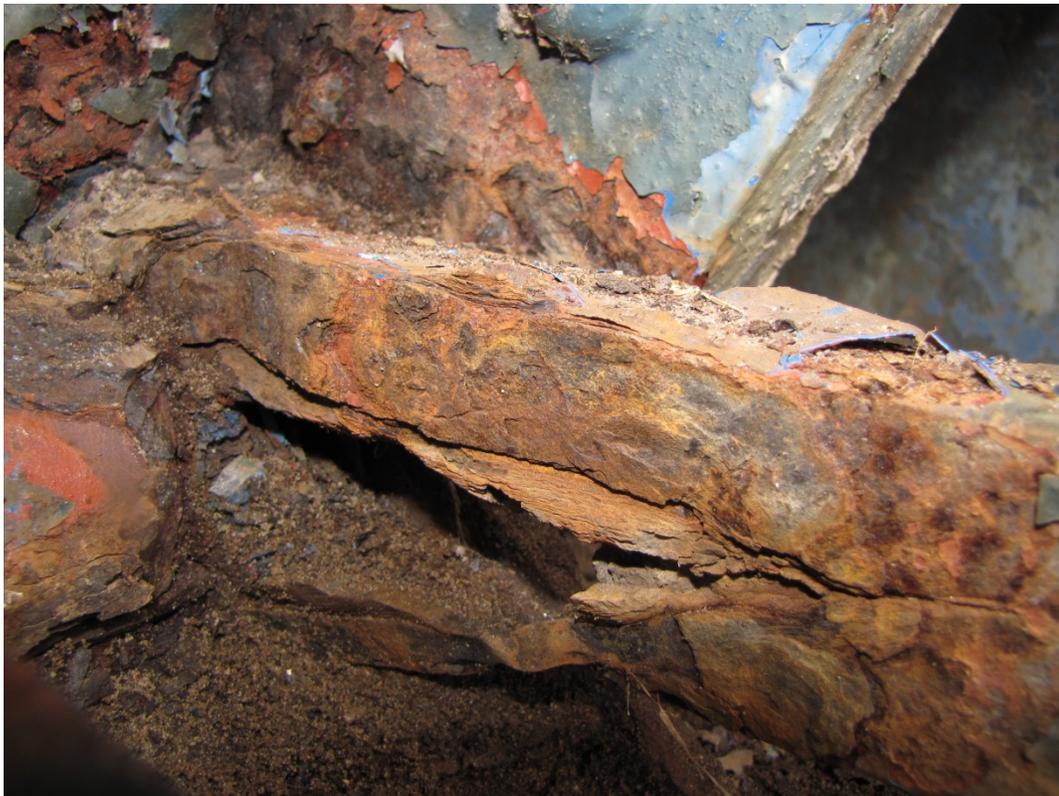
Photo F19: North bottom chord I-bar at east end of bridge has lost more than 90% of its lower cross-section.

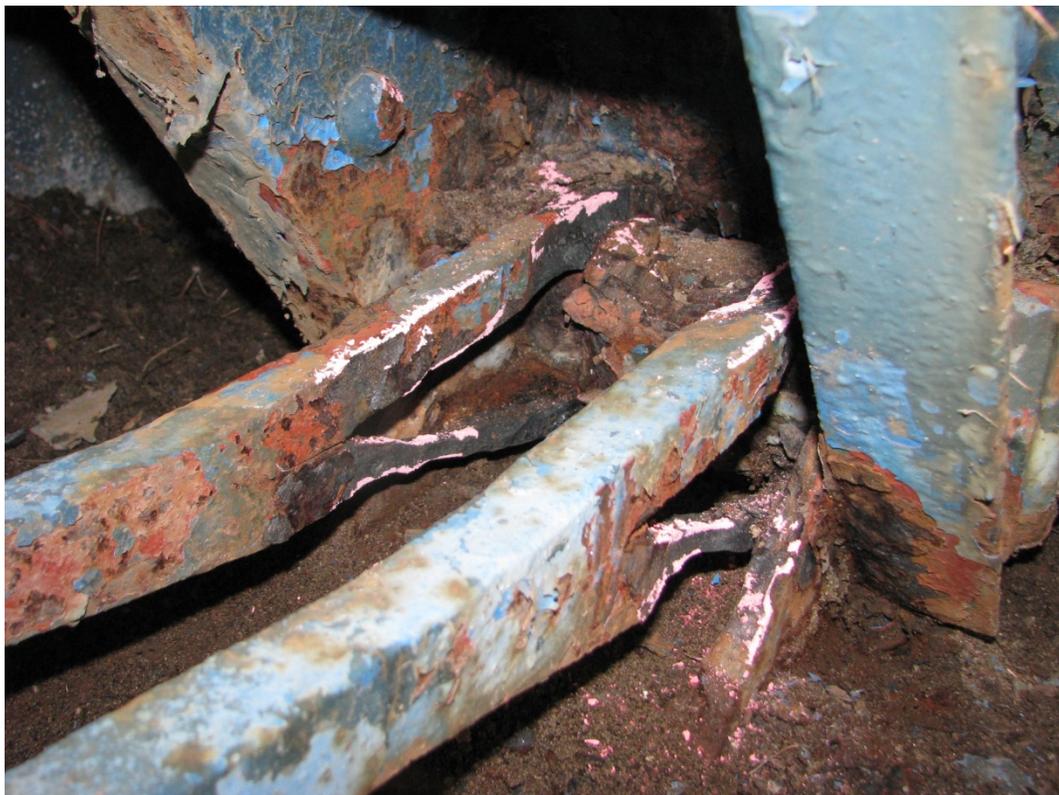
Photo F20: Very severe section loss in the south bottom chord I-bars at the east end of bridge.

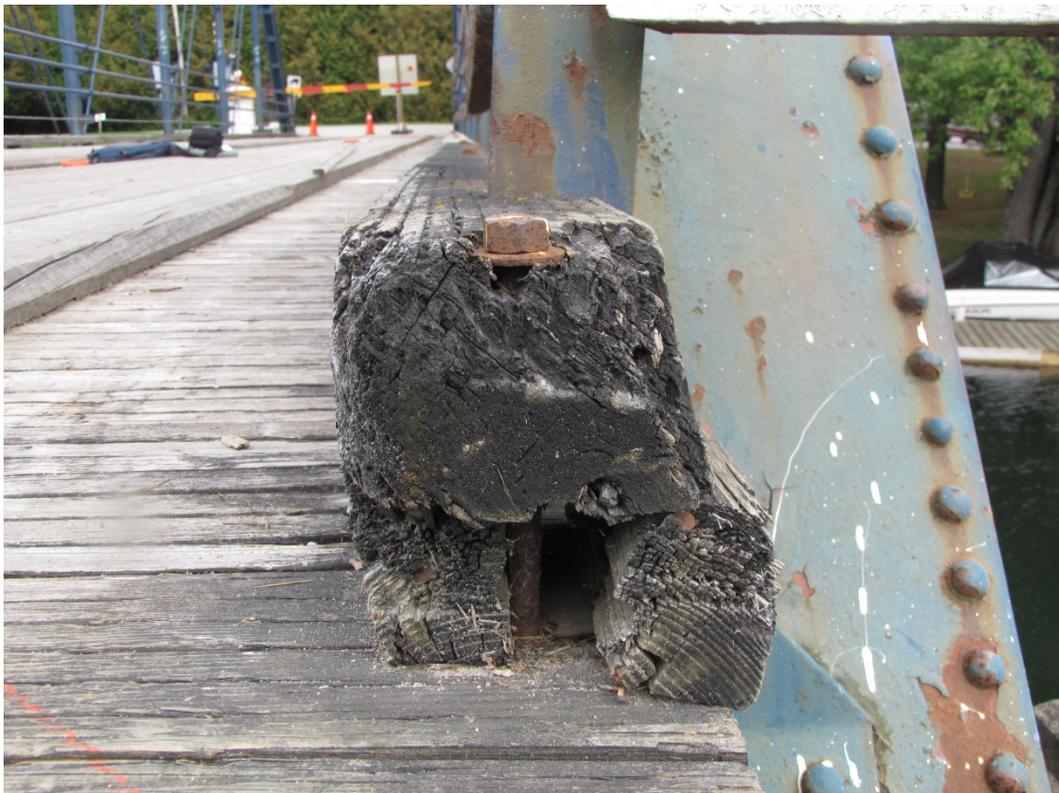
Photo F28: The block beneath the west end of the south curb has split into two pieces.

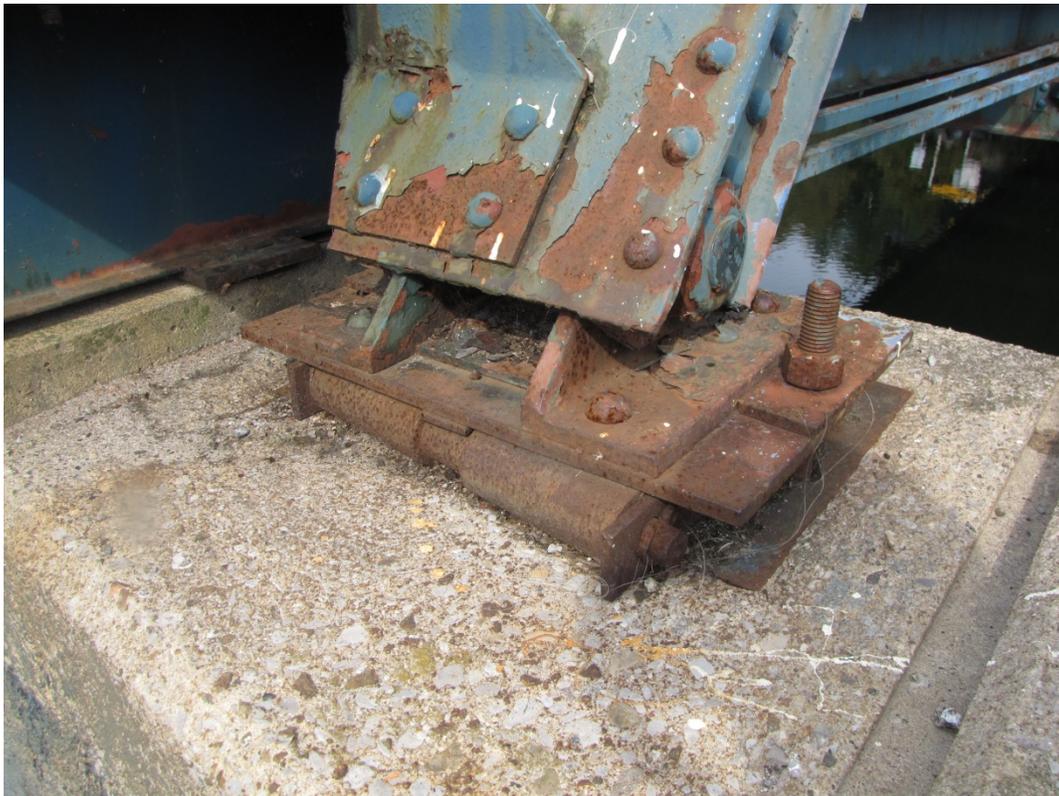
Photo F29: South-west bearing – the roller has twisted diagonally and is partially off the steel bearing plate.
