Hamlet Bridge (Bridge 57) Comprehensive Detailed Inspection and Structure Evaluation Report (PCA Project No. 2011-4650-20027340)

Comprehensive Detailed Inspection and Structure Evaluation Report

Parks Canada Project No. 2011-4650-20027340

Delcan Corporation

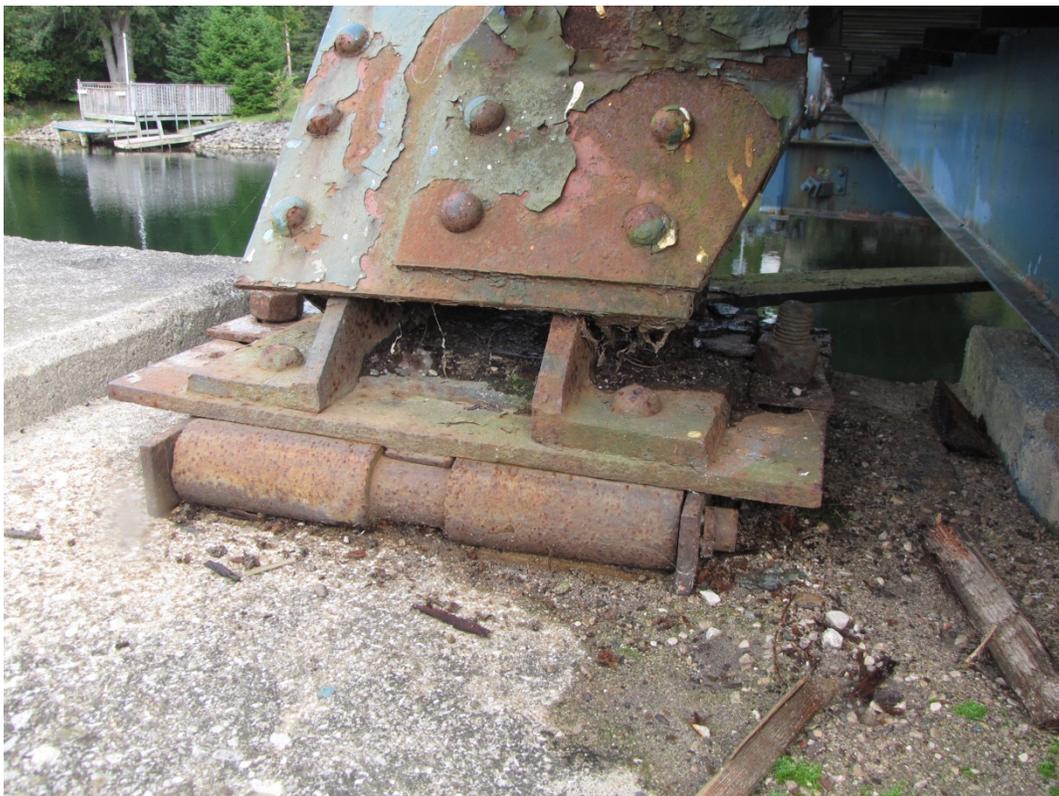
Photo F30: North-west bearing – the roller is no longer on the steel bearing plate.

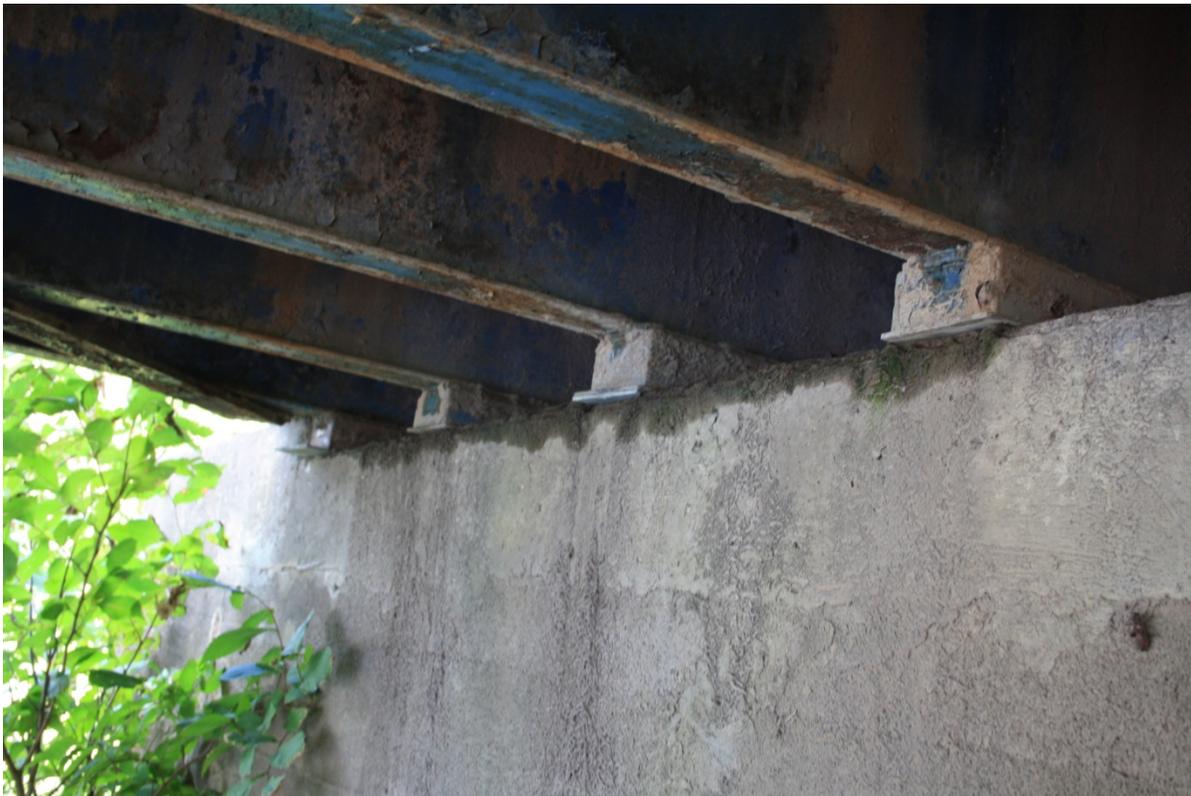
Photo F31: Stringer bearings at east end of bridge.

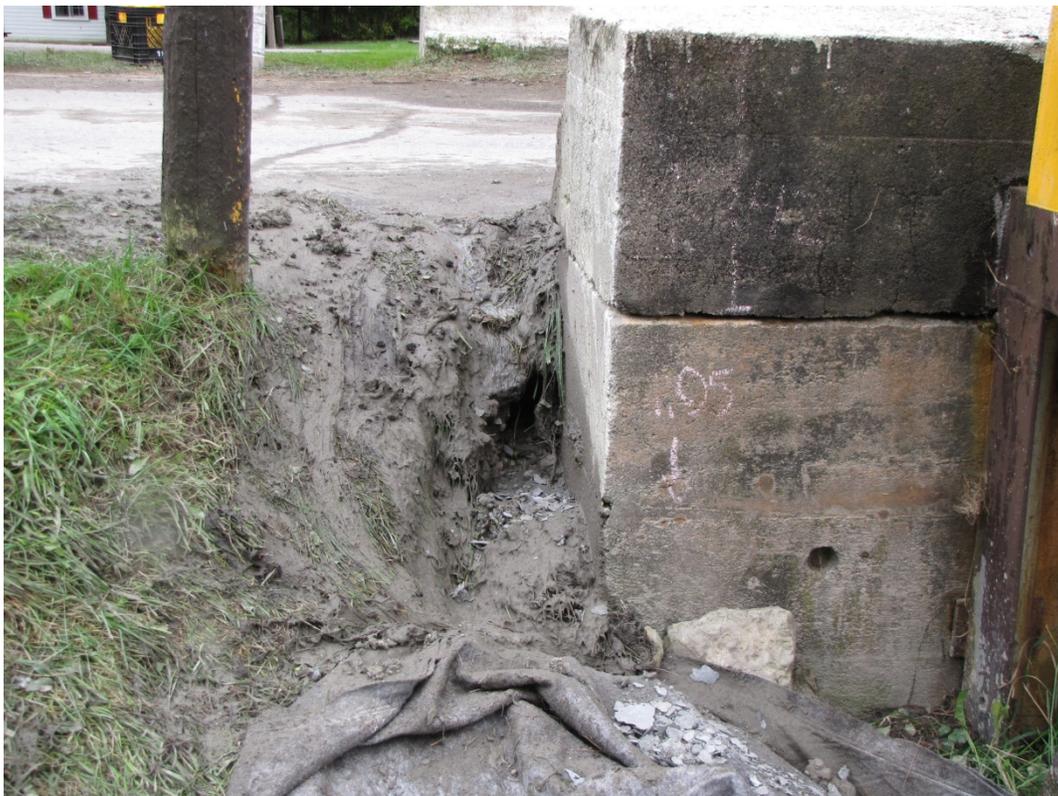
Photo F32: Erosion of the north-east embankment material around the guiderail post.

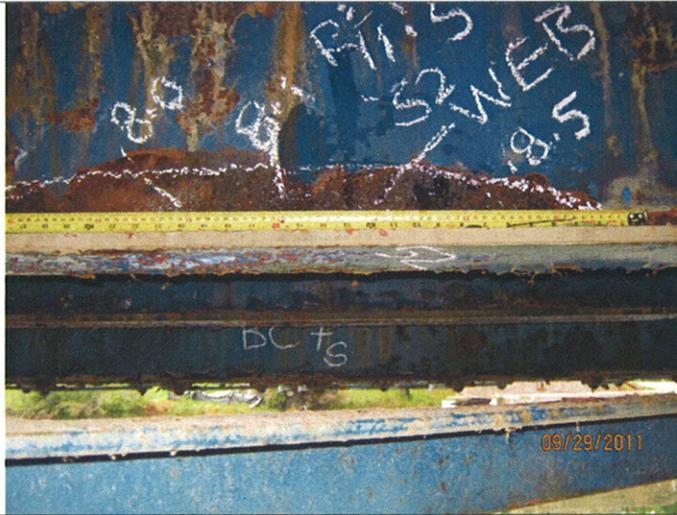
1

- 2.1 Stringer(s) exhibited severe corrosion as noted on ultrasonic report and photo #'s 1, 2, 3 & 14.
- 2.2 The cantilever bridge "hub" structure exhibited severe corrosion / total loss as noted on the ultrasonic inspection report and photo #'s 5 & 6. Also per visual inspection report and photo #'s 19, 20 & 21.

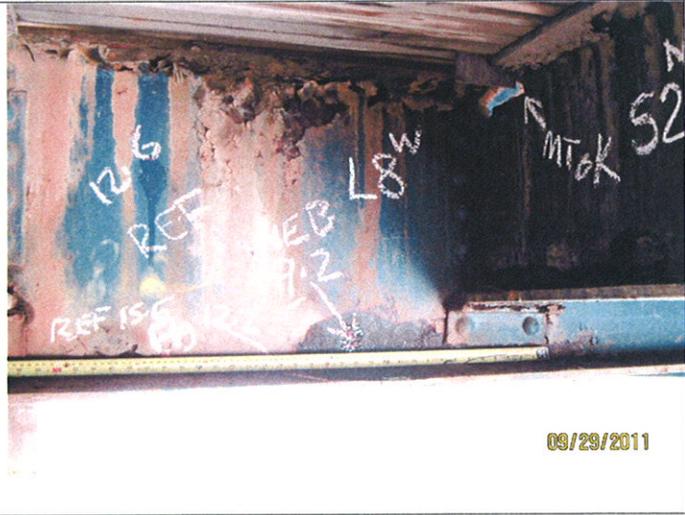
4

- 2.3 Floor braces exhibited moderate to severe corrosion as per ultrasonic report and photo #'s 4, 7, 8, 9, 10, 11, 12, 13 & 15.
- 2.4 Diagonal bracing member detected in 'delaminated condition' as per visual report and photo # 16.
- 2.5 Cross / wind bracing detected with severe corrosion / total loss of member, as per visual report and photo #'s 17 & 18.
- 2.6 Thickness readings obtained were isolated to areas exhibiting greater than 10% (visual) loss. Access and time constraints limited the number of readings obtained. All accessible corrosion areas were recorded for client review / evaluation.

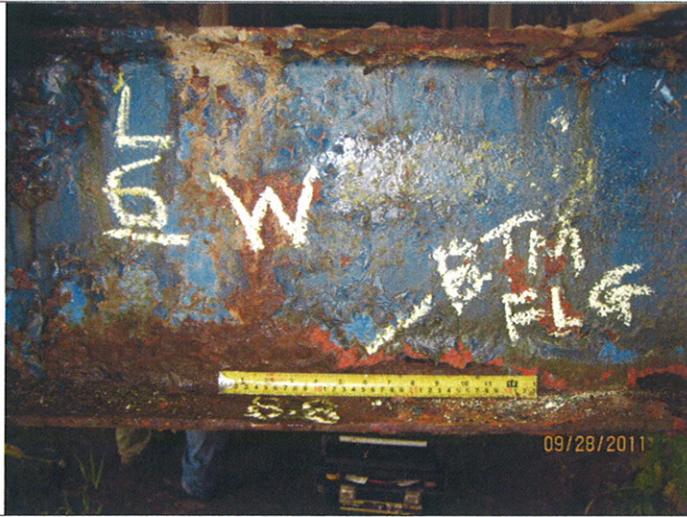
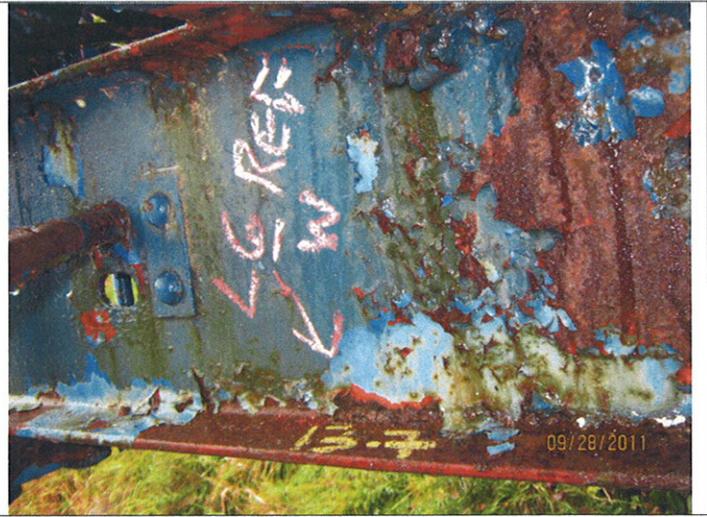
- 2.1 Cross beam (flange & web sections) exhibited severe corrosion / section loss as noted on ultrasonic report and photo #'s 1, 3, 5, 6, 7 & 8.
- 2.2 Vertical truss posts (flanges) at pinned connections exhibited severe corrosion per ultrasonic report and photo #'s 2 & 4. Also see visual report and photo # 9.

Item	Member	Reference / Adjacent 'T' mm	Thickness Reading mm:	Remarks:	Photo #:
			1		
Cross Beam L6	Bottom Flange	13.7	8.8	Flange toe to web corrosion (80mm long)	1-1 & 1-2
Cross Beam L6	Web	10.0		Reference UT	
Post V5 (North)	Flange (South-East)	10.0	6.4	Corrosion at pinned connection	2
Cross Beam L5	Bottom Flange	13.4	8.9	Flange toe to web corrosion	3
Stringer S5 & S6 (North-West)	Web	5.4		Reference UT	
	Bottom Flange	4.6		Reference UT	
Post V4 North	Flange (South-East)	10.4	3.2	Corrosion at pinned connection	4
Cross Beam L4 (East) at S7	Web	10.7	5.8	Corrosion adjacent to flange	5
Cross Beam L4 (East) at S3	Web	10-10.7	6.2-8.3	Corrosion adjacent to flange	6

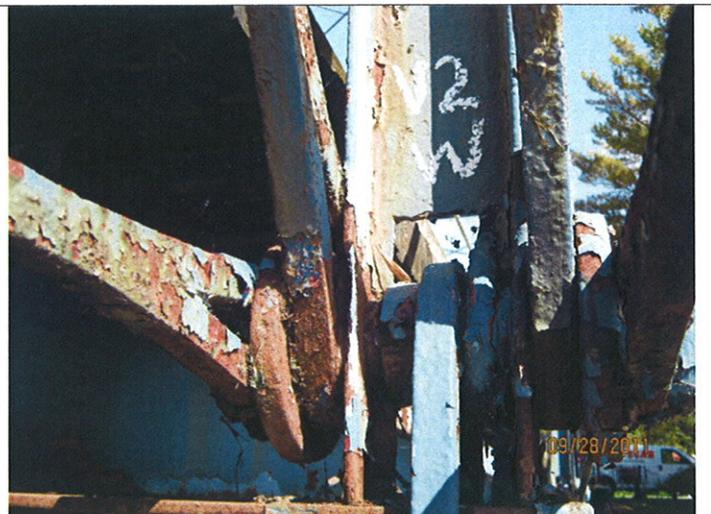
ITEM #:	MEMBER	DESCRIPTION	REMARKS	Photo #:
V2 Post (South) at L2	Flange (North West)	Flange Corrosion <50% section loss to knife-edge, Flange to pin sleeve		9
V6 End Post (North) above L6 pinned connection	I Beam	Deflection off of vertical	From previous bridge impact (vehicular)	10-1 & 10-2
Cross Beam L5 (South) at BC5	Web, Flange	Paint deterioration (typical condition of bridge)	Surface corrosion <10%	
Strut U5 (South)	Plate, Flange	Paint deterioration (typical condition of bridge)	Surface corrosion <10%	
Bottom Chord BC6 at L7 (North)	Forged Eye Ends (Bottom)	*>90% section loss / corrosion*	*Tension Member*	11
Bottom Chord BC6 at L7 (South)	Forged Eye Ends (Bottom)	*>90% section loss / corrosion*	*Tension Member*	12-1 & 12-2

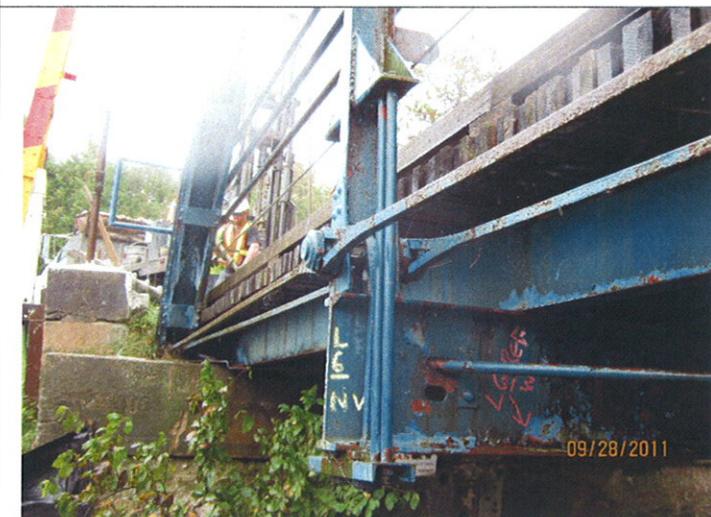
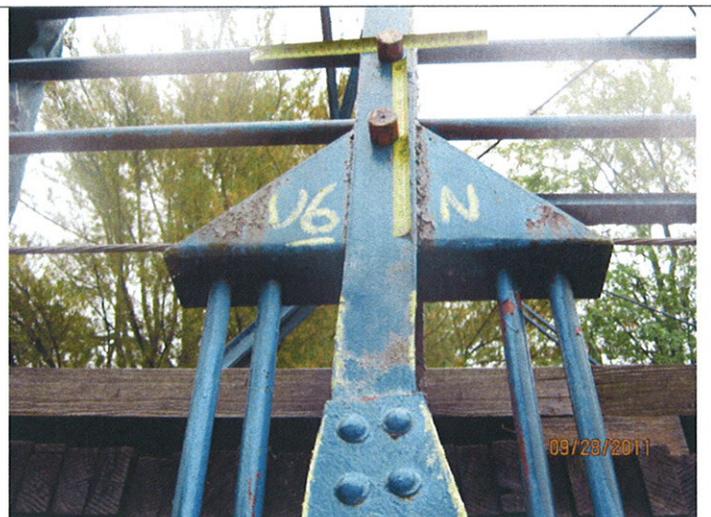
- 2.3 Bottom chord tension member(s) / forged eye (ends) exhibited severe corrosion at the East abutment pinned connection points as per visual report and photo #'s 10 & 11.
- 2.4 1 vertical truss post exhibited mechanical damage (previous impact) with deflection noted on visual inspection report and photo # 12.
- 2.5 Thickness readings obtained were isolated to areas exhibiting greater than 10% (visual) loss. Access and time constraints limited the number of readings obtained. All accessible corrosion areas were recorded for client review / evaluation.
- 3.0 Results:
- 3.1 The attached ultrasonic thickness readings, visual inspection reports and magnetic particle inspection reports pages 1 through 7 inclusive conclude this report.

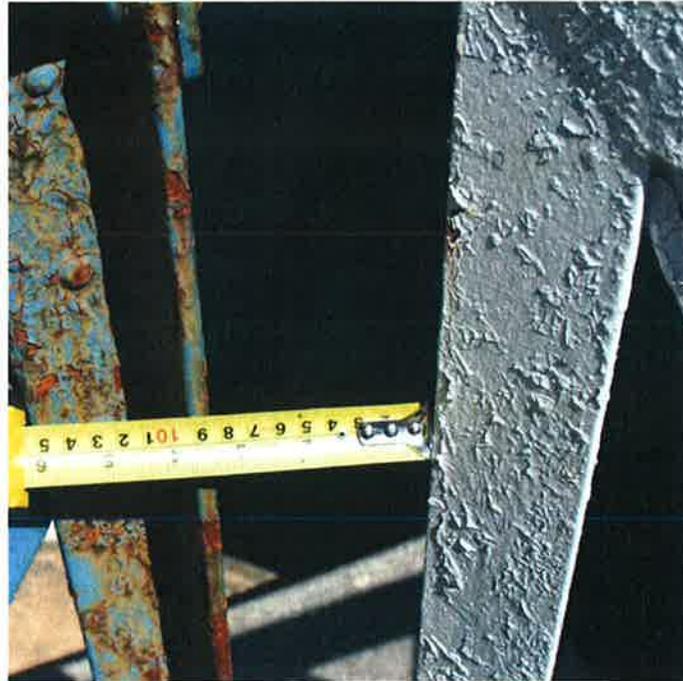
As shown in Pictures 1 and 2 below, the space between the guardrails of the swing bridge and fixed bridge is about 30 mm wider on the north side of the bridge (Picture 1) than on the south side of the bridge (Picture 2). The swing bridge operator has reported that the space between the guardrails of the swing bridge and fixed bridge used to be approximately the same width on both the north and south sides of the bridge, however, the width of the space on the both sides of the bridge have decreased over the past several years. It is inferred from these observations that the foundations of the fixed bridge have moved relative to the swing bridge.

Picture 1: The space between the guardrails of the swing bridge and fixed bridge on the north side; the space was reported to be wider in the past.

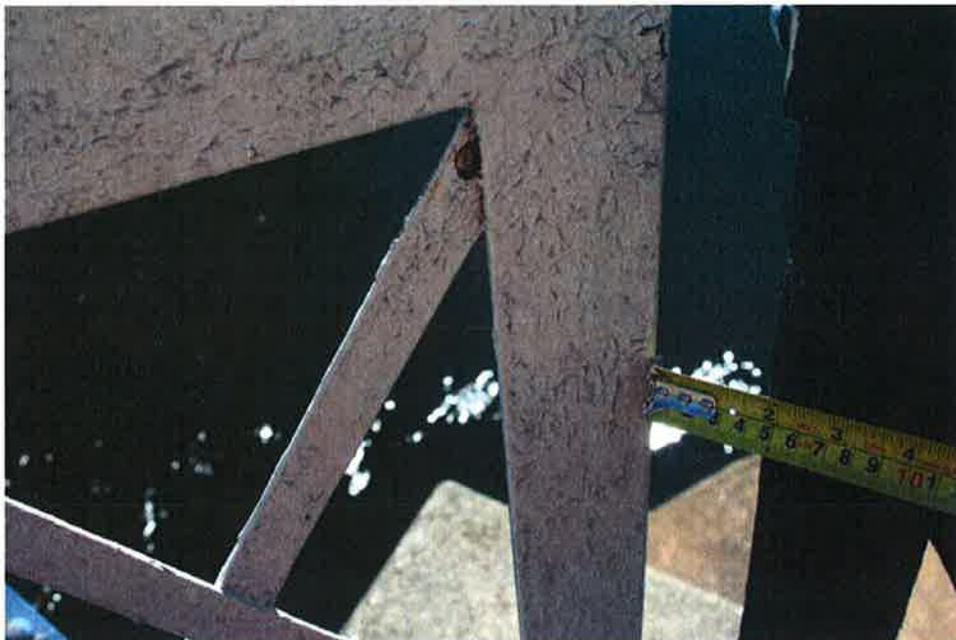
Picture 2: The space between guardrails of the swing bridge and fixed bridge on the south side; the space used to be much wider and was approximately the same as the space on the north side. It is now about 30 mm less than the space on the north side.

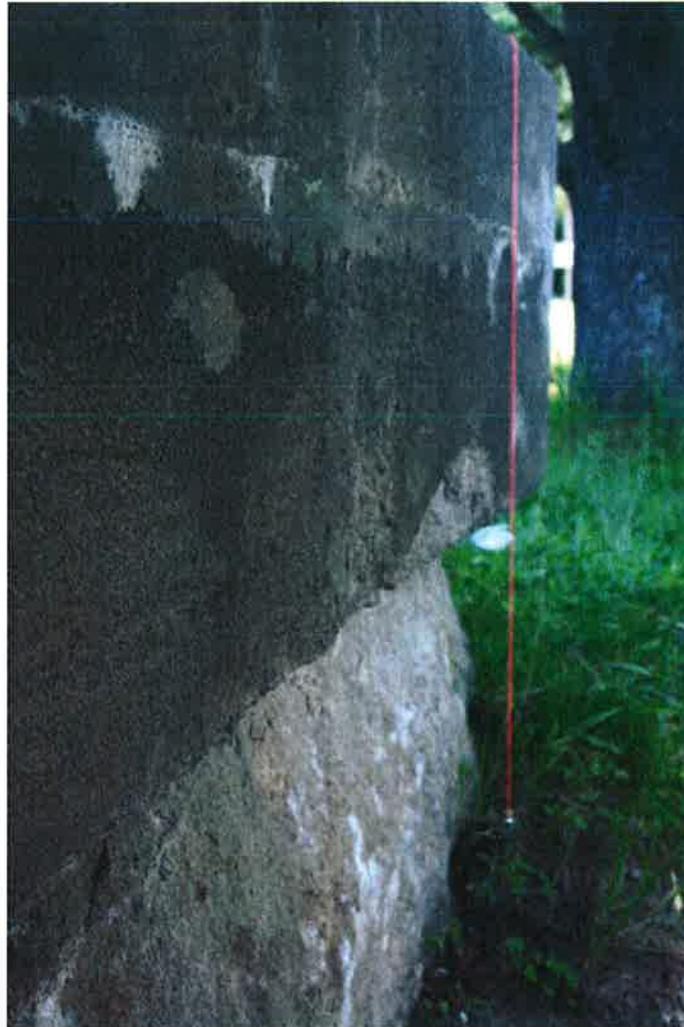
As shown in the Picture 3 below, the abutment face wall is tilting towards the river.

Picture 3: Note the tilting of the abutment wall and the severe concrete spalling at the lower portion of the abutment wall; a horizontal linear crack through the middle of the entire wall appears to be a construction joint.

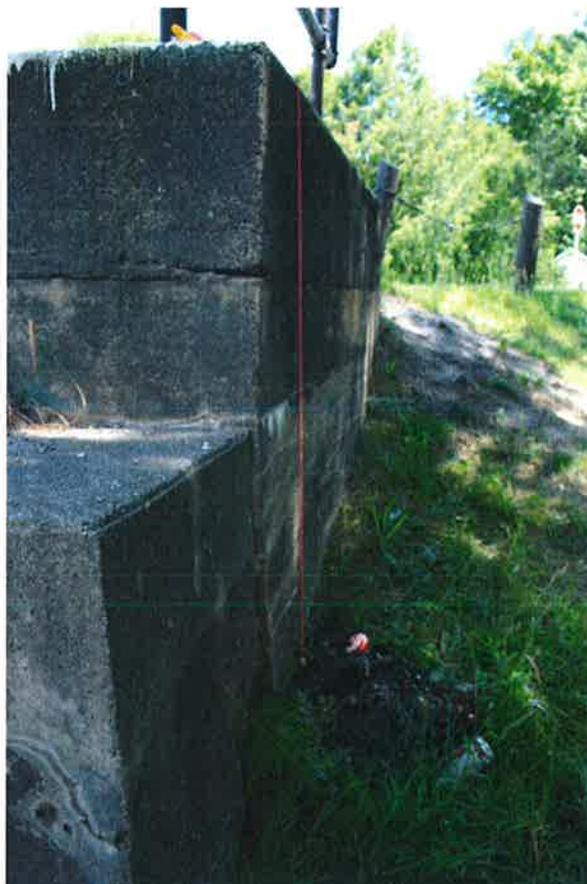
As shown in the Picture 4 below, the outwards tilting of the southeast wing wall was also noted.

Picture 4: Note the tilting of the southeast wing wall; the linear crack at the ground surface level appears to be a construction joint.

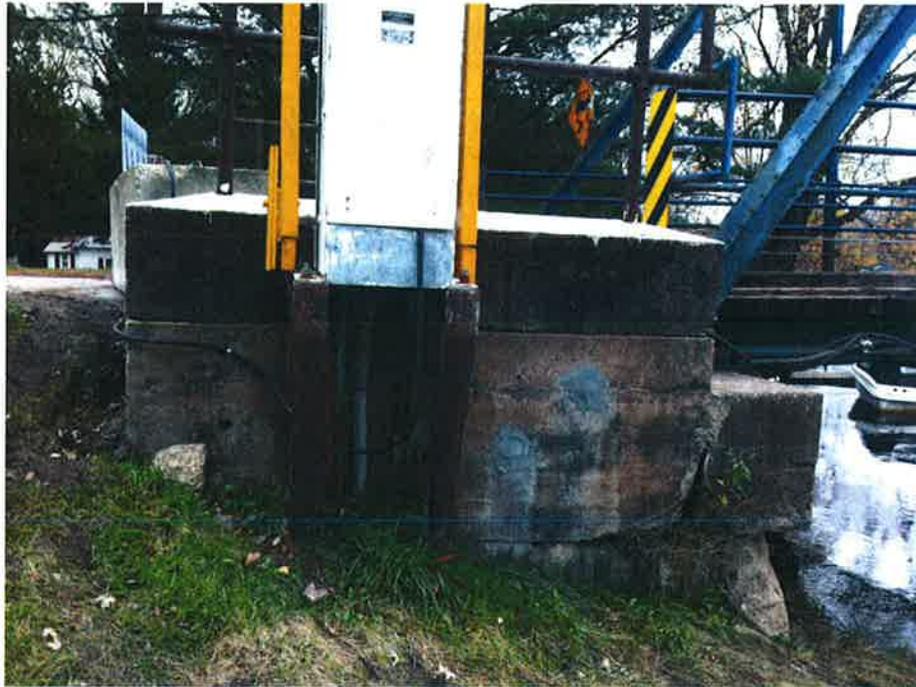
No.5: North wing wall of east abutment, looking south; the linear cracks appear to be construction joints.

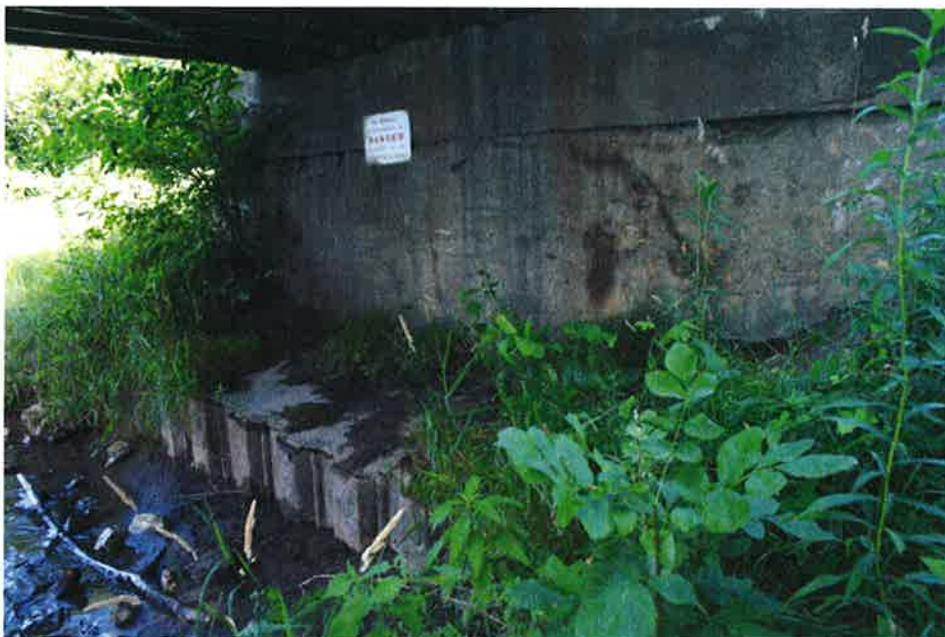
No.6: The north abutment concrete wall under the bridge; note the sheet pile wall installed for erosion protection; note the concrete platform behind the sheet pile walls.

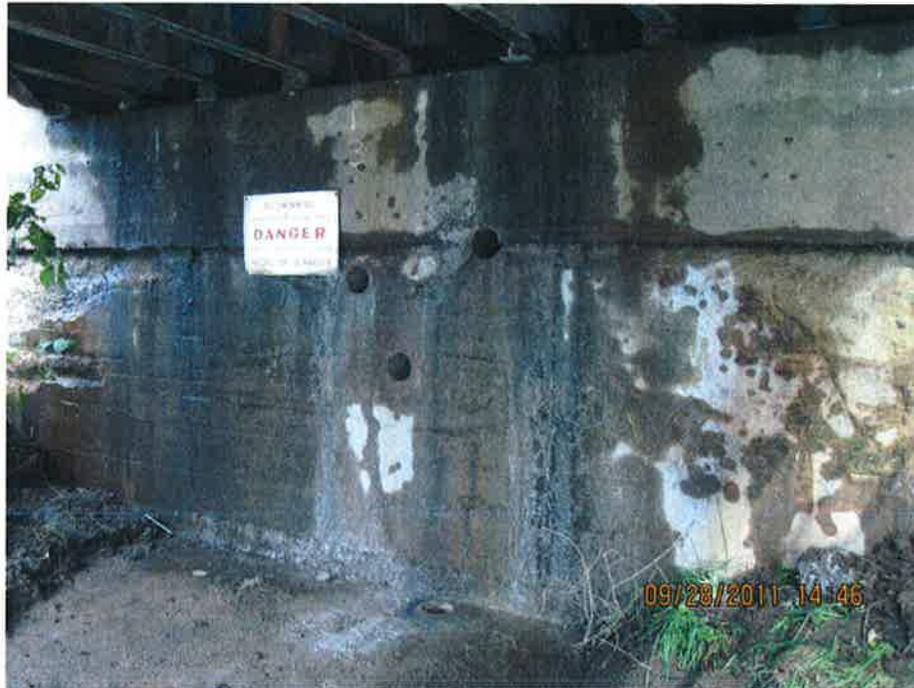
Concrete was encountered in the horizontal corehole carried out on the west face of the abutment wall as shown in the Photos 7, 13 to 15, on Figures 13D, 13G and 13H. The horizontal corehole was located on the existing linear crack (i.e. construction joint). As noted in the photos, the linear construction joint is generally horizontal and runs through the entire corehole length. Based on the water stains observed from the construction joint surfaces, the concrete appears to be separating along most of the construction joint likely due to erosion along the joint. Some vertical cracks were observed in the retrieved cores. The length of the corehole is approximately 1.7 m (i.e. inclined backwall). The concrete wall is about 1.2 m wide at the ground surface.

No.7: The north abutment concrete wall under the bridge; the linear crack appears to be the construction joint.

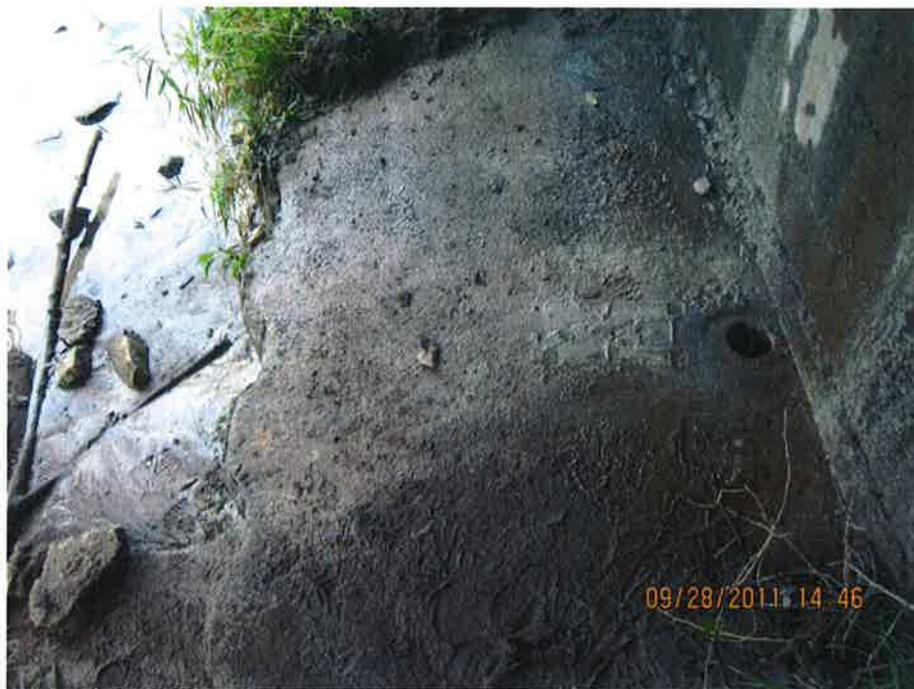
No.8: The concrete platform between the sheet piles and abutment wall; the core hole was terminated in the concrete due to refusal on steel rebar at a depth of about 0.5 m.

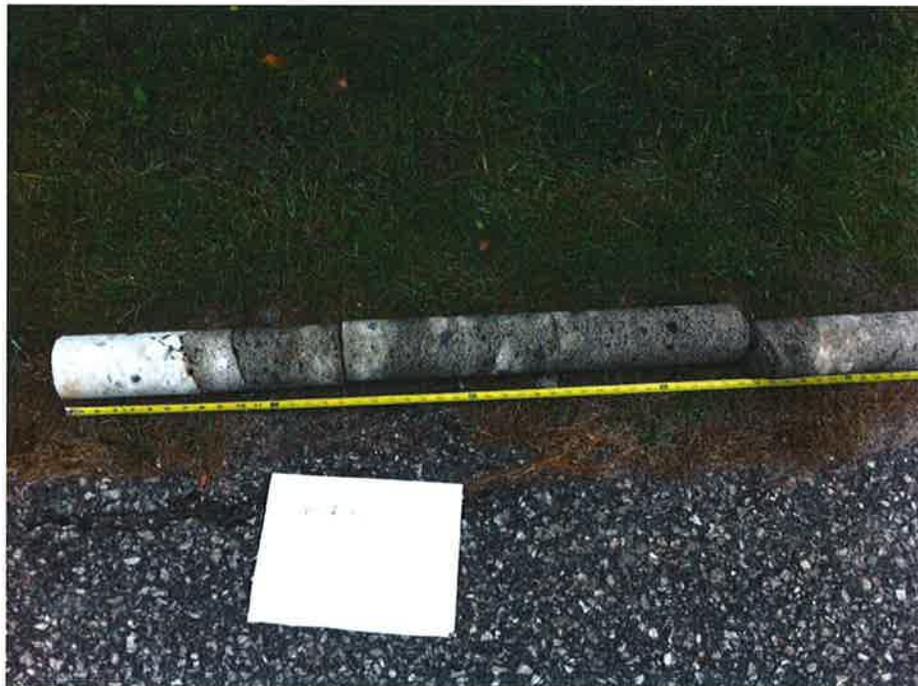
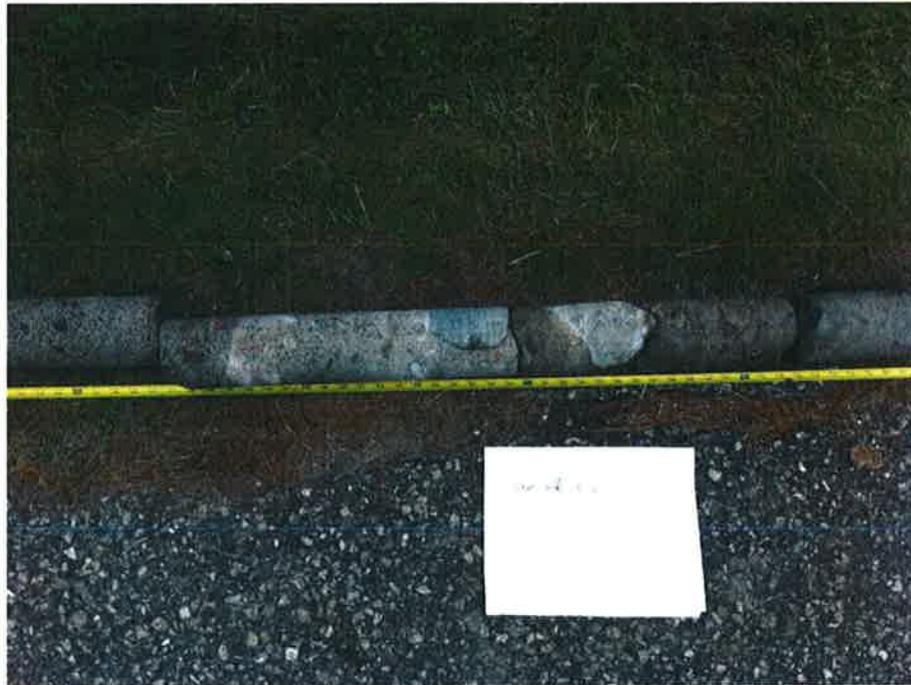
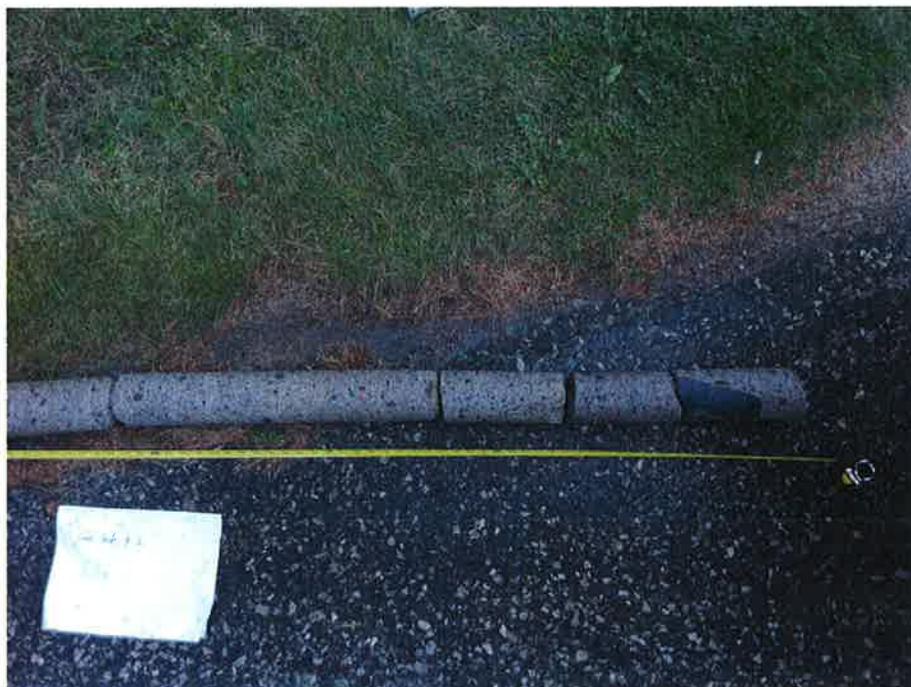
Concrete was encountered from ground surface to about 3.5 m (i.e. the abutment wall height at this location) below ground surface in the vertical corehole as shown in Photos 10 to 12 on Figures 13E to 13F. Two concrete core samples obtained from the vertical corehole were tested for compressive strength according to CSA A23.2 C14 as shown on Figure 9. The measured compressive strengths were 18.2 MPa and 14.2 MPa.

No.10: Concrete cores in vertical corehole at Borehole 3 location.

No.11 Concrete cores in vertical corehole at Borehole 3 location.

No.12: Concrete cores in vertical corehole at Borehole 3 location.

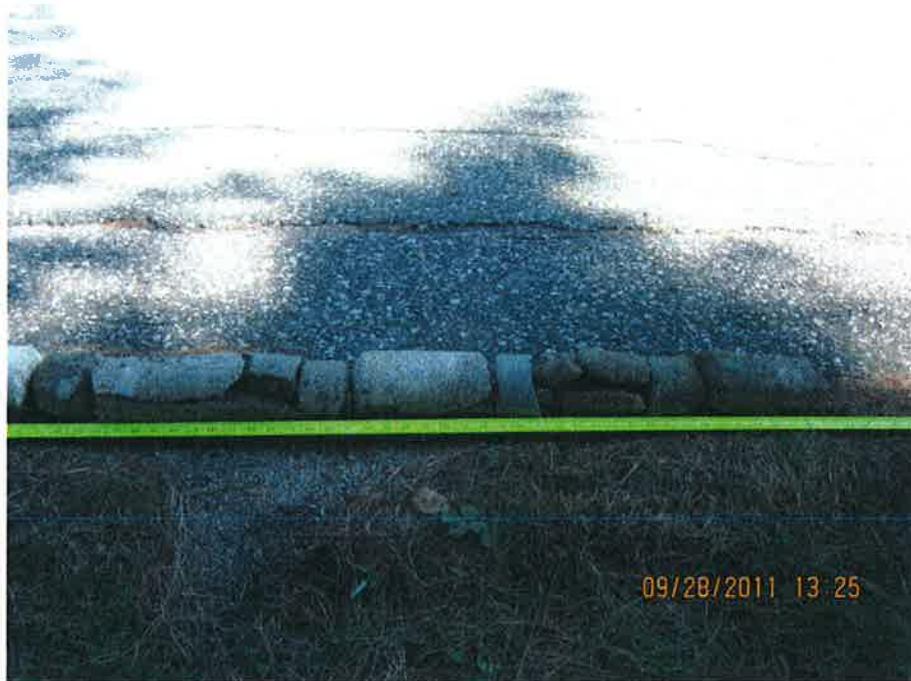
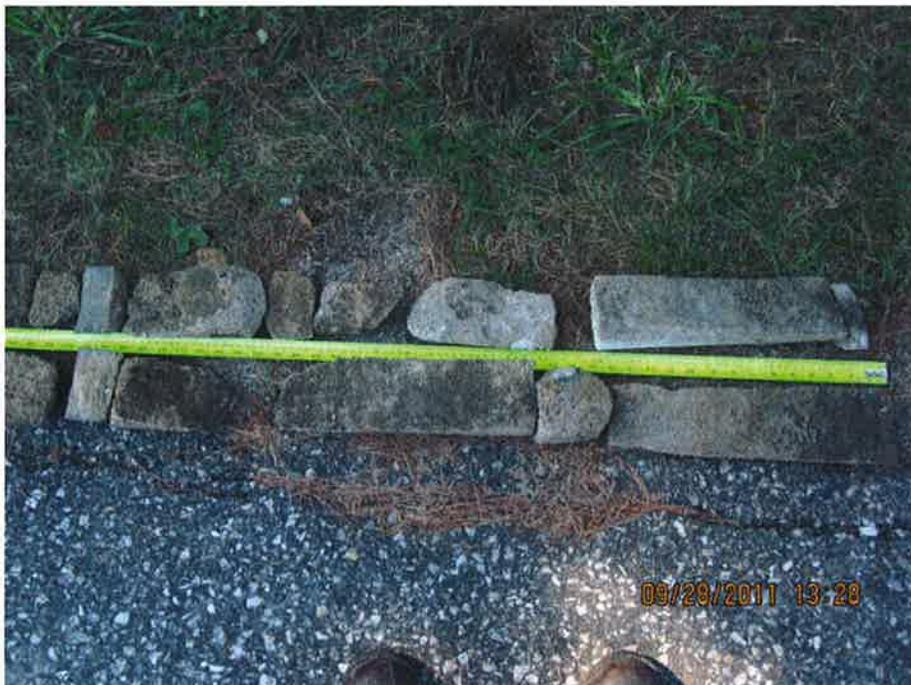
No.13: The cores of the horizontal corehole on the abutment wall.

No.14: The cores of the horizontal corehole on the abutment wall.

No.15: Looking into the horizontal concrete corehole on the abutment wall.

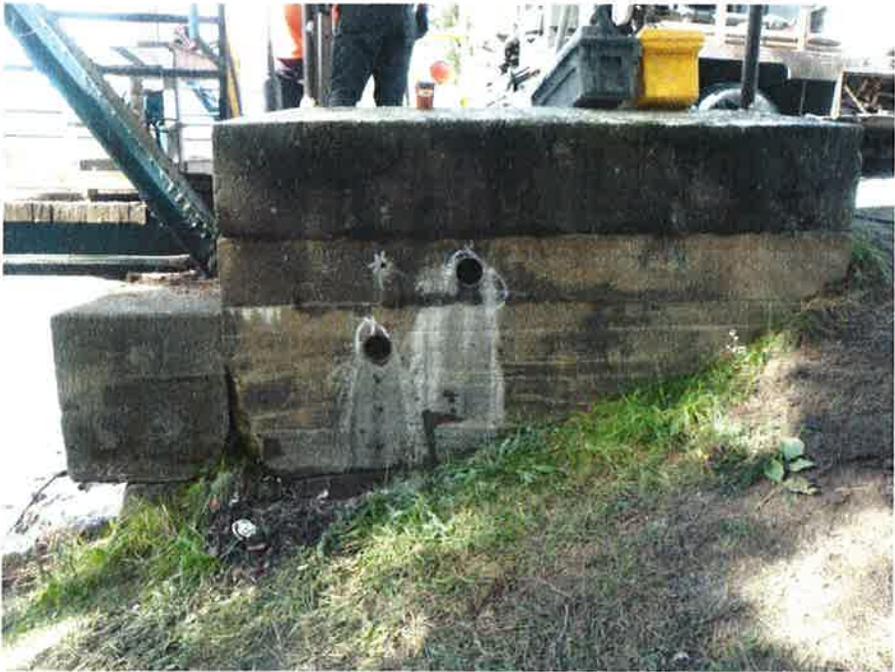
The east abutment and wingwalls appear to be the original concrete from around 1920. Photographs of the southeast wingwall, east abutment and the northeast wingwall are shown on Figures 4-4, 4-5 and 4-6, respectively. The southeast and northeast wingwalls appear to be built in several sections and some of the joints have started to deteriorate. The concrete is relatively sound with no delaminations noted on the two wingwalls. The southeast wingwall exhibited some light scaling along the exposed section just above the ground line. The northeast wingwall exhibited some heavier scaling/spalling on the lower corner where the wingwall met the abutment. A few random cracks were also noted on the two wingwalls. The east abutment was in fair condition with several delaminated areas across the face of the abutment. Some spalling or heavy scaling was also observed, particularly on the northeast corner. Scouring of the surface by ice and debris during spring runoff may be the cause of most of the spalling/scaling observed.

Figure 4-4 Overview of southeast wingwall facing north. Note the location of cores C3 (lower) and C4 (upper).

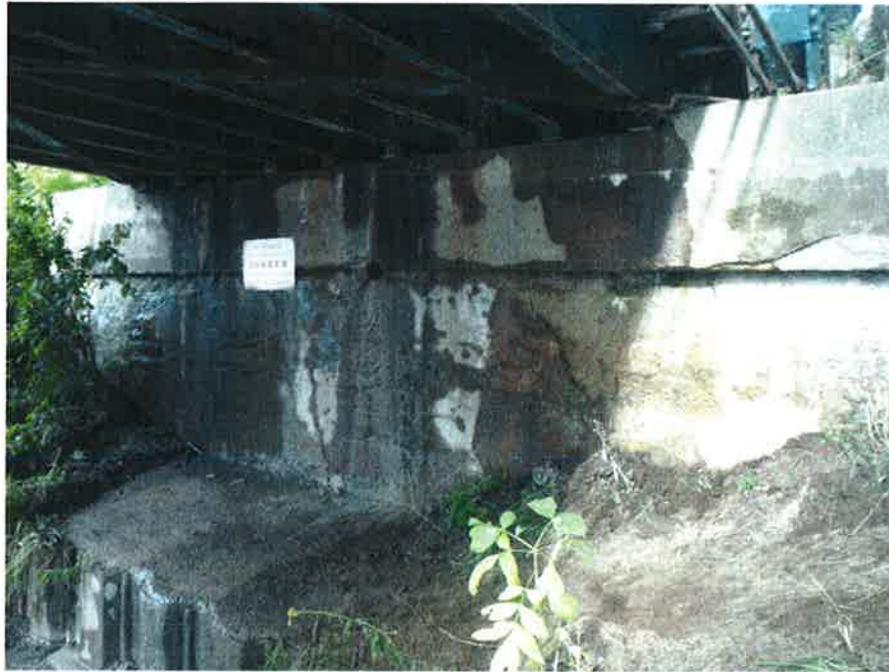
Figure 4-5 Overview of east abutment.

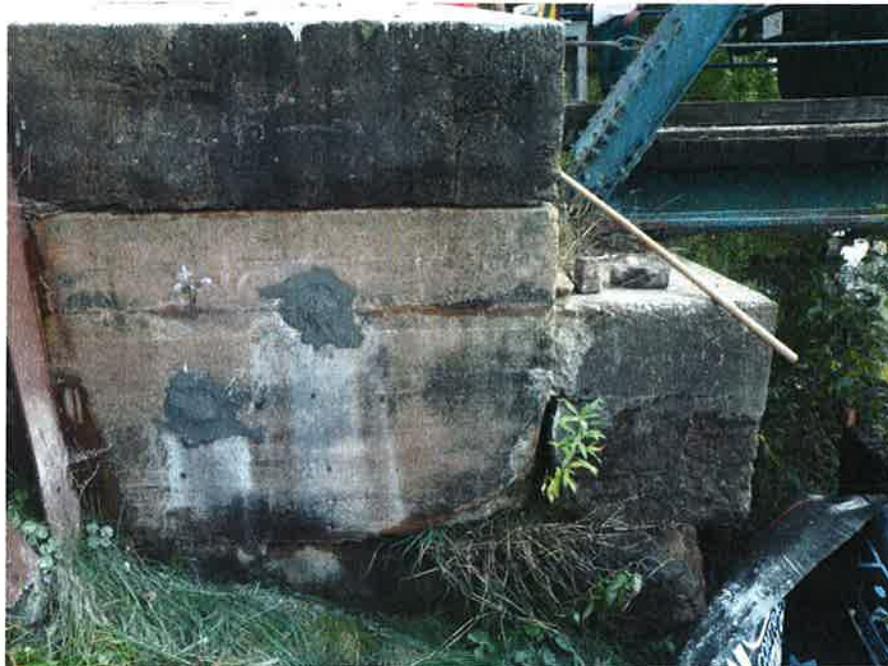
Figure 4-6 Overview of northeast wingwall with locations of cores C5 (upper) and C6 (lower).

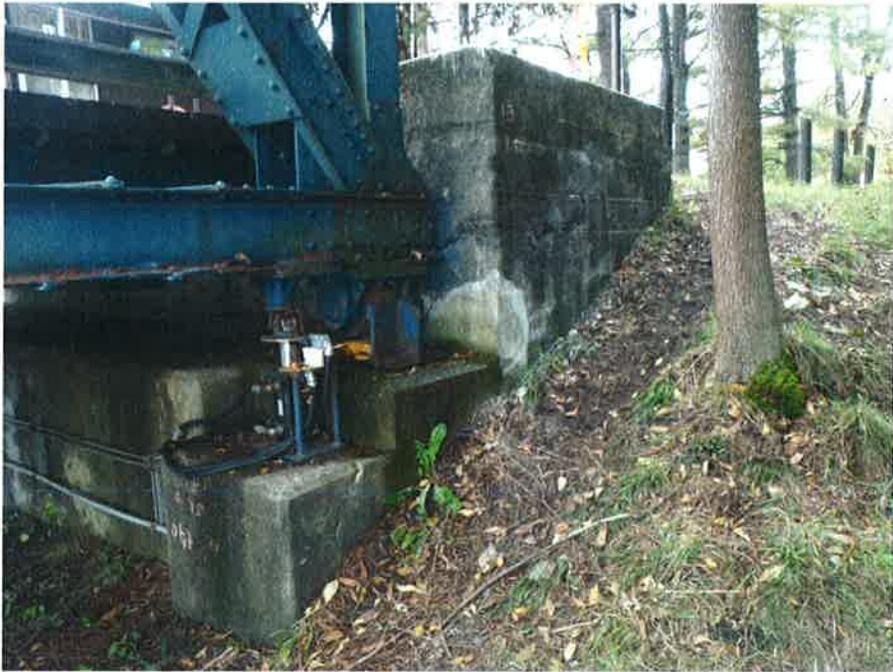
The west end of the northwest wingwall is also original concrete and is in good to fair condition. Some scaling was observed on the surface but no delaminations were noted. A photograph of the northwest wingwall is shown on Figure 4-7.

Figure 4-7 Overview of northwest wingwall.

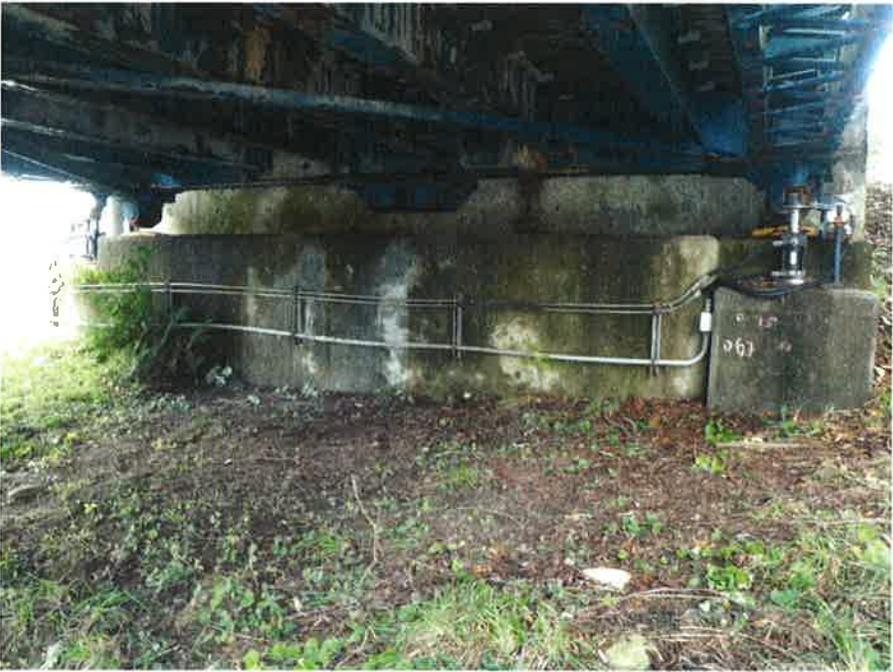
The faces of the west abutment and the southwest wingwall were replaced during the rehabilitation around 1990 and are in good condition. A few short random cracks were observed at each end of the abutment. No significant scouring or spalling was observed. The southwest wingwall was in good condition with no significant deterioration observed. Photographs of the west abutment and the southwest wingwall are shown on Figures 4-8 and 4-9, respectively.

Figure 4-8 Overview of west abutment.

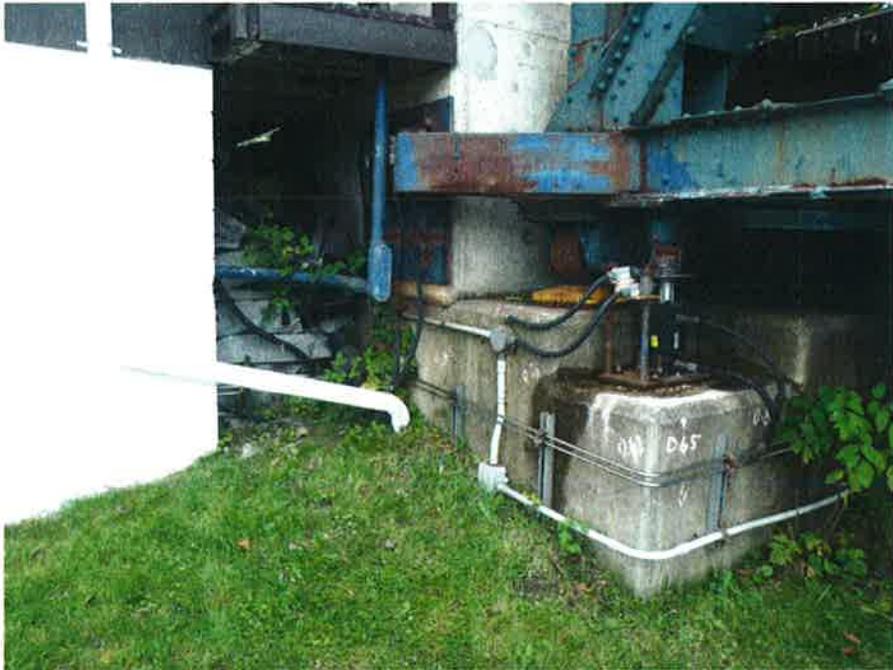
Figure 4-9 Overview of southwest wingwall.

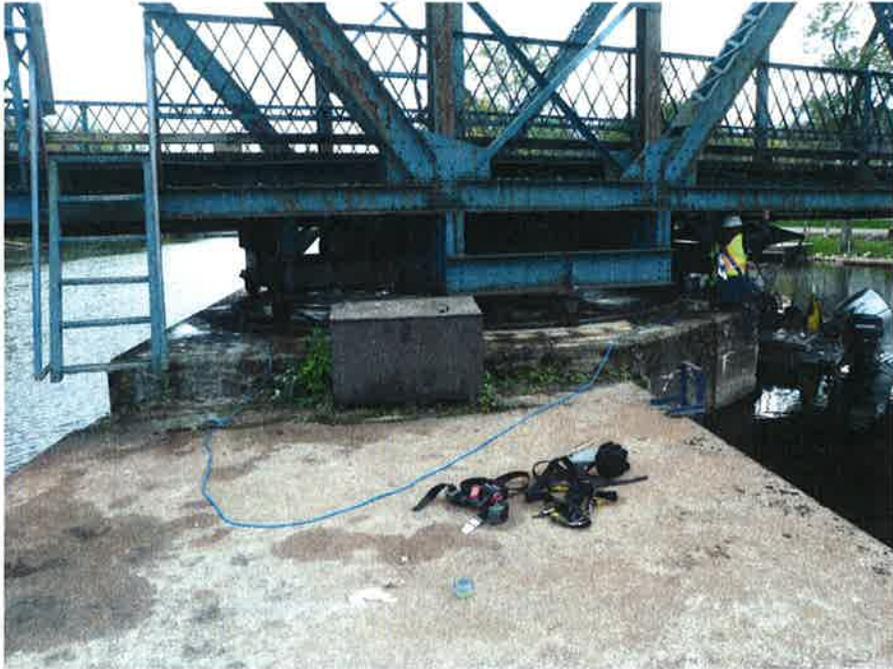
A visual condition survey was carried out on the top surface of the centre pivot pier. Photographs of the north side of the pivot pier and the pier extending north from the pivot pier are shown on Figures 4-10 to 4-12. Photographs of the south side of the pivot pier and the pier extending south from the pivot pier are shown on Figures 4-13 to 4-15. The overall condition of the top surface of the pivot pier is shown in Figure 5-3 in Attachment 5. The top surface of the pivot pier exhibited some spalling or heavy scaling over several areas. Random stained cracks were also observed, concentrated mostly in the northeast and southeast corners of the pivot pier.

Figure 4-10 Overview of north side of pivot pier.

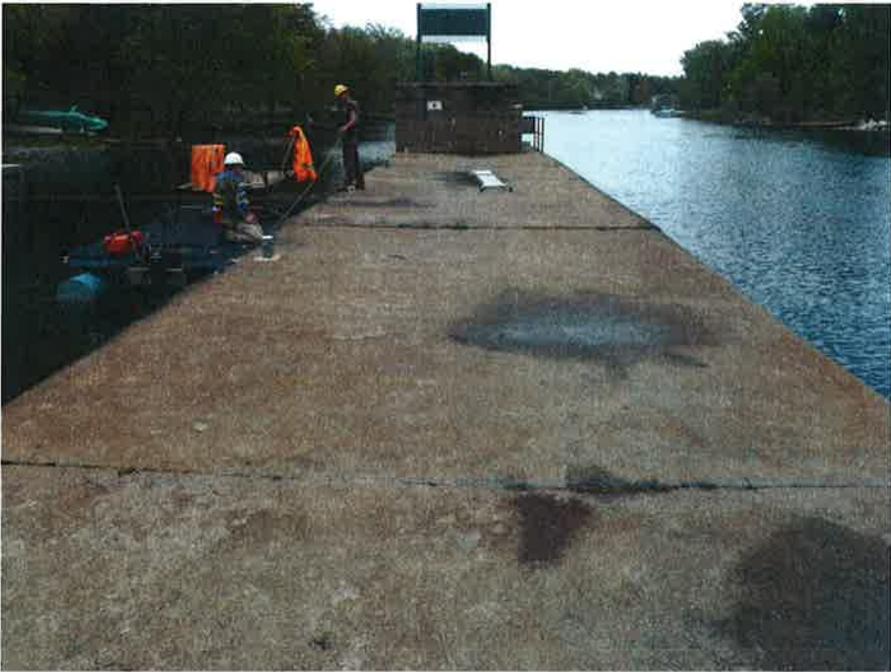
Figure 4-11 Overview of centre pivot pier facing north.

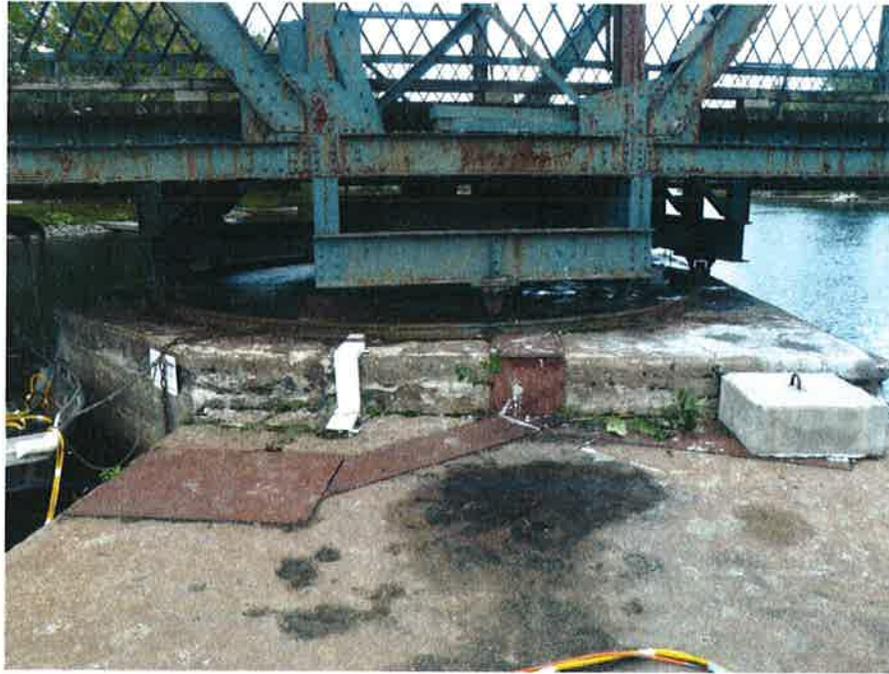
Figure 4-13 Overview of south side of pivot pier.

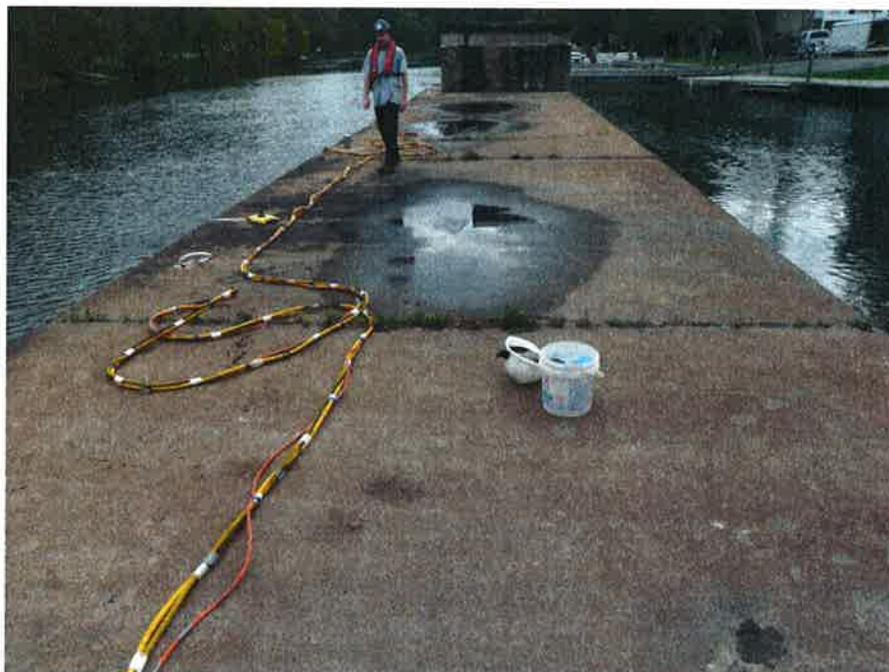
Figure 4-14 Overview of centre pivot pier facing south.

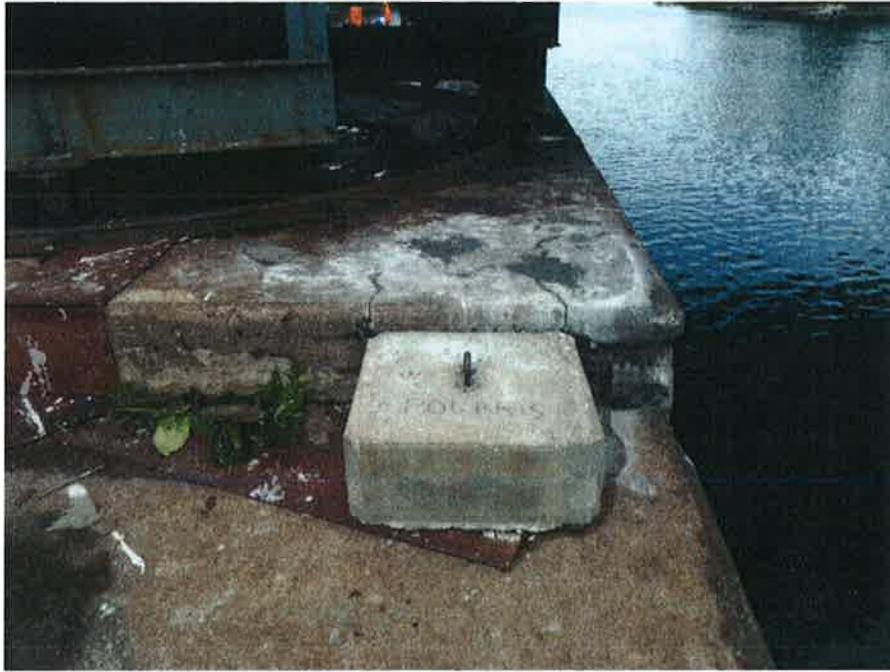
Core No.		C13	C14	
Location (Station, Gridline), m		Central Pivot Pier	Central Pivot Pier	
Diameter, mm		94	94	
Length, mm		190	200	
Full Depth		N	N	
Condition of Concrete ¹		G	G	
Defects in Concrete		N	N	
Condition of Reinforcing steel bar ²		N/A	N/A	
Corrosion Potential at Nearest Grid Point, V		N/A	N/A	
Compressive Strength, MPa		30.3	34.6	
Chloride Content % Chloride by Weight of Concrete	Horizon			
	0–10 mm			
	20–30 mm			
	40–50 mm			
	60–70 mm			
	80–90 mm			
	100-110 mm			
	105-115 mm			
140-150 mm				
160-170 mm				
Air Voids	Air Content, %			
	Specific Surface, mm ² /mm ³			
	Spacing Factor, mm			
Testing Laboratory		Golder Associates Ltd.	Golder Associates Ltd.	
Remarks		Surface of concrete lightly scaled or spalled. No significant defects in core body. Some coarse aggregate particles, max size >40mm.	Surface of concrete lightly scaled or spalled. No significant defects in core body. Some coarse aggregate particles, max size >40mm.

Figure 4-15 Location of cores C13 and C14 on south side of pivot pier.
