Hamlet Bridge (Bridge 57) Comprehensive Detailed Inspection and Structure Evaluation Report (PCA Project No. 2011-4650-20027340)

Comprehensive Detailed Inspection and Structure Evaluation Report

Parks Canada Project No. 2011-4650-20027340

Delcan Corporation

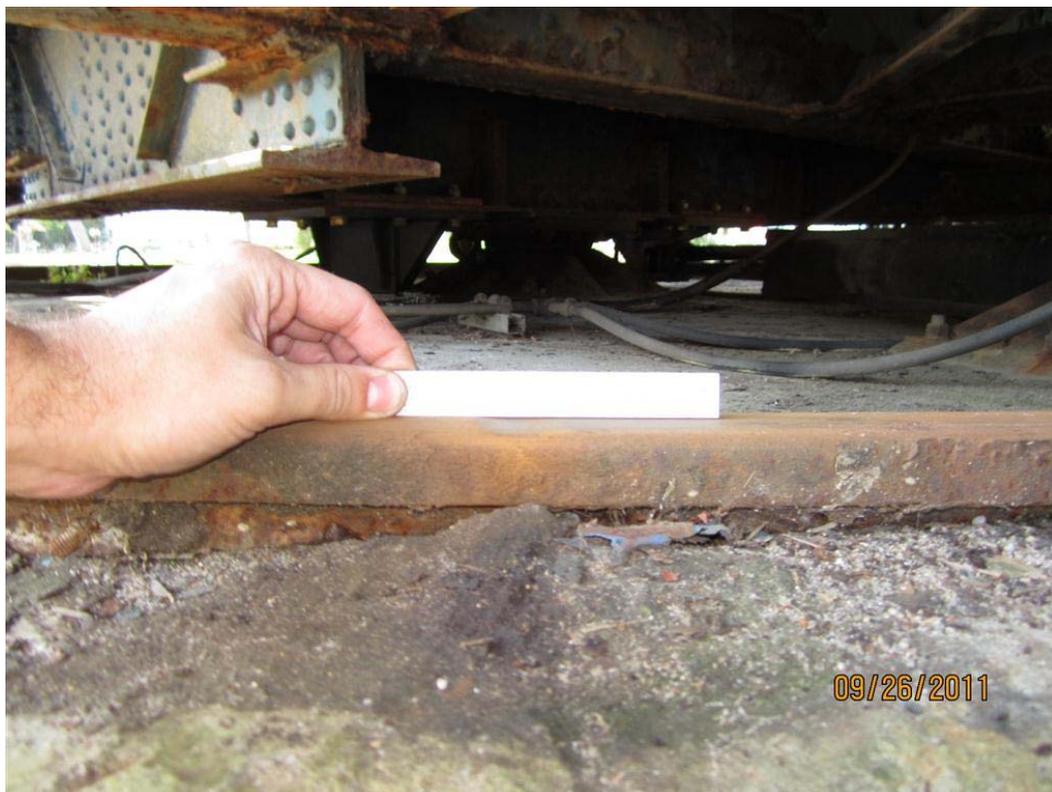
Photo M4: There is an impression on top of the rail from the wheel as a result of carrying live load.

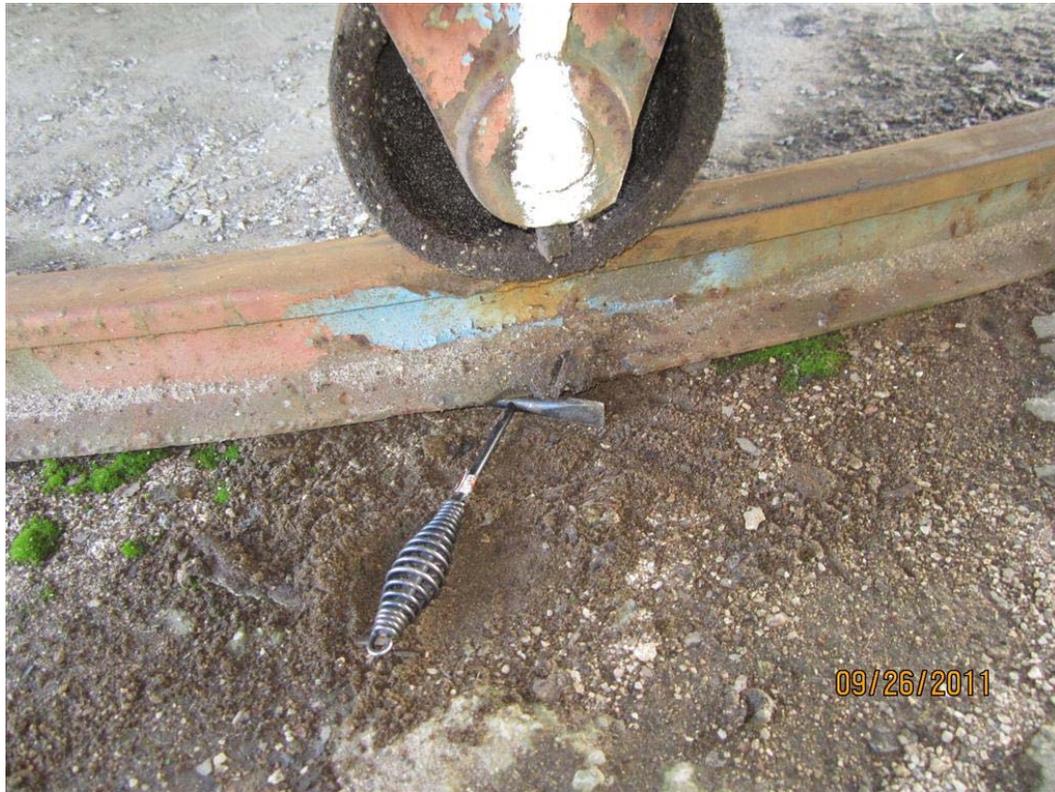
Photo M5: The rail support pier is undermined along a significant portion of the rail.

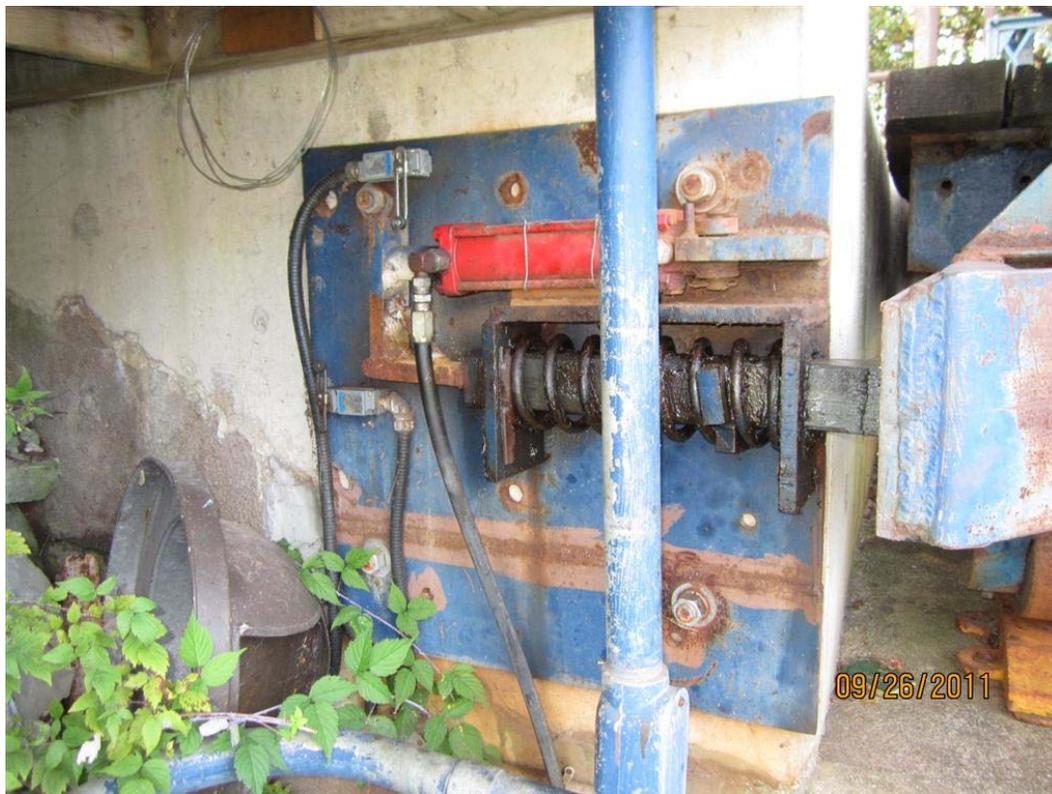
Photo M10: General view of the west locking pin machinery.

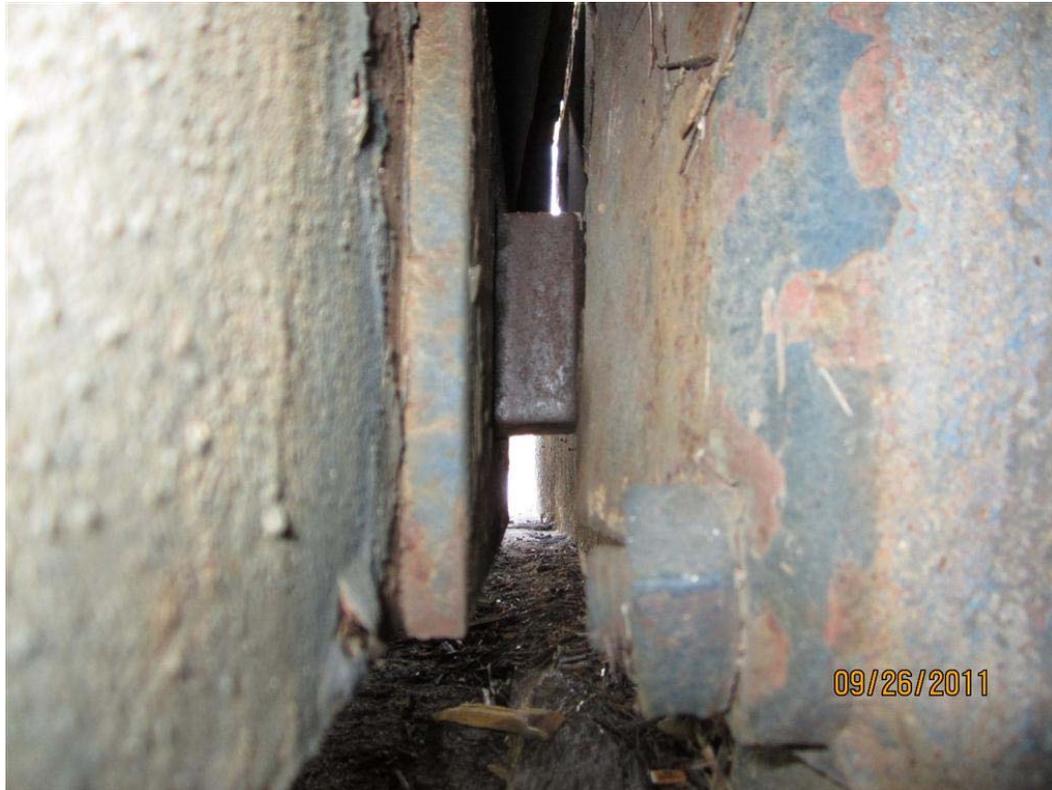
Photo M11: The east centering lock pin does not travel far enough to engage the receiver.

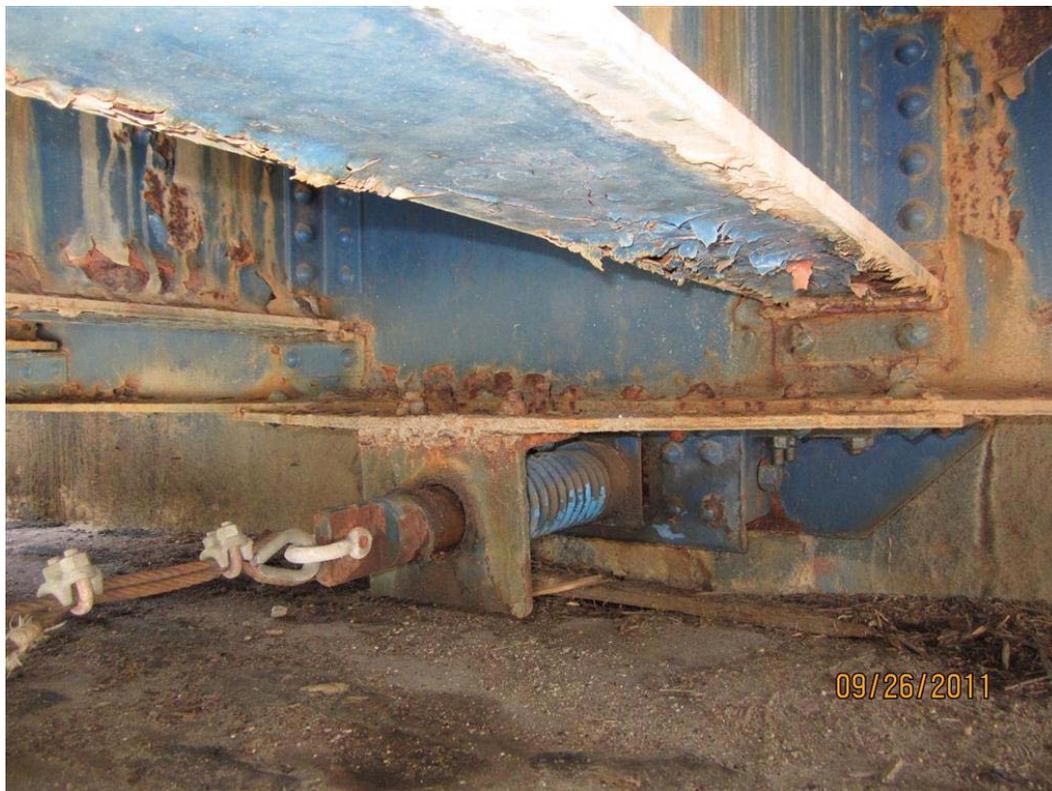
Photo M12: General view of the east locking pin.

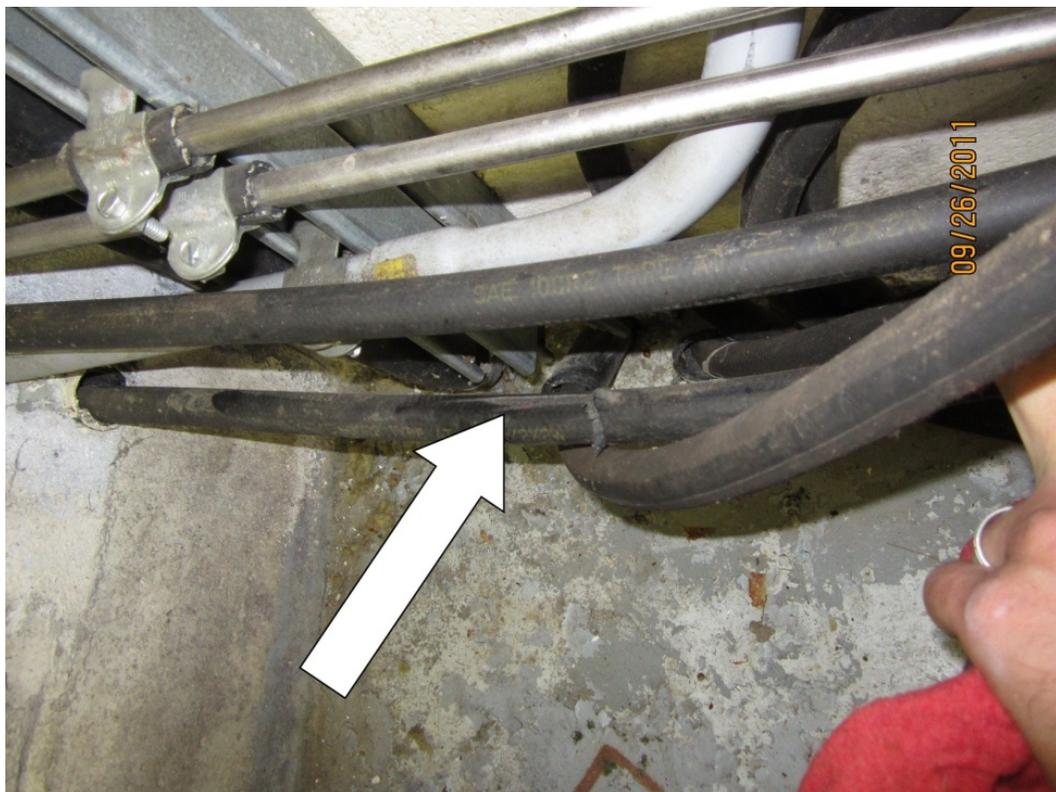
Photo M16: HPU. One hose is abraded at a location near the hose exit from the operator's house.

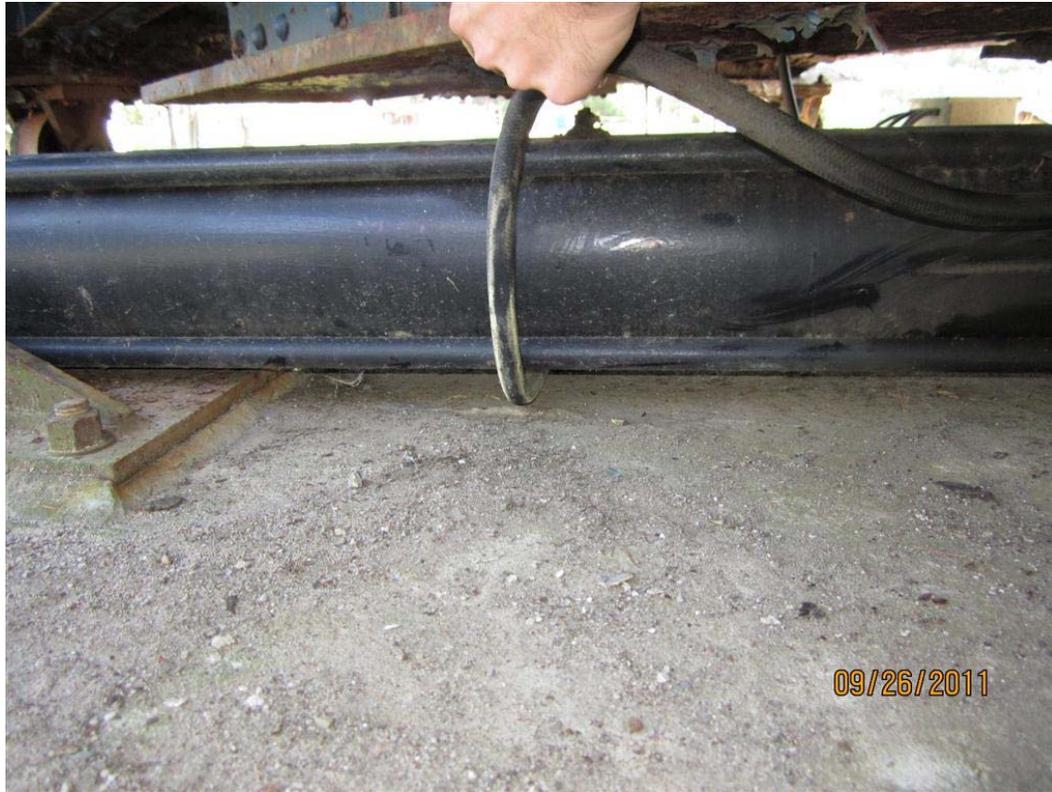
Photo M17: The flexible hoses that connect the span drive cylinders to the hard piping are abraded.

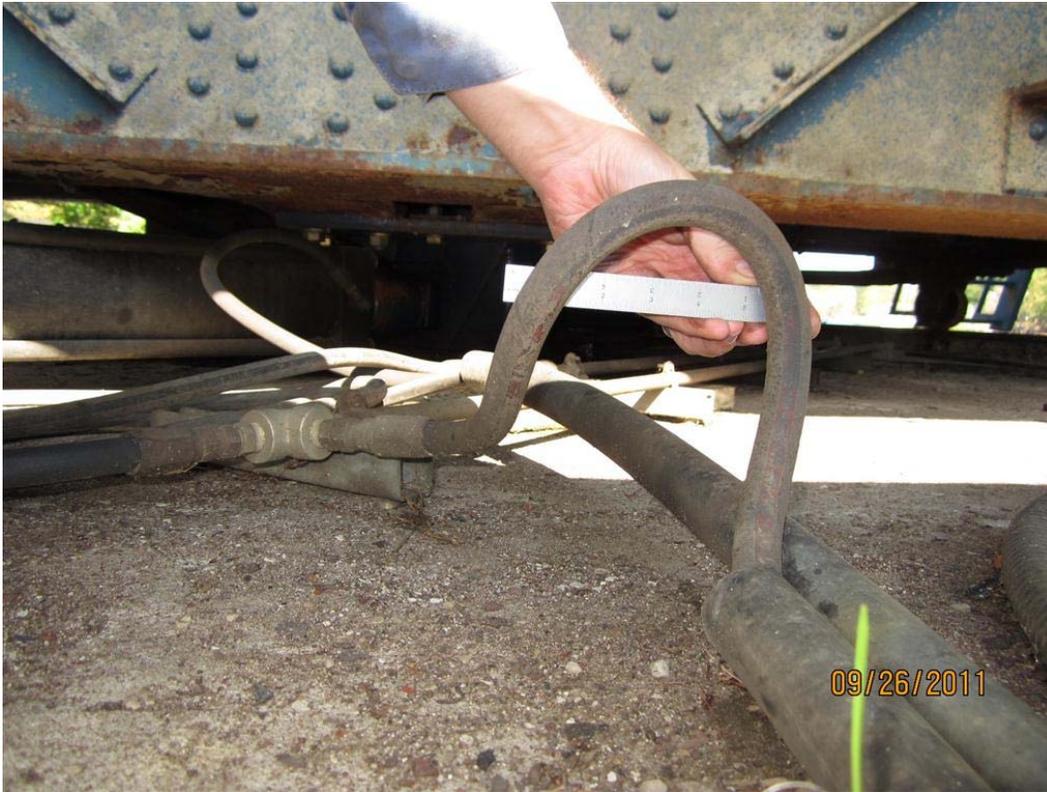
Photo M19: The blind end flexible hose connecting the HPU to the piping at the pier exhibits a severe bend radius (less than 120 mm radius).

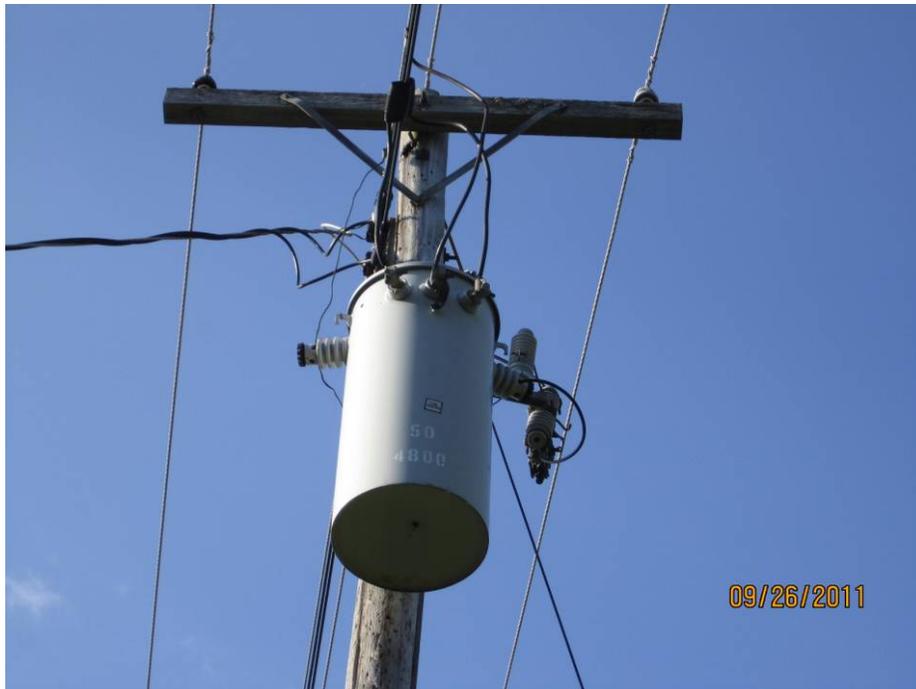
Photo E1: Existing oil filled pole mounted transformer providing 120/240V, single phase service for the bridge operating system. Note the lightning and fused cutouts used to protect the transformer installation.

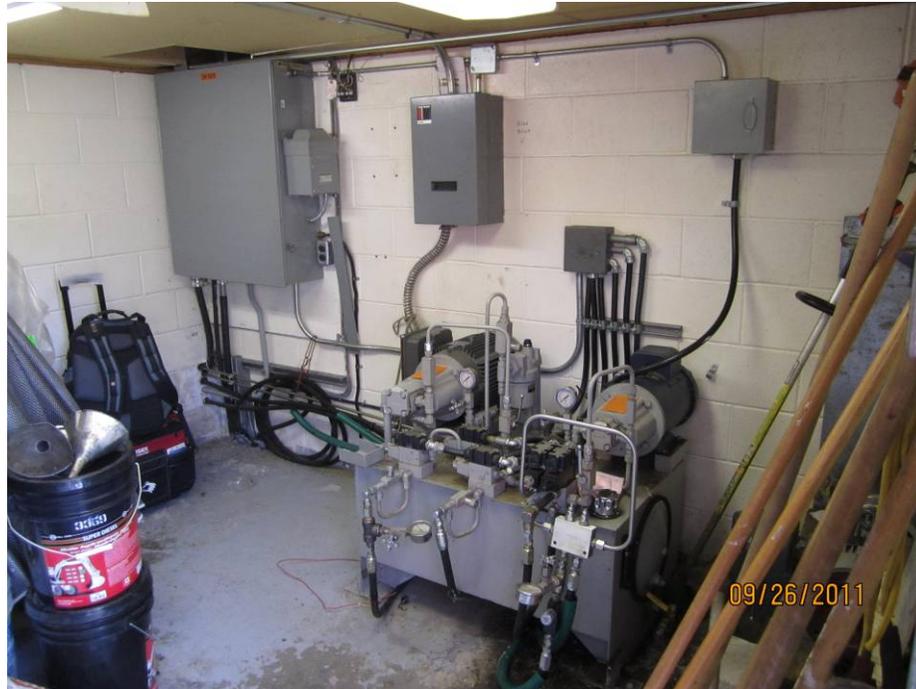
Photo E3: The swing span hydraulic pump motor, end lift / locking pin hydraulic pump motor, and solenoid valve system was replaced as part of the 1991/1992 rehabilitation and, as can be seen, is in good operational condition having been well installed and housed in the protected area of the bridge control building.

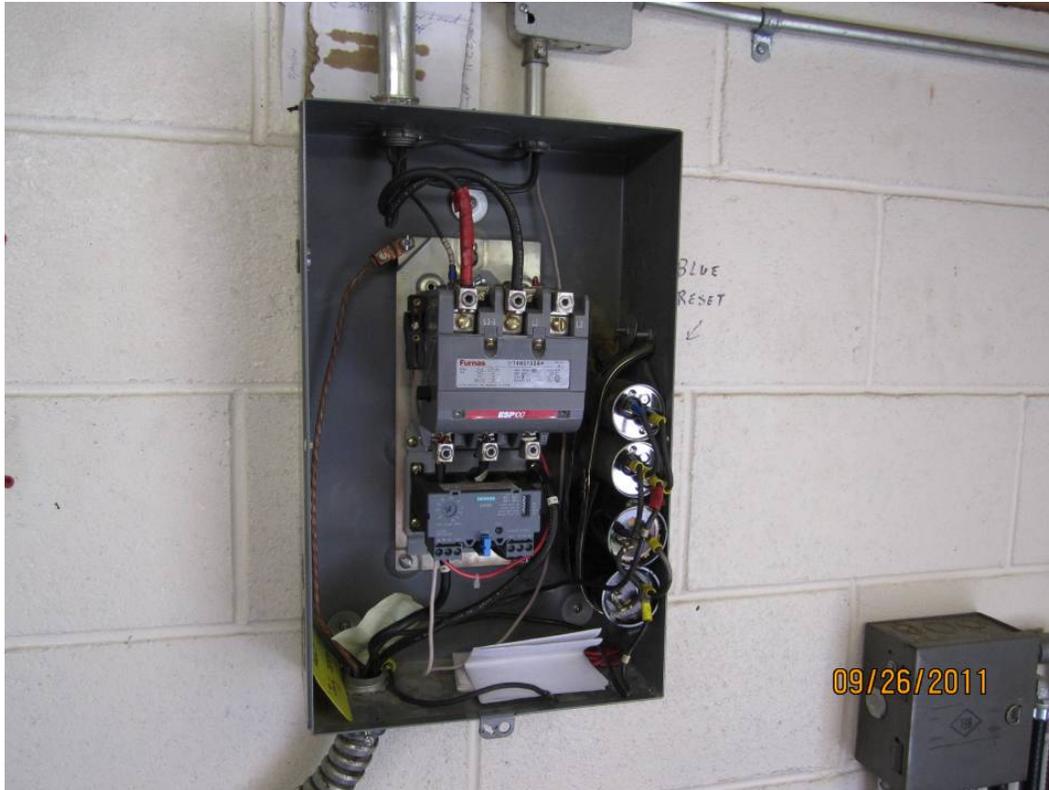
Photo E5: Swing Span Hydraulic Pump Motor Starter. Note the as new condition of the starter (Replaced in 2009).

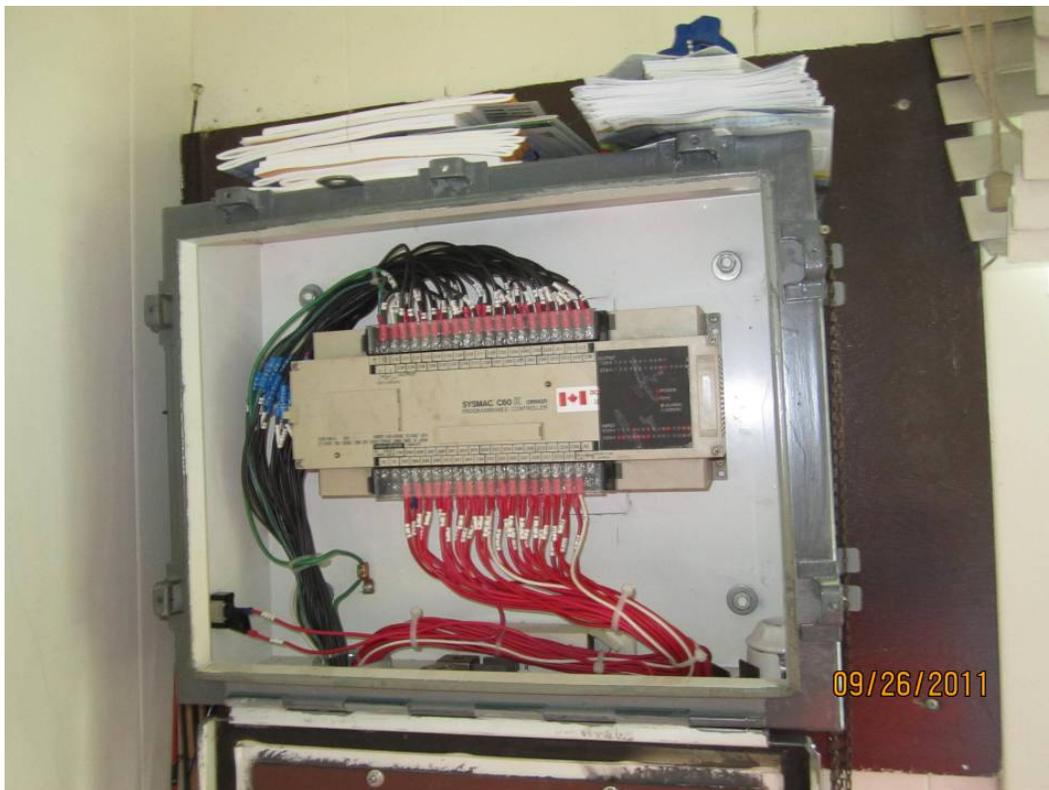
Photo E6: PLC Controller in the wall mounted enclosure. Note the PLC controller is obsolete.

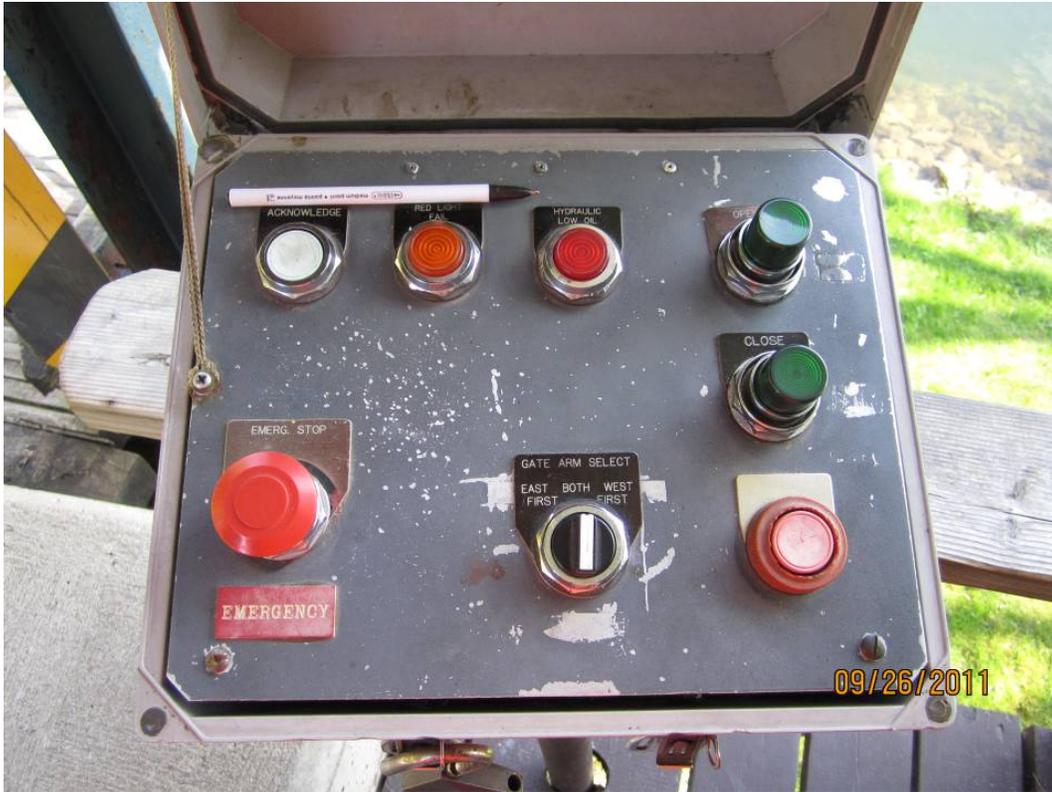
Photo E7: Bridge Operators Control Console. Note the two pushbutton controls for traffic control and bridge operation and the limited indication lights for status indication. Additionally, note the pushbutton at the lower right hand corner is not labelled.

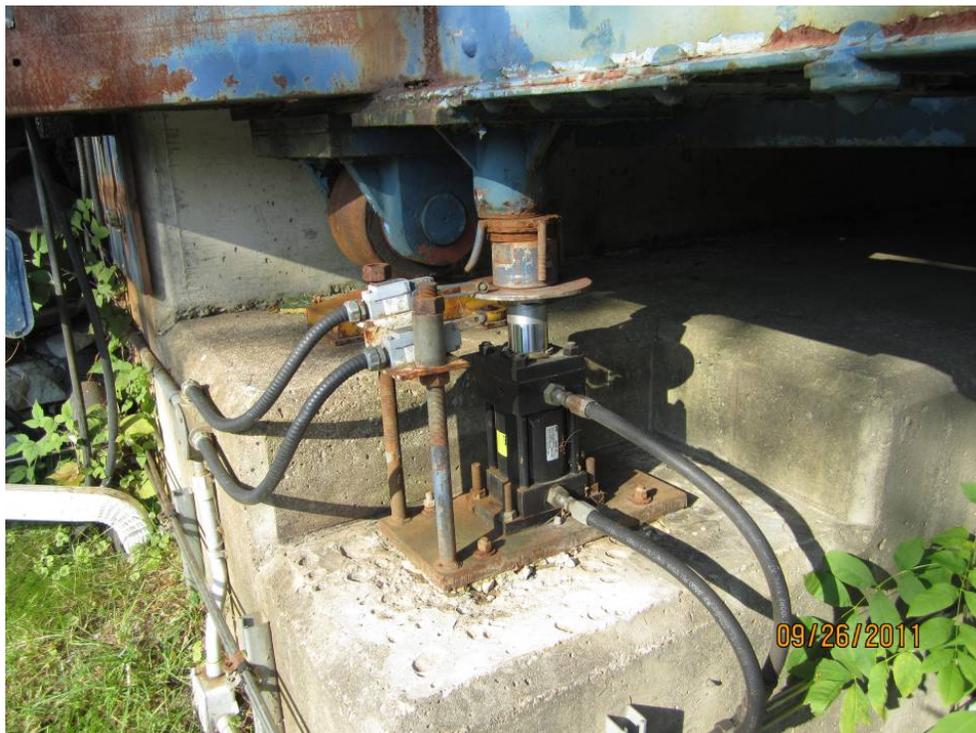
Photo E8: Bridge End Lift System. Note the corrosion on the limit switch support.

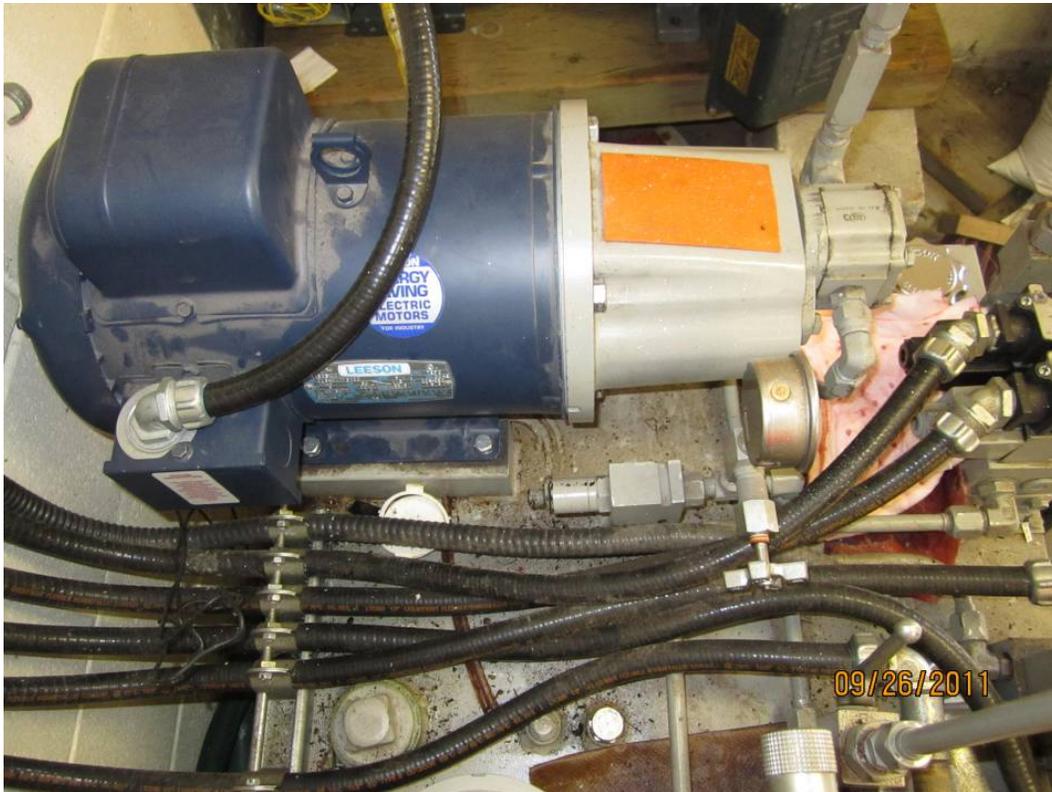
Photo E9: End Lift / Locking Pin Hydraulic Pump Motor. Note the as new condition of the motor.

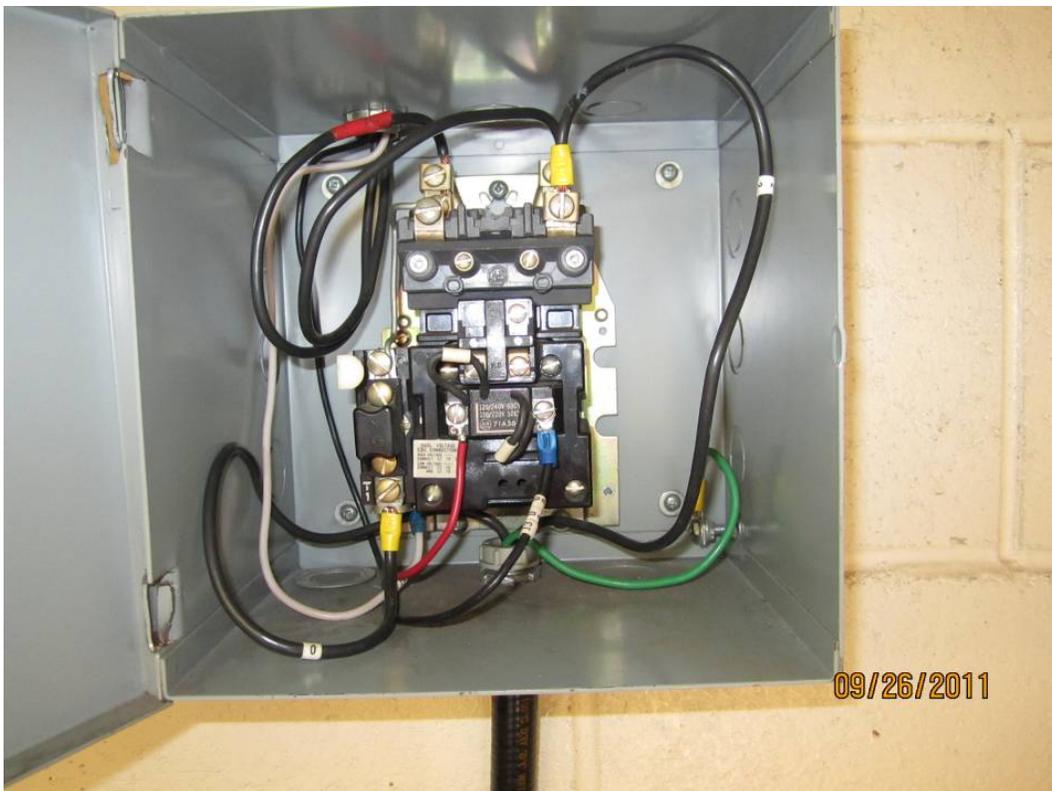
Photo E10: End Lift / Locking Pin Hydraulic Pump Motor Starter. Note the starter is a single phase starter provided with thermal overload protection.

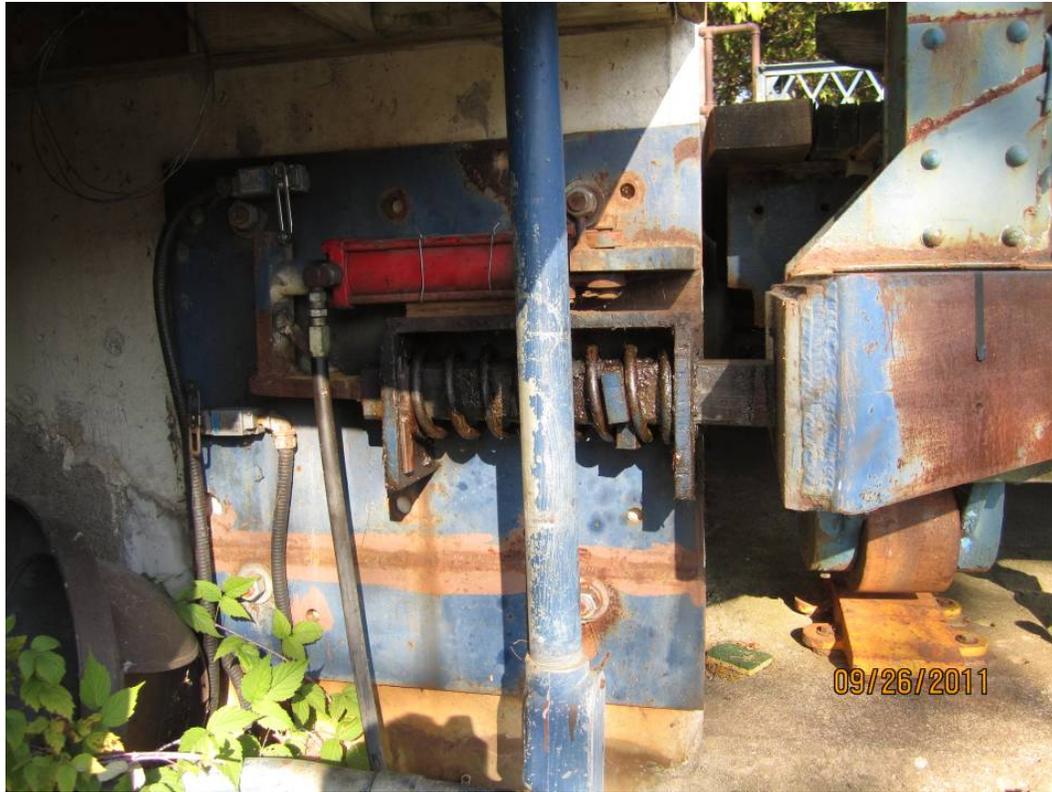
Photo E11: West Locking Pin. Note the corrosion on the mounting plate.

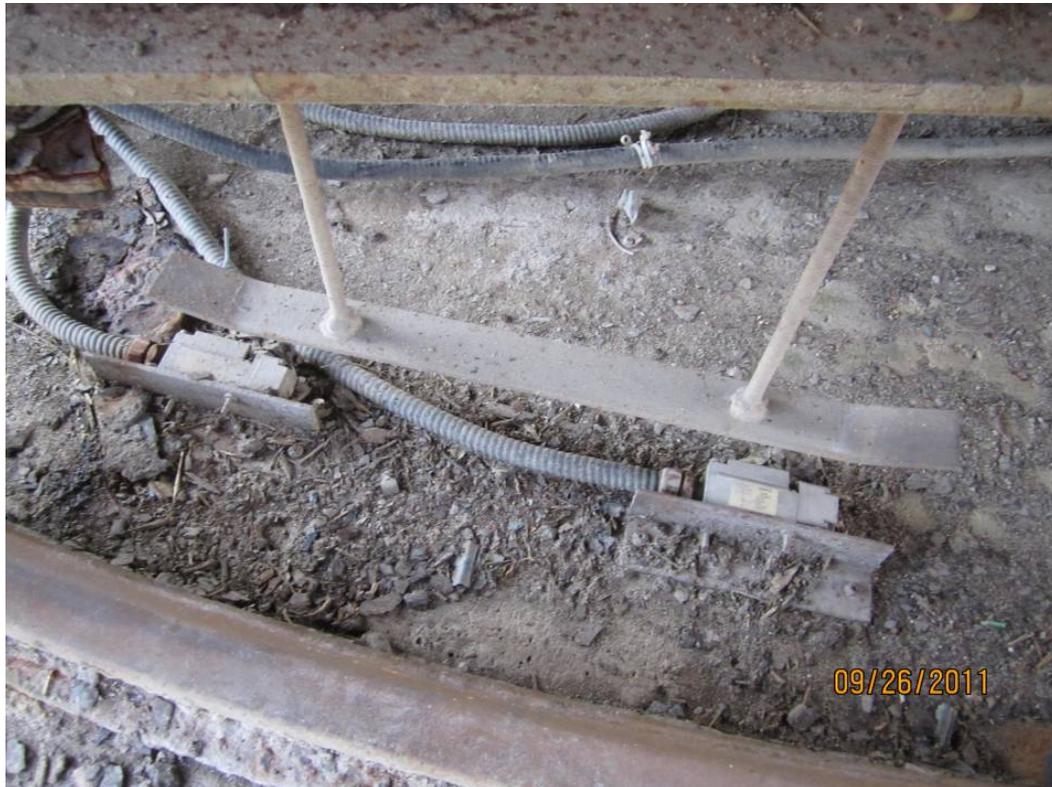
Photo E12: Typical Bridge Drive System Control Limit Switches. Note the debris on and around the limit switches.

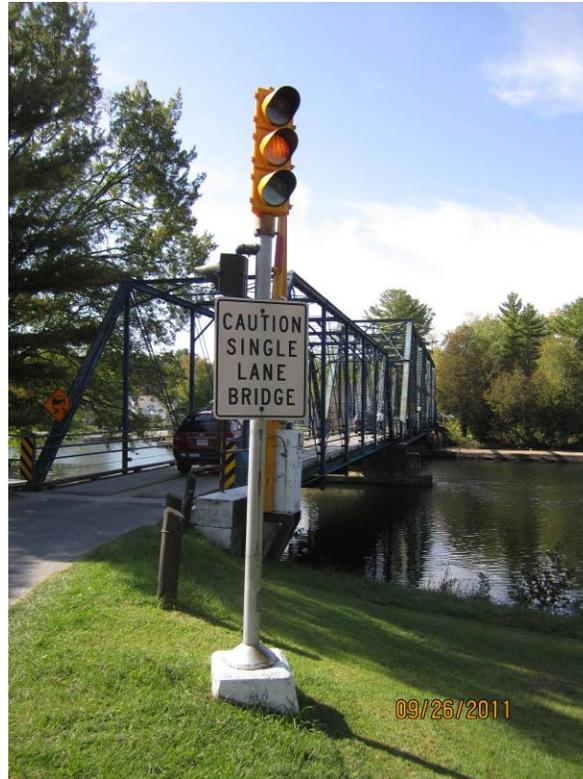
Photo E13: Typical Traffic Signal. Note the good condition of the pole and the signal heads. Also note the warning sign mounted on the signal pole.

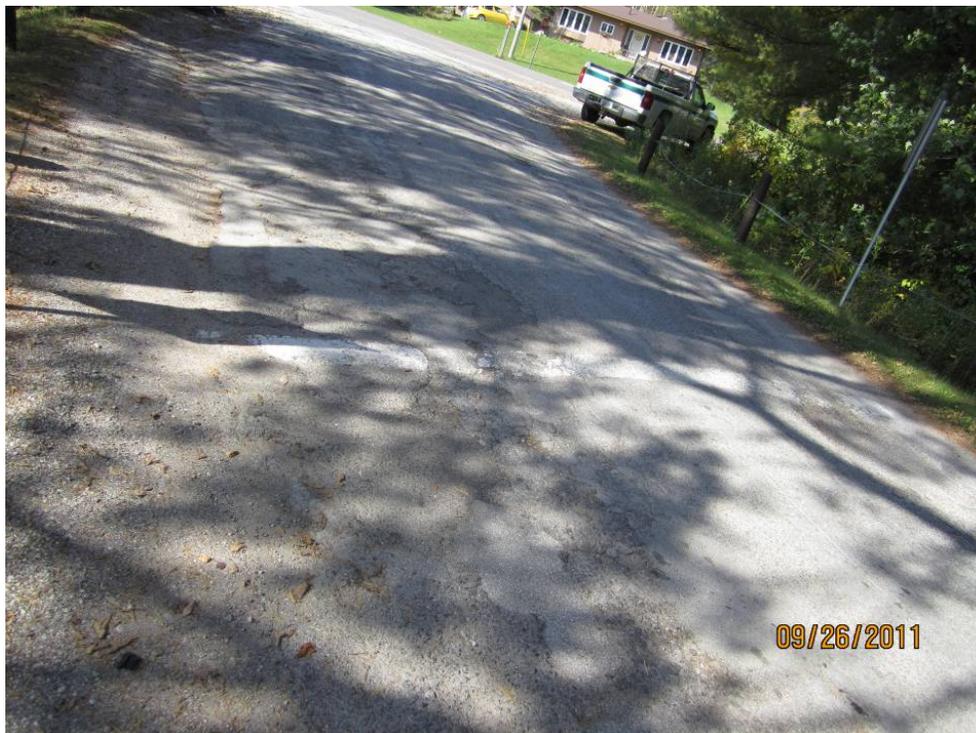
Photo E14: West Approach Stop Bar. Note the stop bar is heavily worn.

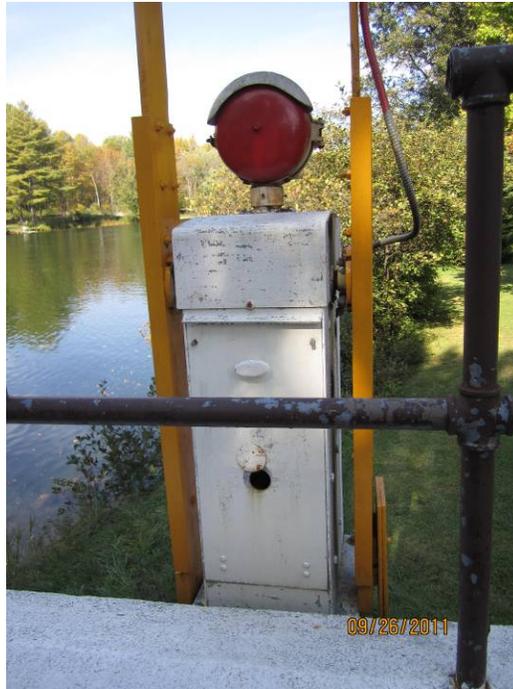
Photo E15: Typical Traffic Gate. Note the gong is provided on top of the gate enclosure to provide audible warning for the traveling public. Also note the cutout for the hand crank mechanism.

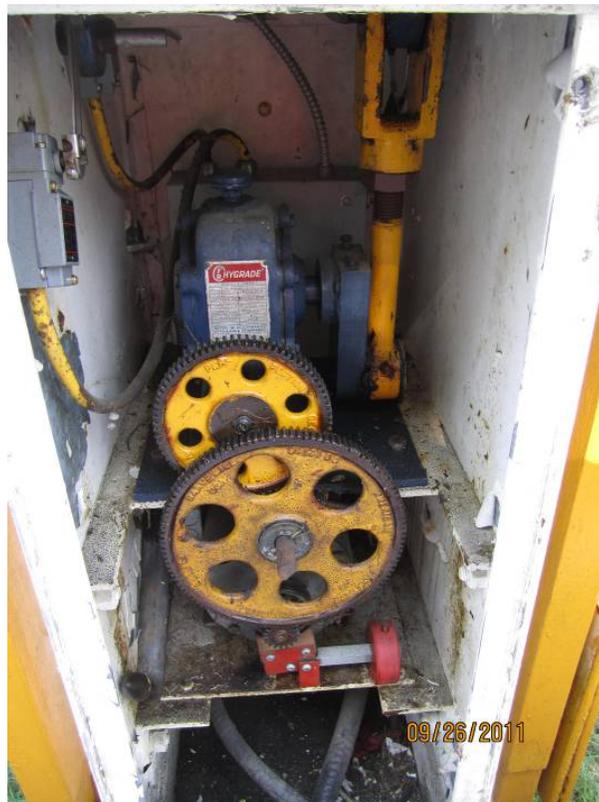
Photo E16: Typical Traffic Gate Equipment. Note the gate is provided with raised and lowered limit switch but no hand crank limit or door switches are provided.

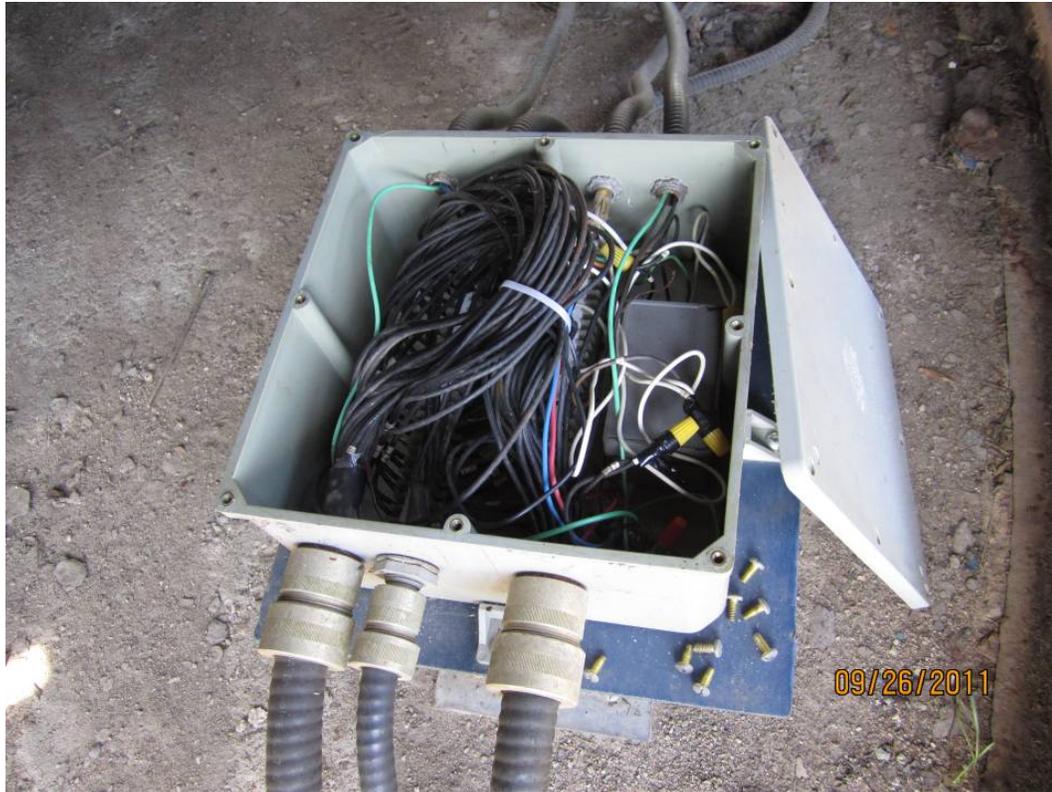
Photo E19: Center Pier Submarine Cable Junction Box. Note the poor installation of the wires.

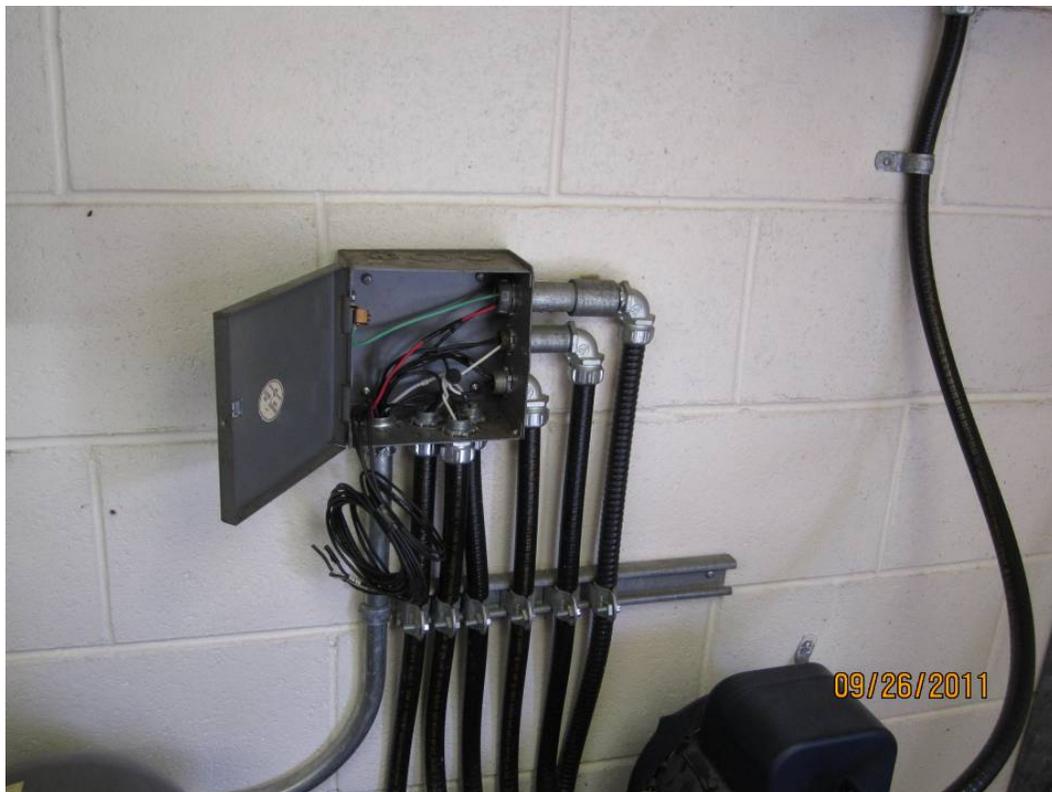
Photo E20: Typical Junction Box. Note the spare or unused wires are not properly terminated.

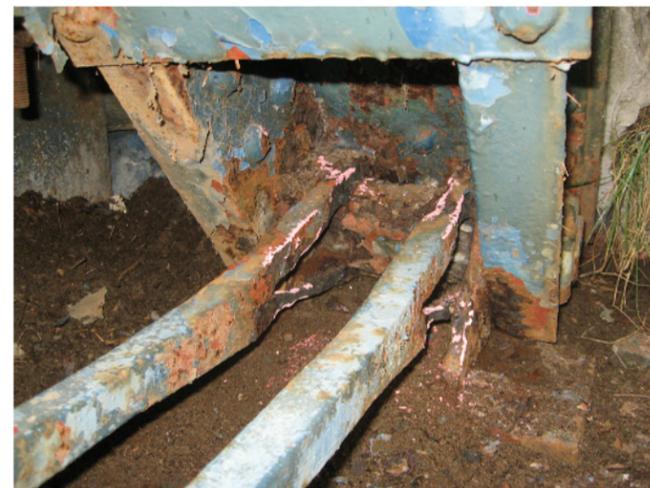
PHOTO AT EAST ABUTMENT

(SOUTH BEARING SHOWN, NORTH BEARING SIMILAR)
