EXECUTIVE SUMMARY

Delcan Corporation (Delcan) has been retained by Public Works and Government Services Canada to conduct visual evaluations of 56 bridge structures and 6 culvert structures along the British Columbian portion of the Alaska Highway in both 2009 and 2011. Also, as part of this contract, Delcan was to complete live load capacity factor structural evaluations for 11 of the Alaska Highway bridge structures. In 2009, Delcan performed 6 of these live load capacity factor structural evaluations: Beaton River at km 232.8, Sikanni Chief River at km 256.1, Buckinghorse River at km 277.6, Bougie Creek at km 357.4, Adsett Creek at km 366.0, and Jackfish Creek at km 424.8. Enclosed in this submission are the live load capacity factor structural evaluations performed for the 5 other bridge structures: Kledo River at km 509.1, Steamboat Creek at km 515.3, Tetsa River 1 at km 584.6, Toad River at km 671.7, and Peterson Creek at km 678.6. Also enclosed are the 2009 condition inspection reports for these 5 bridges.

Kledo River Bridge, Alaska Highway, km 509.1 Live Load Capacity Factor Structural Evaluation

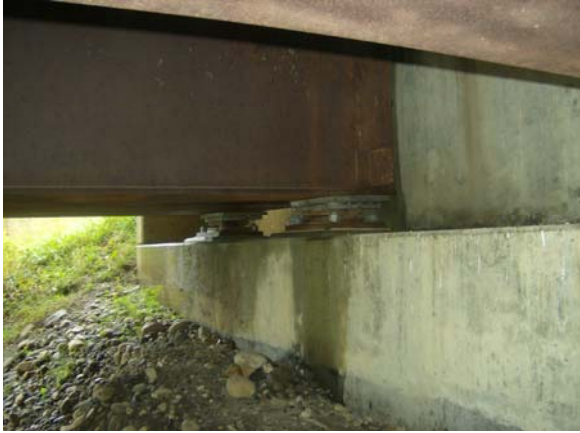
Figure 7: Box Girder Bearing.

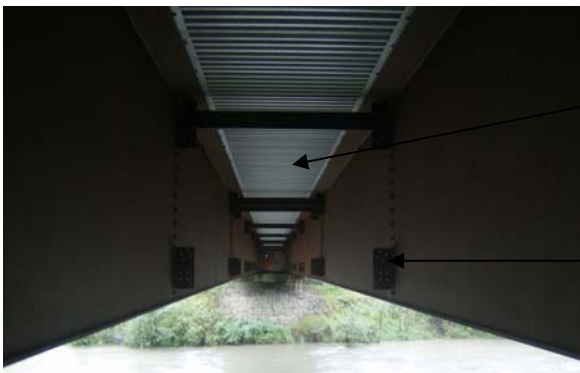
Figure 8: Between Box Girders.

Stay-in-Place Steel Deck Formwork.

Properly Removed Transverse Bracing from Between Box Girders.

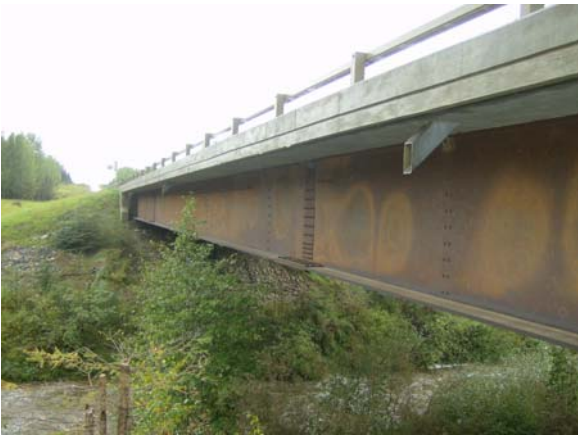
Figure 5: Exterior Girder.

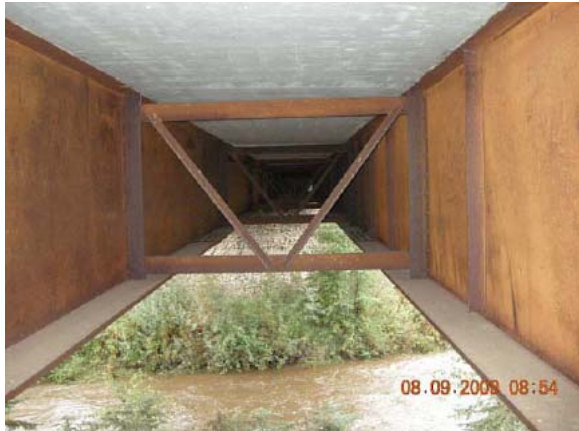
Figure 9: Intermediate Bracing.

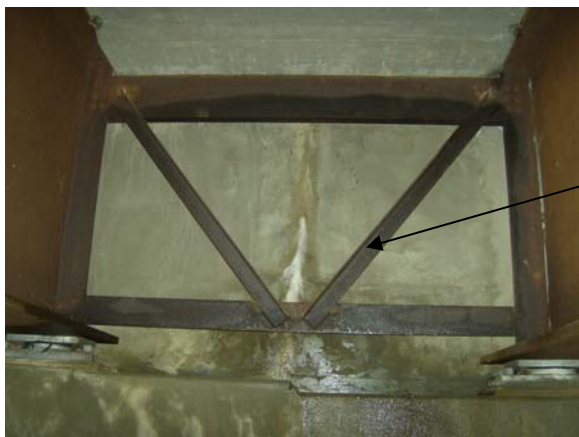
Figure 10: End Bracing.

End Diagonal Bracing Orientation is Shown Differently on Original Structural Drawings.

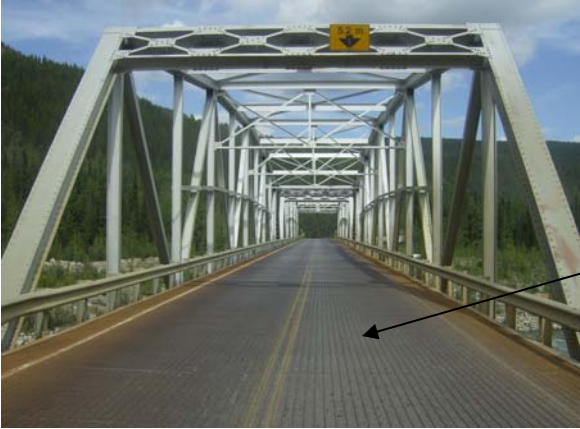
Figure 4: Deck.

Steel Grating Deck.

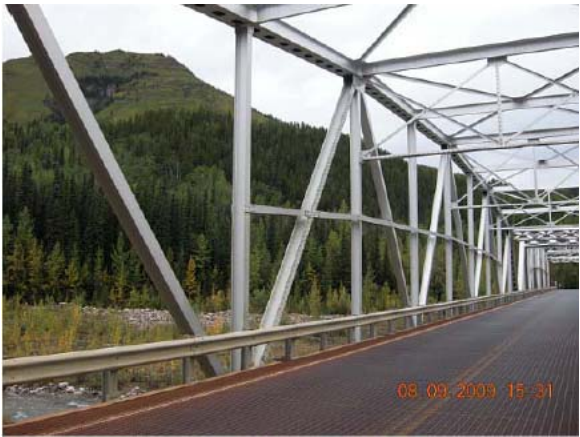
Figure 5: Truss.

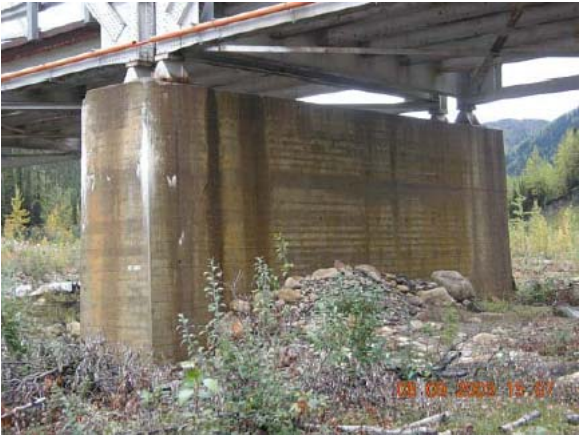
Figure 6: Truss-Span to Truss-Span Pier.

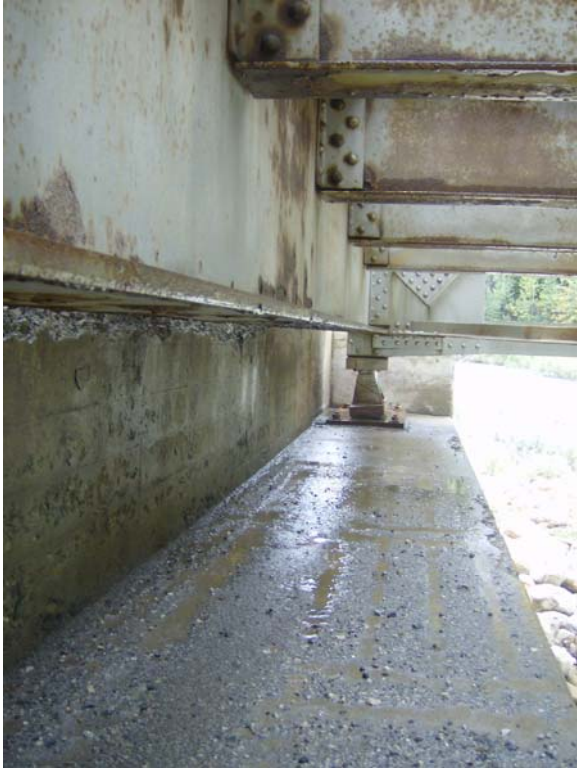
Figure 7: Truss Bearing.

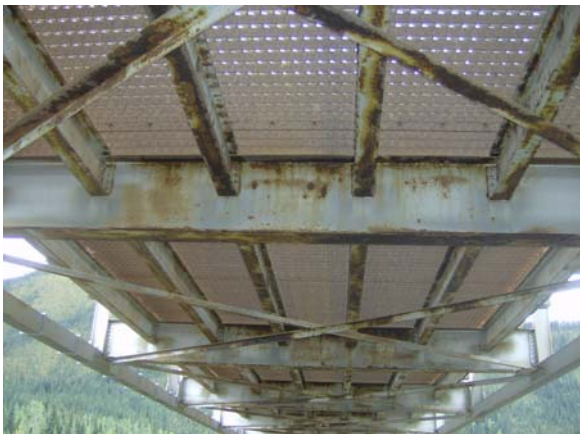
Figure 8: Stringer Lines.

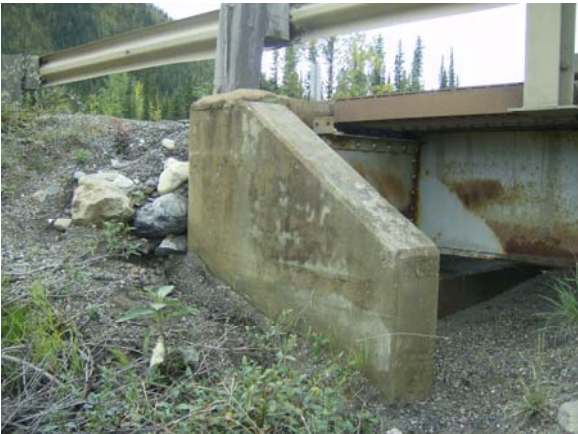
Figure 20: Jackspan Abutment.

Unused Steel Brackets Still Attached to Exterior Sides of Exterior Jackspan Girders.

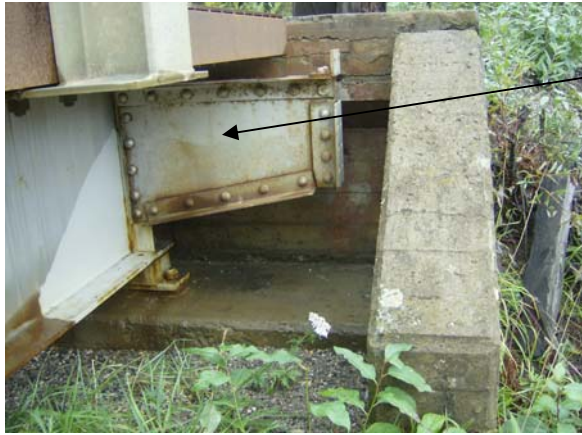
Unused Steel Brackets Still Attached to Exterior Sides of Exterior Jackspan Girders.

Figure 21: Exterior Jackspan Girder Bearing.

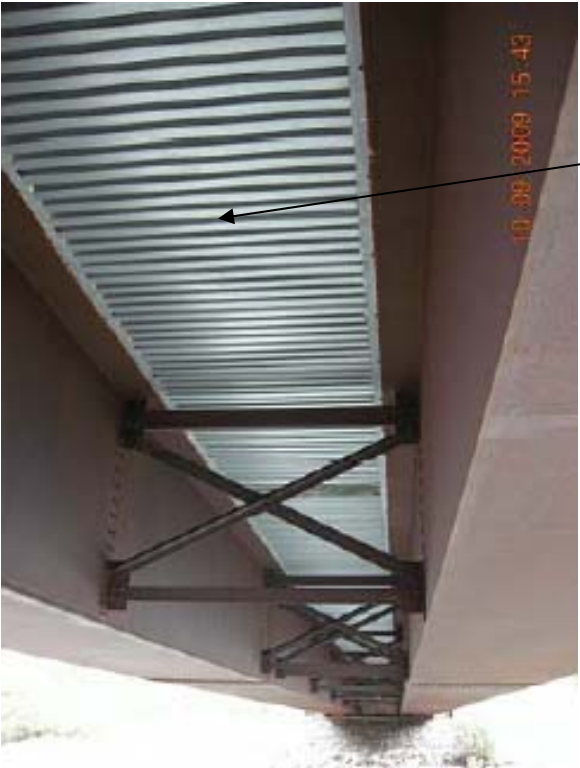
Figure 8: Between Box Girders.

Stay-in-Place Steel Deck Formwork.

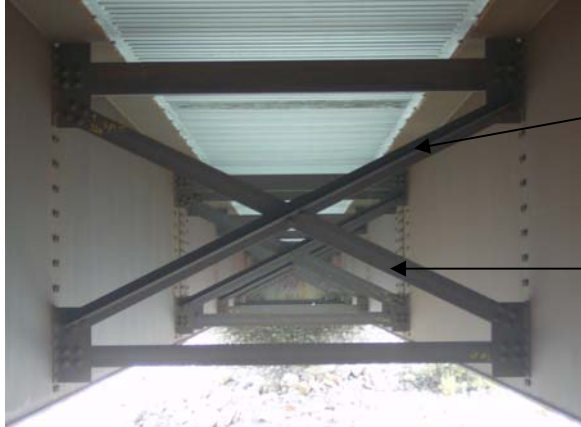
Figure 9: Intermediate Bracing.

Bracing Between Box Girders
Not Properly Removed.

Bracing Orientation is Shown Differently
on Original Structural Drawings.

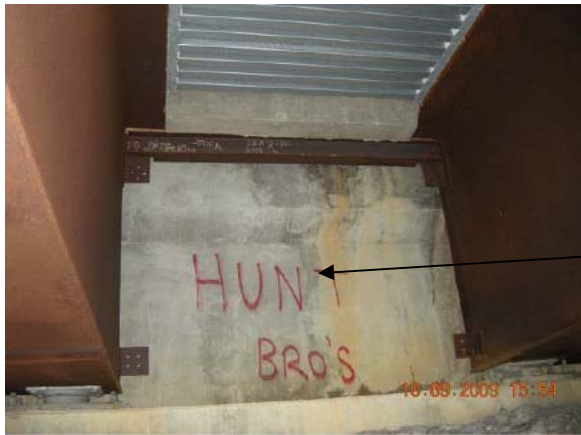
Figure 10: South End Bracing.

South End Bracing Not
Supposed to be Removed.

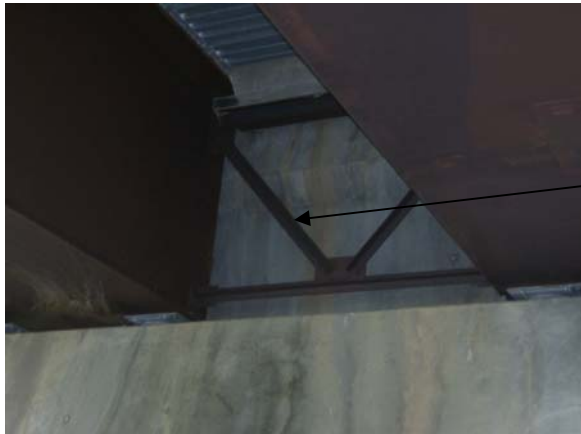
Figure 11: North End Bracing.

North End Bracing
Properly Left in Place.

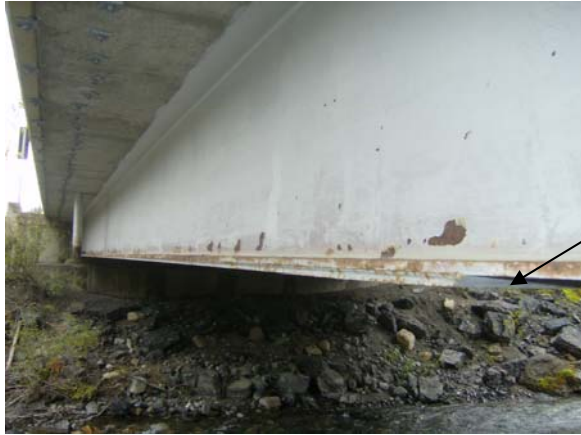
Figure 5: Exterior Girder.

Stiffening Plates Welded Along Centre Portions of Girders' Bottom Flanges (from the Time of Original Construction).
