**HAZARDOUS MATERIALS
REMOVAL SPECIFICATIONS
BEAVERLODGE RESEARCH CENTRE
PROJECT NO.: R.078150.002
BEAVERLODGE, ALBERTA**

Public Works and Government Services Canada

26 JULY 2016

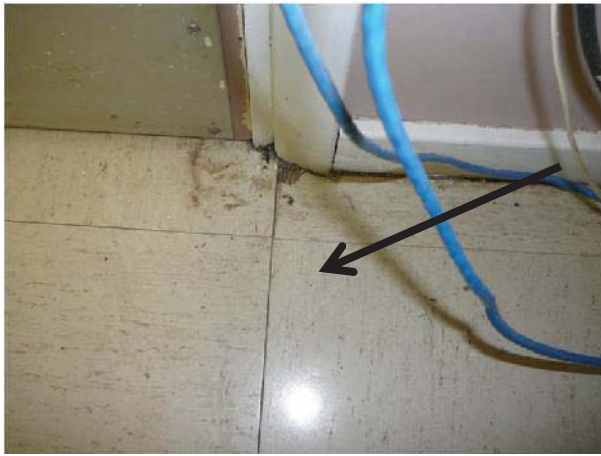
#53 Header House

Sample A26 : Floor tile containing asbestos in room 2E

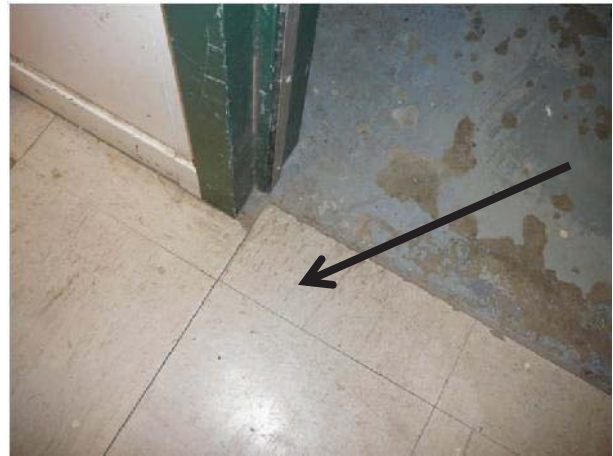
#53 Header House

Sample A27 : Floor tile containing asbestos in room 3E

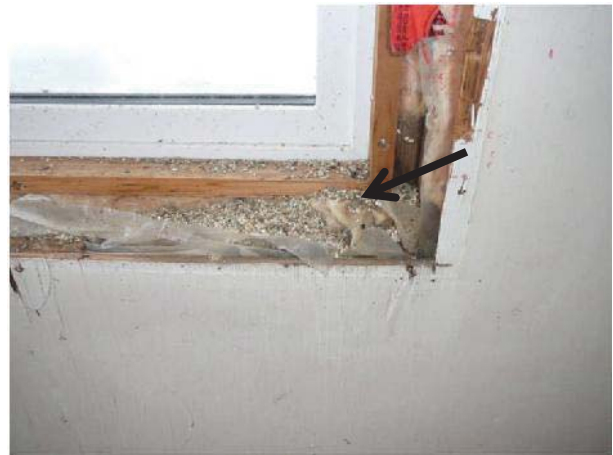
#54 Animal Hospital

Sample A45 : Insulation containing asbestos in the walls & ceiling

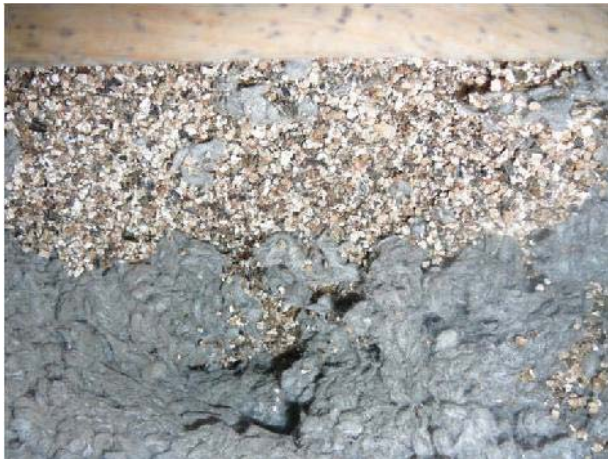
#2 Residence

Sample A63, A90 & A91 : Insulation containing asbestos in the attic

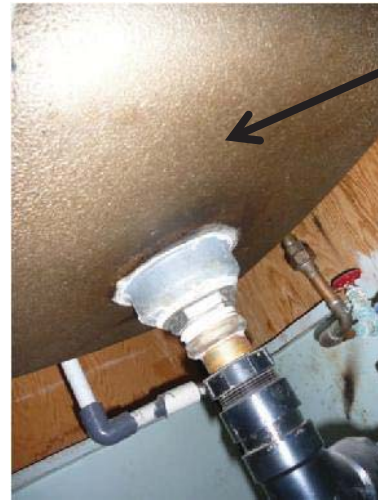
#53 Header House

Sample A64 : Sink insulation containing asbestos in room 2E

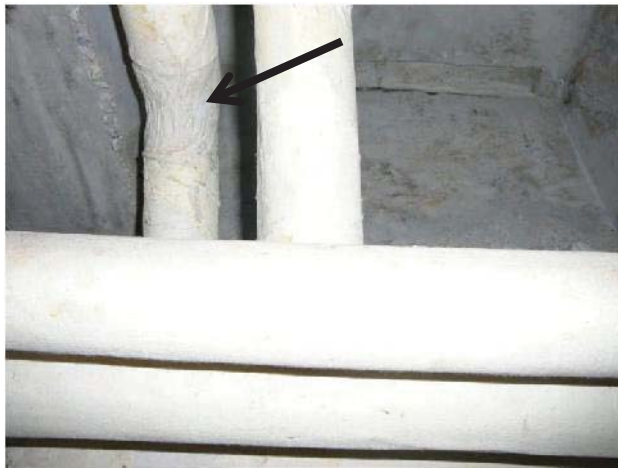
#21 Administration Building

Sample A65 & A66 : Pipe insulation containing asbestos in corridor 3

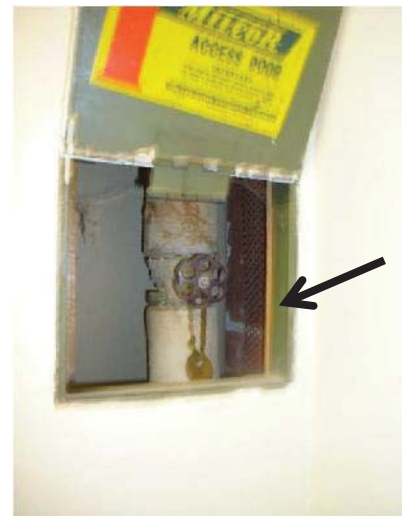
#21 Administration Building

Sample A67 : Pipe insulation containing asbestos in corridor 3

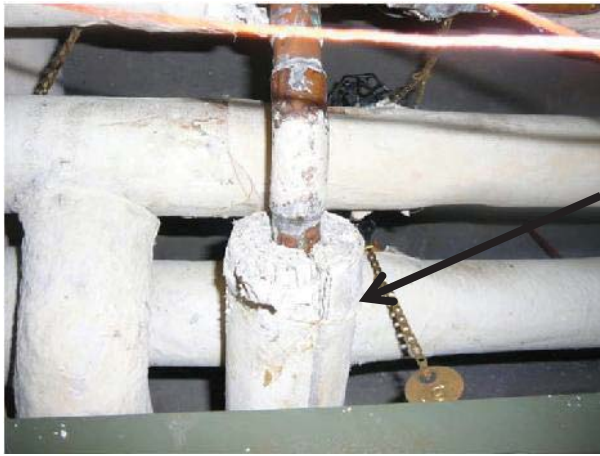
#21 Administration Building

Sample A68 : Pipe insulation containing asbestos in corridor 4

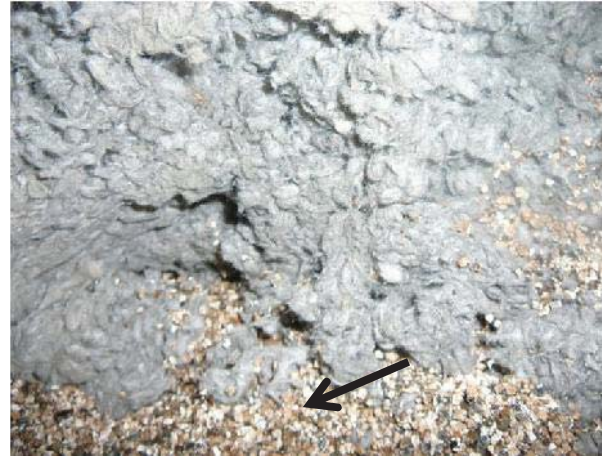
#38A Beef Unit Garage

Sample A69, A92 & A93 : Insulation containing asbestos in the attic

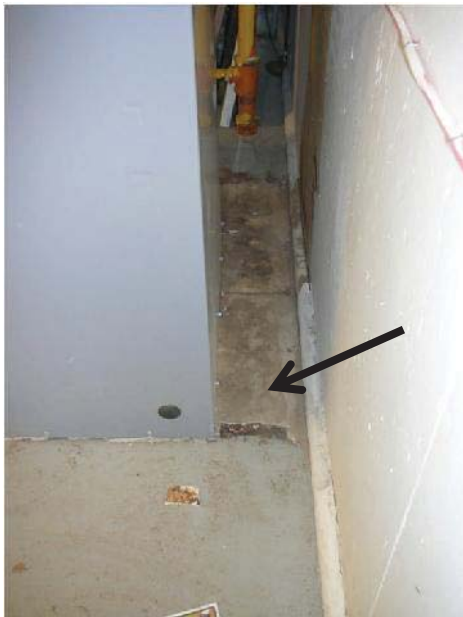
#38A Beef Unit Garage

Sample A70 : Floor tile containing asbestos in room 1

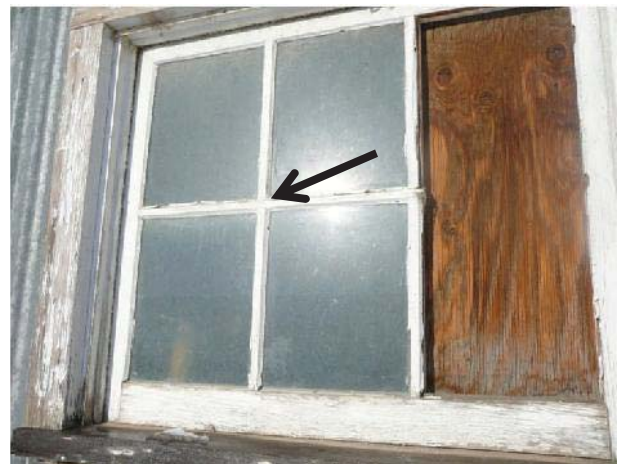
#40 Beef Unit Test Barn

Sample A72 : Window caulking containing asbestos on the exterior

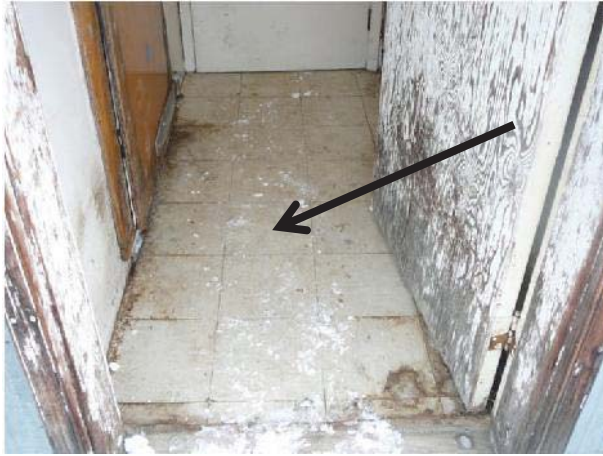
#54 Animal Hospital

Sample A74 : Floor tile containing asbestos in the entrance

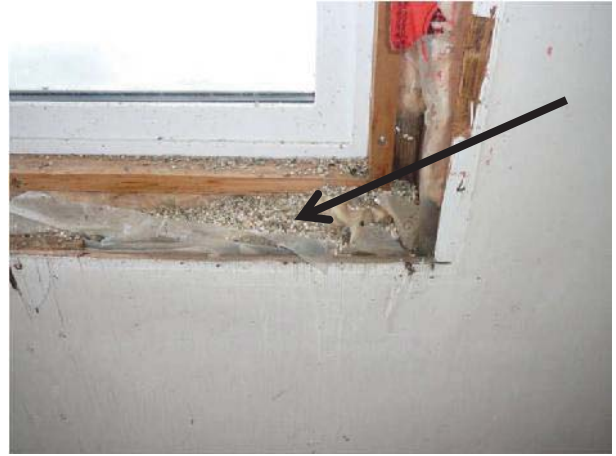
#54 Animal Hospital

Sample A75 & A29 : Insulation containing asbestos in the walls & attic

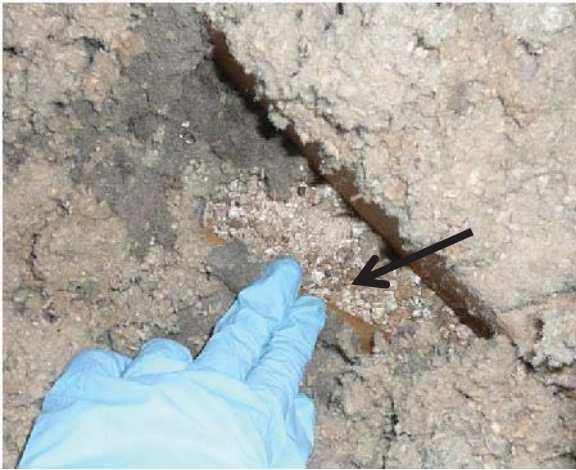
#41 Beef Unit Residence

Sample A58, A88 & A89: Insulation containing asbestos in the attic

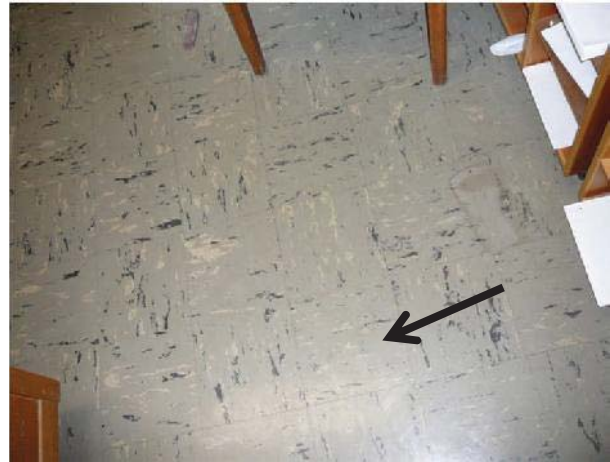
#21 Administration

Sample A94, A95 & A96: Floor tile containing asbestos in rooms 4 & 6

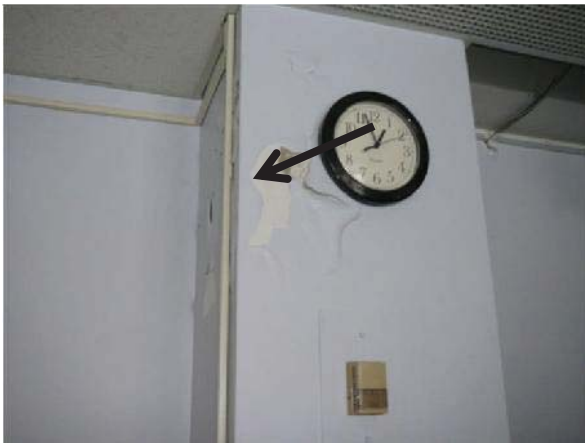
#21 Administration

Area of water damage in room 118

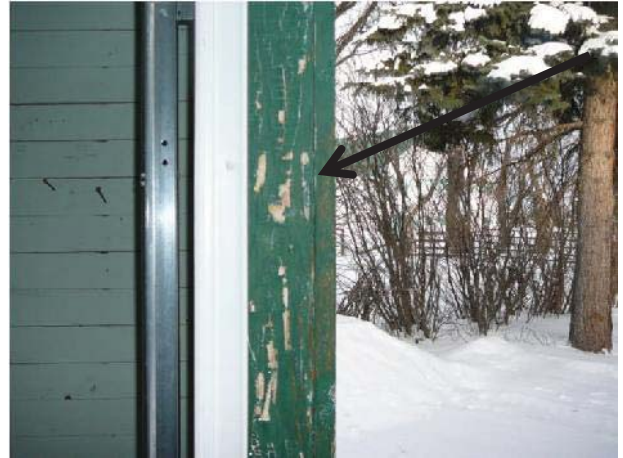
#2 Residence

Sample P13 : Dark green paint containing lead on the exterior

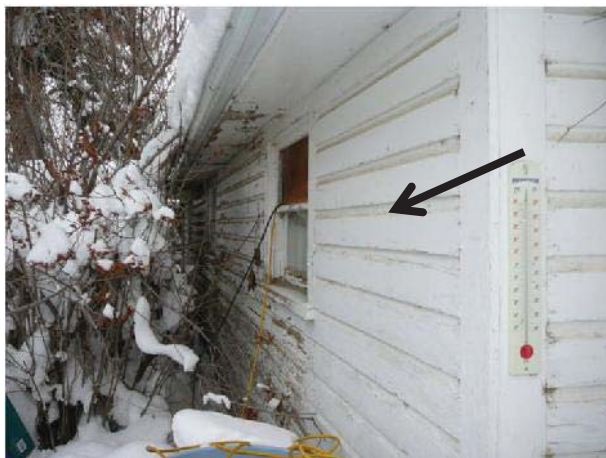
#38A Beef Unit Garage

Sample P16: White paint containing lead on the exterior

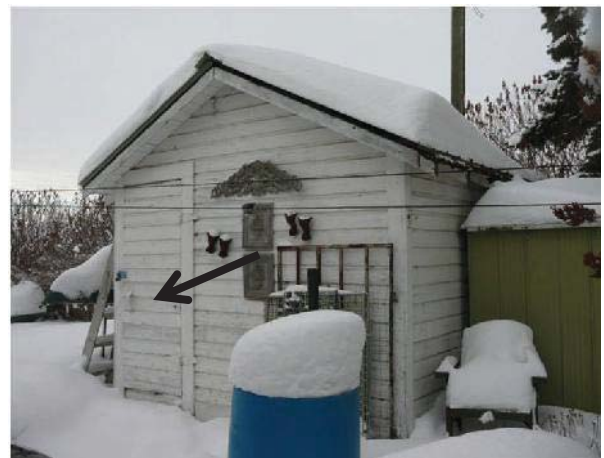
#41A Shed

Sample P17: White paint containing lead on the exterior

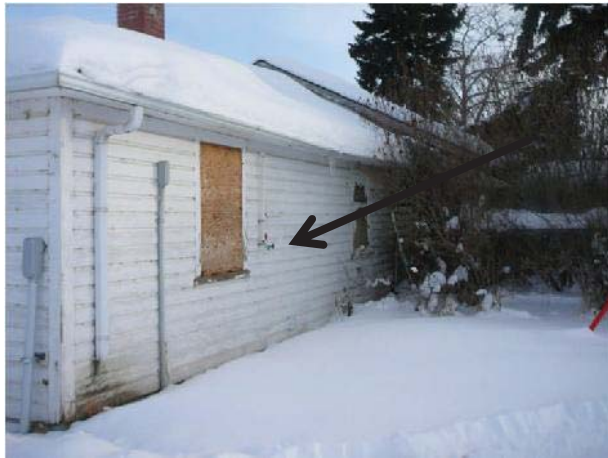
#38A Beef Unit Garage

Sample P21 : White paint containing lead on the exterior

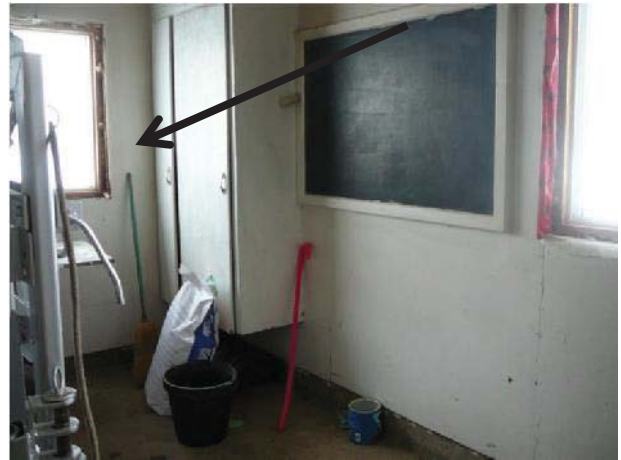
#54 Animal Hospital

Sample P29 : White paint containing lead inside the main room

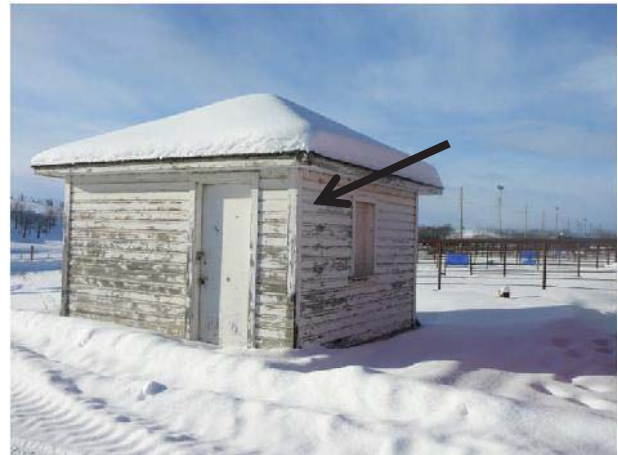
#38 Pump House

Sample P24: White paint containing lead on the exterior

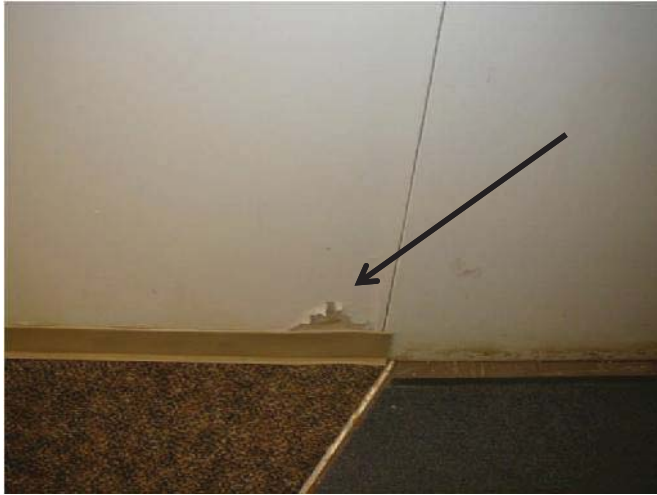
#1: Administration Office

Sample A37: Drywall mud on basement hallway wall

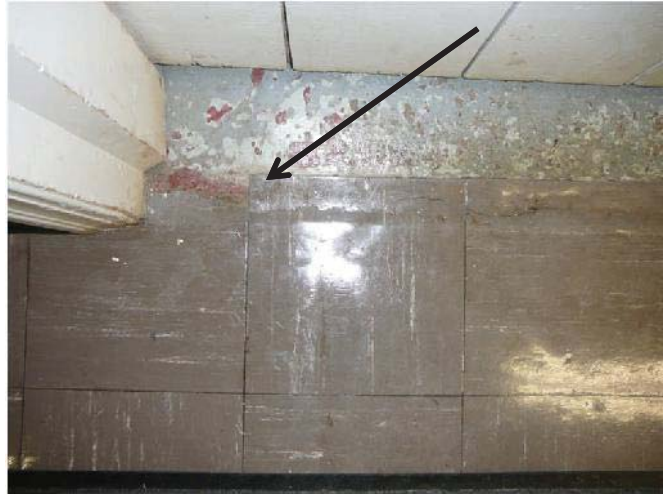
#1: Administration Office

Sample A41 & A75: Brown/white 9x9 floor tile on basement hall floor

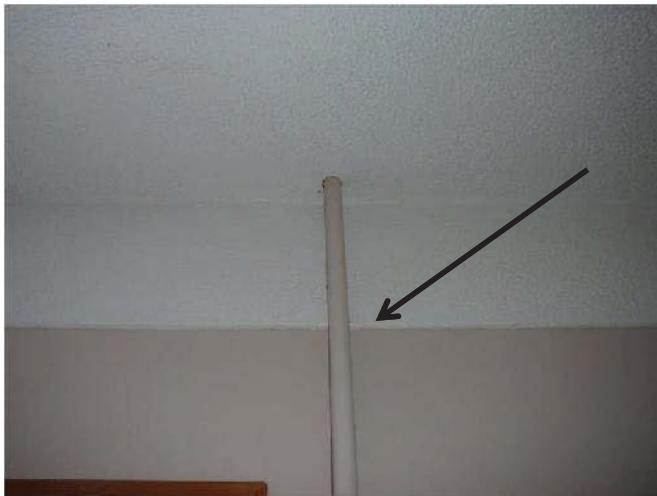
#1: Administration Office

Sample A62: Ceiling texture on SW wall of Office 3

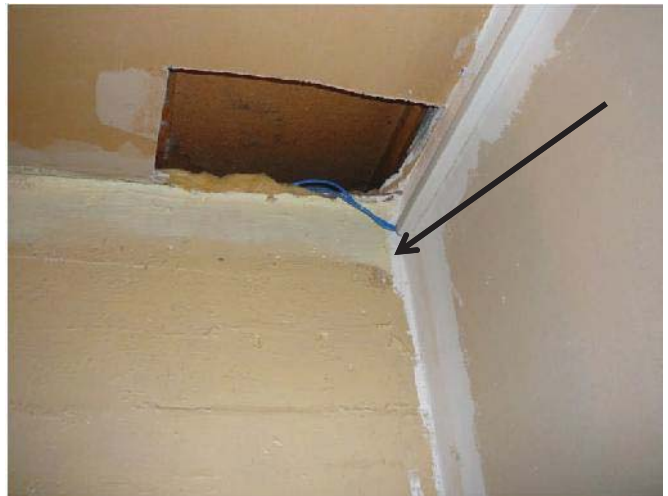
#1: Administration Office

Sample A42: Drywall mud on Furnace Room wall

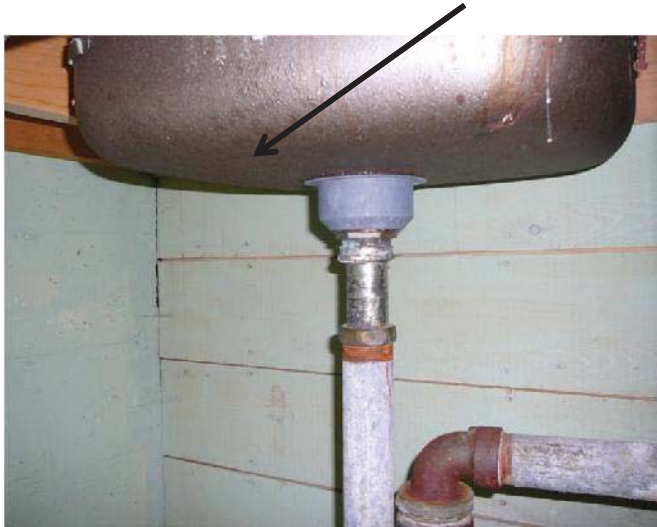
#1: Administration Office

Sample A46: Sink insulation in dark room

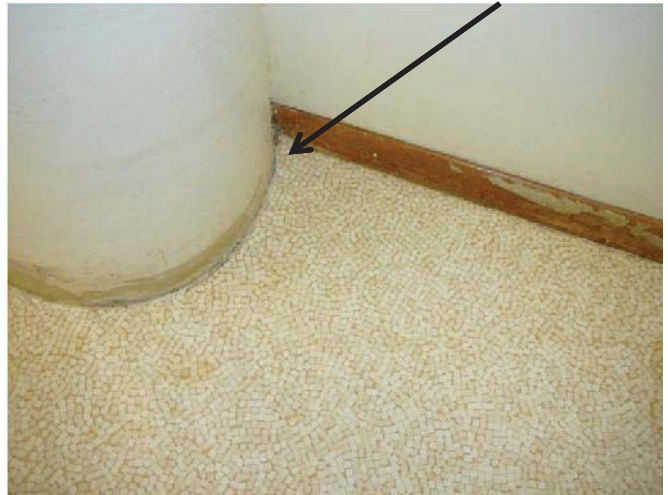
#1: Administration Office

Sample A49: Brown square linoleum on basement conference room floor

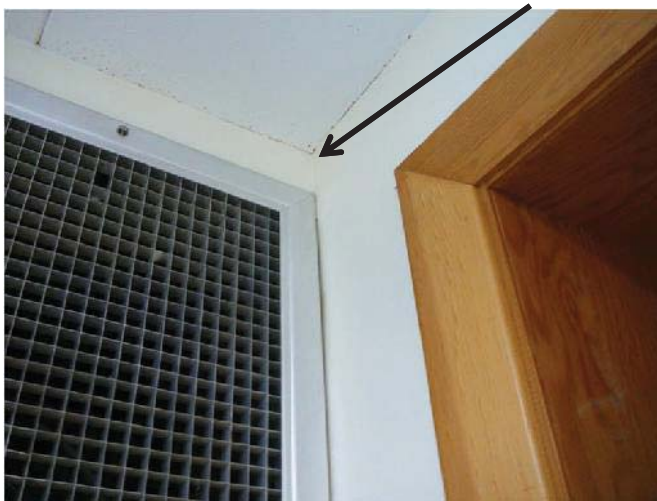
#1: Administration Office

Sample A51: Drywall mud on basement conference wall

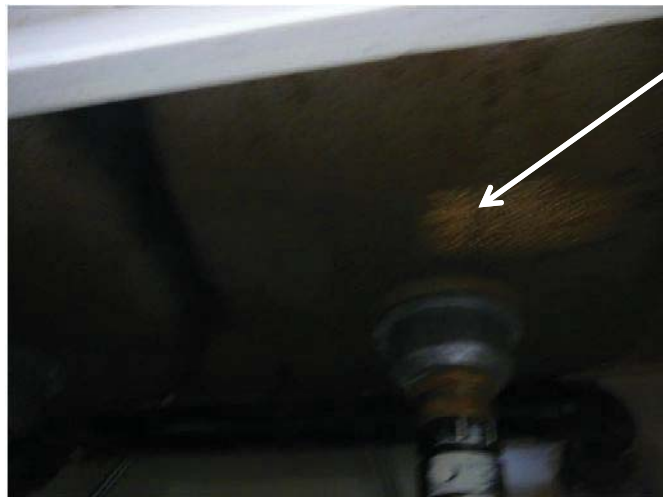
#1: Administration Office

Sample A53: Sink insulation in basement kitchen

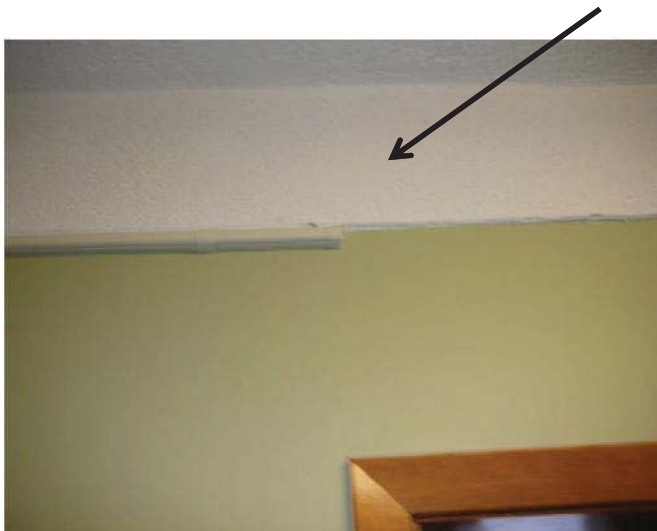
#1: Administration Office

Sample A60: White ceiling texture on main floor hall ceiling

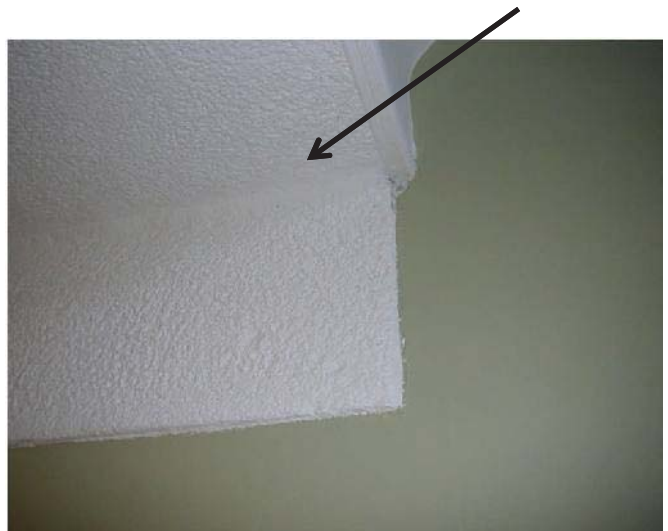
#1: Administration Office

Sample A61: White ceiling texture at east stairs

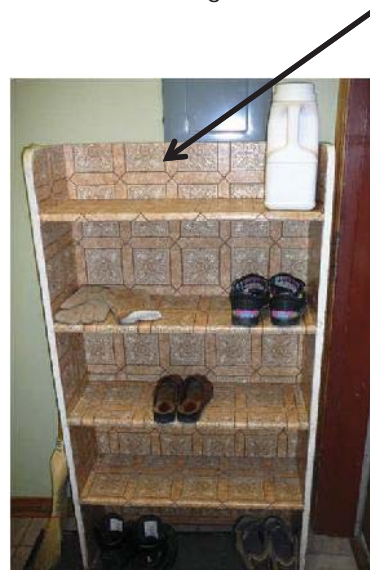
#1: Administration Office

Sample A33: Brown linoleum on shoe rack in east stairwell.

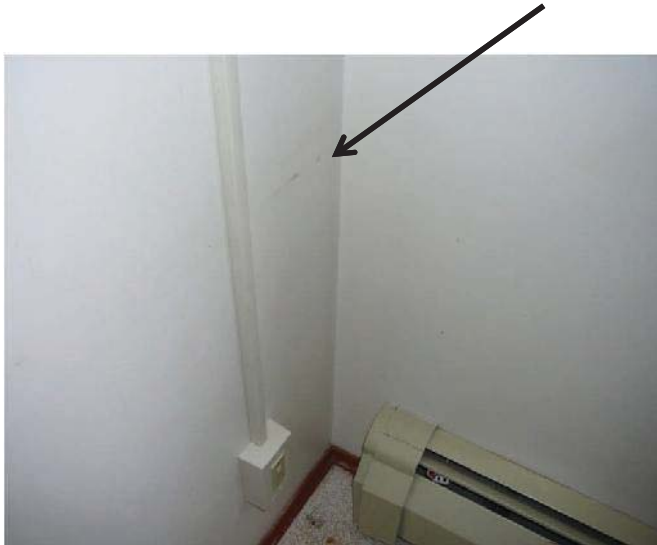
#1: Administration Office

Sample A68: Drywall mud on office 20 wall

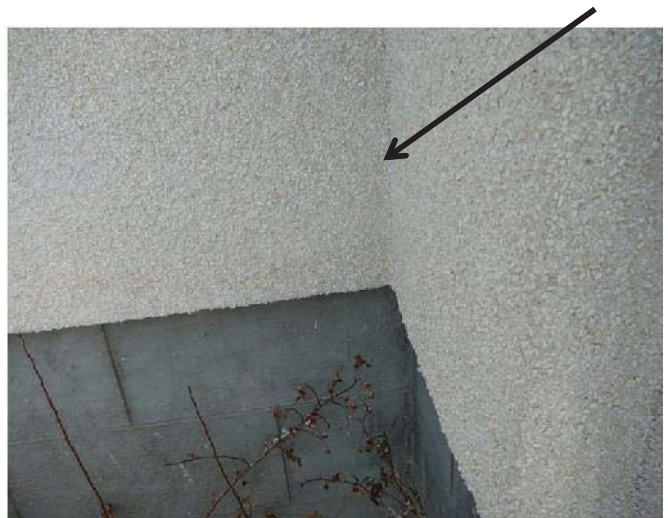
#1: Administration Office

Sample A70, A71 & A 72: Stucco on exterior of building

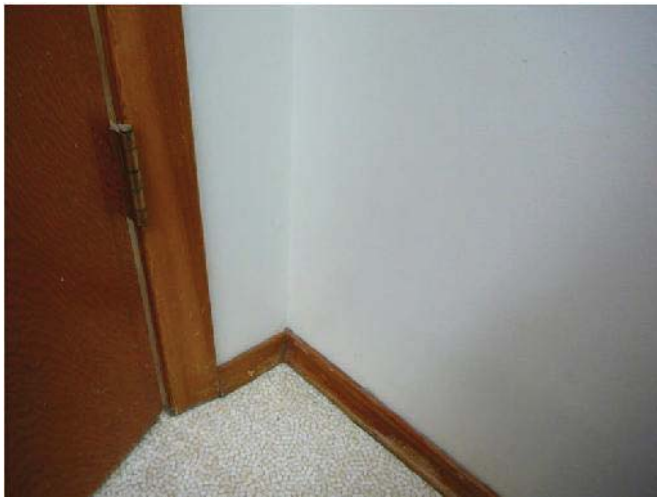
#10: Administration Office

Sample A52: Drywall mud on south east Kitchen wall

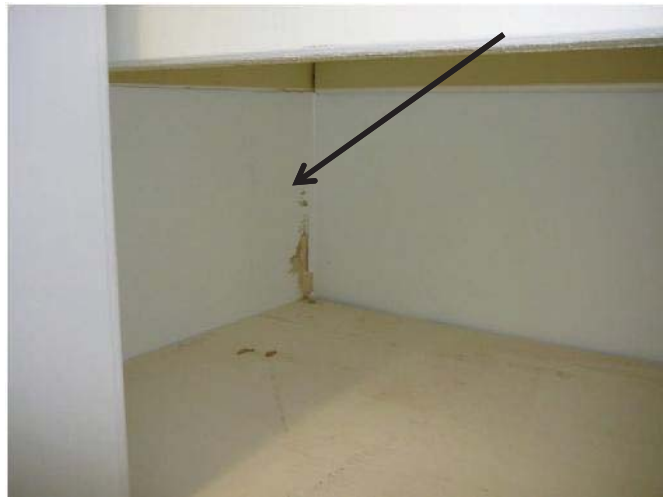
#10: Canola Laboratory

Sample A126: Drywall mud on second level office 6 wall

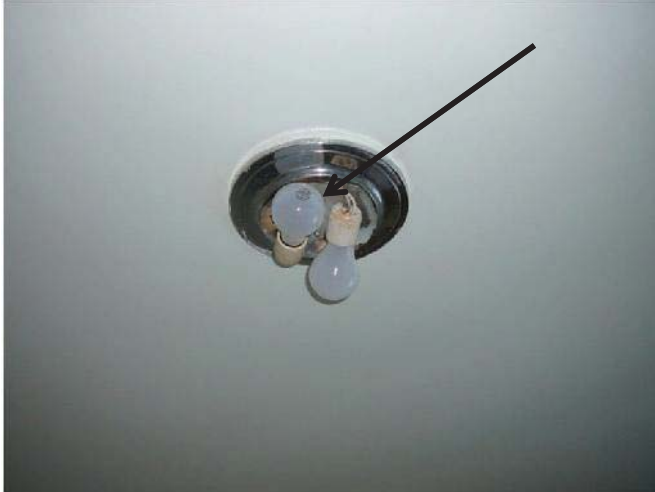
#10: Canola Laboratory

Sample A96: Black/silver light insulation from fixture in second level Office 4

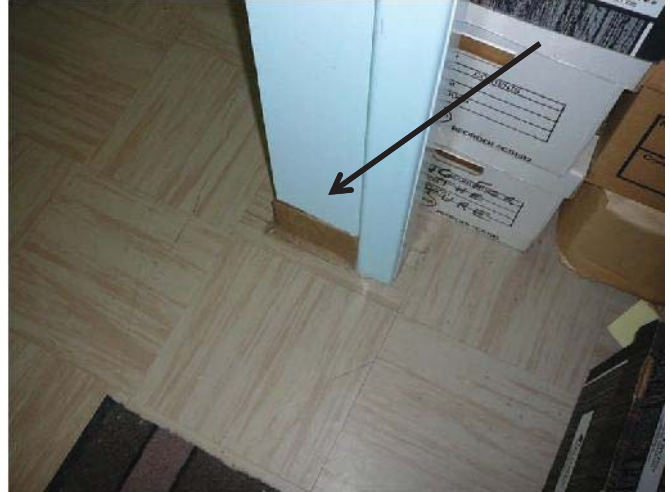
#10: Canola Laboratory

Sample A98: Brown 12x12 floor tile on Office 5 floor

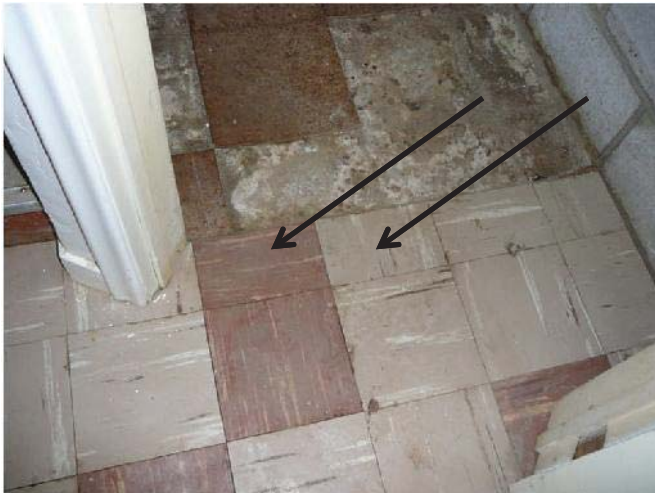
#10: Canola Laboratory

Sample A116 & A117: Light brown & Dark brown 9x9 floor tile on Storage 8 floor

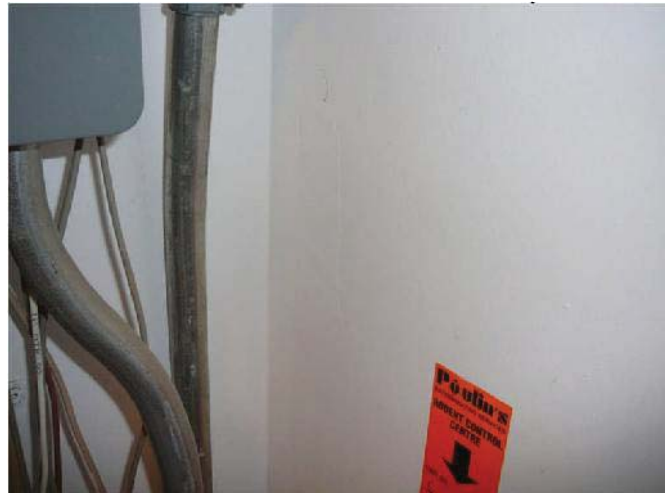
#10: Canola Laboratory

Sample A129: Drywall mud on main level under electrical box wall

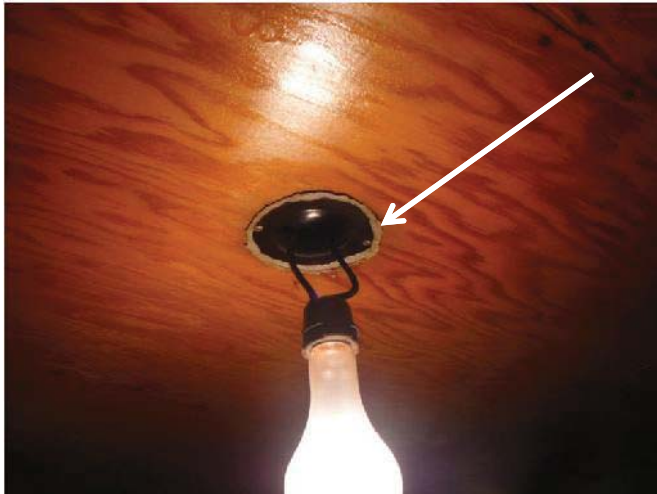
#10: Canola Laboratory

Sample A119: Gray caulking around light in basement storage 8

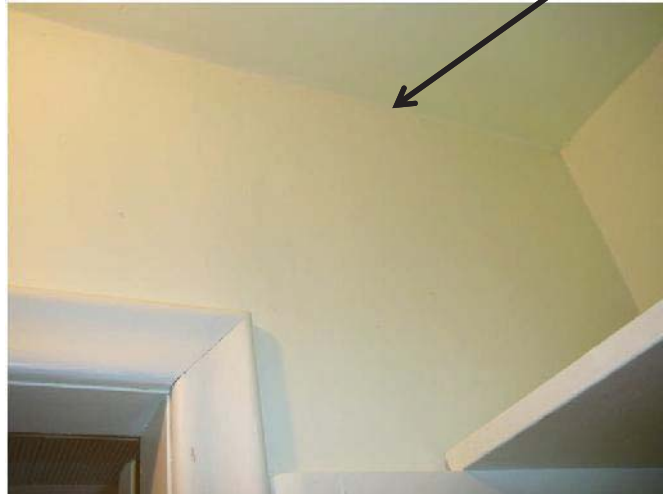
#10: Canola Laboratory

Sample A128: Drywall mud on closet wall of in 2nd floor storage

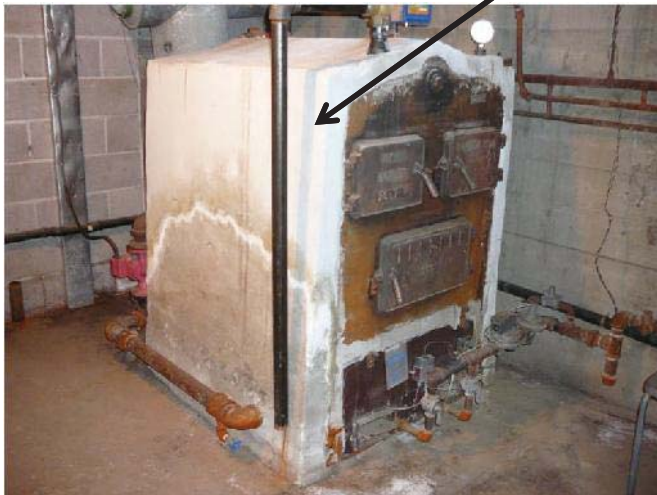
#10: Canola Laboratory

Sample A121: White insulation covering boiler in furnace room

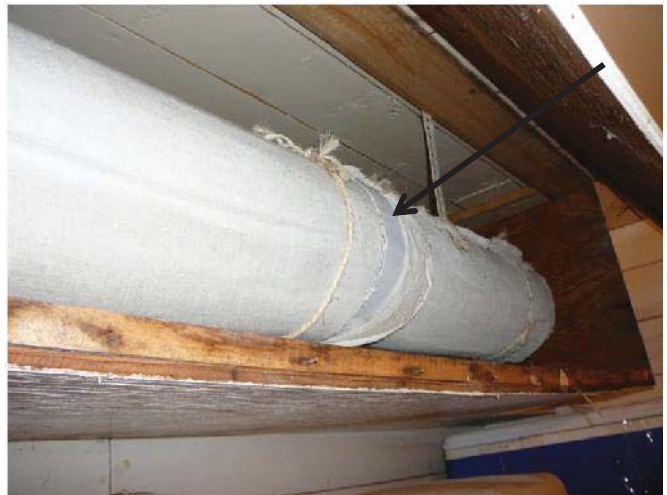
#10: Canola Laboratory

Sample A120: White airocell insulation on basement storage 6 pipe

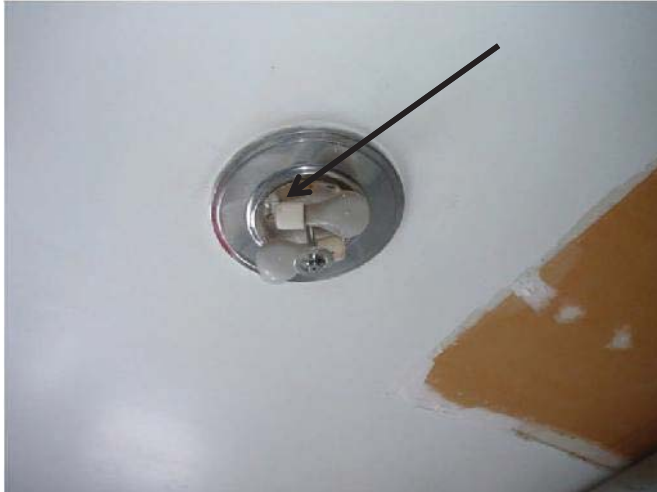
#10: Canola Laboratory

Sample A102: Black/silver light insulation from fixture in main level storage room

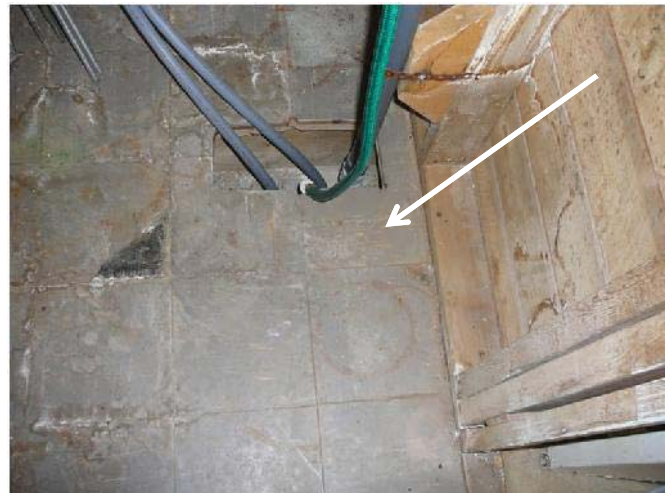
#10: Canola Laboratory

Sample A118: Black caulking around wiring in basement storage 5

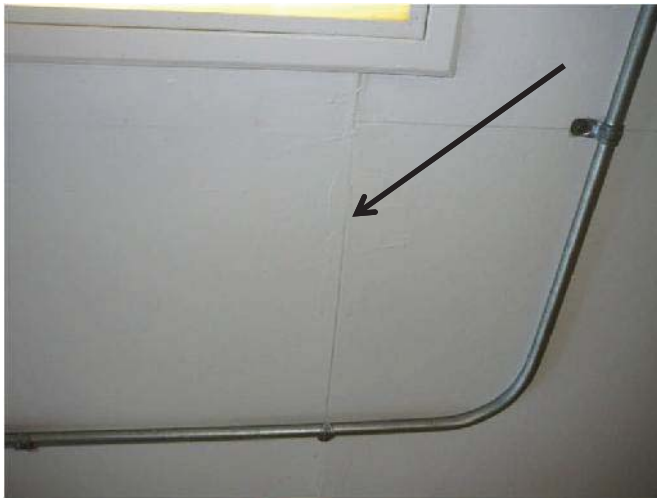
#14: Soils Research Building

Sample A146: Drywall mud on furnace room wall.

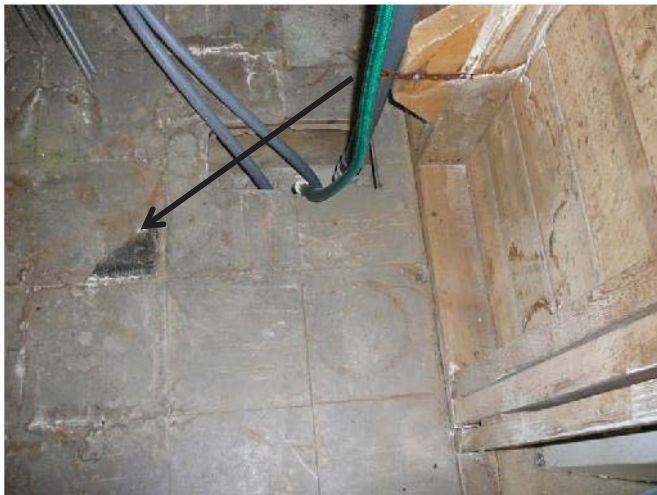
#14: Soils Research Building

Sample A166: Gray transite board in the 2nd level power panel room

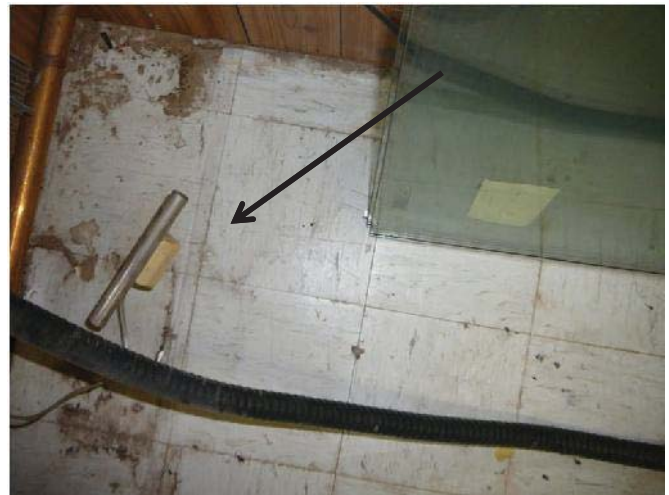
#14: Soils Research Building

Sample A168: Dark gray 9x9 floor tile on power panel room floor

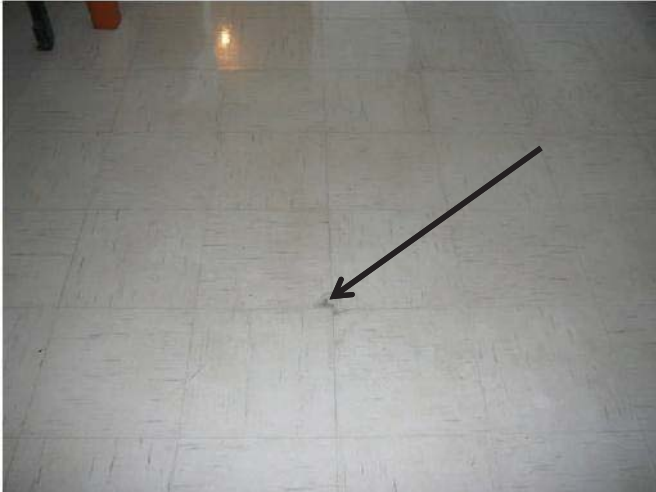
14: Soils Research Building

Sample A178: White/gray 9x9 floor tile on 2nd level office 2 floor

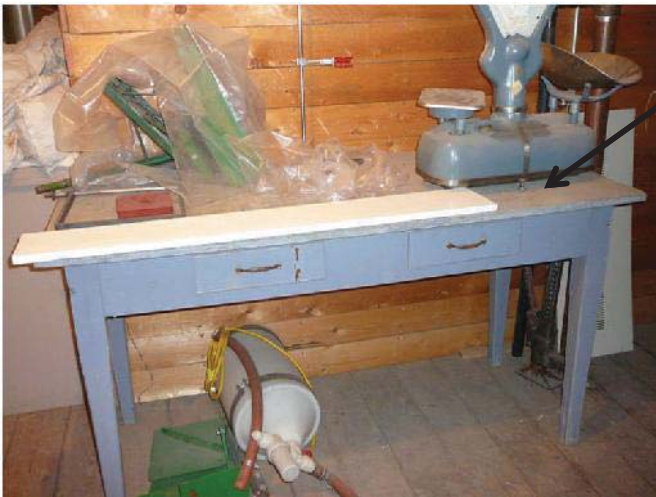
#15: Ecology Building

Sample A11: Gray counter top on main level north lab

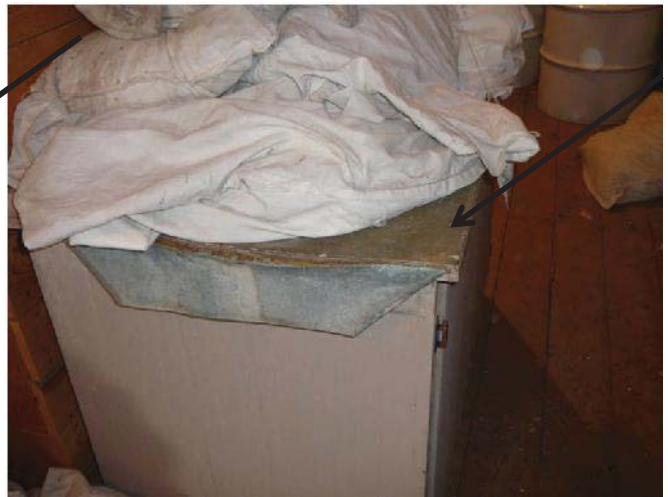
#15: Ecology Building

Sample A20: Gray counter top on 2nd level desk

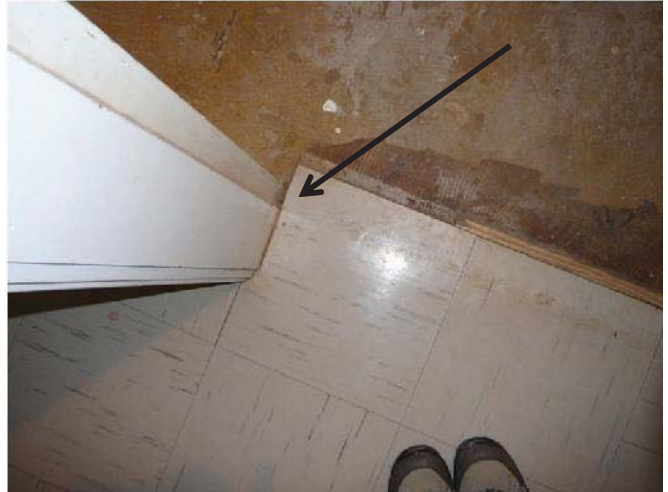
#15: Ecology Building

Sample A7: White/blue 12x12 floor tile on main entrance hall floor

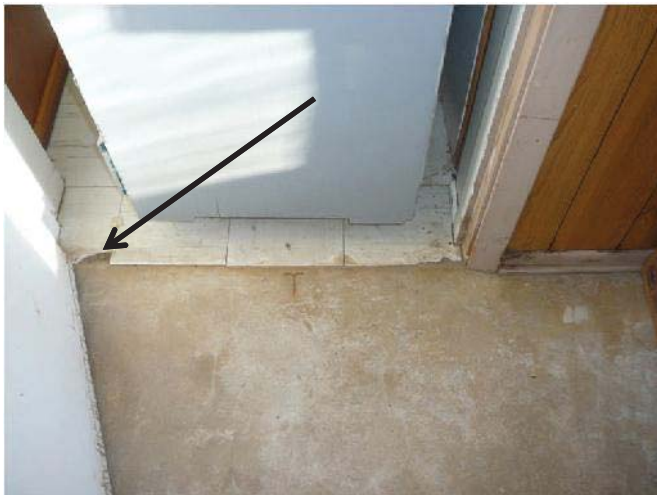
#15: Ecology Building

Sample A3: White/gray 9x9 floor tile on main level south lab floor

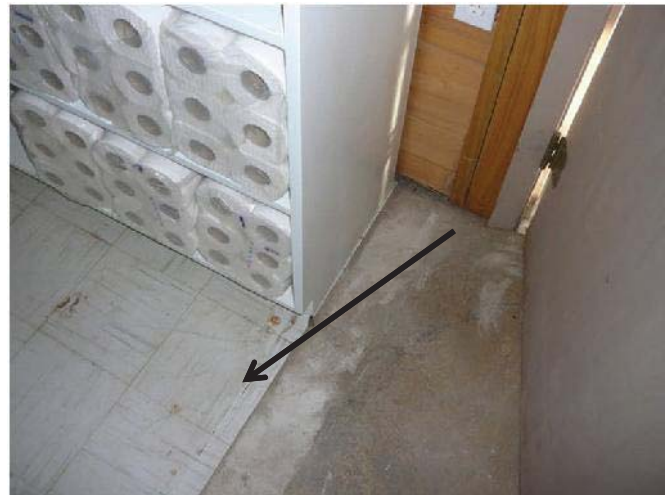
#15: Ecology Building

Sample A4: White/gray 9x9 floor tile on main level south lab floor

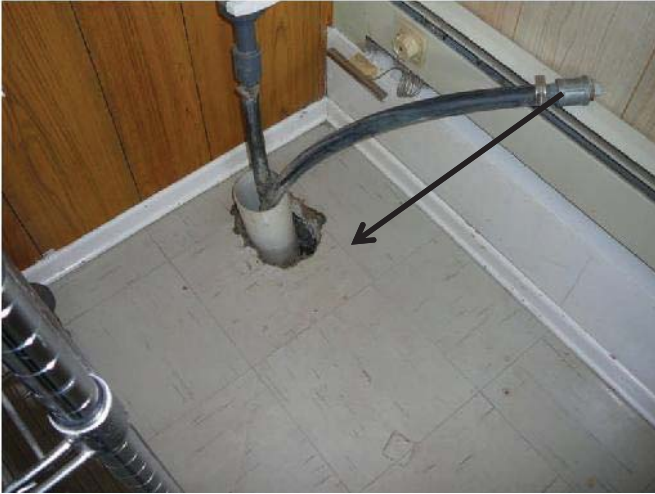
#15: Ecology Building

Sample A5: White/gray 9x9 floor tile on main level south storage floor

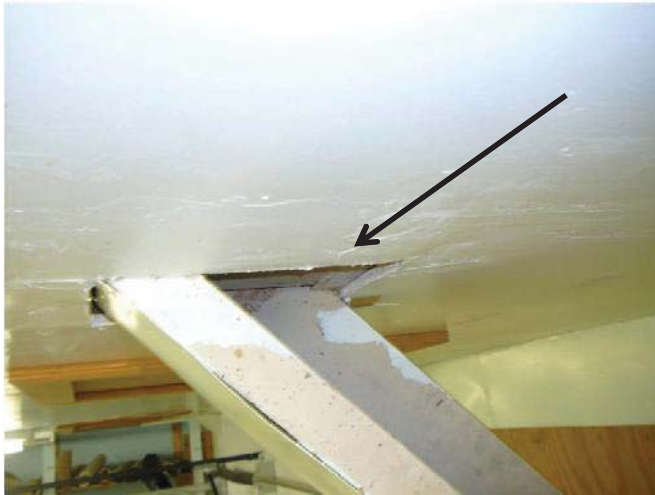
#17: Carpenter Shop

Light fixture with backing in storage crawlspace above office

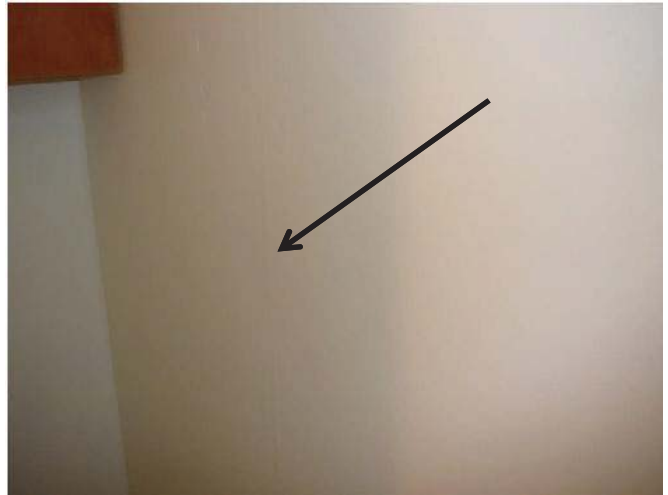
#17: Carpenter Shop

Sample A184: Drywall mud on garage ceiling

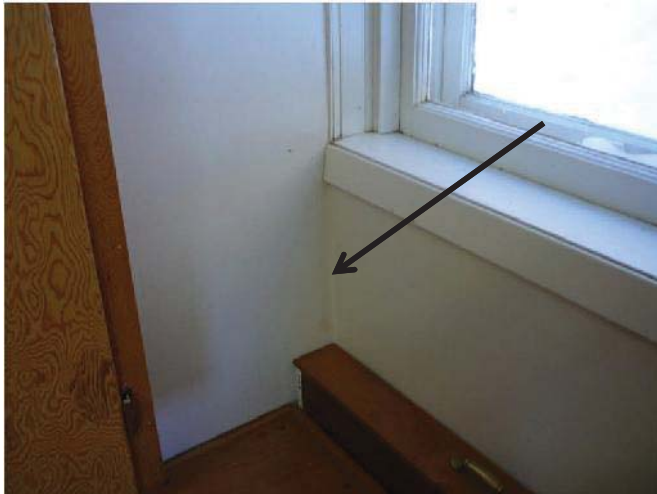
#17: Carpenter Shop

Sample A190: Drywall mud on bathroom wall

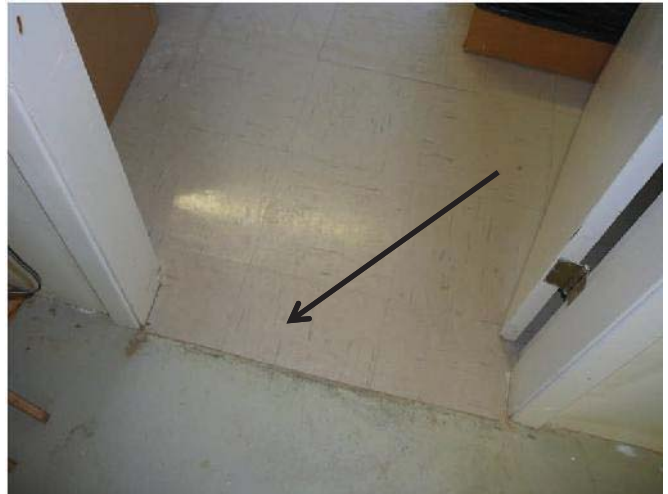
#17: Carpenter Shop

Sample A186: Drywall mud on office wall

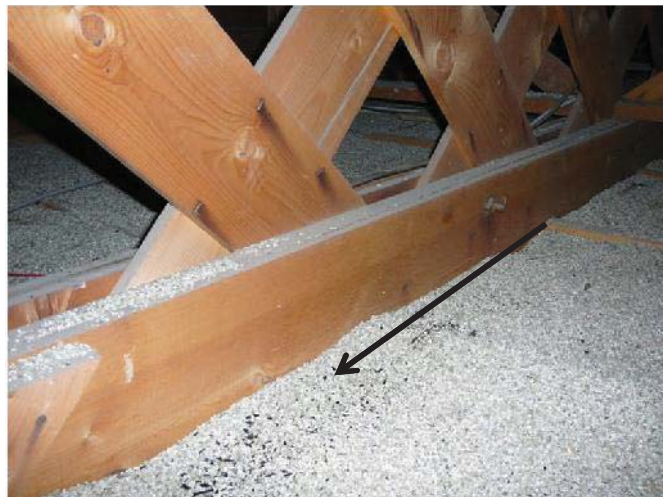
#17: Carpenter Shop

Sample A181: Brown/silver vermiculite in the attic

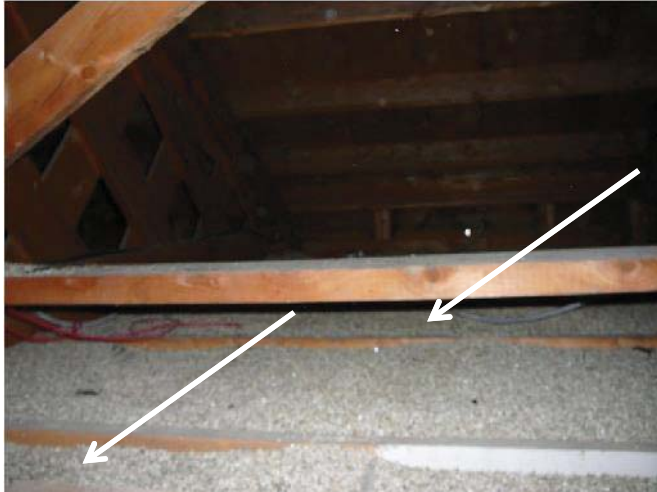
#17: Carpenter Shop

Sample A182: Brown/silver vermiculite in the attic

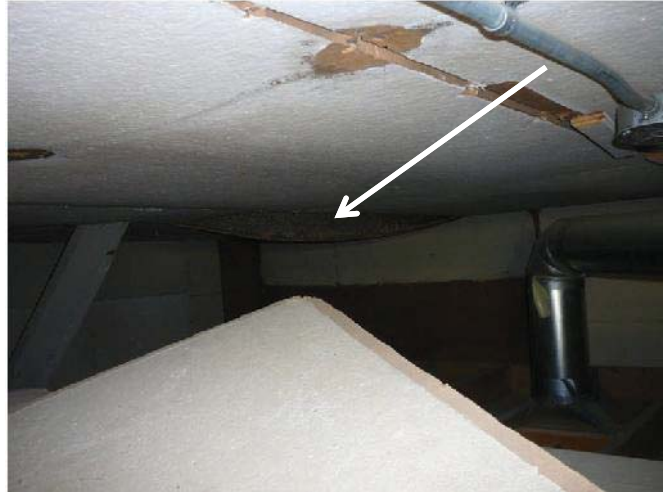
#17: Carpenter Shop

Sample A183 & A185: Brown/silver vermiculite in the attic

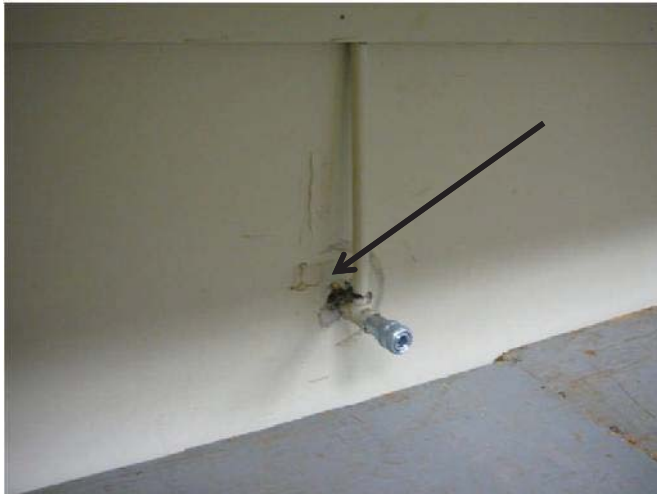
#26: Storage

Sample A208: Drywall mud on air drying room wall

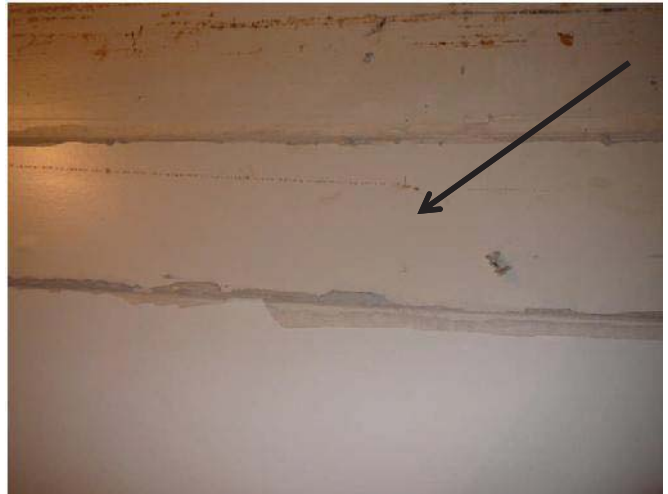
#26: Storage

Sample A207: Drywall mud on furnace room wall

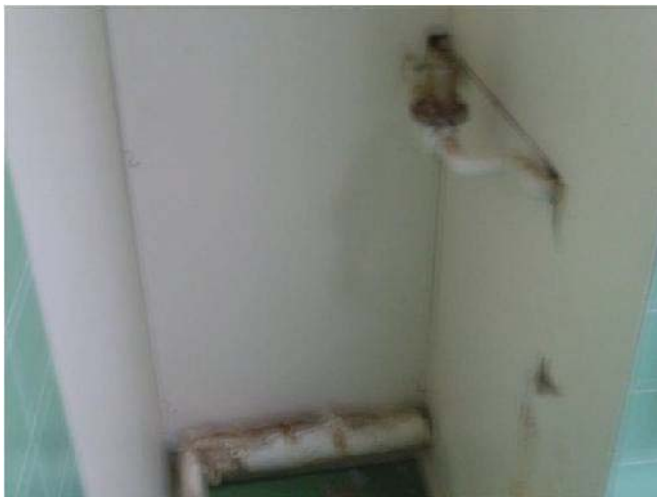
#26: Storage

Sample A216: Drywall mud on Women's washroom wall

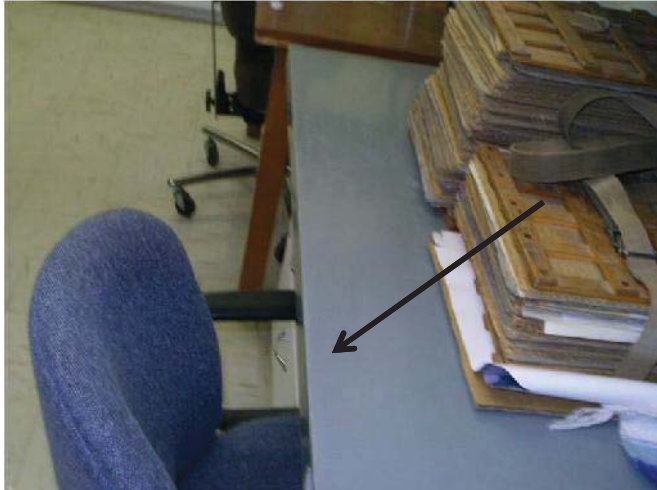
#26: Storage

Sample A212: Gray cement countertop in office 3

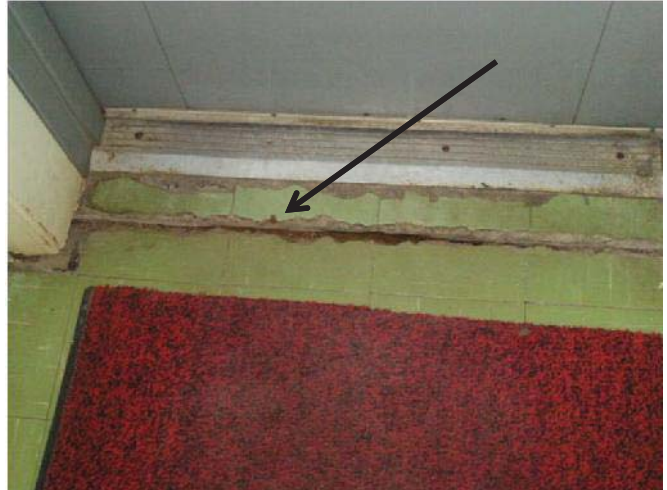
#26: Storage

Sample A214: Green 9x9 floor tile on bathroom hall floor

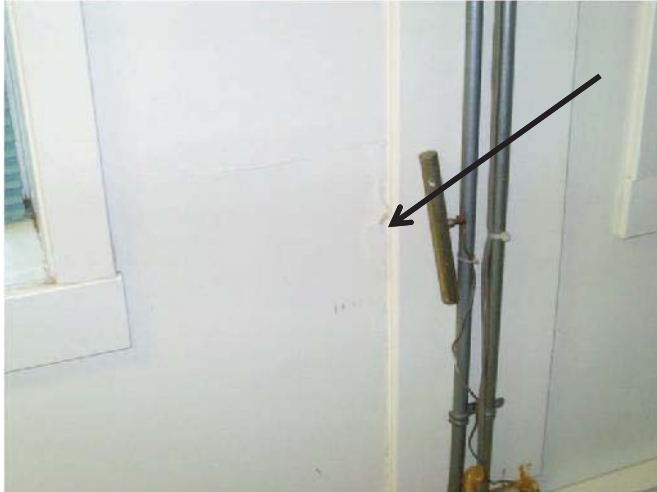
#26: Storage

Sample A217: Drywall mud on office 4 wall
