**HAZARDOUS MATERIALS
REMOVAL SPECIFICATIONS
BEAVERLODGE RESEARCH CENTRE
PROJECT NO.: R.078150.002
BEAVERLODGE, ALBERTA**

Public Works and Government Services Canada

26 JULY 2016

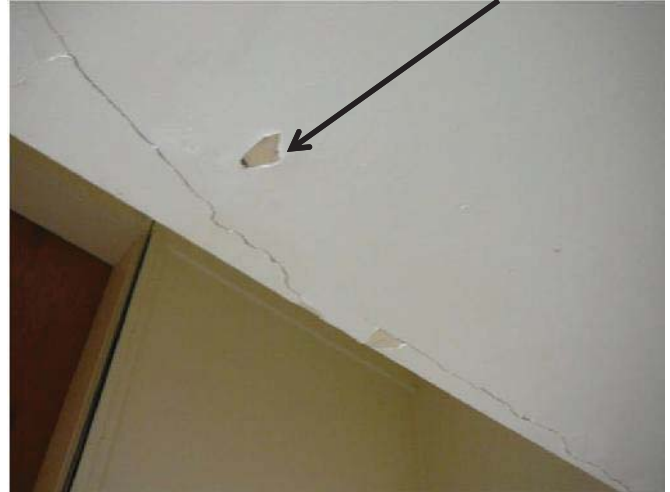
#26: Storage

Sample A224: Drywall mud on main hall wall

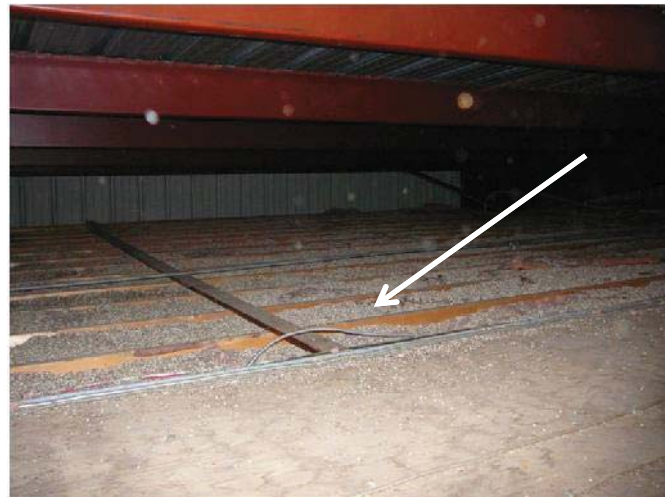
#26: Storage

Sample A225: Brown/silver vermiculite in attic

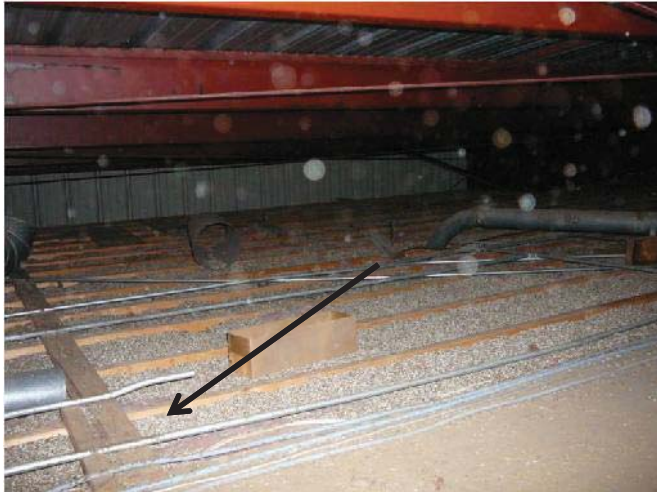
#26: Storage

Sample A226: Brown/silver vermiculite in attic

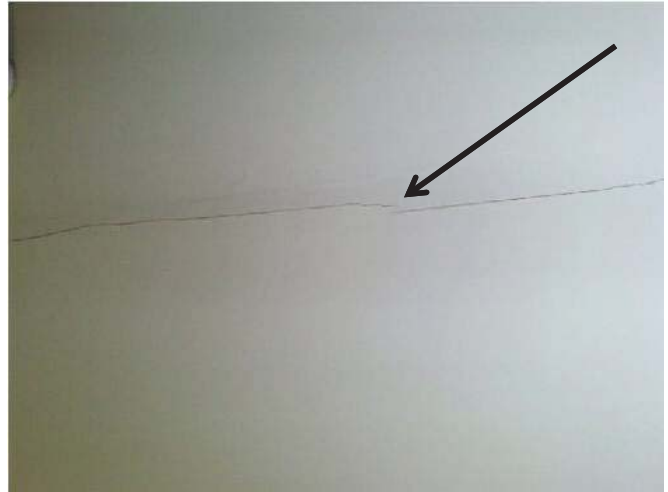
#26: Storage

Sample A218: Drywall mud on the main hall wall

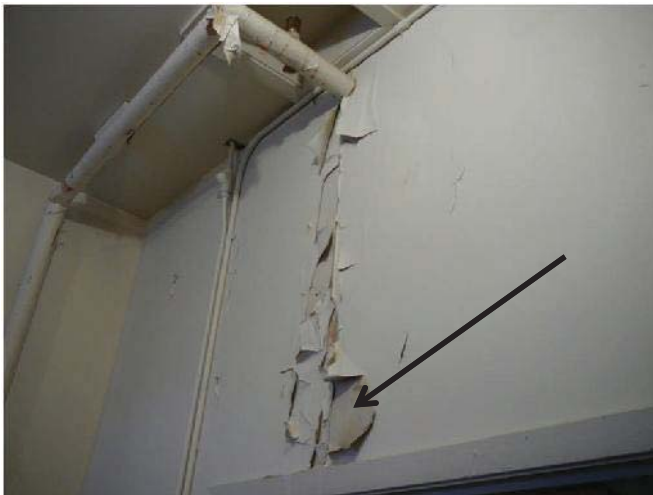
#26: Storage

Sample A199: Drywall mud on the threshing room wall

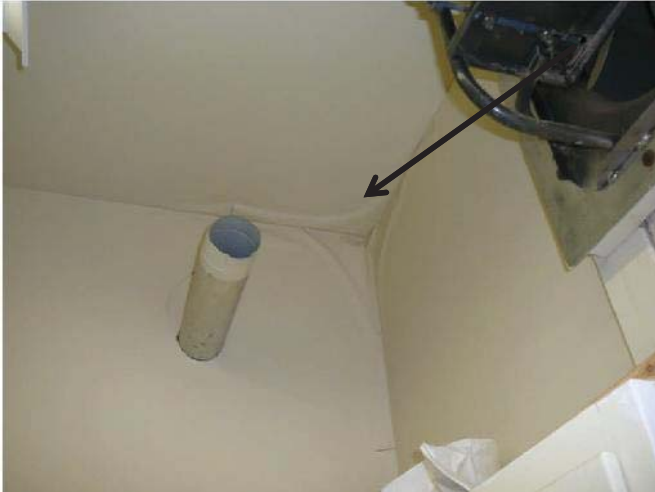
#26: Storage

Water damage on office 1 wall/ceiling corner

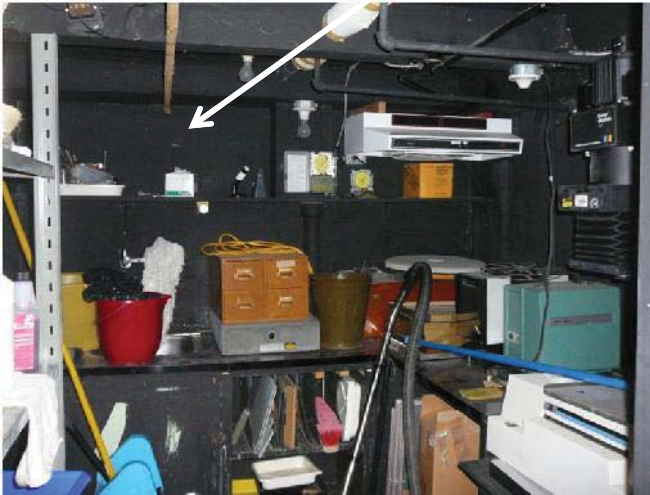
#1: Administration Office

Sample P14: Black paint on dark room walls and ceiling

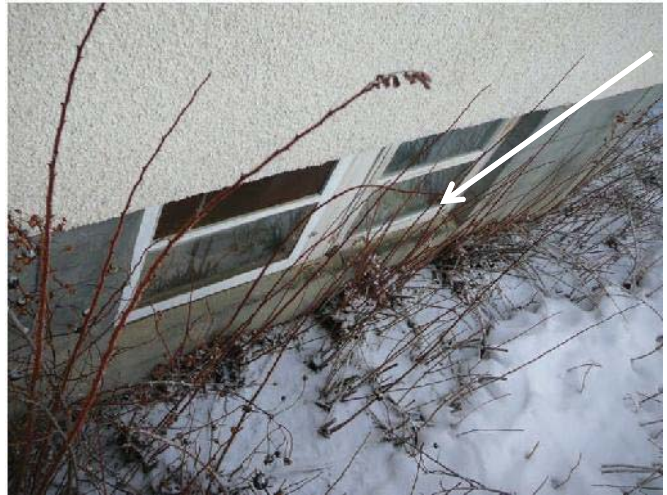
#1: Administration Office

Sample P17: White paint on exterior window

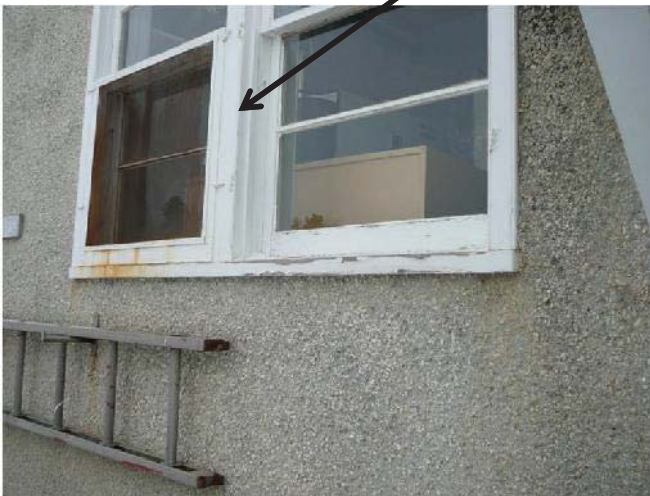
#10: Canola Laboratory

Sample P31: White paint on exterior trim

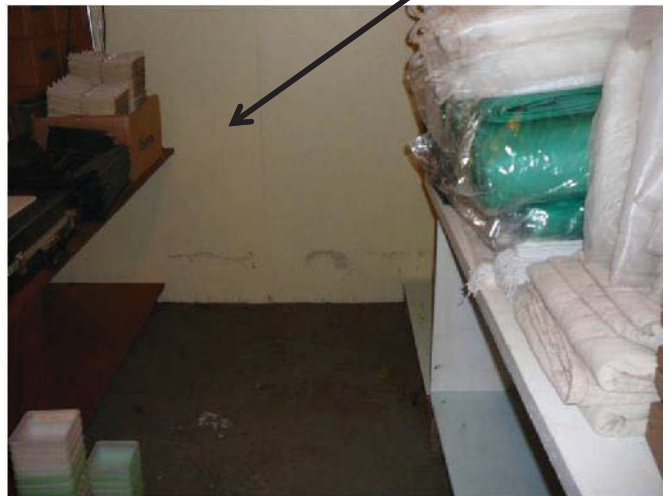
#10: Canola Laboratory

Sample P29: Yellow/white paint on walls and ceiling in storage 2

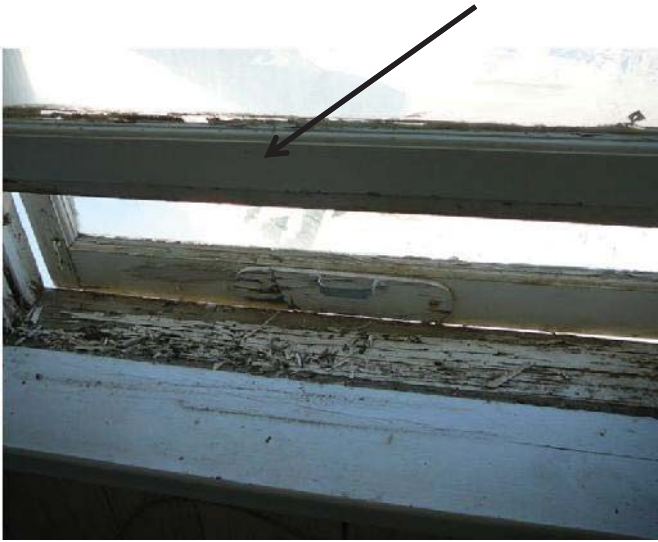
#14: Soils Research Building

Sample P37: White paint on trim in office 1

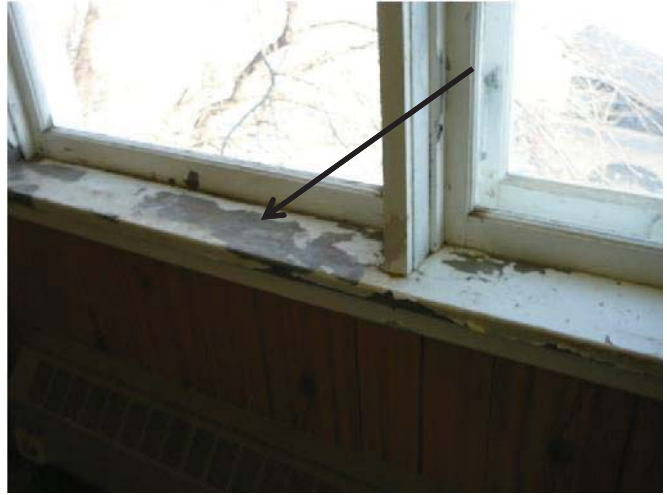
#14: Soils Research Building

Sample P36: White paint on trim in lab 2

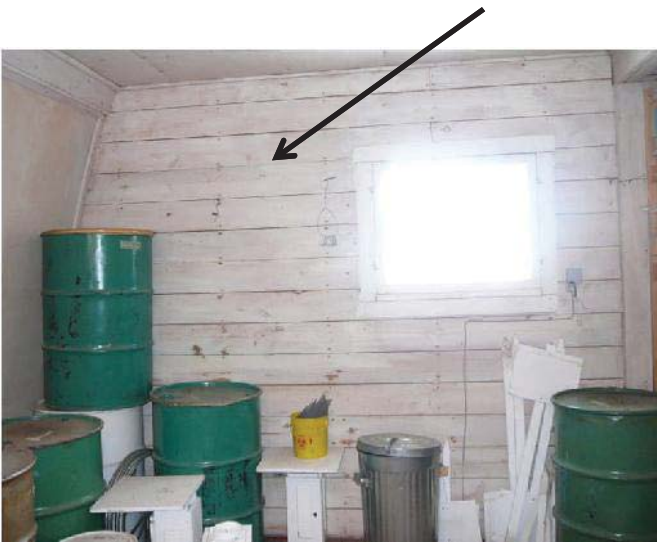
#15: Ecology Laboratory

Sample P10: White paint on 2nd floor walls

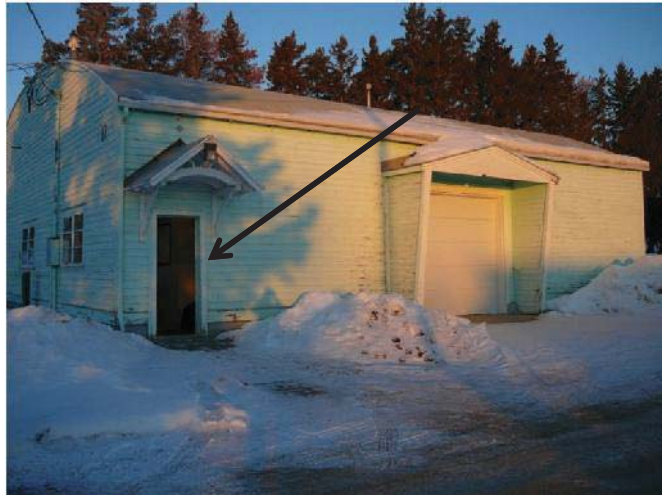
#17: Carpenter Shop

Sample P38: Blue paint on building exterior

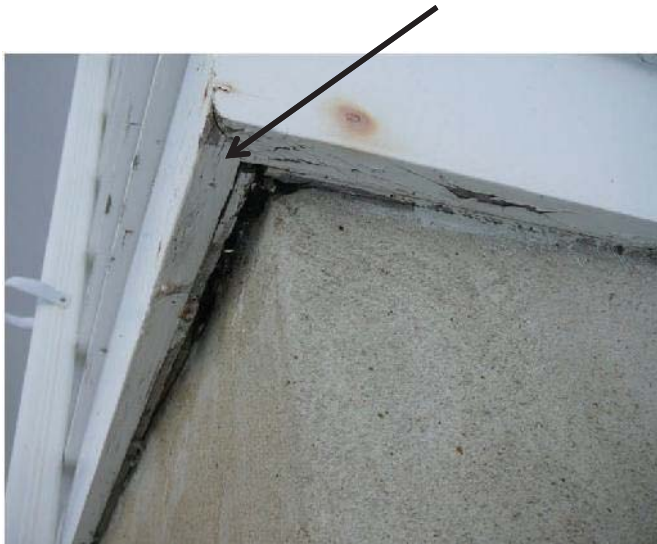
#18: Apiculture Laboratory

Sample P20: White paint on west side of exterior wall

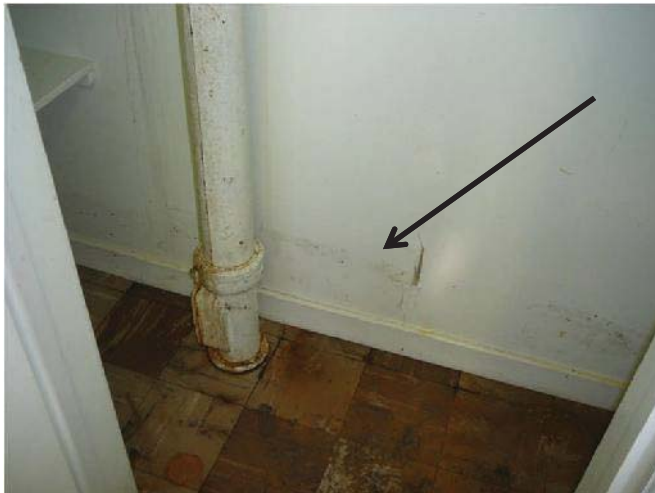
#10: Canola Laboratory

View of flood line in basement

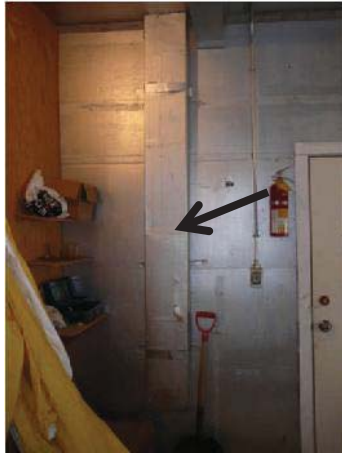
#33 Processing and Carpenter Shop

Sample A1 : Duct insulation containing asbestos

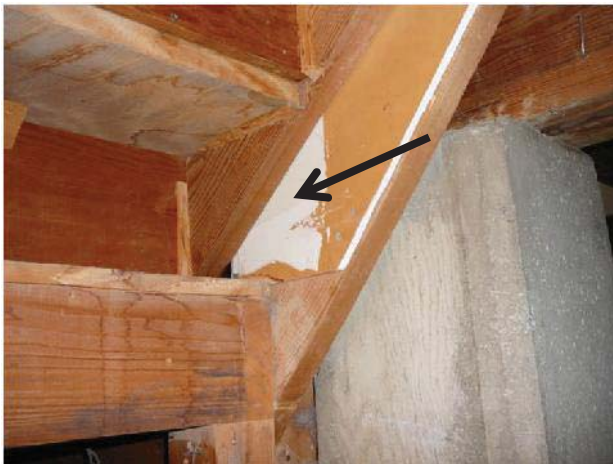
#60 Duplex House

Sample A15 : Drywall mud containing asbestos

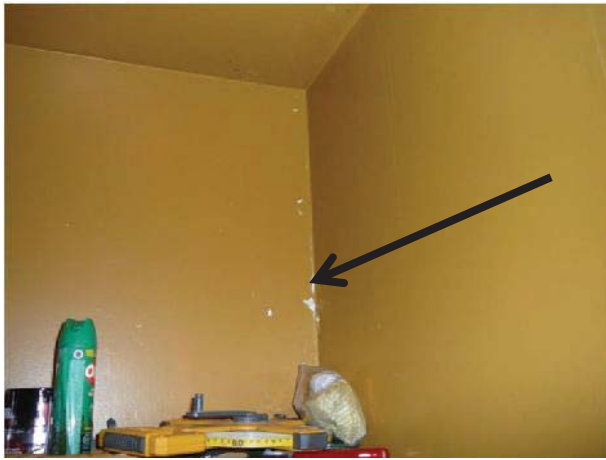
#60 Duplex House

Sample A18: Drywall mud containing asbestos

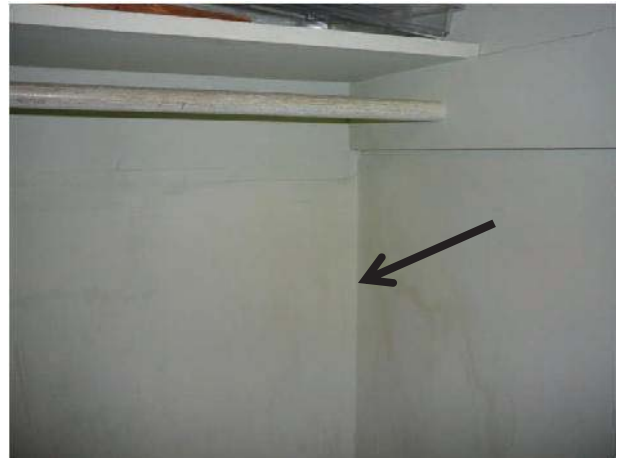
#60 Duplex House

Sample A20 : Drywall mud containing asbestos

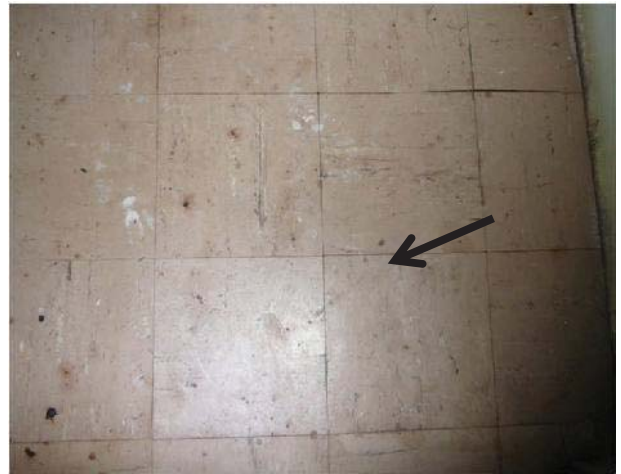
#2 Administration Office

Sample A35 : Floor tile containing asbestos

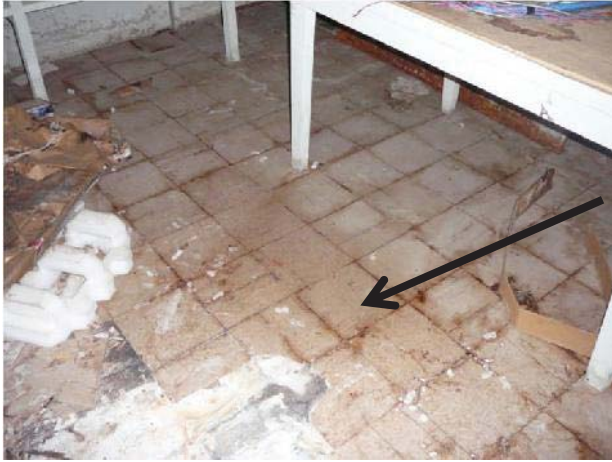
#2 Administration Office

Sample A36 : Floor tile containing asbestos

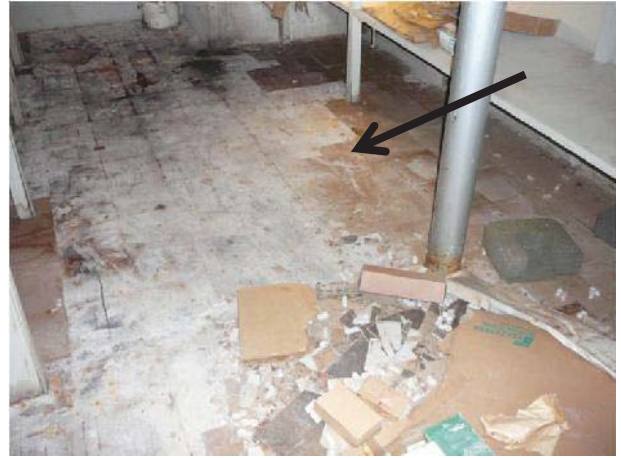
#2 Administration Office

Sample A37 : Floor tile containing asbestos

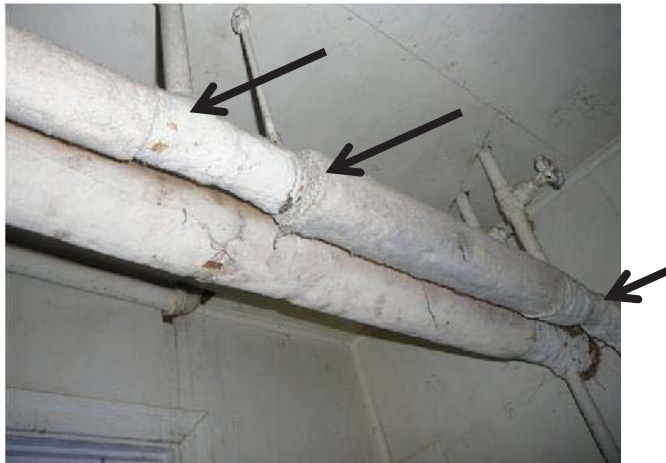
#2 Administration Office

Sample A38, A39 & A40 : Pipe insulation containing asbestos

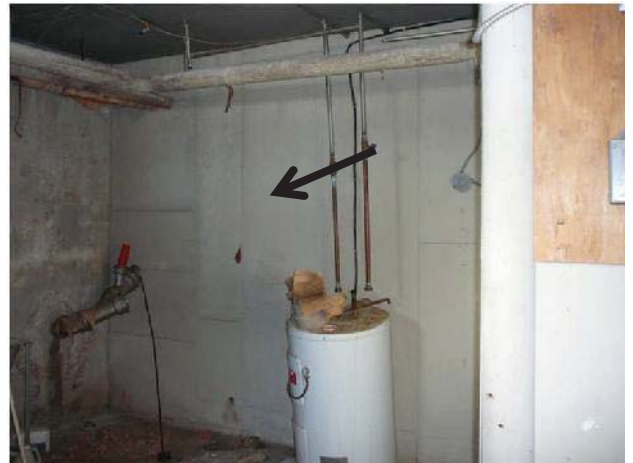
#2 Administration Office

Sample A41 : Transit board containing asbestos

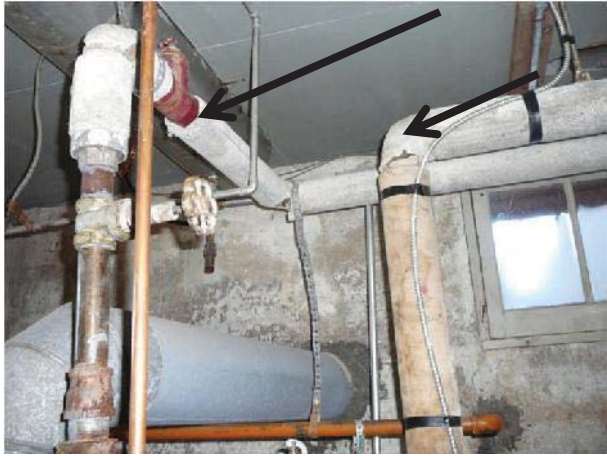
#2 Administration Office

Sample A42 & A43 : Pipe insulation containing asbestos

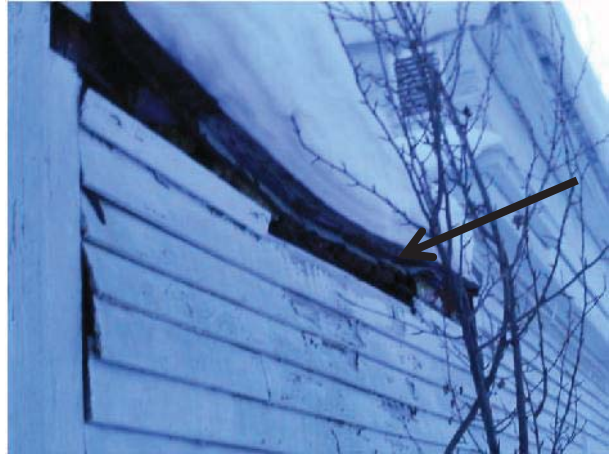
Pump House

Sample A70 & A71: Vermiculite insulation containing asbestos

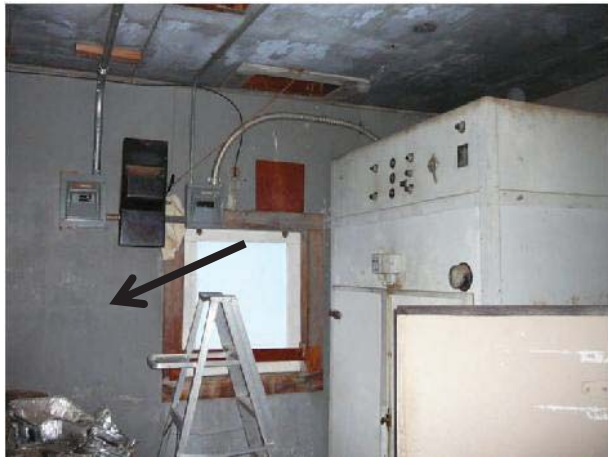
#37 Drying Shed

Sample A72 : Transite board containing asbestos

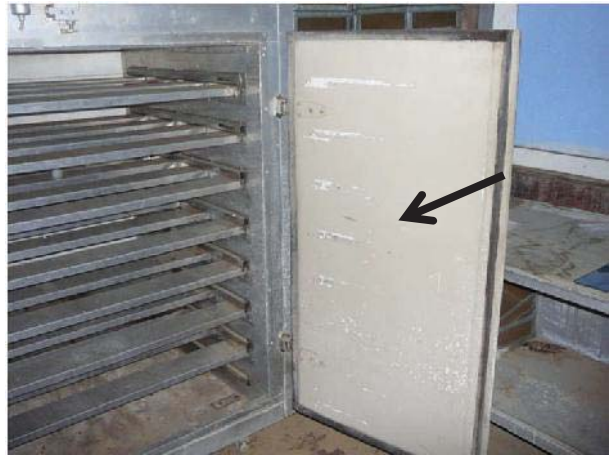
#37 Drying Shed

Sample A73 : Insulation board containing asbestos

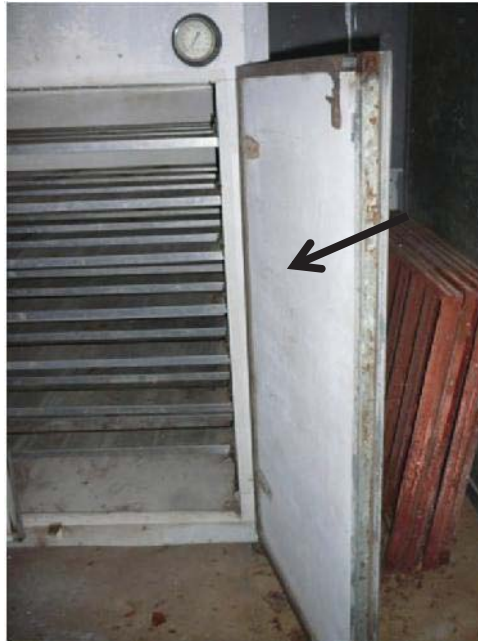
#37 Drying Shed

Sample A76: Insulation board containing asbestos

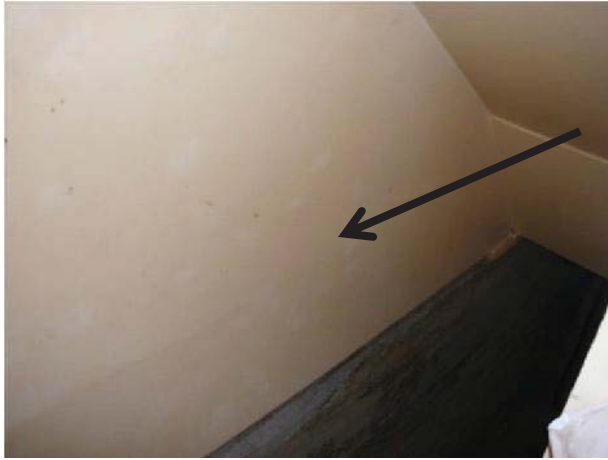
#60 Duplex House

Sample P10 : Yellow paint containing lead

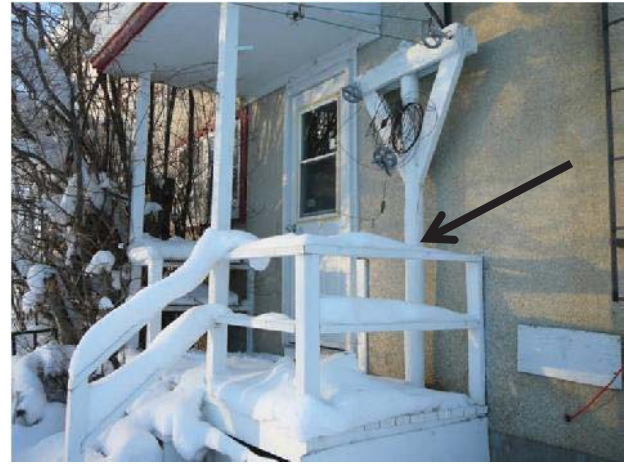
#60 Duplex House

Sample P13 : White paint containing lead

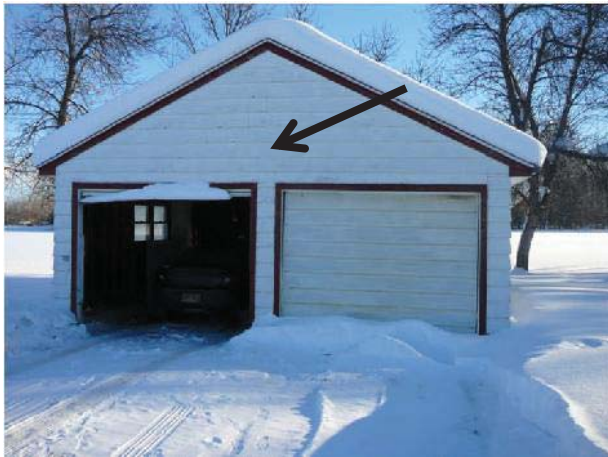
#60A Garage

Sample P14: White paint containing lead

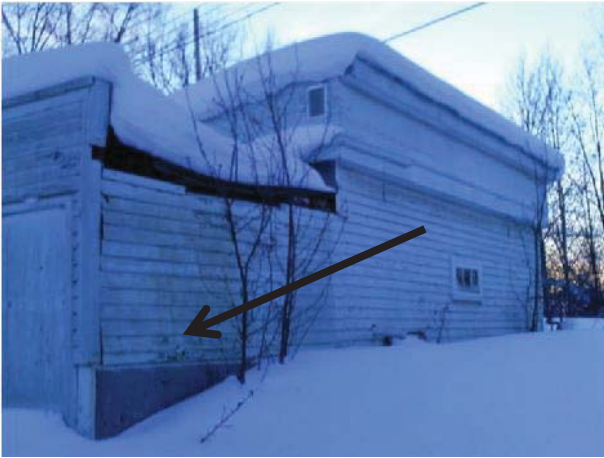
Pump House

Sample P23: White paint containing lead
