**HAZARDOUS BUILDING MATERIALS SURVEY
CANADIAN FOOD INSPECTION AGENCY SPACE,
NORTHWEST ATLANTIC FISHERIES CENTRE, ST. JOHN'S
NEWFOUNDLAND AND LABRADOR**

Submitted to:
Public Works and Government Services Canada
Environmental Services
The John Cabot Building
10 Barters Hill, PO Box 4600
St. John's, NL
A1C 5T2

March 2013

AMEC Project No. TF13076482

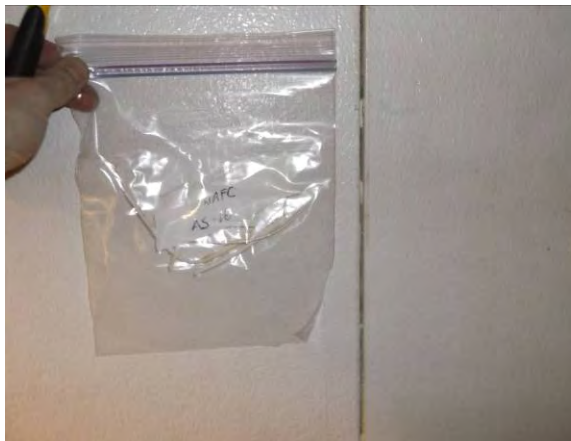
One (1) sample of caulking (AS-10) was collected from the seams of metal sheet flooring in N20-113 and analyzed for asbestos content (refer to Photo 11, Appendix B). Asbestos was not detected in the caulking sample collected and submitted for analysis.

Photo 11: View of caulking sample AS-10.

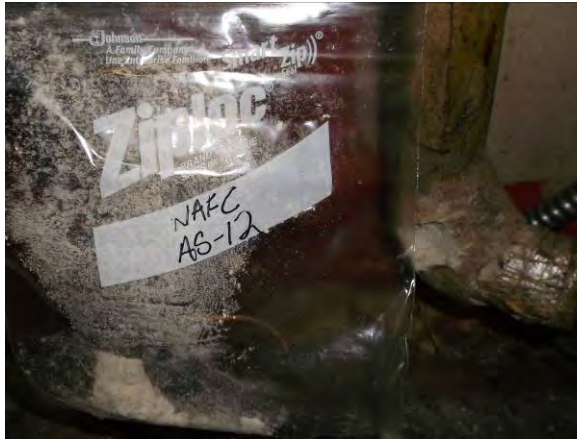
Five (5) samples of parging with cloth wrap (AS-12, AS-30, AS-43, AS-48 and AS-56) were collected from pipe elbow insulation (approximately 3" diameter) in N20-109, O21-105, N20-125, P20-115 and P20-123 and analyzed for asbestos content (refer to Photos 13, 31, 44, 49 and 57, Appendix B). One (1) sample of parging with cloth wrap (AS-07) was collected from pipe elbow insulation (approximately 4" diameter) in M19-101 and analyzed for asbestos content (refer to Photo 8, Appendix B). One (1) sample of parging with cloth wrap (AS-62) was collected from pipe elbow insulation (approximately 6" diameter) in O19-101 and analyzed for asbestos content (refer to Photo 63, Appendix B). Asbestos was not detected in any of the pipe elbow parging samples collected and submitted for analysis.

Photo 13: View of pipe elbow parging sample AS-12.

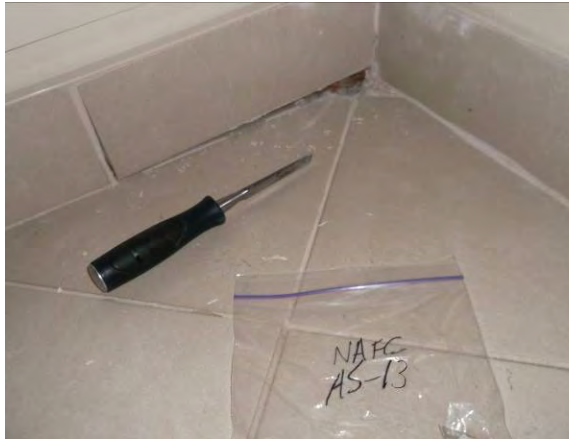
Four (4) samples of ceramic tile grout (AS-13, AS-15, AS-17 and AS-34) and one (1) sample of ceramic tile (AS-14) were collected in O19-102, O19-103, O19-104 and N20-104 and analyzed for asbestos content (refer to Photos 14, 15, 16, 18 and 35, Appendix B). Asbestos was not detected in any of the ceramic tile grout or ceramic tile samples collected and submitted for analysis.

Photo 14: View of ceramic tile grout sample AS-13.

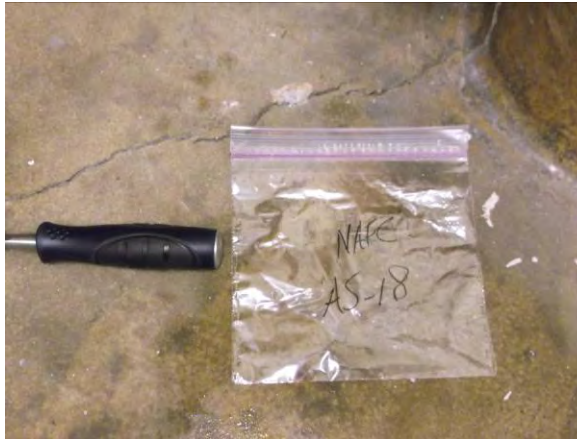
Two (2) samples of light brown and brown concrete floor coating (AS-18 and AS-36) were collected in P20-113 and M21-103 and analyzed for asbestos content (refer to Photos 19 and 37, Appendix B). Asbestos was not detected in the concrete floor coating samples collected and submitted for analysis.

Photo 19: View of concrete floor coating sample AS-18.

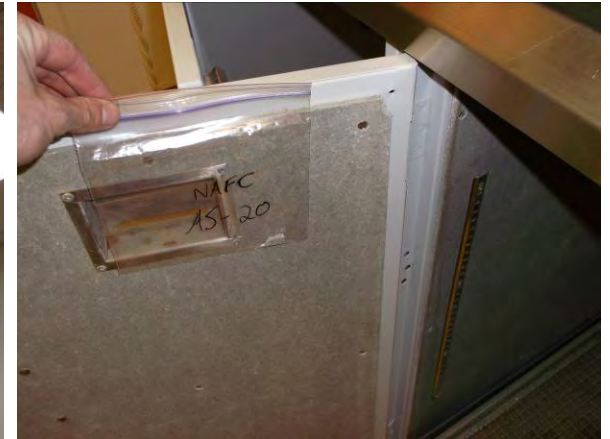
Three (3) samples of cement board (AS-20, AS-31 and AS-44) were collected in P20-113, O21-101 and M21-103 and analyzed for asbestos content (refer to Photos 21, 32 and 45, Appendix B). Chrysotile asbestos (ranging from 20% to 30%) was detected in samples AS-20 and AS-44 at levels above the applicable *NL Asbestos Abatement Regulations (111/98)* (i.e., <1%) and therefore this material (i.e. cement board (transite) in fume hoods and around ovens) is considered to be an ACM. Asbestos was not detected in the cement board sample collected in O21-101 (i.e. AS-31).

Photo 21: View of cement board (transite) sample AS-20.

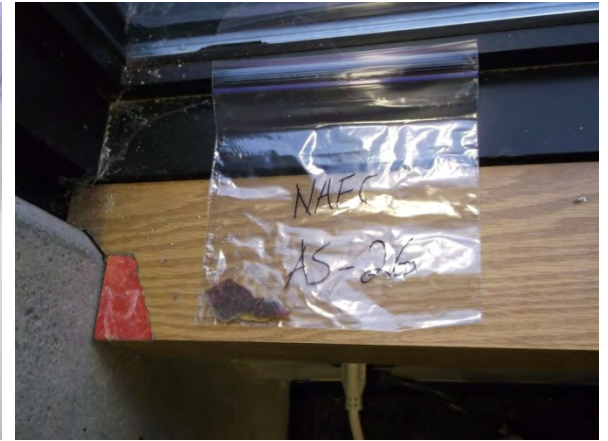
One (1) sample of faux wood veneer and red mastic (AS-26) was collected in P20-106 and analyzed for asbestos content (refer to Photo 27, Appendix B). Asbestos was not detected in the concrete floor coating and associated mastic sample collected and submitted for analysis.

Photo 27: View of wood veneer and mastic sample AS-26.

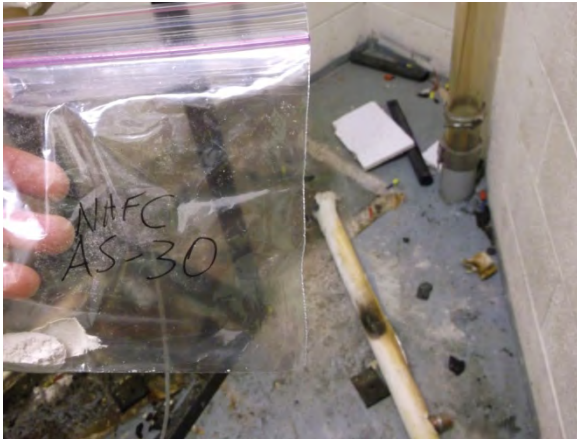
Photo 31: View of pipe elbow parging sample AS-30.

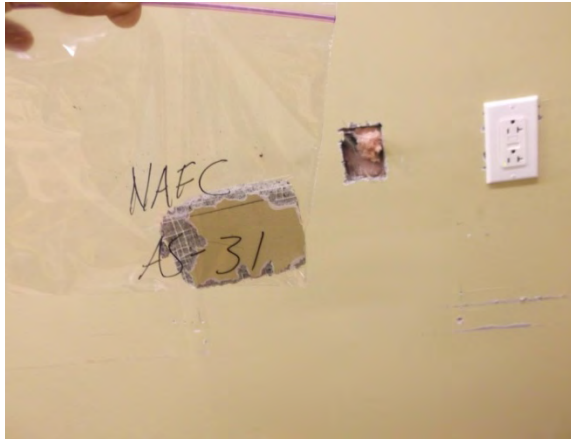
Photo 32: View of cement board sample AS-31.

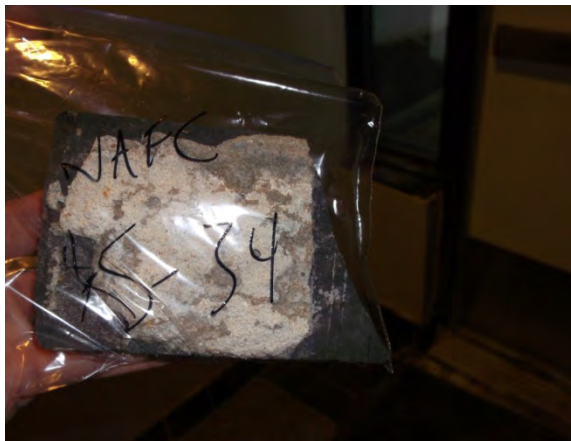
Photo 35: View of ceramic tile and grout sample AS-34.

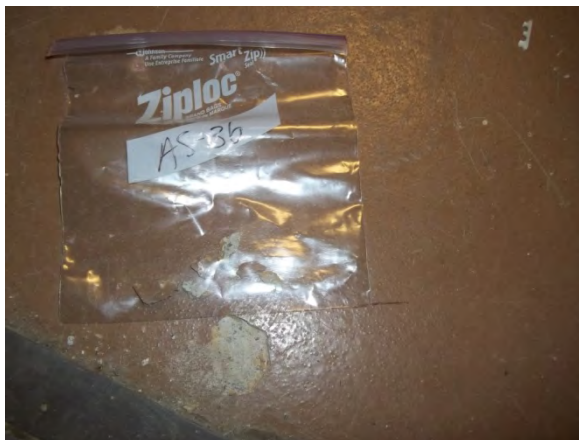
Photo 37: View of concrete floor coating sample AS-36.

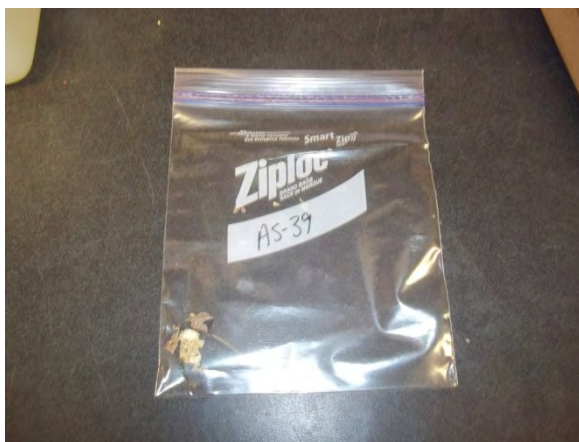
Three (3) samples of black countertop (AS-39, AS-40 and AS-52) were collected in N20-121, N20-122 and P20-121 and analyzed for asbestos content (refer to Photos 40, 41 and 53, Appendix B). Asbestos was not detected in the black countertop samples collected and submitted for analysis.

Photo 40: View of countertop sample AS-39.

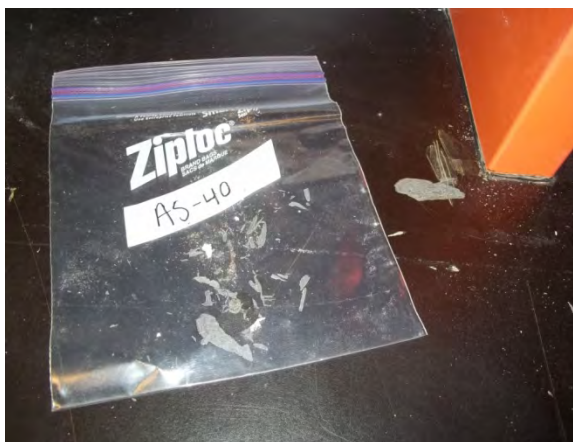
Photo 41: View of countertop sample AS-40.

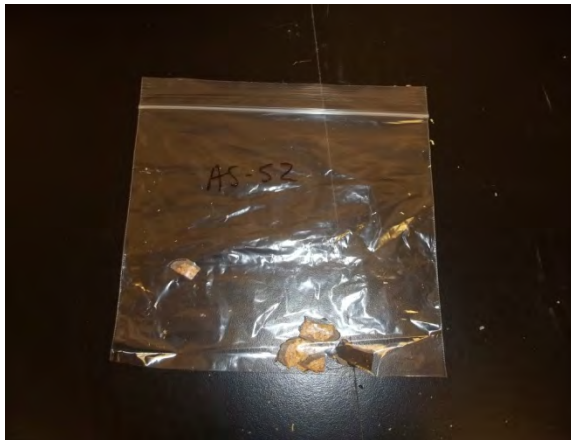
Photo 53: View of countertop sample AS-52.

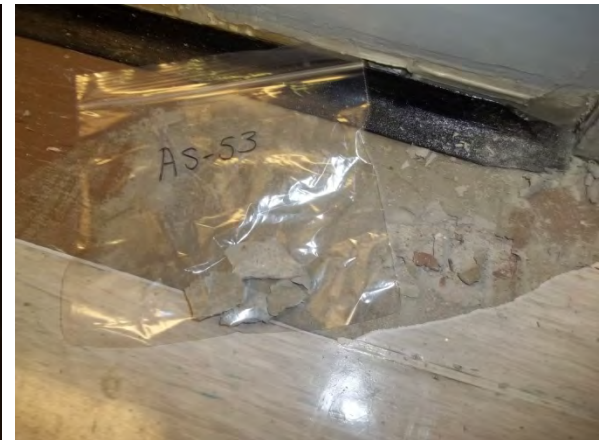
One (1) sample of floor leveling compound (AS-53) was collected in P20-125 and analyzed for asbestos content (refer to Photo 54, Appendix B). Asbestos was not detected in the cement floor leveling compound sample collected and submitted for analysis.

Photo 54: View of floor levelling compound sample AS-53.

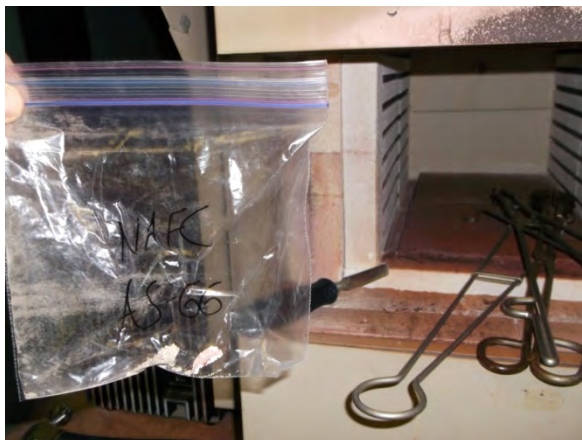
One sample of white brick (AS-66) was collected from an oven in N20-120 and analyzed for asbestos content (refer to Photo 67, Appendix B). Asbestos was not detected in the oven white brick sample collected and submitted for analysis.

Photo 67: View of oven brick sample AS-66.

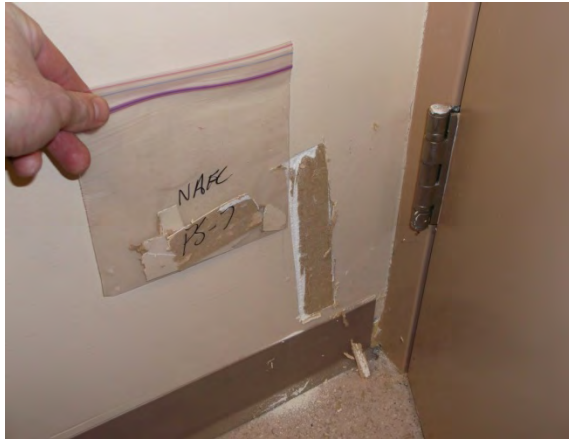
Concentrations of lead in the paint samples ranged from non-detect (<5.0 mg/kg) to 930 mg/kg (refer to Table C-1, Appendix C). Five (5) of the 19 paint samples (PS-07, PS-08, PS-13, PS-15 and PS-19) contained lead at concentrations above the Federal HPA criterion of 90 mg/kg but below the former Federal HPA criterion of 5,000 mg/kg (refer to Photos 74, 75, 80, 82 and 86, Appendix B). All of the other paint samples analyzed were either non-detect for lead (i.e. <5.0 mg/kg) or contained lead at concentrations below the applicable Federal HPA criterion (i.e. 90 mg/kg).

Photo 74: View of paint sample PS-07.

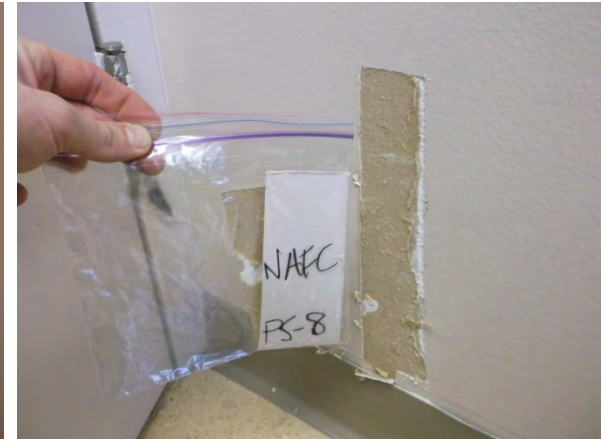
Photo 75: View of paint sample PS-08.

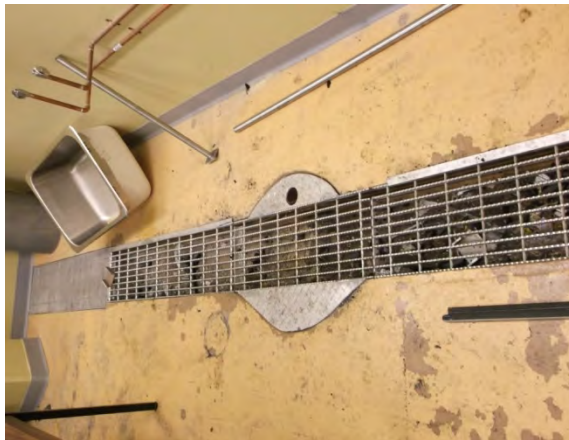
Photo 77: Location of paint sample PS-10.

The paint visible throughout the CFIA Space was generally in good condition. Peeling and flaking paint was observed on the concrete floor in O21-101 (refer to Photo 77, Appendix B).

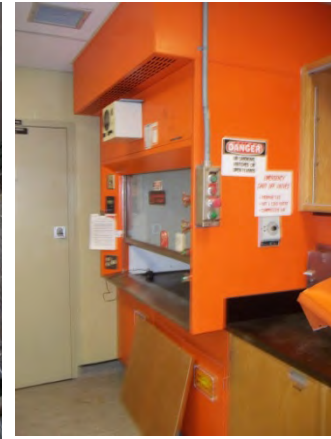
- N20-115: one (1) laboratory fume hood observed with organic solvents and biological hazards labels; sink/fume hood drains connected to glass piping (refer to Photos 93 to 95, Appendix B).

Photo 93: View of fume hood in N20-115.

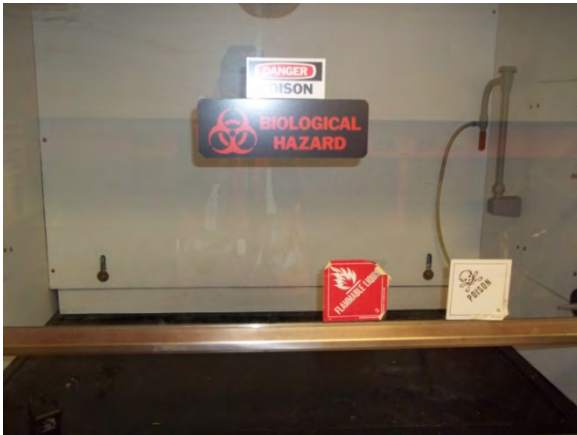
Photo 94: View of fume hood in N20-115.

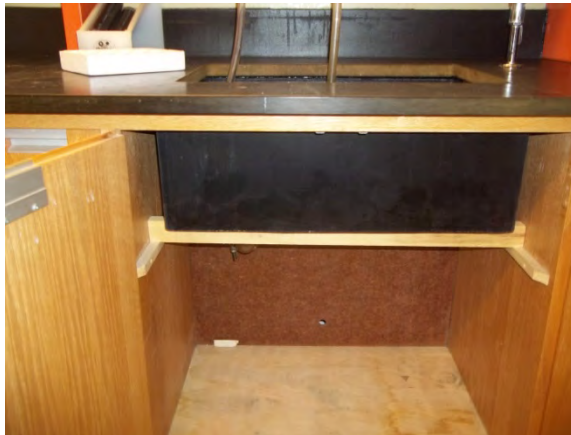
Photo 95: View of laboratory sink in N20-115.

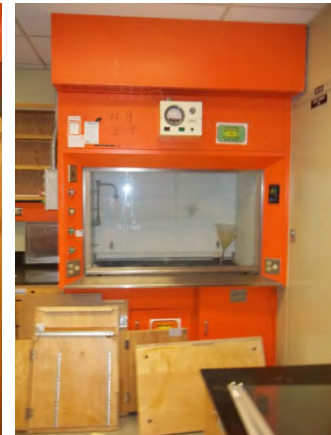
- N20-116: one (1) laboratory fume hood observed with organic solvents label; fume hood drain connected to glass piping (refer to Photo 96, Appendix B).

Photo 96: View of fume hood in N20-116.

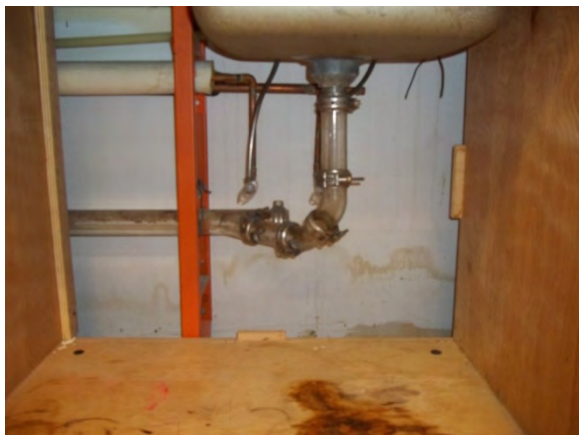
- N20-118: sink drain connected to glass piping (refer to Photo 97, Appendix B).
- N20-119: sink drain connected to glass piping (refer to Photo 98, Appendix B).

Photo 97: View of laboratory sink in N20-118.

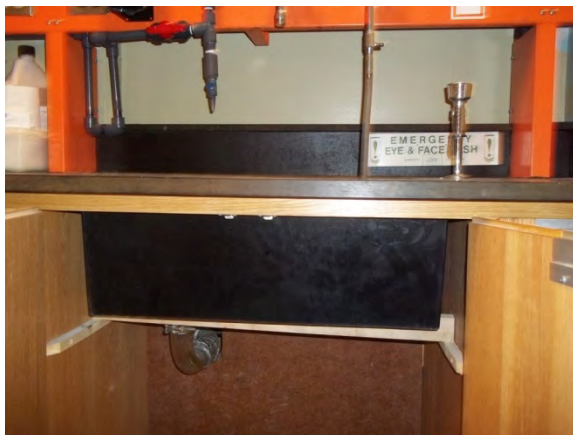
Photo 98: View of laboratory sink in N20-119.

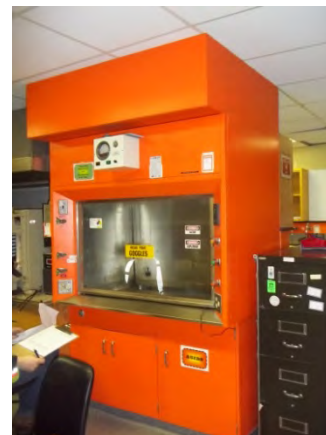
- N20-120: four (4) laboratory fume hoods observed with perchloric acid, organic solvents and acids labels; some residual dust observed in hoods; fume hood drains connected to glass piping (refer to Photos 99 to 102, Appendix B).

Photo 99: View of fume hood in N20-120.

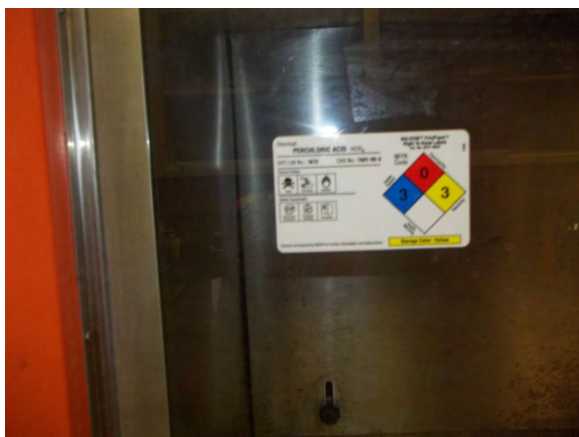
Photo 100: View of perchloric acid label on fume hood in N20-120.

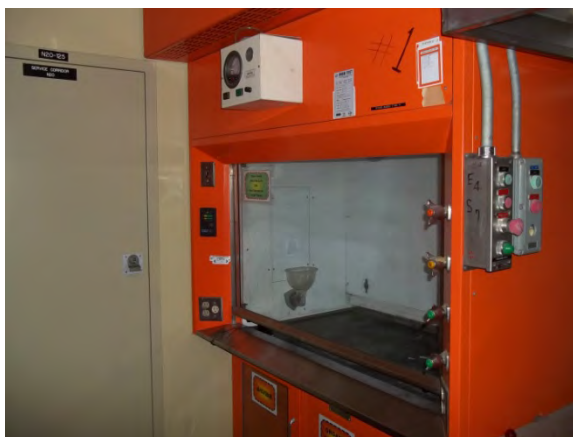
Photo 101: View of fume hood in N20-120.

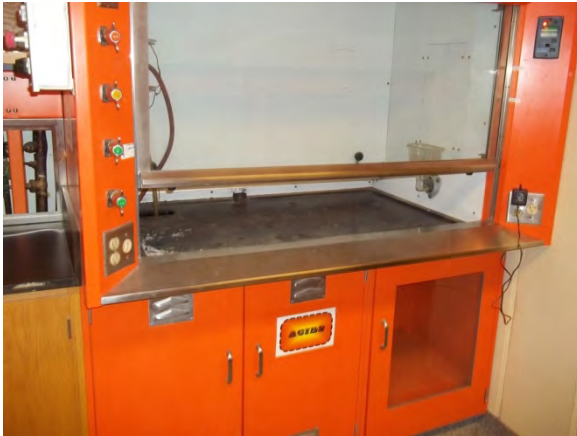
- N20-122: one (1) laboratory fume hood observed with acids label; fume hood drain connected to glass piping (refer to Photos 103 and 104, Appendix B).

Photo 103: View of fume hood in N20-122.

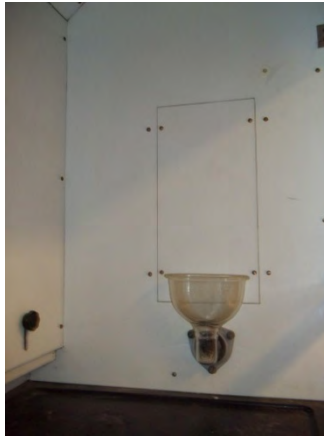
Photo 104: View of drain inside fume hood in N20-122.

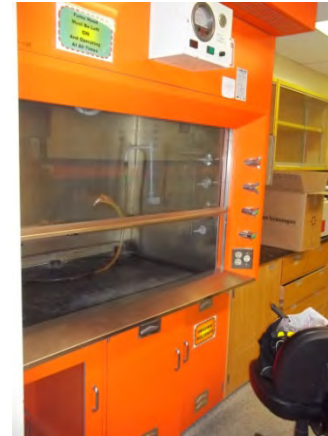
- N20-123: one (1) laboratory fume hood observed with organic solvents label; fume hood drain connected to glass piping (refer to Photos 105 to 107, Appendix B).

Photo 105: View of fume hood in N20-123.

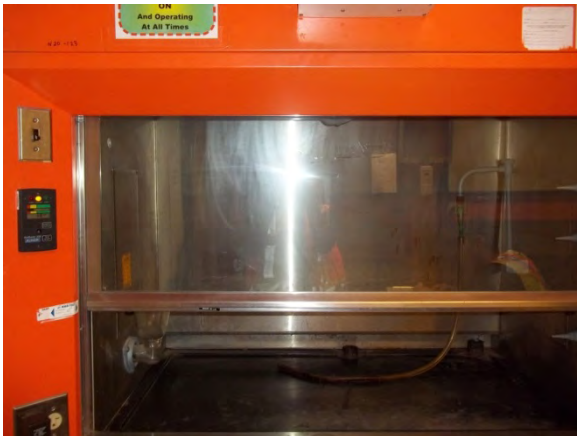
Photo 106: View of fume hood in N20-123.

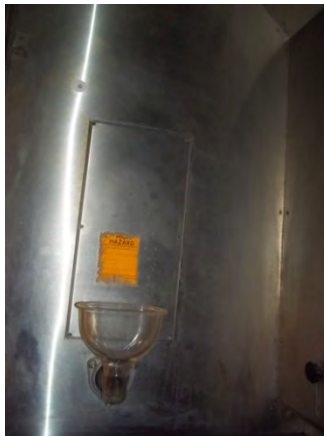
Photo 107: View of drain inside fume hood in N20-123.

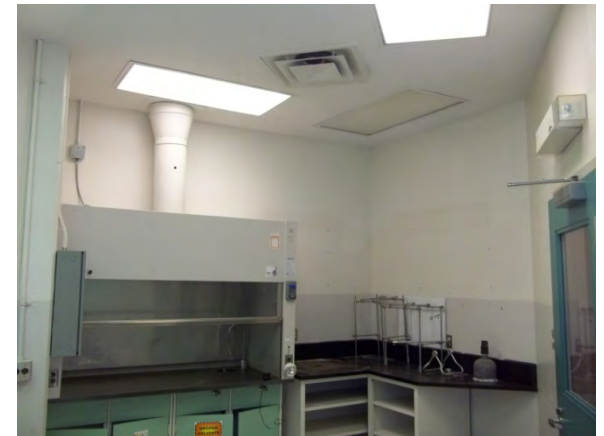
- N20-124/124a: two (2) laboratory fume hoods observed with organic solvents, acetone, carbon tetrachloride and chloroform labels (refer to Photos 108 and 109, Appendix B).

Photo 108: View of fume hood in N20-124/N20-124a.

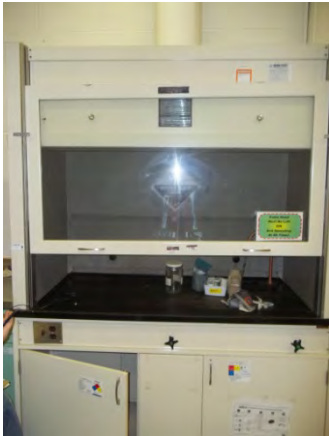
Photo 109: View of fume hood in N20-124/
N20-124a.

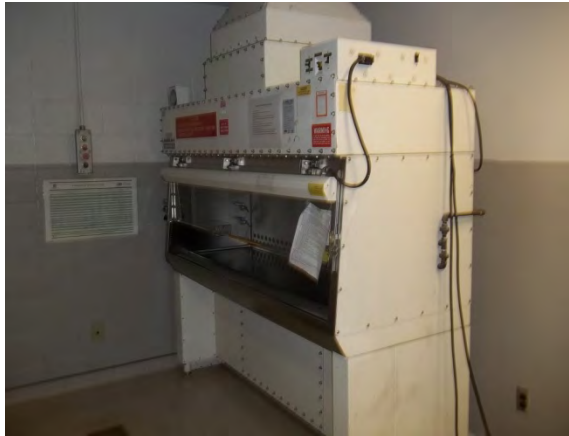
- P20-125: one (1) laboratory fume hood observed (refer to Photo 110, Appendix B).
- P20-112: one (1) laboratory fume hood and glass piping observed (refer to Photos 111 and 112, Appendix B).

Photo 110: View of fume hood in P20-125.

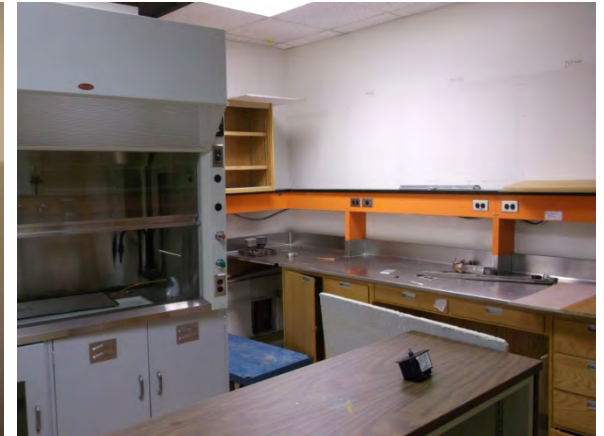
Photo 111: View of fume hood in P20-112.

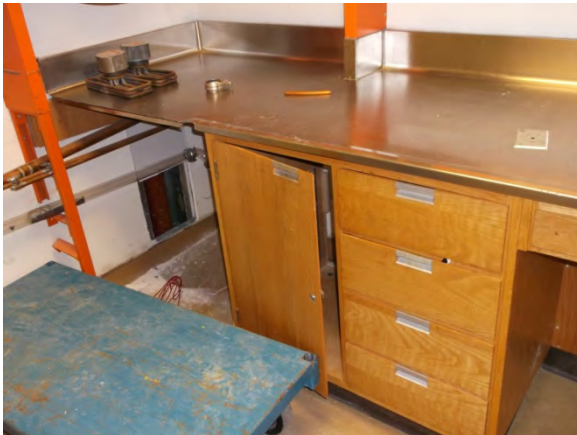
Photo 112: View of laboratory drainage
piping in P20-112.

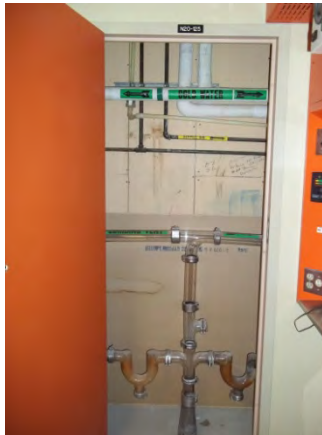
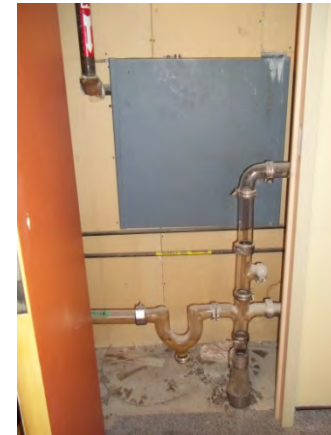
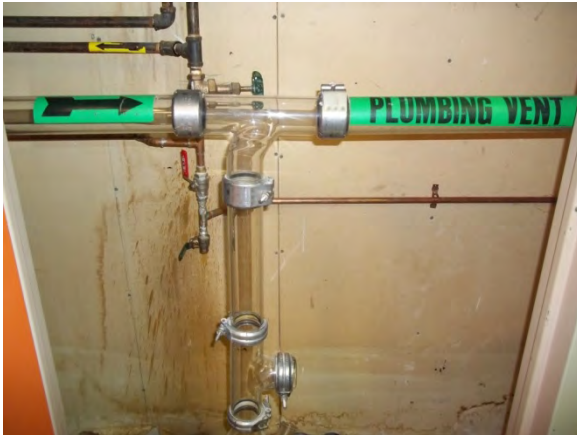
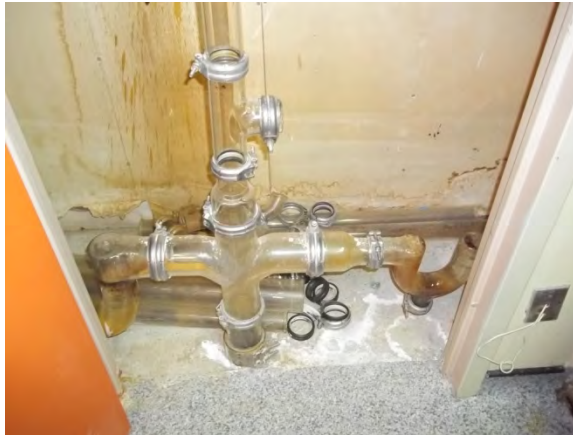
- N20-125: glass piping observed throughout service corridor; possible unknown residual/waste chemicals (i.e. staining and liquid) observed at locations of some pipe traps (refer to Photos 113 to 116, Appendix B).

Photo 113: View of piping in service
corridor N20-125.

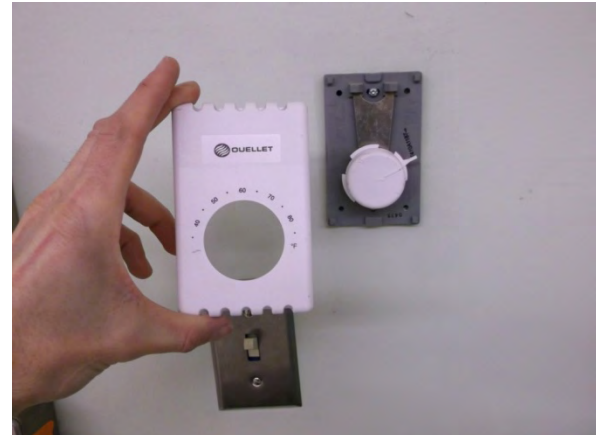
Nine (9) types of thermostats were identified throughout the CFIA Space during the investigation (refer to Photos 117 to 125, Appendix B). Results of the thermostat inspection are summarized

Photo 117: View of white rectangular Outlet thermostat.

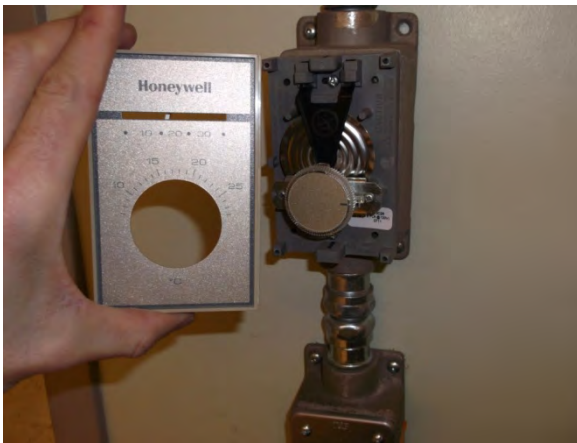
Photo 118: View of silver rectangular Honeywell thermostat.

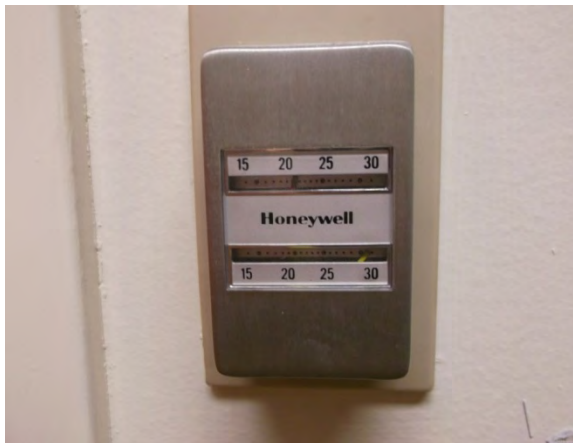
Photo 119: View of steel rectangular Honeywell thermostat.

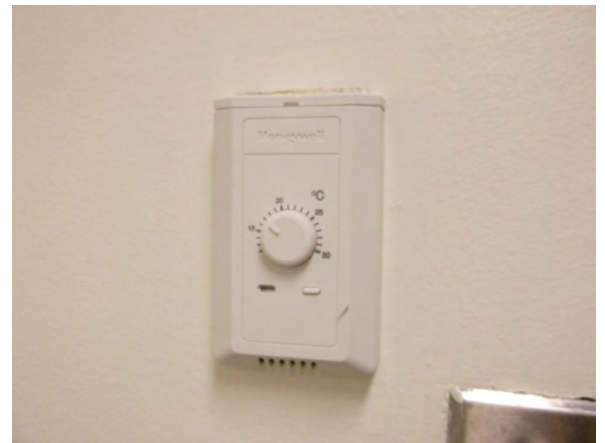
Photo 120: View of large white rectangular Honeywell thermostat.

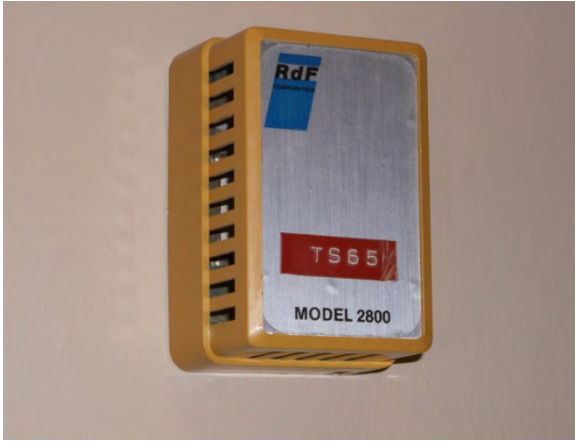
Photo 121: View of yellow RDF thermostat.

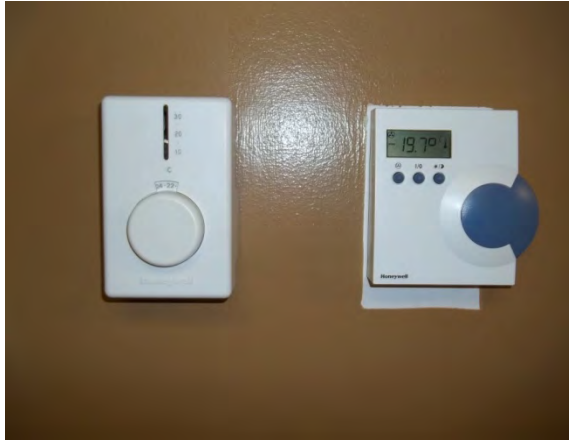
Photo 122: View of white Honeywell rectangular (left) and electric square (right) thermostats.

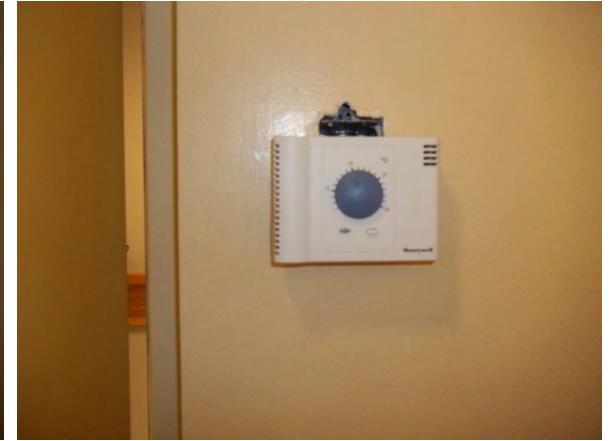
Photo 123: View of white Honeywell electric square thermostat.

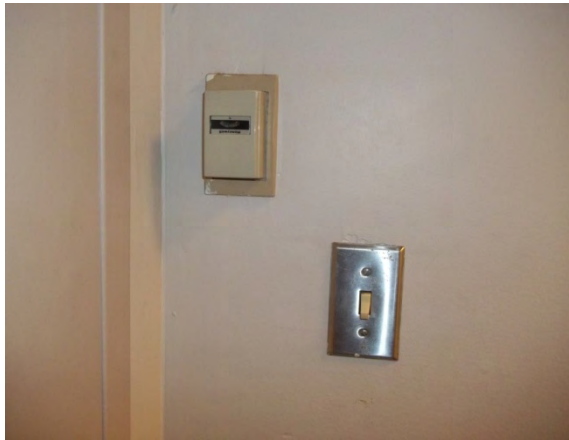
Photo 125: View of brown Honeywell rectangular thermostat.

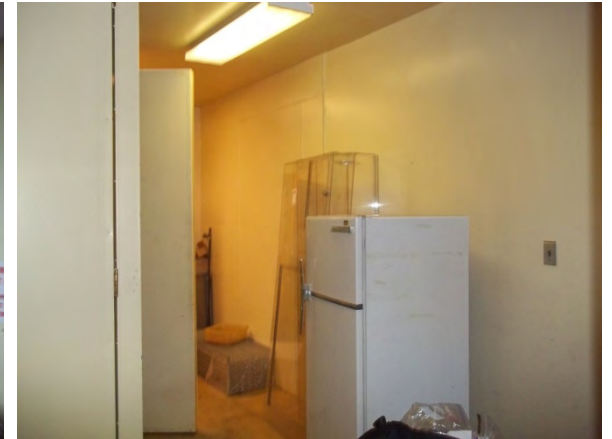
in N20-107 and N20-123 (refrigerants unknown) and three (3) domestic refrigerators (refrigerants unknown) in M21-105, P20-120 and P20-123 (refer to Photos 126 to 129, Appendix B). Although several fire extinguishers (i.e. dry chemical) were identified in the CFIA Space, the labels on these units, where observed, did not indicate the presence of halon or other ODS ingredients (refer to Photo 130, Appendix B).

Photo 129: View of domestic refrigerator.

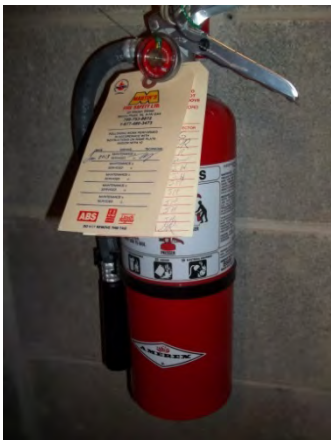
Photo 130: View of dry chemical fire extinguisher.

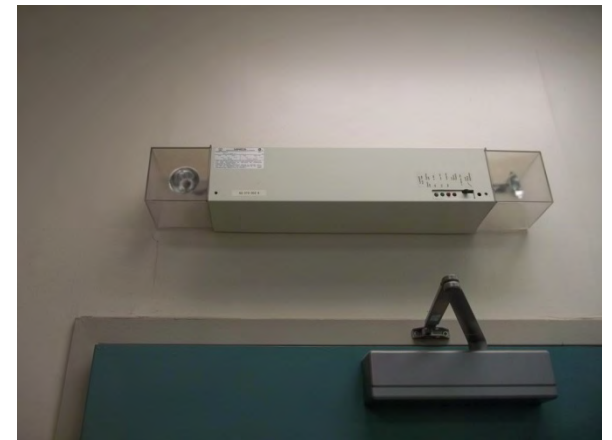
Several potential lead-acid battery containing devices (i.e., emergency light fixtures) were noted inside the CFIA Space at the time of the Site inspections (refer to Photo 132, Appendix B).

Photo 132: View of emergency light fixture.
