CANADA CENTRE FOR INLAND WATERS (CCIW)

Burlington, Ontario

LEVEL 2 (Life Cycle)
BUILDING CONDITION REPORT
September 2009

**Environment Canada
Canada Centre for Inland Waters (CCIW)
NWRI BUILDING**

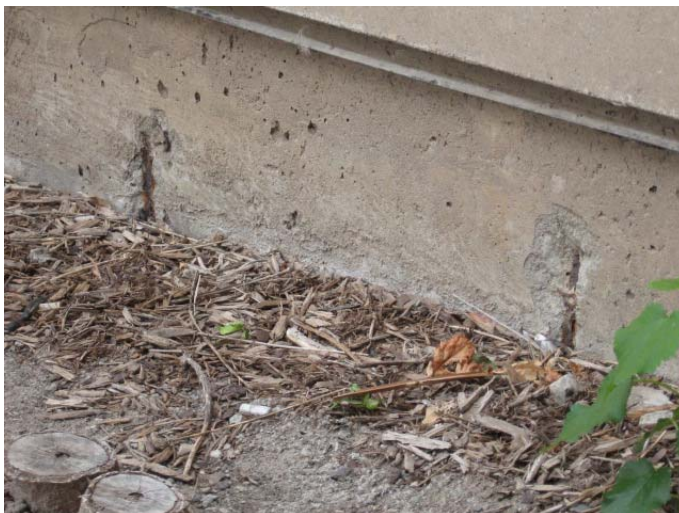
AR-013 – Exposed rebar with deteriorated concrete at foundation.

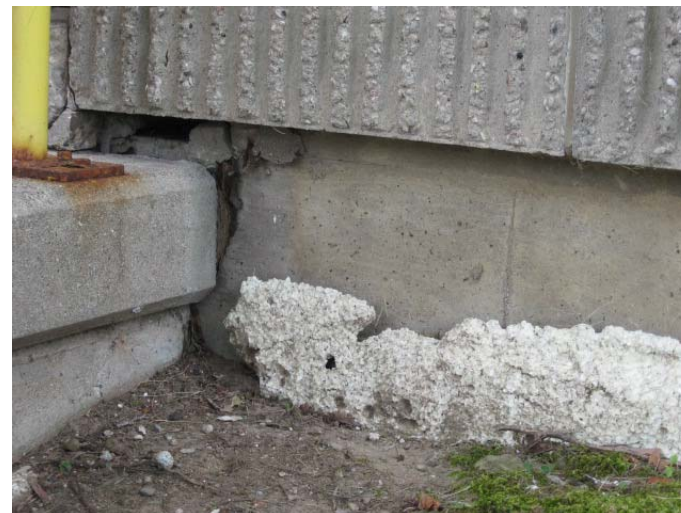
AR-014 – Exposed and deteriorating foundation insulation at Warehouse north elevation.

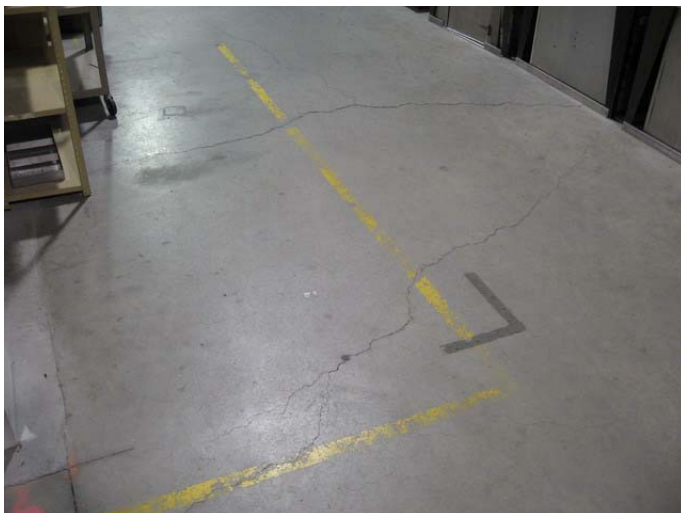
AR-017 – Cracks in concrete floor slab.

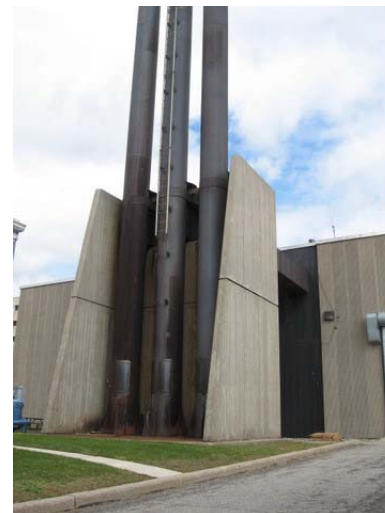
AR-018 – Concrete chimney support structure and rusting metal chimneys/breechings at Boiler Plant west elevation.

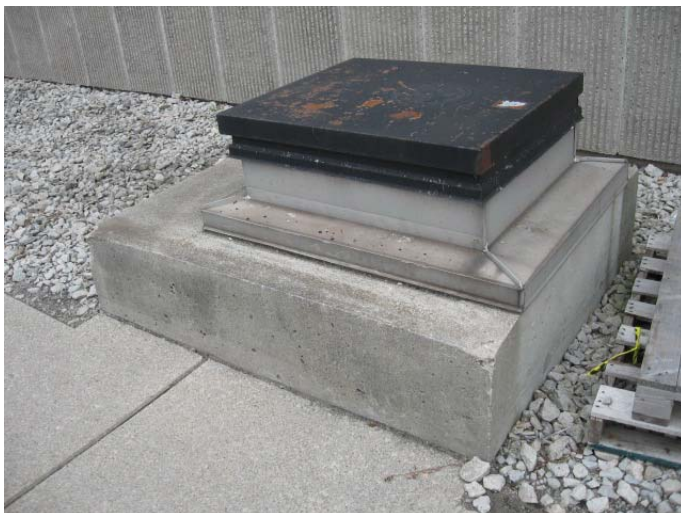
AR-021 – Tunnel access hatch cover with deteriorating paint finish.

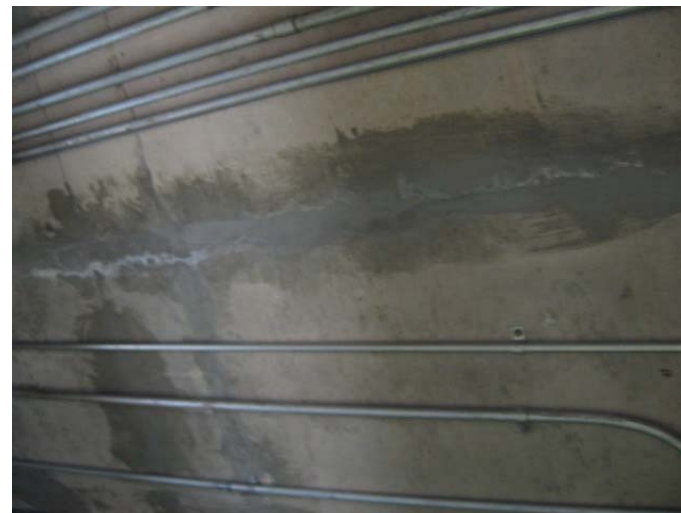
AR-022 – Water staining and efflorescence along ceiling crack in tunnel.

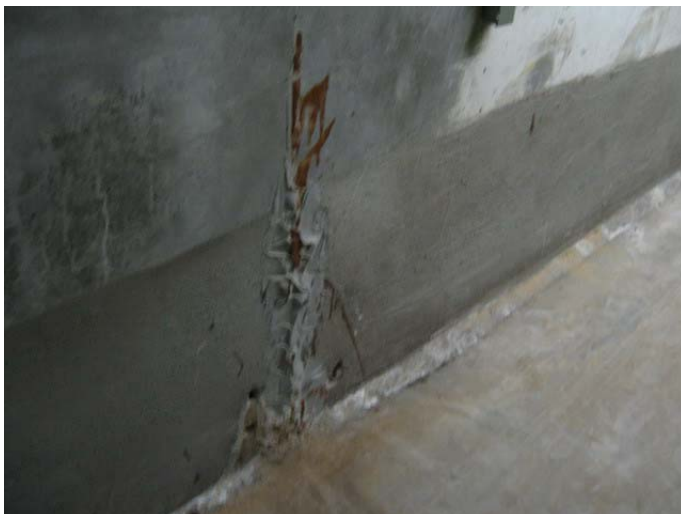
AR-023 – Previous crack repair (poorly executed) in tunnel wall.

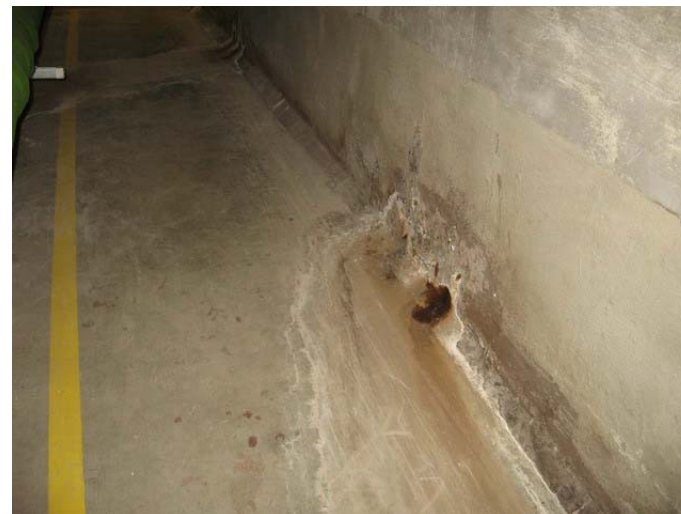
AR-024 – Water staining from ongoing seepage at tunnel wall/floor.

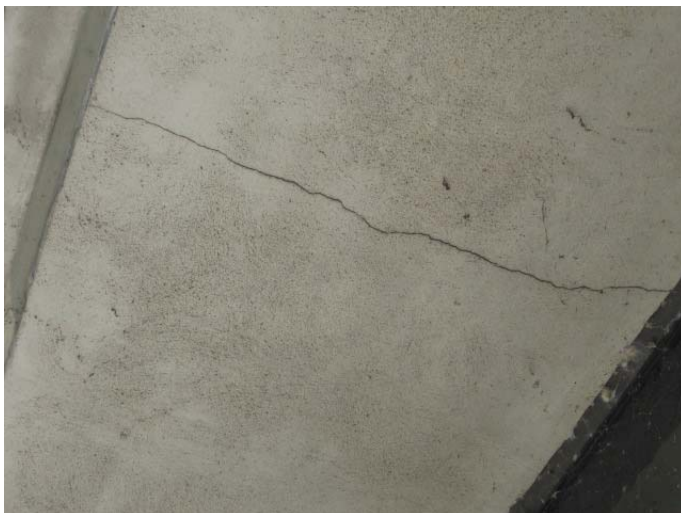
AR-025 – Cement plaster soffit with localized crack.

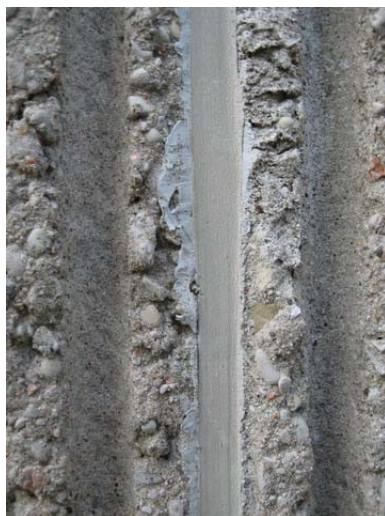
AR-027 – Sealants at concrete sandwich panel joints – old sealant visible.

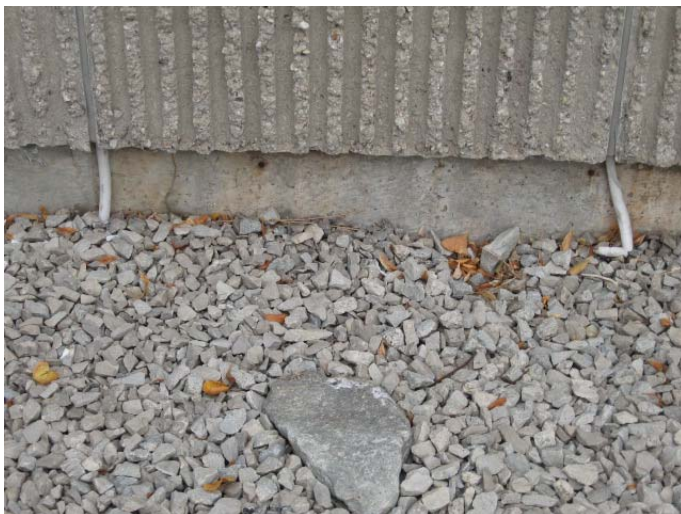
AR-029 – Undersized sealant backer rods falling out of concrete sandwich panel joints.

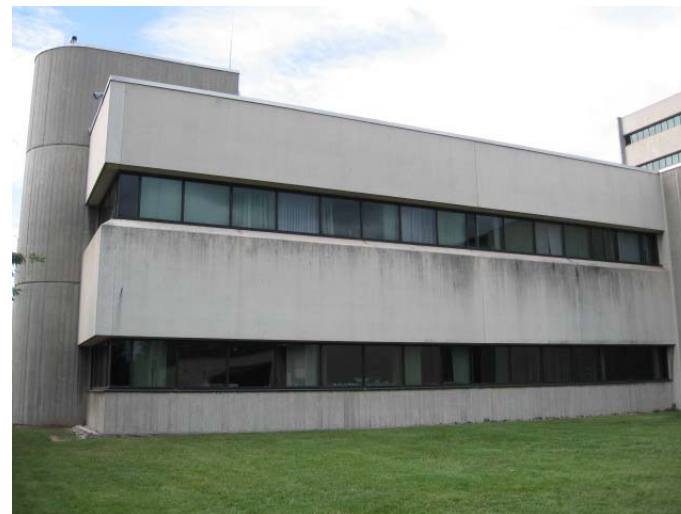
AR-030 – Stained/discoloured surfaces of concrete panels at Hydraulics lab offices.

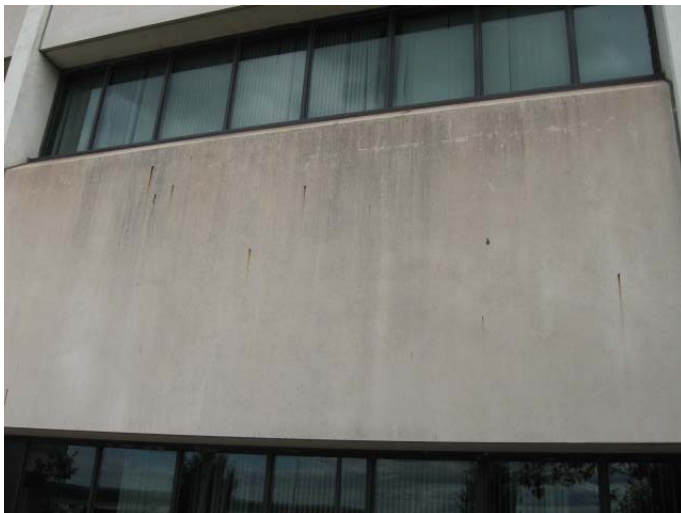
AR-033 – Rusting at exposed rebar and general surface staining/
Discolouring of concrete panels at Hydraulics Lab offices.

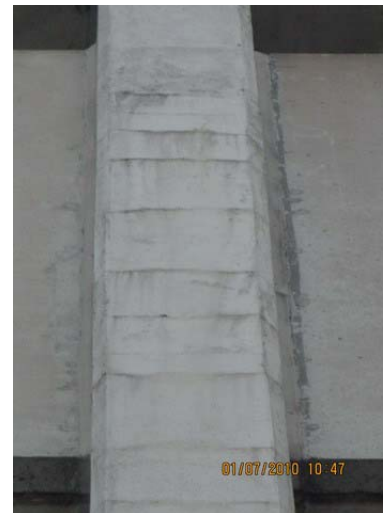
AR-034 – Cracks in cementitious coating on exposed column at
A&L east elevation.

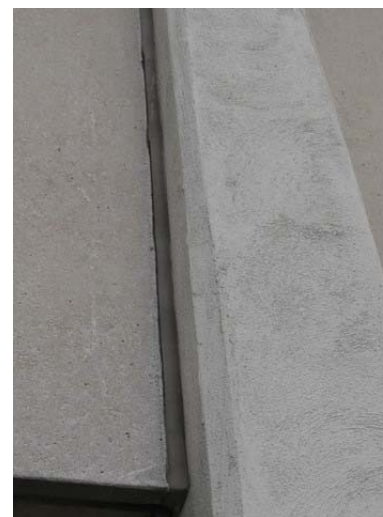
AR-036 – Debonding sealant at concrete panel.

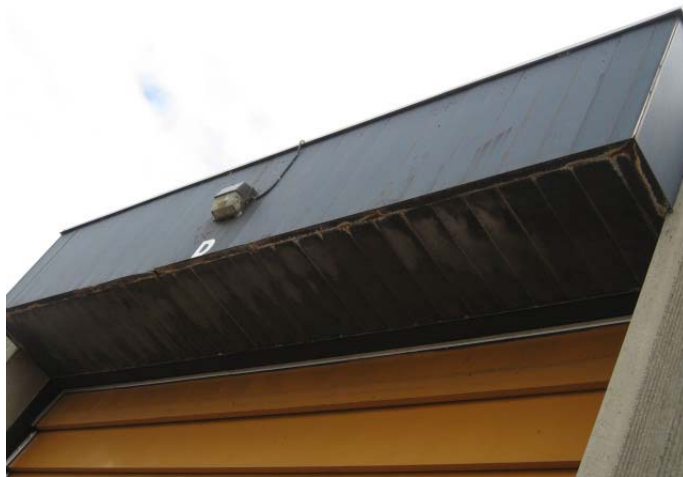
AR-037 – Deteriorated paint finish and rusting metal surfaces at Overhead door canopy siding/soffit.

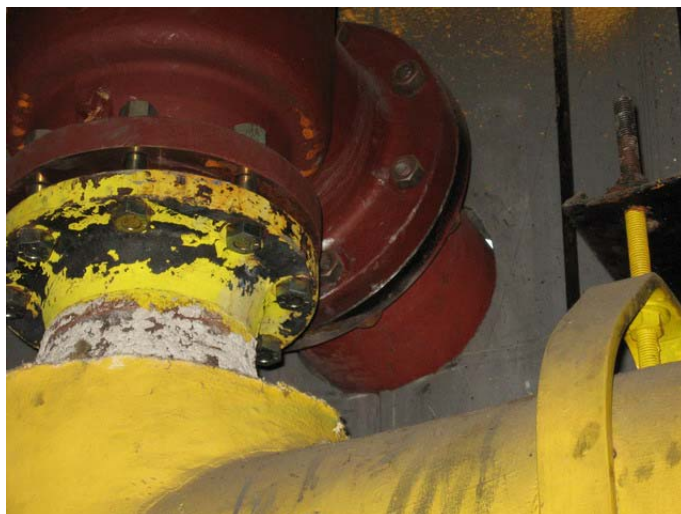
AR-043 – Unsealed penetration in R&D mechanical penthouse metal panel wall.

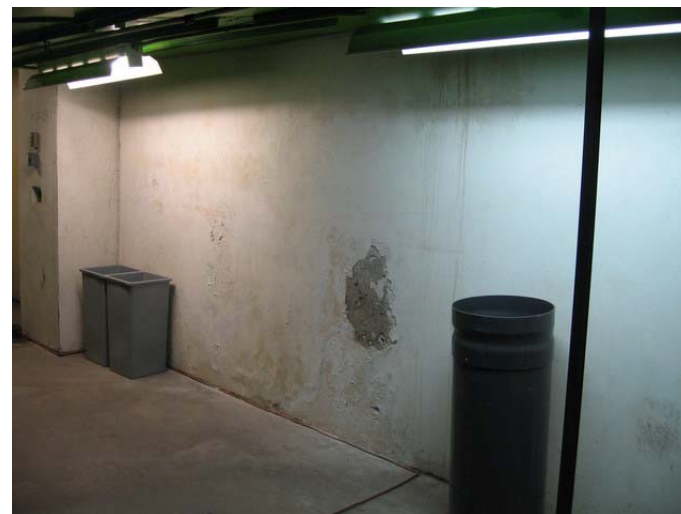
AR-044 – Moisture damaged interior finish at A&L 3rd floor east wall.

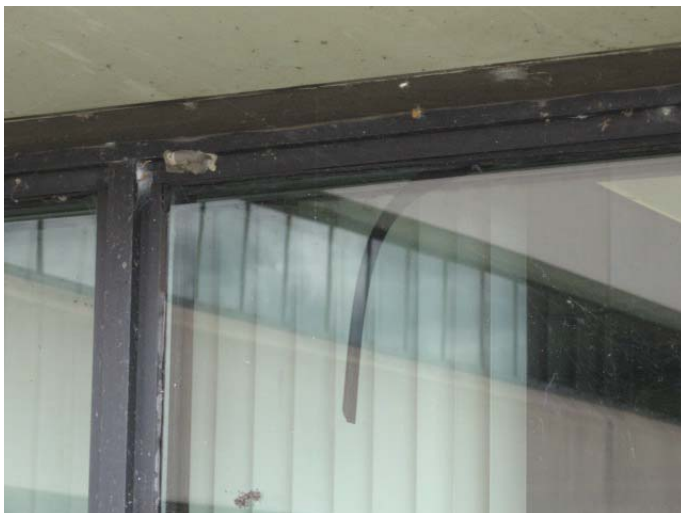
AR-049 – Part of windows interior glazing gasket fallen from place.

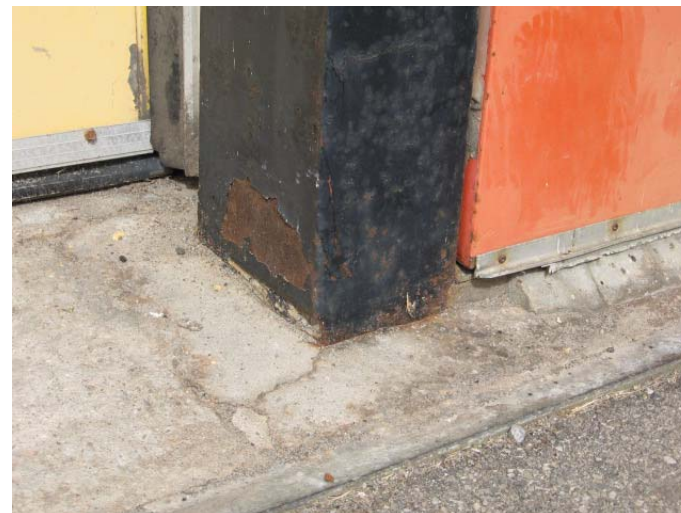
AR-050 – Deteriorated paint finish and rusting metal surfaces at door/overhead door framing.

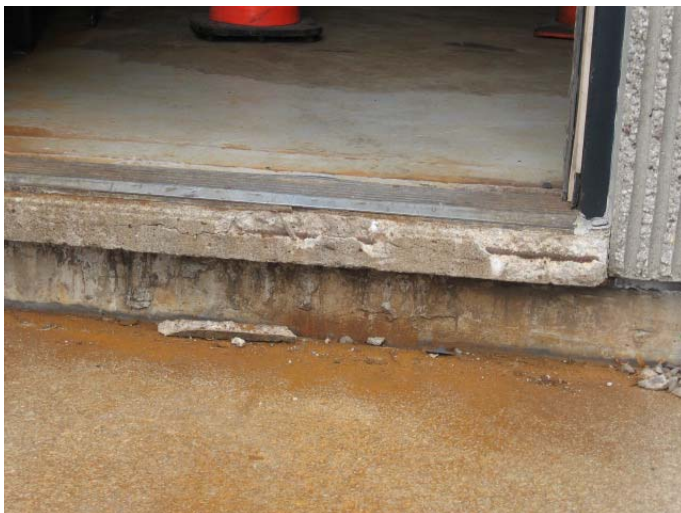
AR-053 – Deteriorating concrete door sill at Boiler Plant (Door 17).

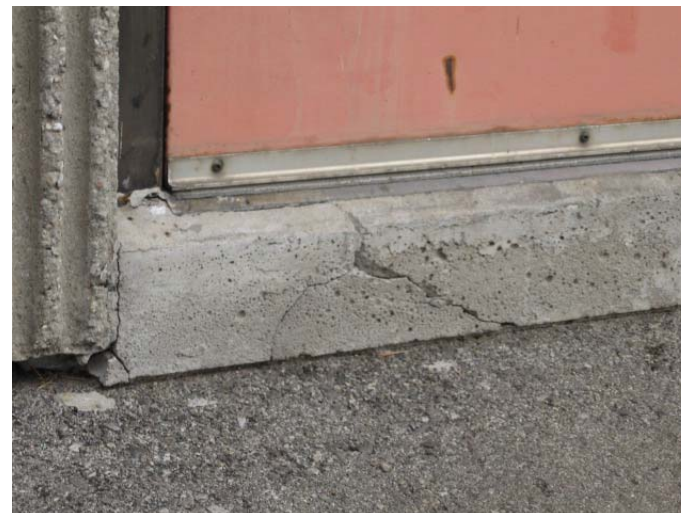
AR-054 – Deteriorating concrete door sill at Warehouse (Door 30).

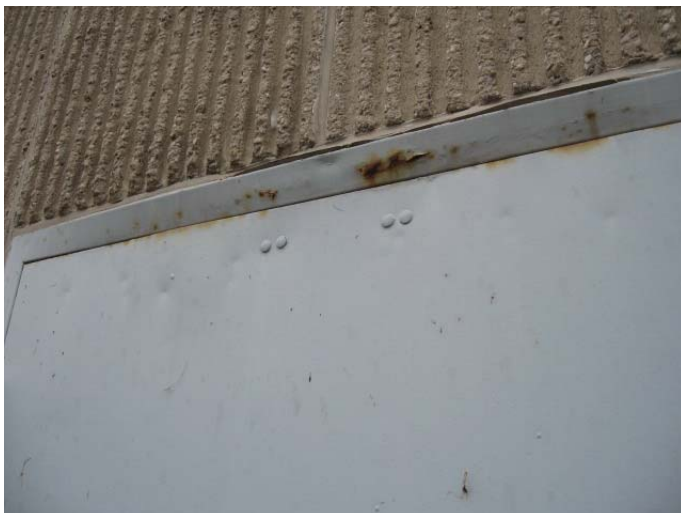
AR-055 – Deteriorated paint finish and rusting metal surfaces at door lintel.

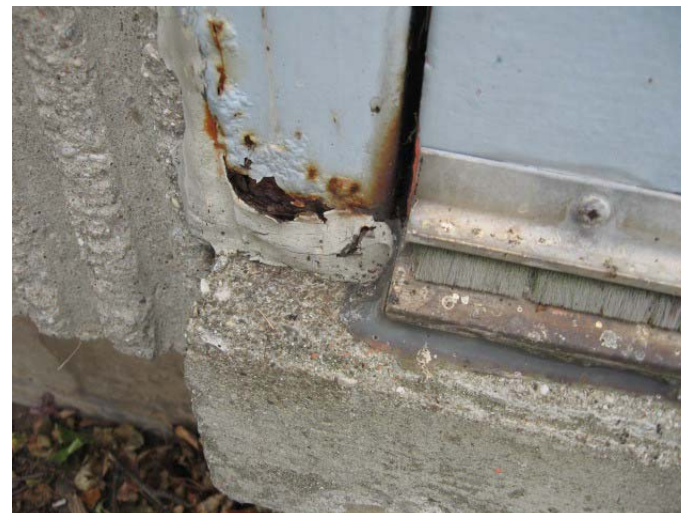
AR-056 – Deteriorated sealant, deteriorated paint finish and rusting metal surfaces at door frame.

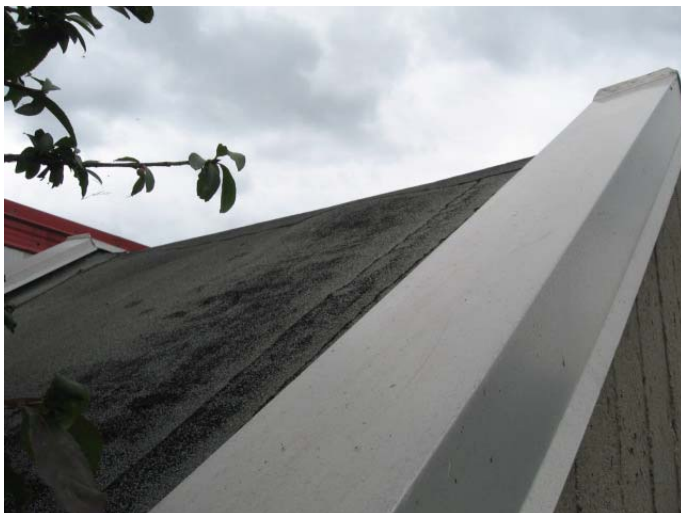
AR-057 – Deteriorated SBS roofing membrane at old guardhouse roof.

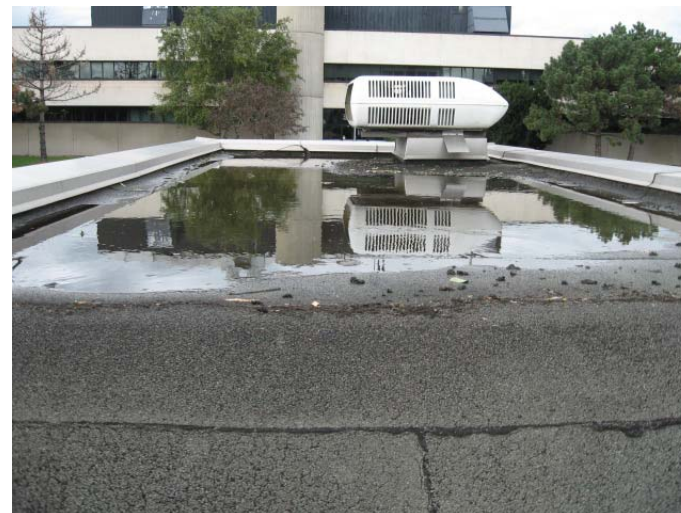
AR-058 – Standing water throughout old guardhouse roof.

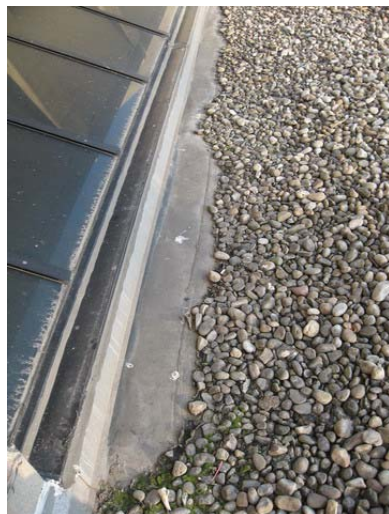
AR-059 – Tenting membrane and displaced ballast at EPDM membrane roofing.

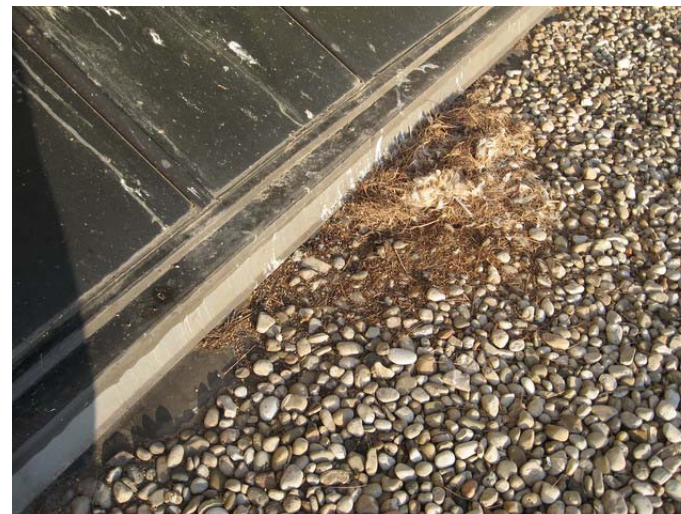
AR-060 – Debris accumulation at EPDM membrane roofing.

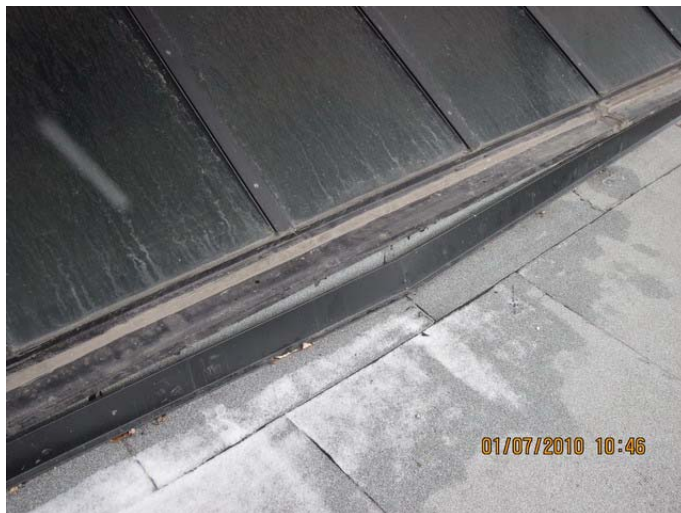
AR-061 – Loose/displaced metal flashing at SBS membrane roofing.

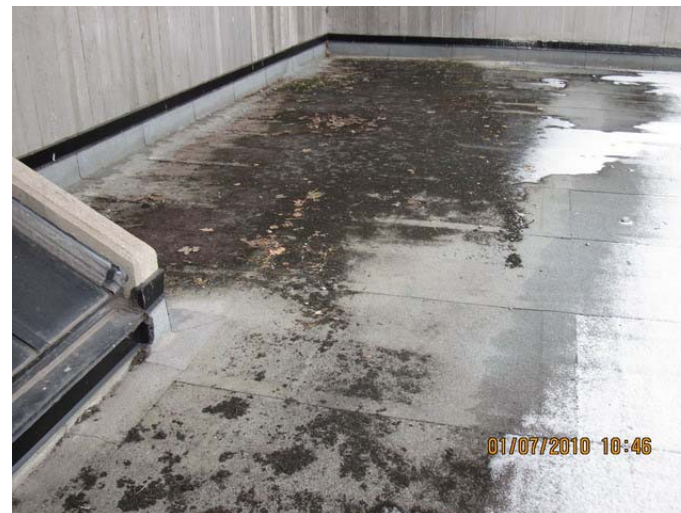
AR-062 – Debris and sediment from standing water accumulation at SBS membrane roofing.

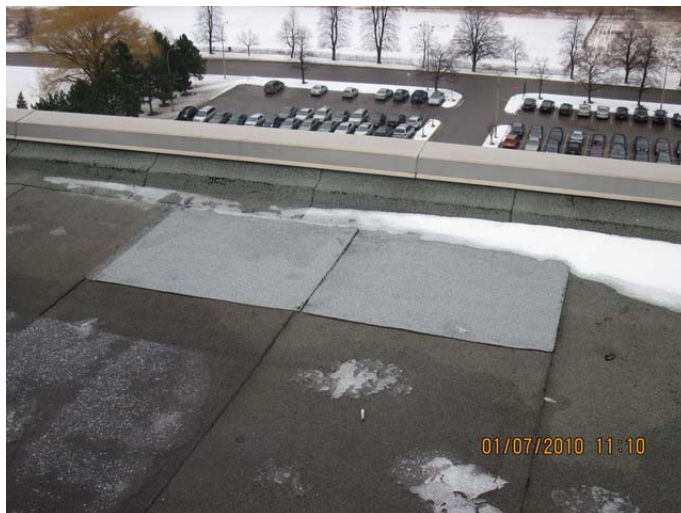
AR-065 – Recently repaired/patched area at SBS membrane roofing.

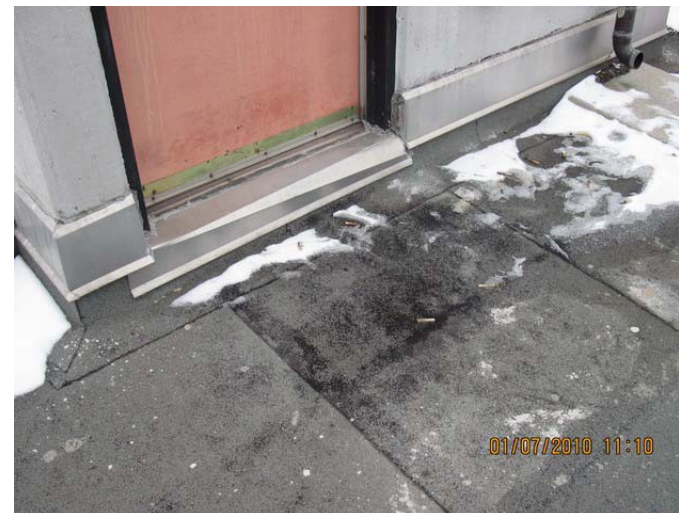
AR-066 – Severe loss of granular material at SBS membrane roofing at roof access point.

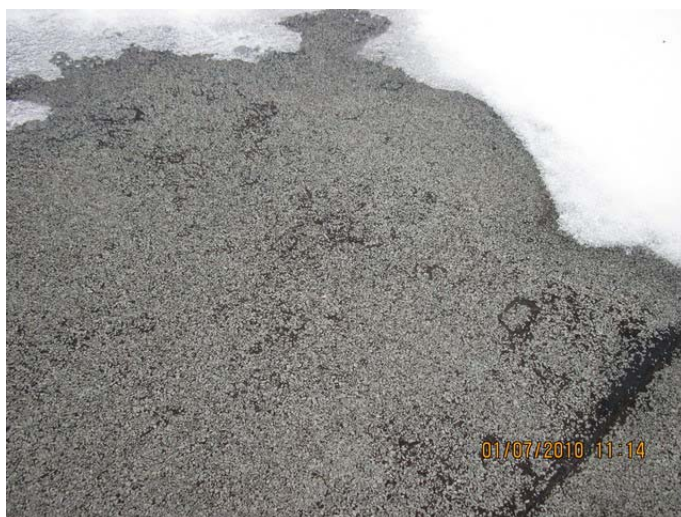
AR-067 – Blister in SBS membrane roofing.

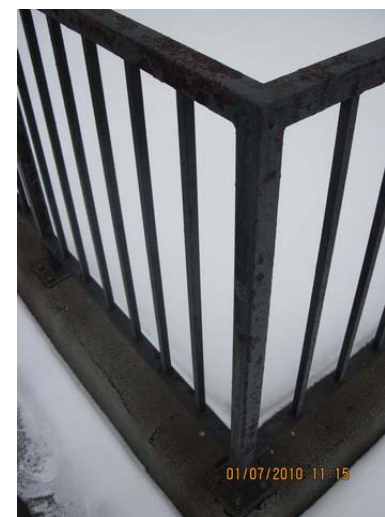
AR-068 – Deteriorated paint finish and rusting metal surfaces at rooftop guard.

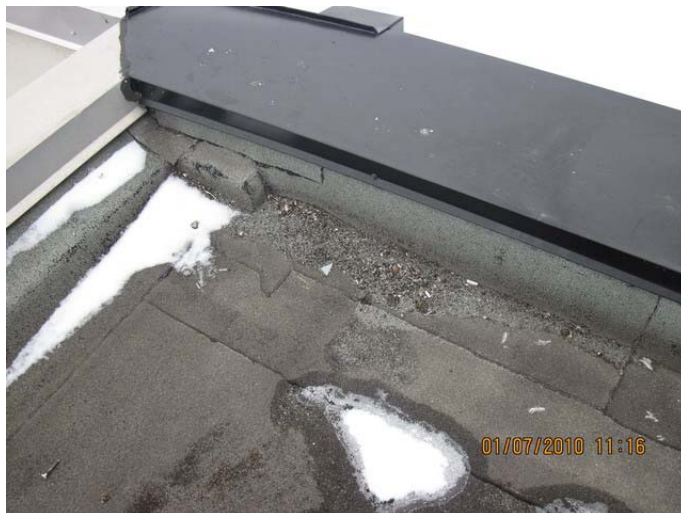
AR-069 – Debris accumulation at SBS membrane roofing.

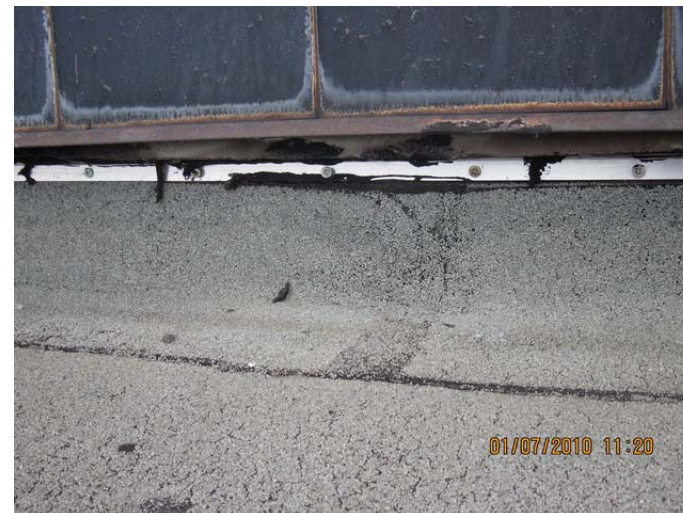
AR-070 – SBS membrane roofing pulled out from behind termination bar at penthouse flashing.

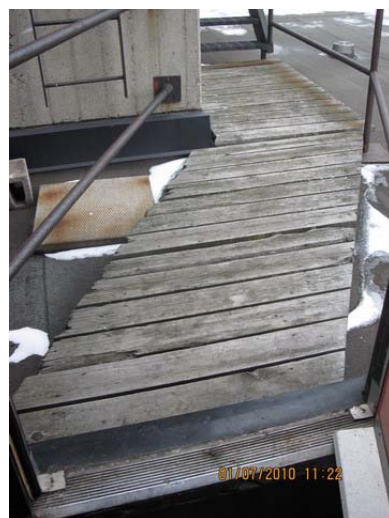
AR-071 – Deteriorated paint finish, rusting metal surfaces and deteriorating wood at rooftop guards and walkway.

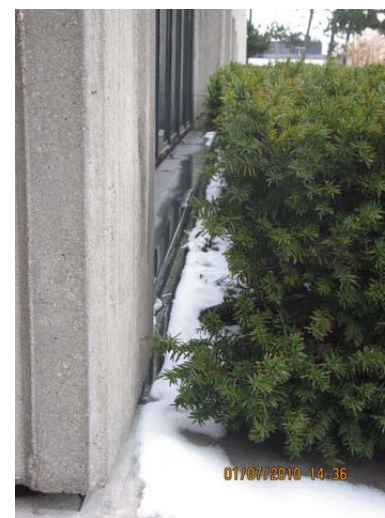
AR-072 – Proximity of vegetation to building face inhibits access for inspection and maintenance.

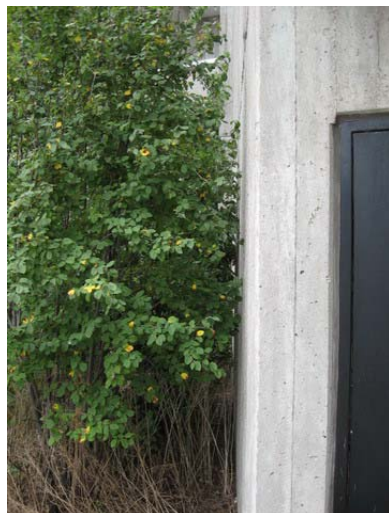
AR-073 – Proximity of vegetation to building face restricts air flow and holds moisture in building envelope.

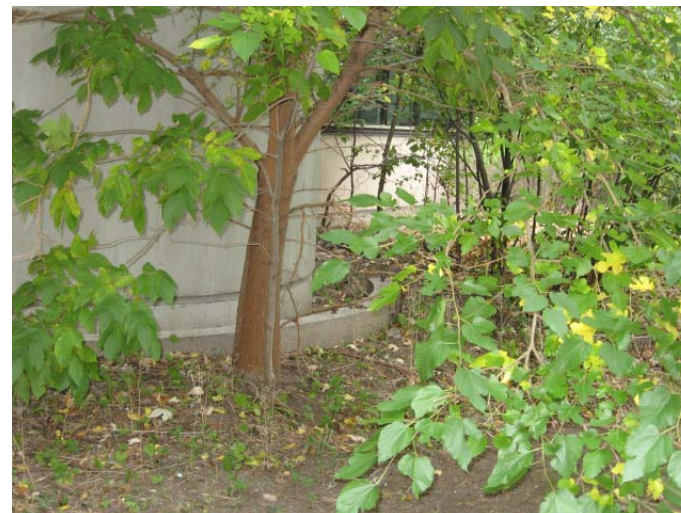
AR-074 – Proximity of vegetation to building face invites foundation damage from roots.

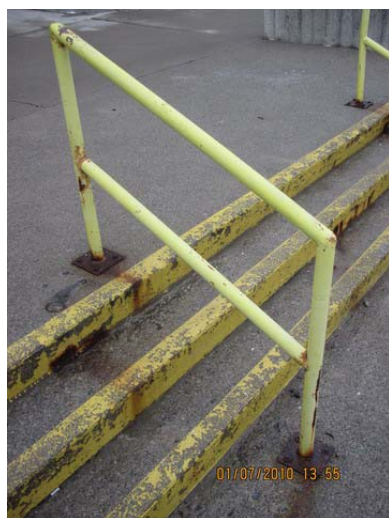
AR-079 – Deteriorated paint finish, rusting metal and stained surfaces from Guards and exposed rebar at R&D west-centre entrance stair.

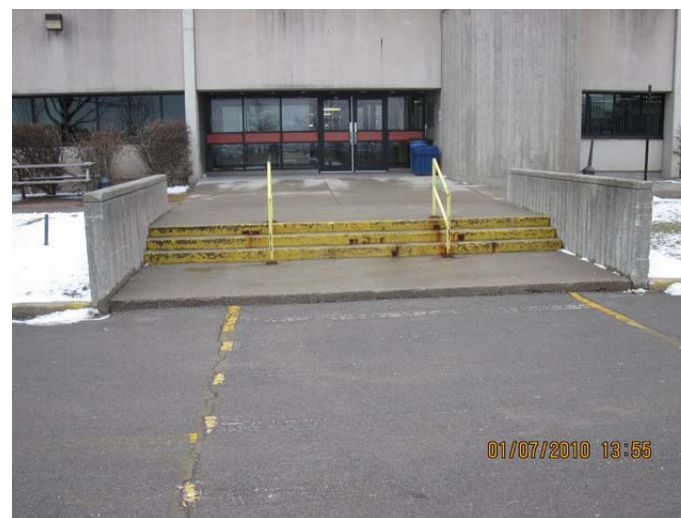
AR-080 – Overview of R&D west-centre entrance stair.

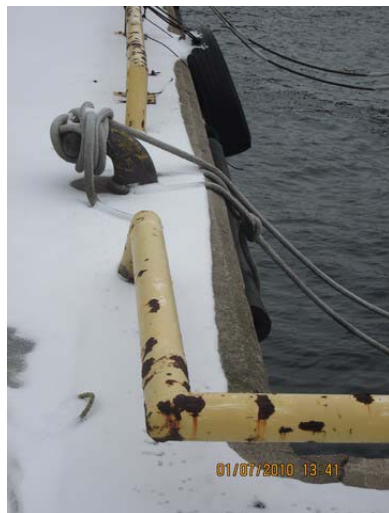
AR-081 – Deteriorated paint finish and rusting metal surfaces at wharfside guards.

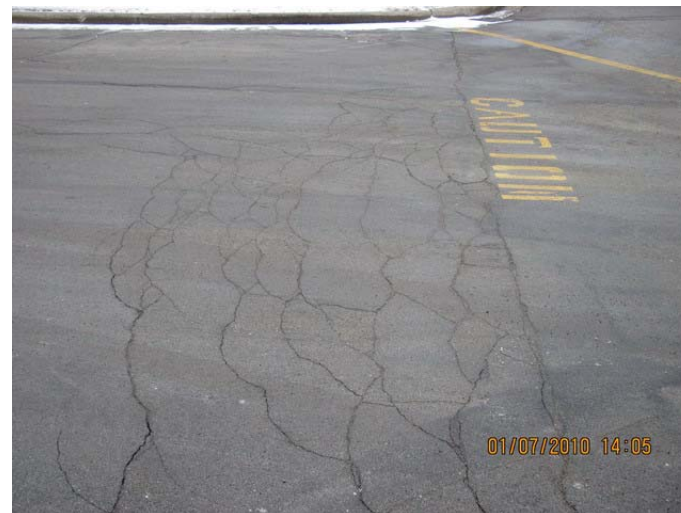
AR-082 – Cracking/alligating of asphalt pavement at driveway.

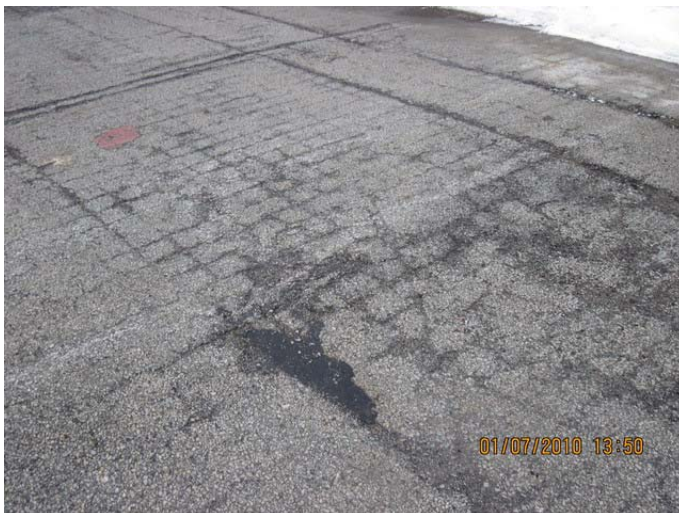
AR-085 – Deteriorated asphalt paving at wharfside outdoor storage/work area.

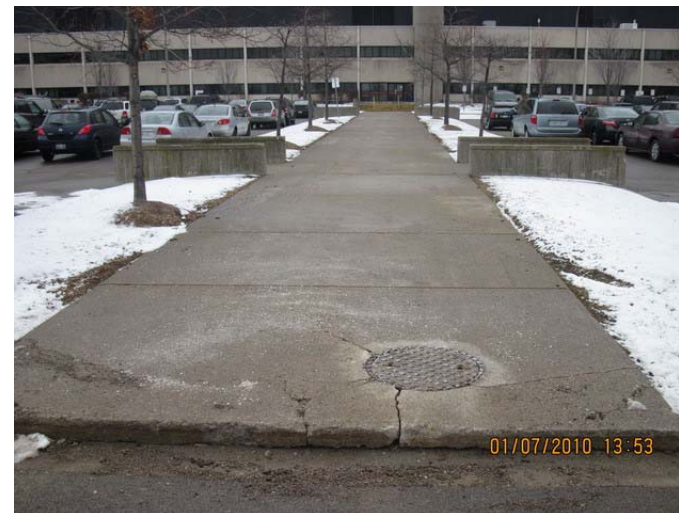
AR-086 – Cracked/broken concrete at walkway through parking area.

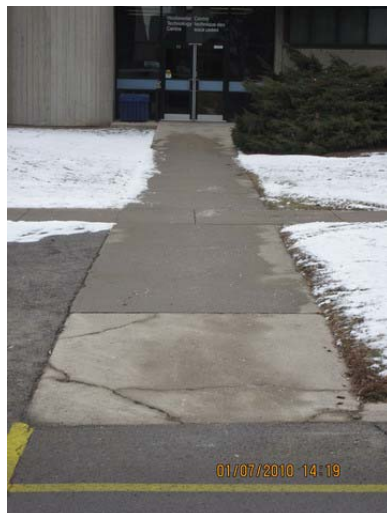
AR-087 – Cracked/broken concrete at walkway curb ramp.

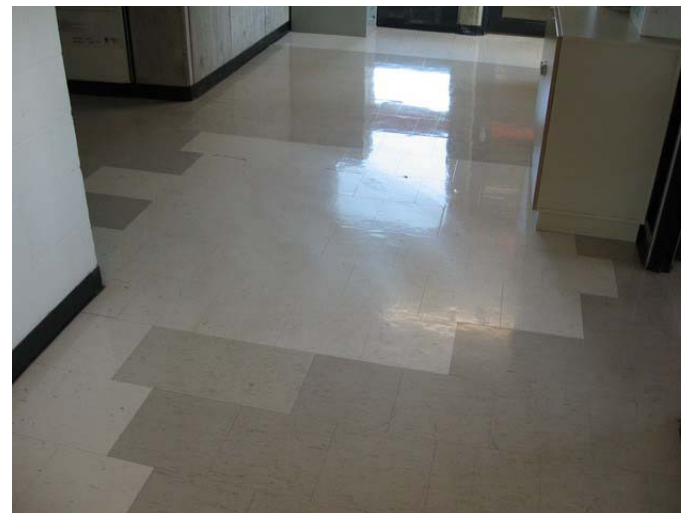
AR-090 – Mismatched vinyl tile used in localized area replacement.

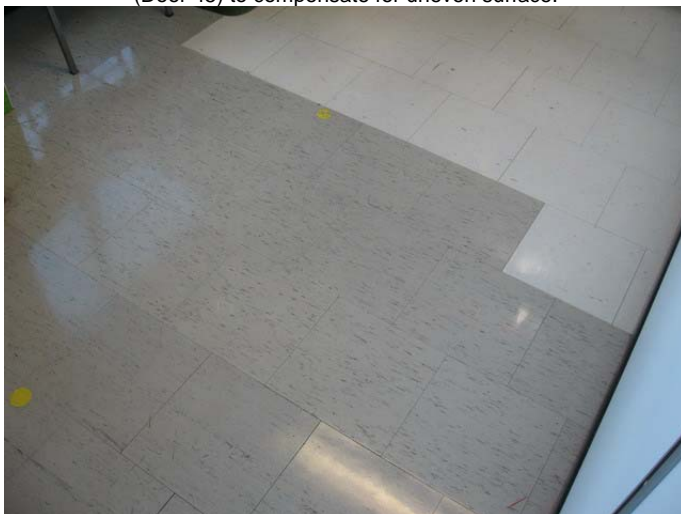
AR-091 – Close-up of vinyl tile used in localized area replacement shows 3 distinct tile colour/patterns used.

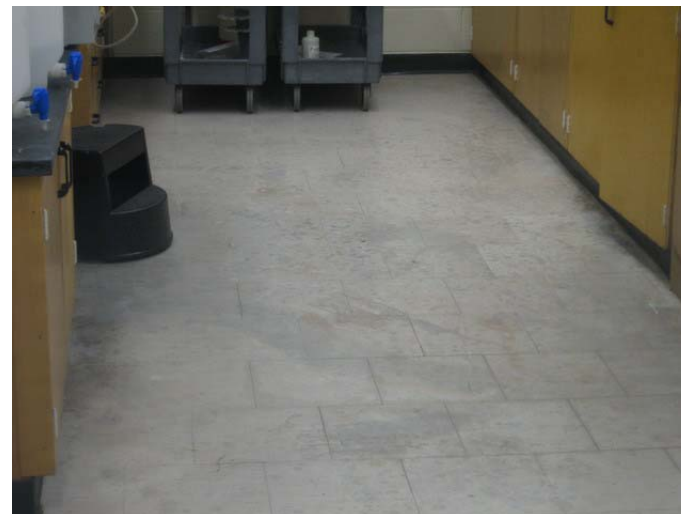
AR-092 – Vinyl tile flooring standing-up poorly at this particular lab – surfaces badly stained and degraded.

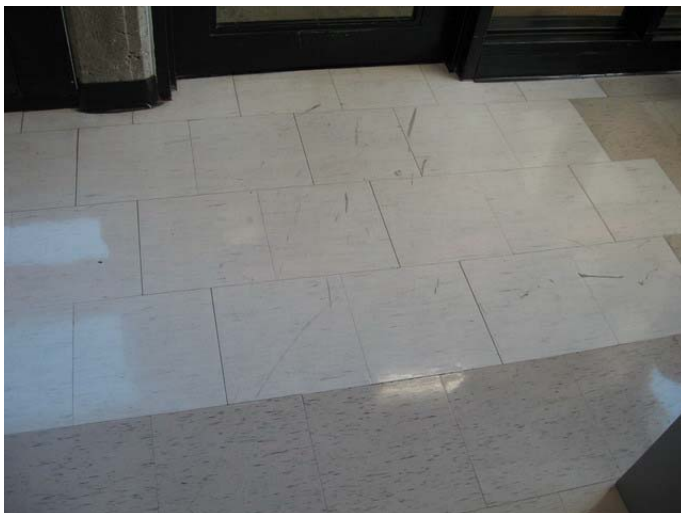
AR-093 – Newer vinyl tile not holding-up as well as older tile.

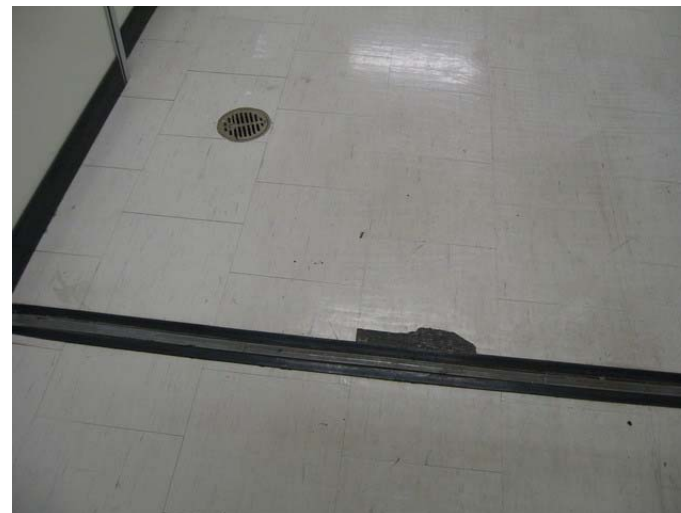
AR-094 – Vinyl tile breaking at building control joint.

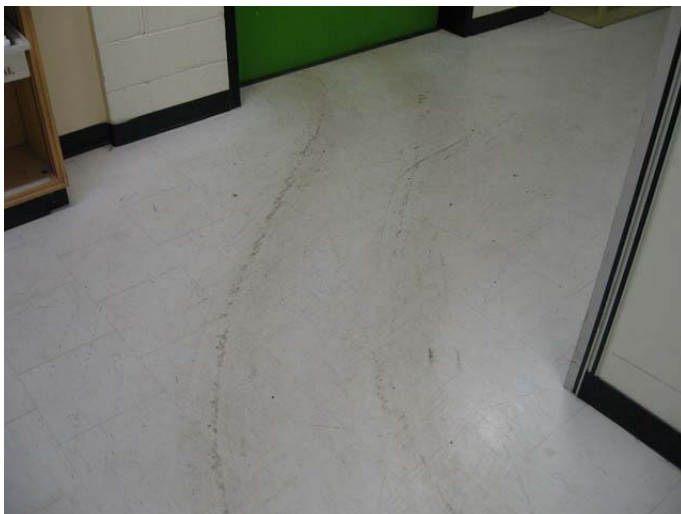
AR-095 – Vinyl tile flooring heavily worn in heavy traffic area adjacent to freight elevator.

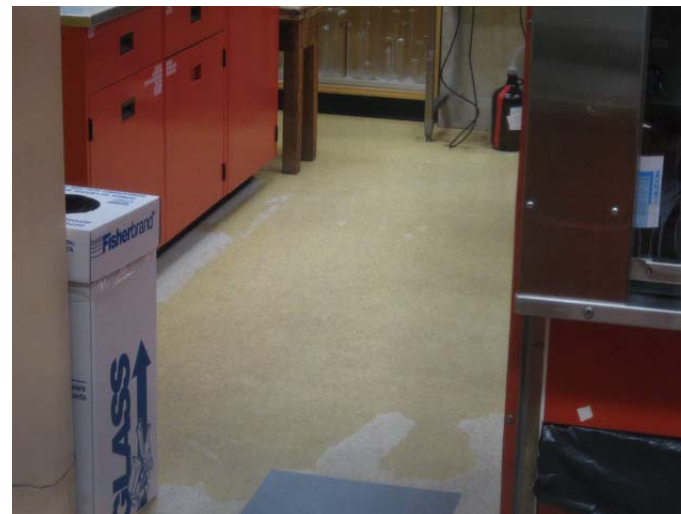
AR-096 – Vinyl sheet flooring standing-up poorly at this particular lab – surfaces badly stained and degraded.

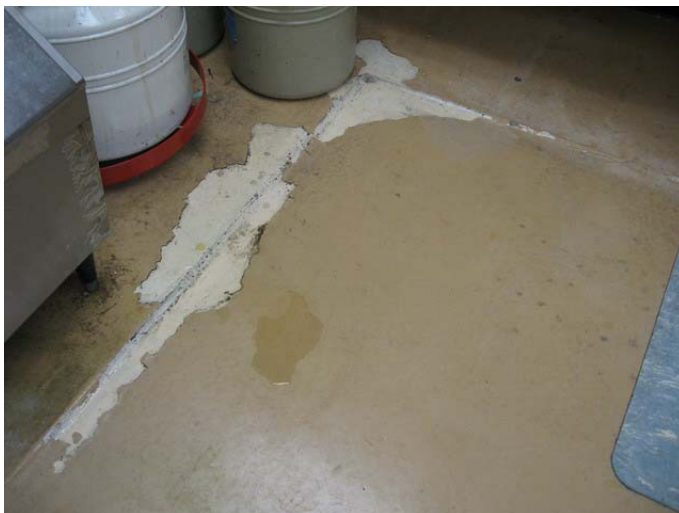
AR-097 – Epoxy flooring standing-up poorly at this particular lab – localized deterioration.

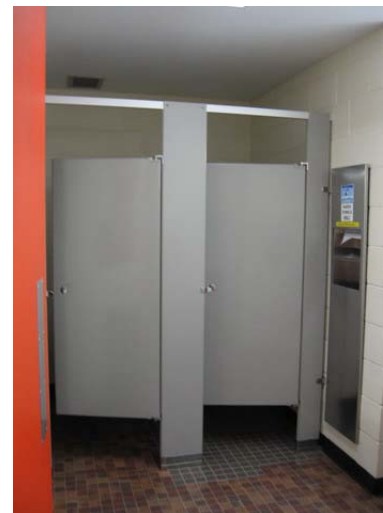
AR-098 – Mismatched ceramic floor tile at localized area replacement in washroom.

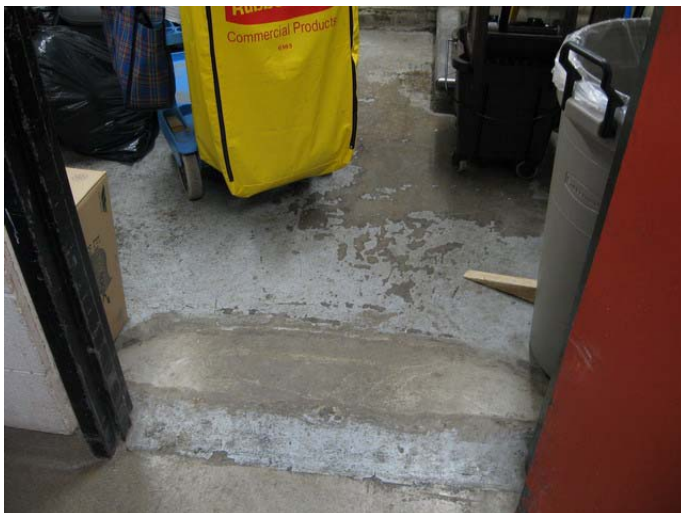
AR-101 – Deteriorated paint finish at janitor room floor.

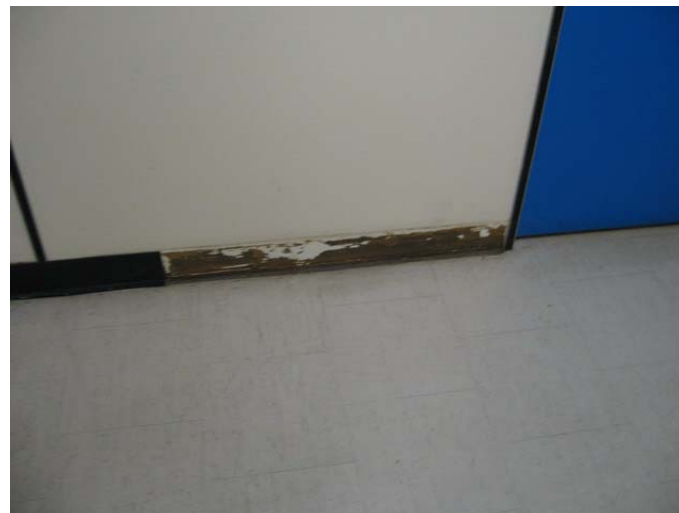
AR-102 – Missing vinyl base – localized throughout.

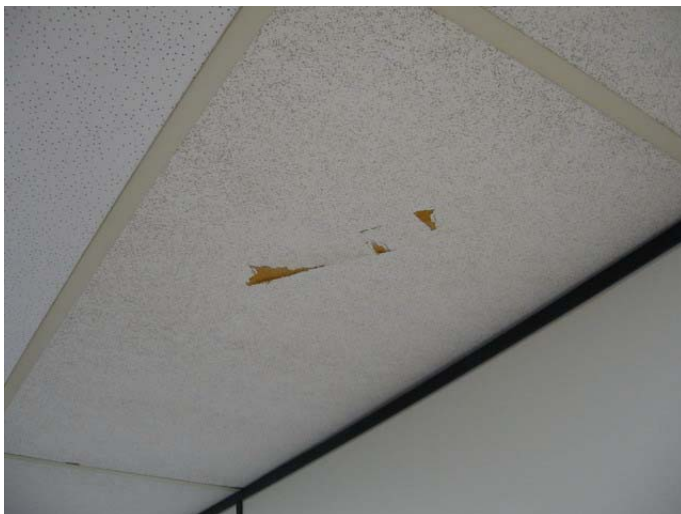
AR-103 – Acoustic ceiling tile with surface damage – cause unknown.

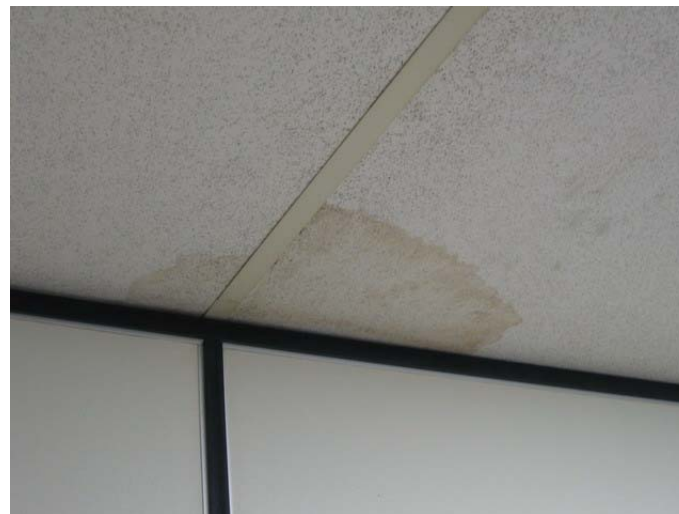
AR-104 – Acoustic ceiling tile with water stain – cause unknown.

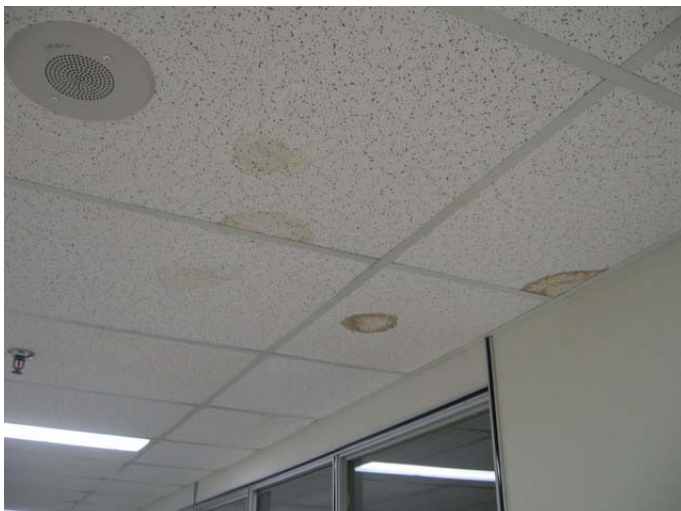
AR-105 – Several acoustic ceiling tile with water stain – cause(s) unknown.

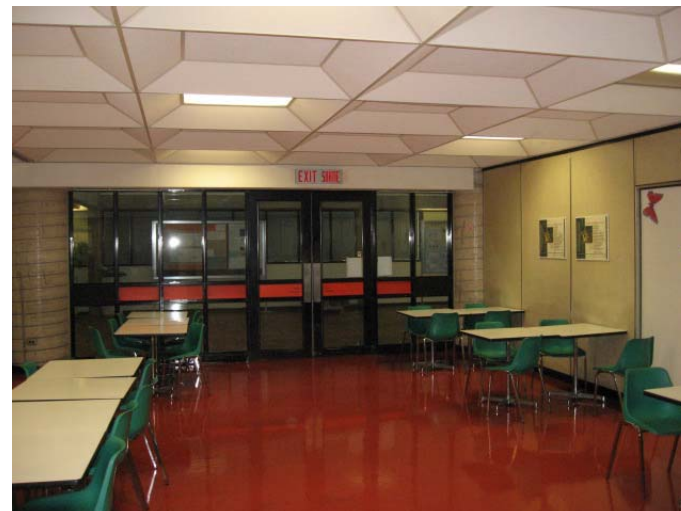
AR-106 – Coffered ceiling in cafeteria (same as library and conference rooms).

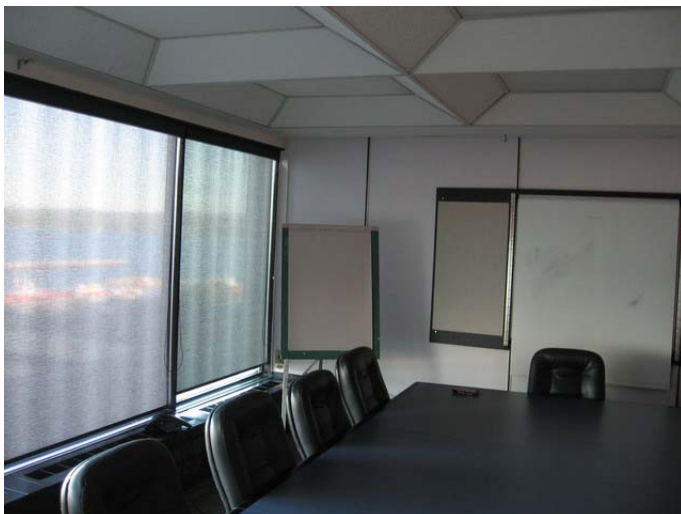
AR-107 – Coffered ceiling in conference room – components no longer commercially available.

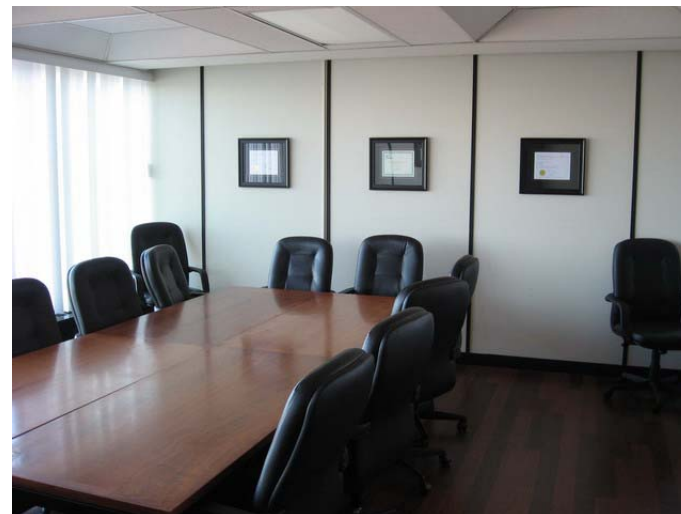
AR-108 – Conference room ceiling with part of original coffered type replaced with conventional flat type.

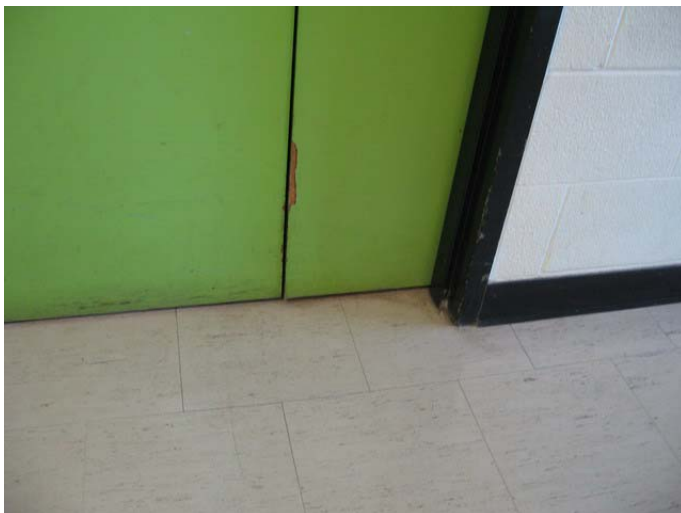
AR-109 – Damaged plastic laminate door finish.

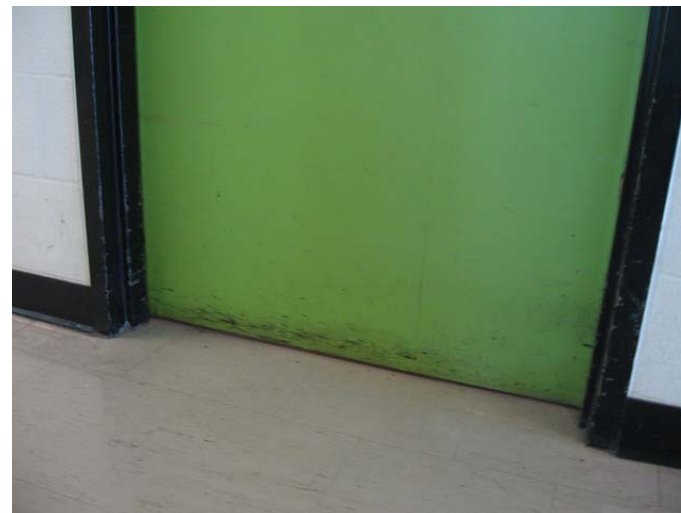
AR-110 – Dirty/stained plastic laminate door finish at bottom of lab door.

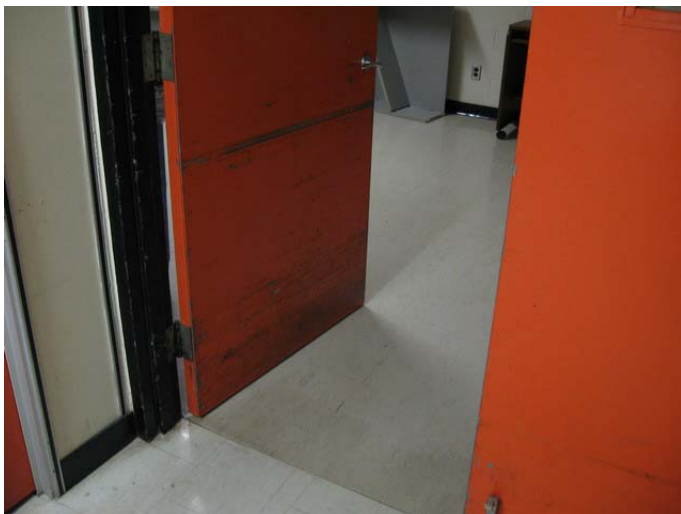
AR-111 – Deteriorated paint finish at metal door in high-traffic location.
