CANADA CENTRE FOR INLAND WATERS (CCIW)

Burlington, Ontario

LEVEL 2 (Life Cycle)
BUILDING CONDITION REPORT
September 2009

**Environment Canada
Canada Centre for Inland Waters (CCIW)
NWRI BUILDING**

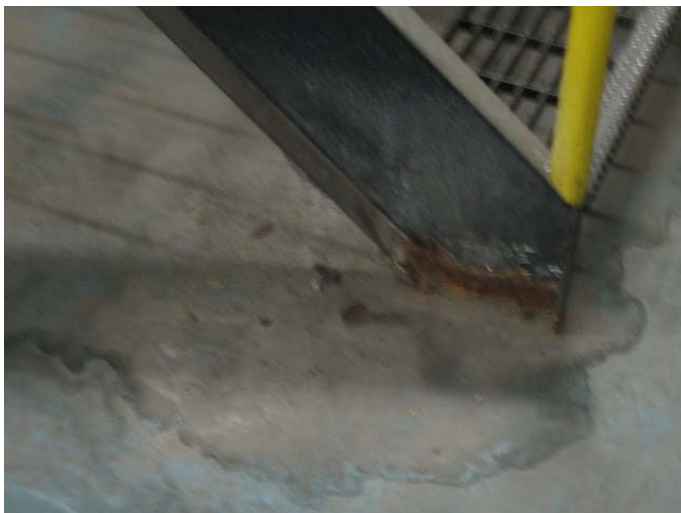
AR-113 – Deteriorated paint finish and rusting metal at Boiler Plant stair.

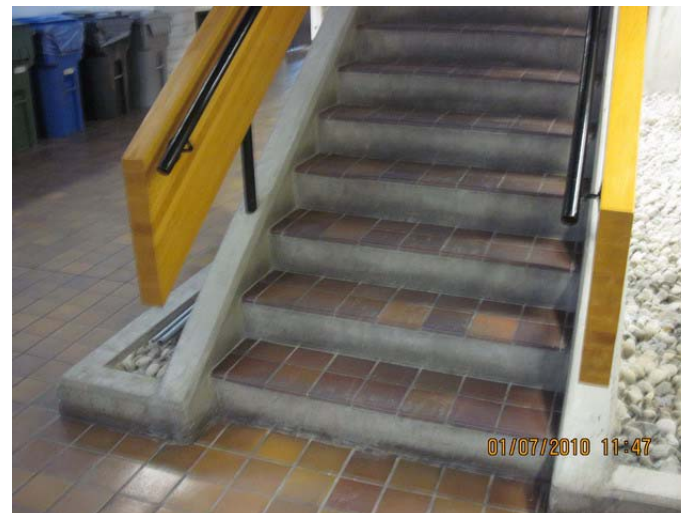
AR-114 – Mall open circulation stair guards with unprotected openings and handrails without extensions and returns.

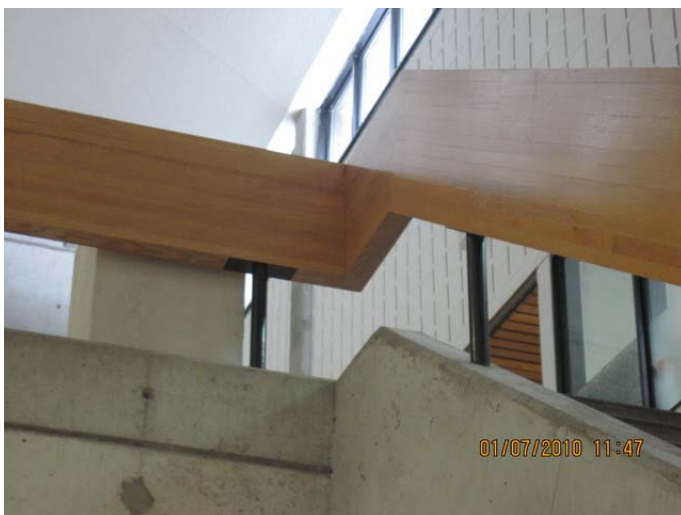
AR-115 – Guards with unprotected openings at Mall 2nd floor.

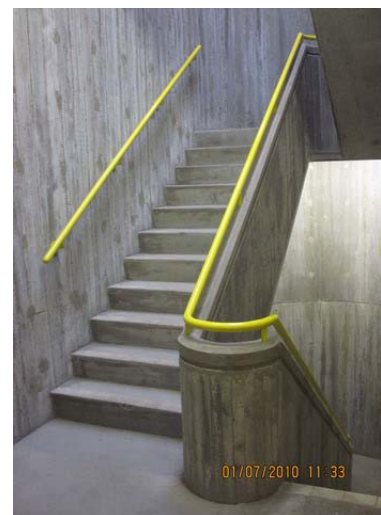
AR-116 – Exit stair handrails without extensions and returns.

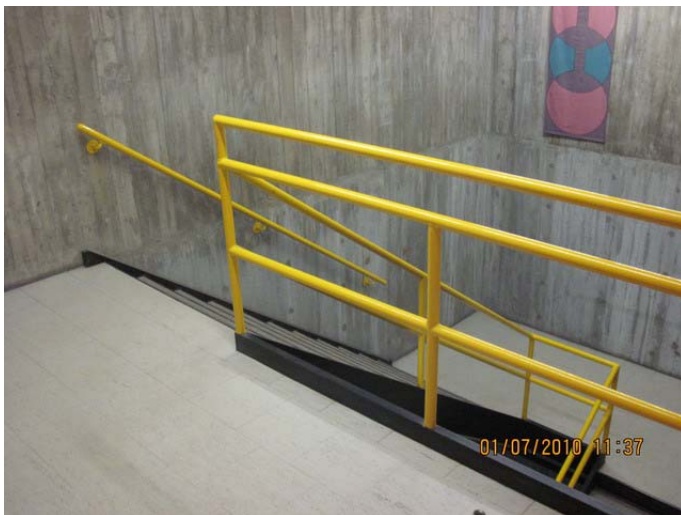
AR-117 – Exit stair guards with unprotected openings and handrails without extensions and returns.

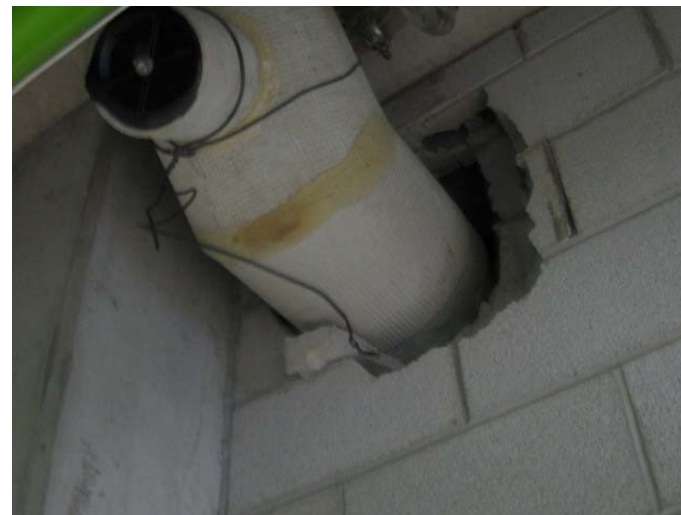
AR-118 – Unsealed penetration in fire separation between lab and service core.

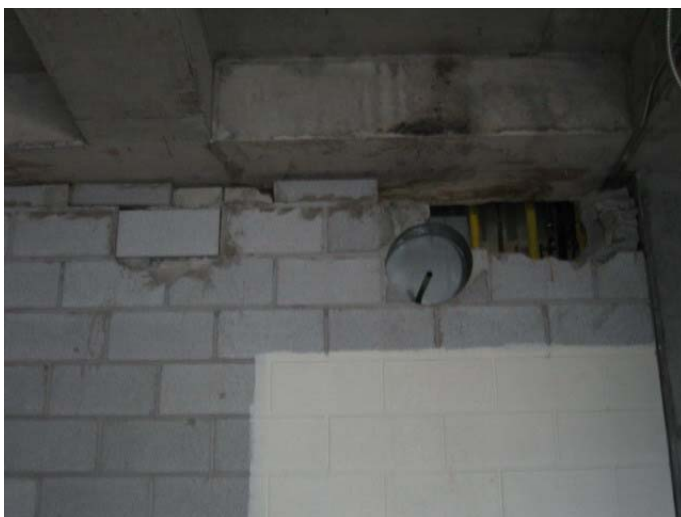
AR-119 – Unprotected openings in fire separation between lab and service core.

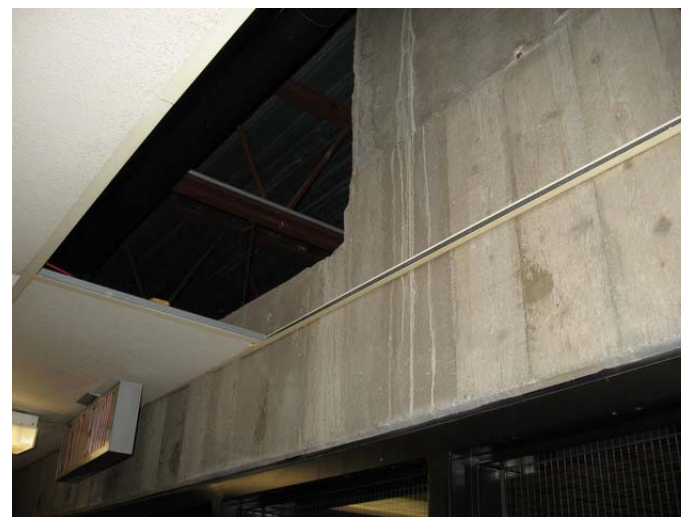
AR-120 – Opening in fire separation between corridor and exit stairwell (HE)

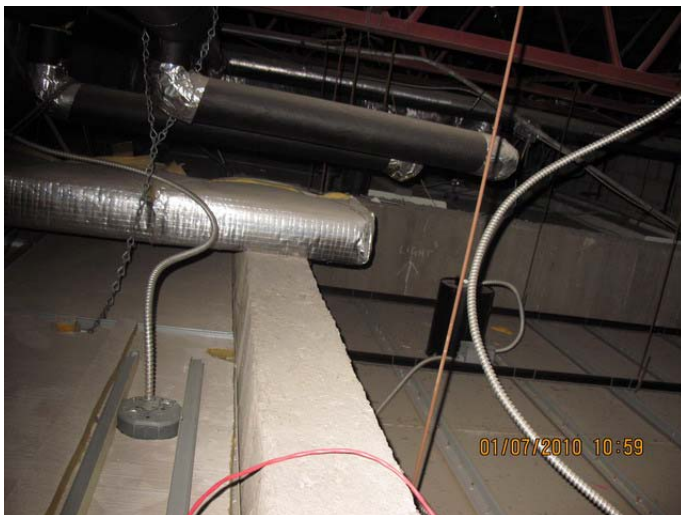
AR-121 – Fire separation between corridor and exit stairwell (HE) only extends to above suspended ceiling.

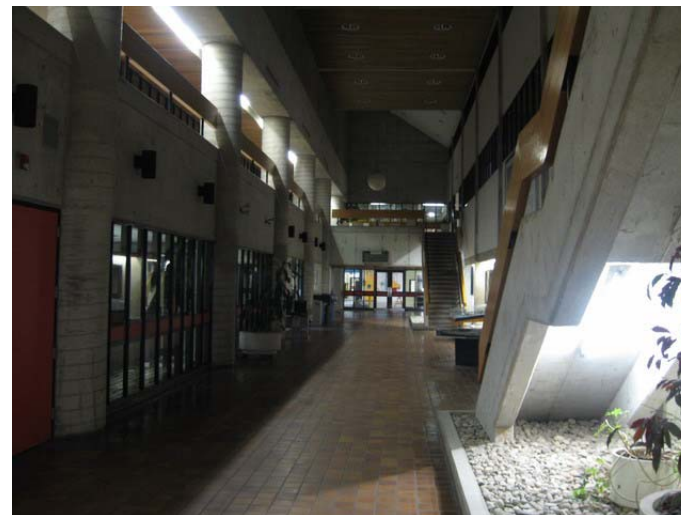
AR-122 – Mall area linking several structures – A&L (left), R&D (right), Hydraulics Lab (ahead) and Warehouse (behind) – with questionable fire separations.

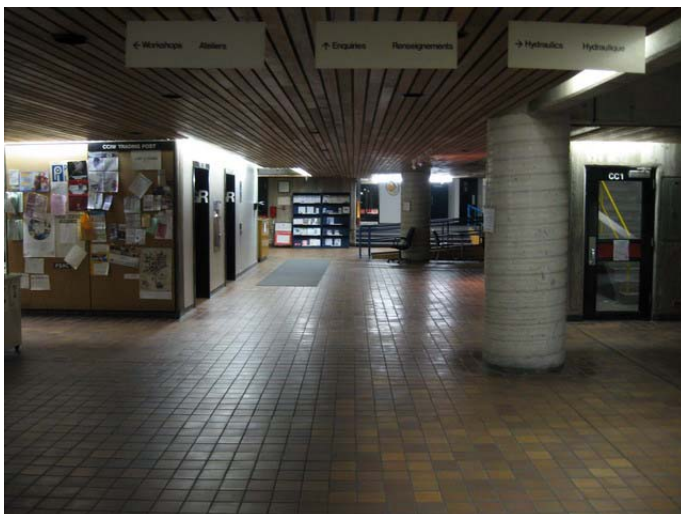
AR-123 – Exit stairwell (CC) at right, leading into 1st floor main entrance/Mall area 'exit lobby' with excessive travel distance to exit door.

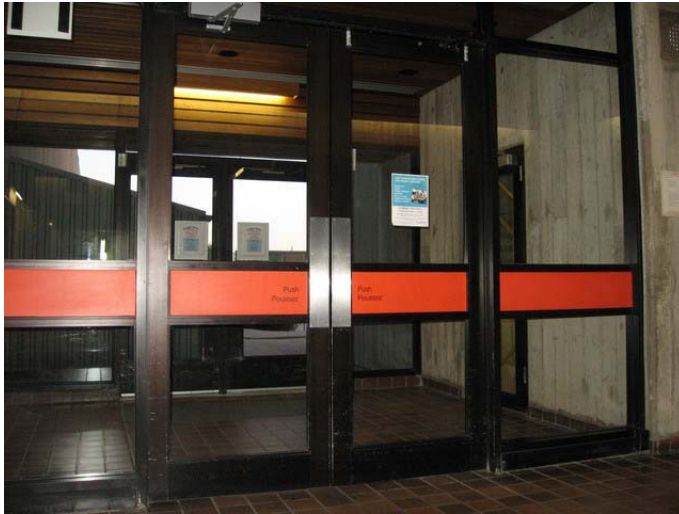
AR-125 – Vestibule at exit stair (NW) with clear glazing and no latching hardware.

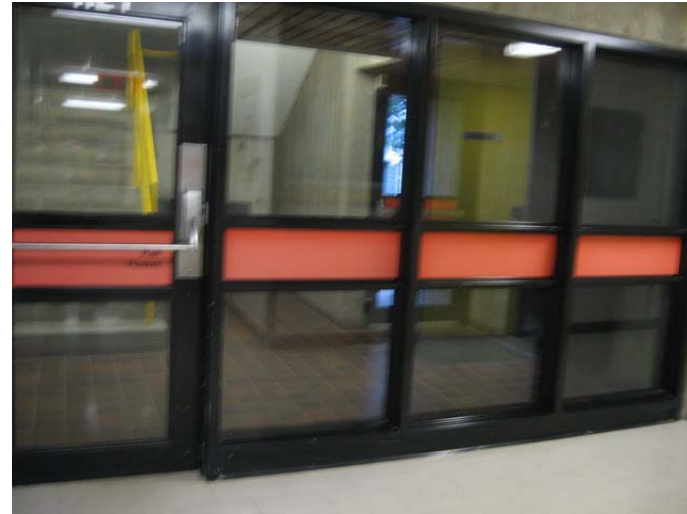
AR-126 – Glazing at exit stair vestibule may exceed allowable limits.

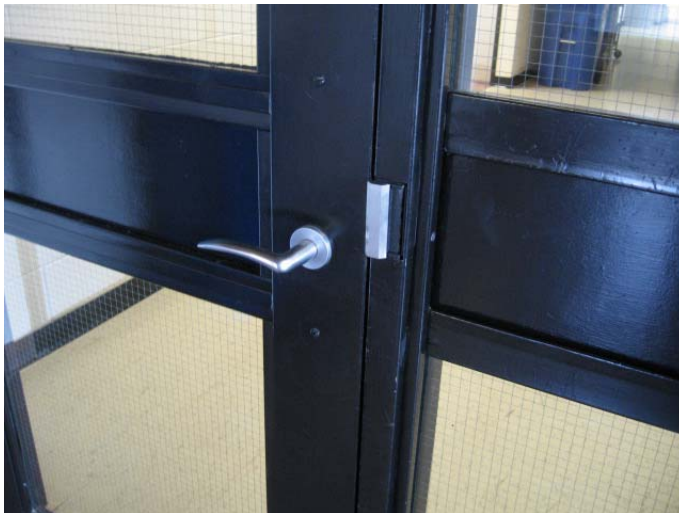
AR-127 – Electric door strike in fire separation – unconfirmed if operation is 'fail secure' or 'fail safe'.

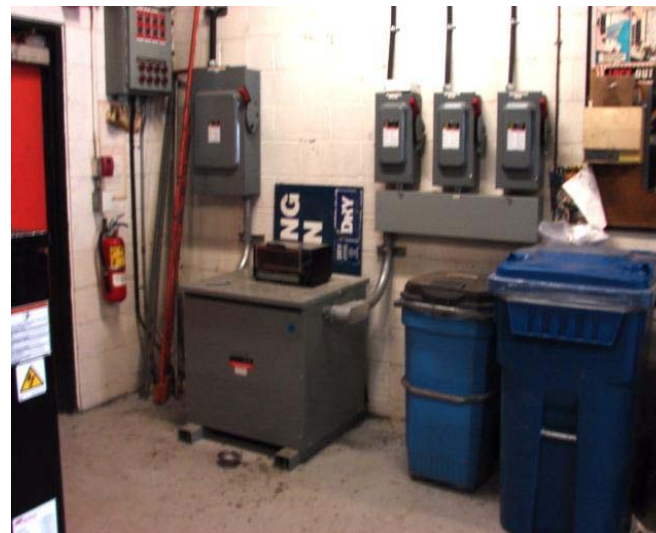
ELE-006 – Stored materials around electrical equipment.

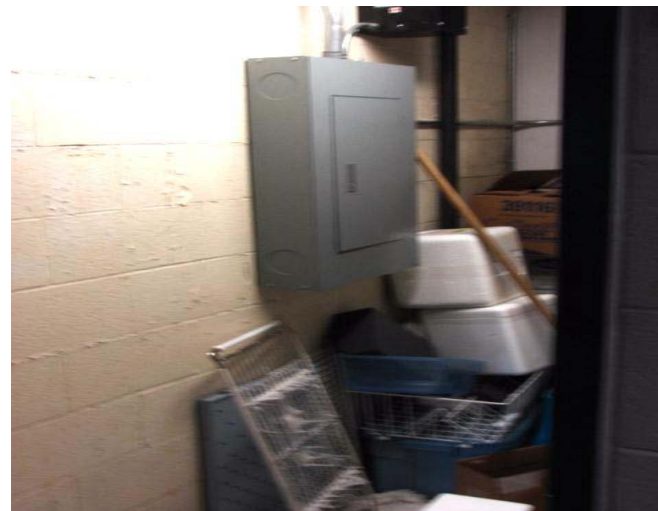
ELE-010 – Stored materials around electrical equipment.

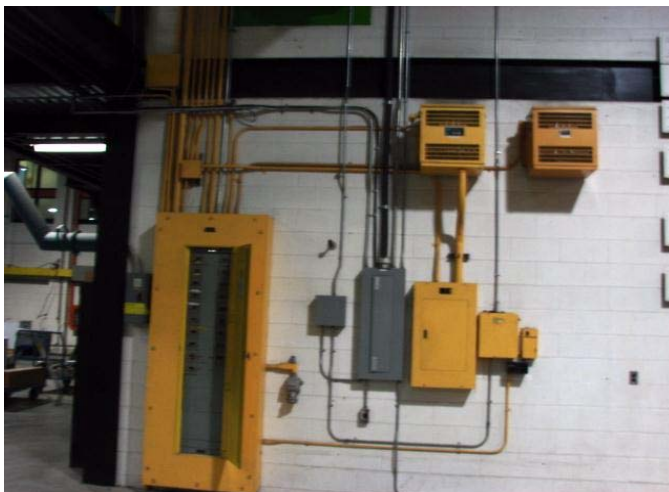
ELE-013 – Wet Lab panels with no guarding.

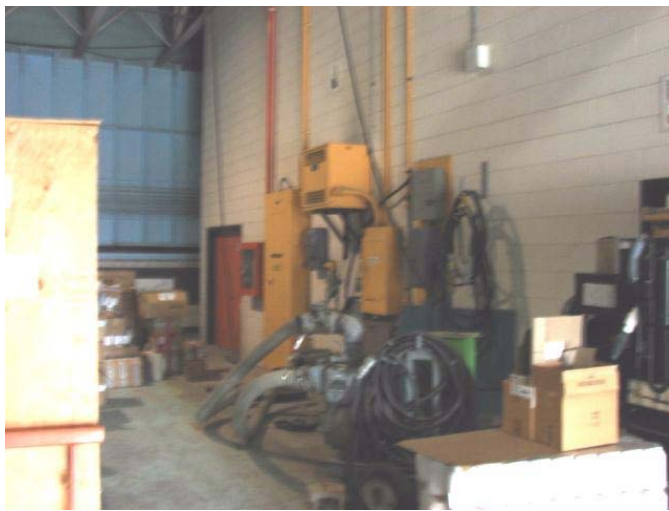
ELE-017 – Stored material around electrical equipment and no guarding.

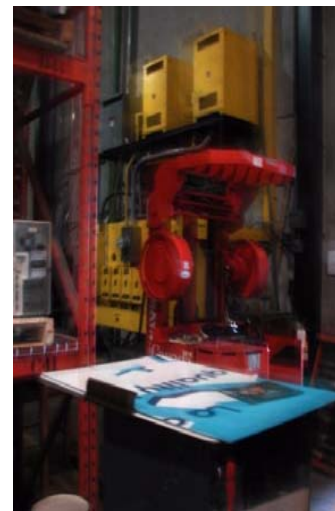
ELE-018 – Stored material around electrical equipment and no guarding.

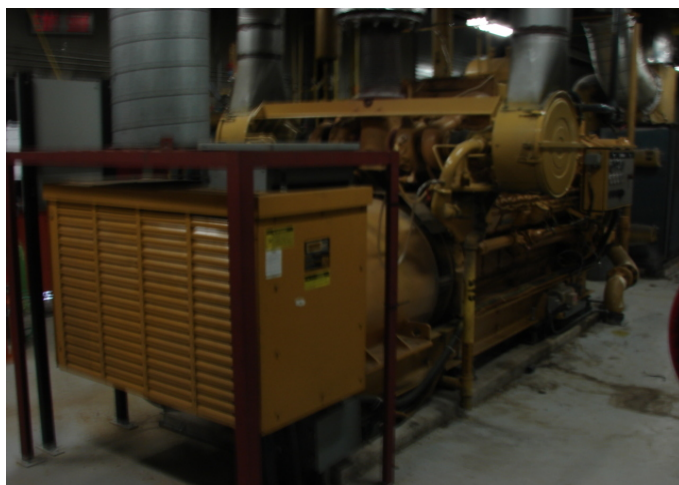
ELE-019 – Cogeneration unit.

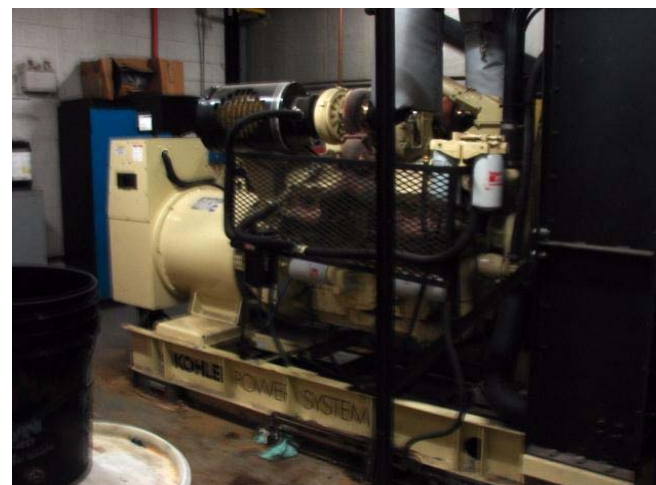
ELE-020 – Emergency power Diesel Generator.

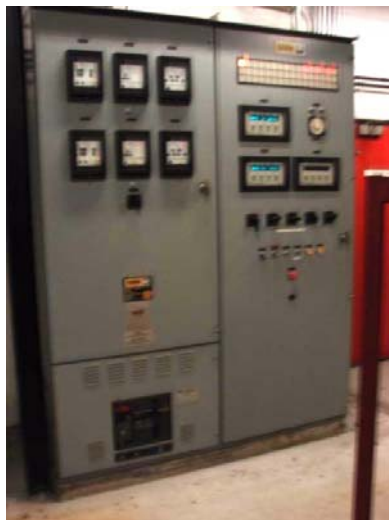
ELE-021 – Cogeneration control and transfer switch.

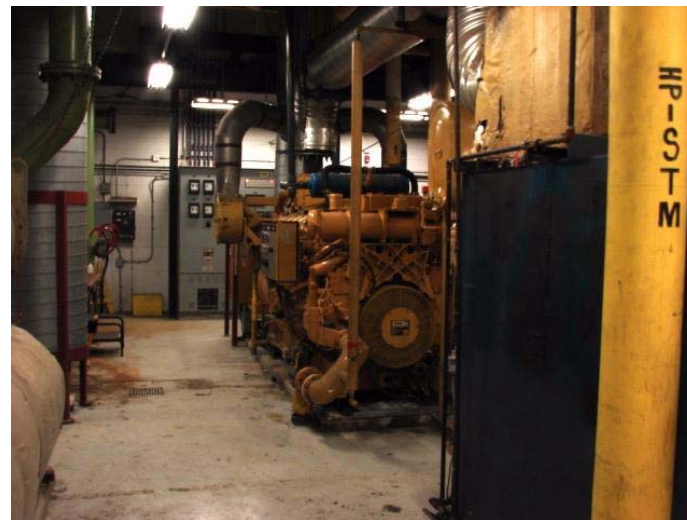
ELE-022 – Cogeneration unit.

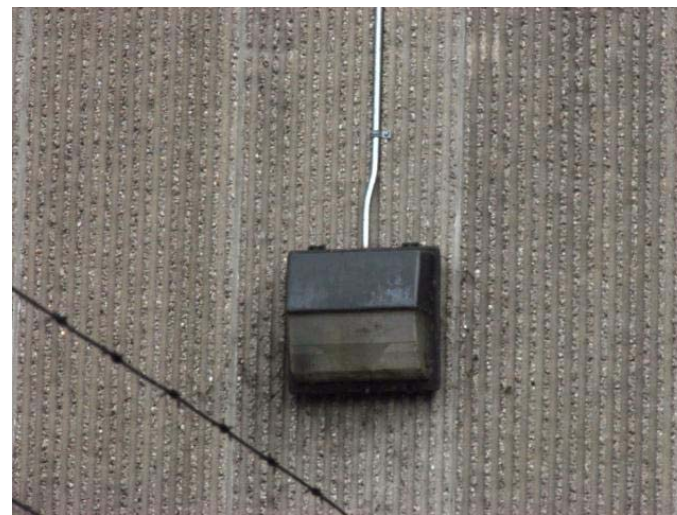
ELE-024 – Typical exterior wall pack.

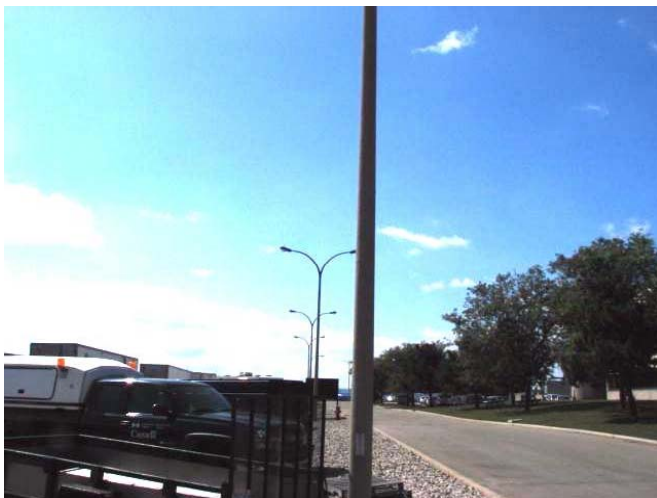
ELE-025 – Typical roadway and parking lights.

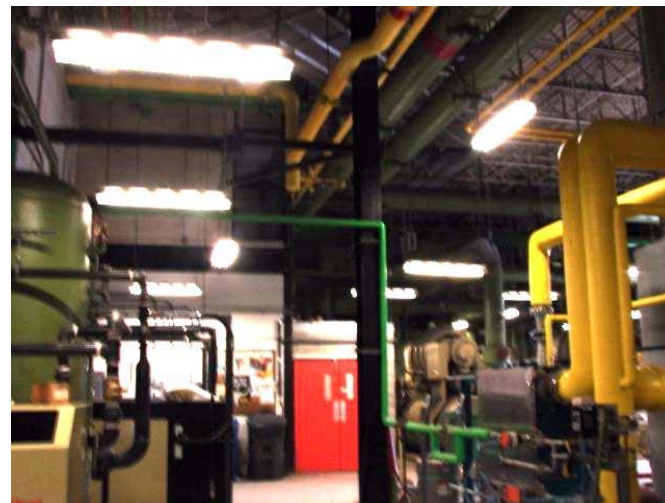
ELE-026 – Boiler room lighting.

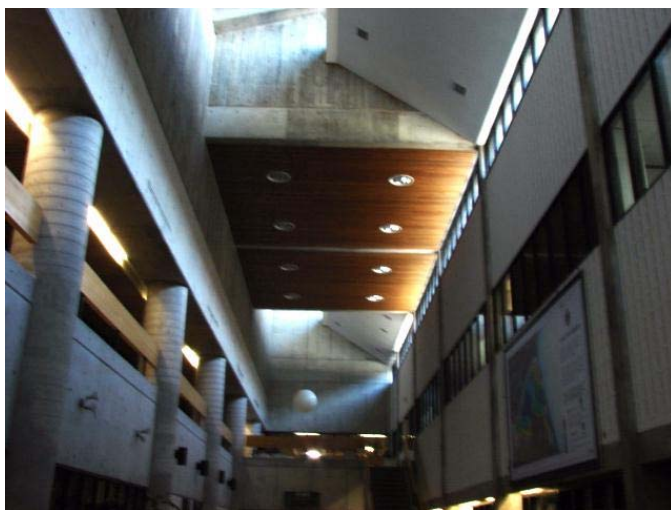
ELE-027 – Main hall lighting (mall area).

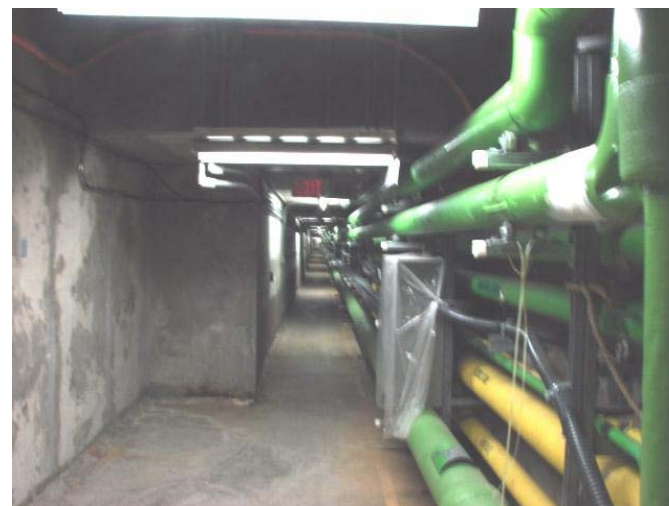
ELE-028 – Tunnel lighting.

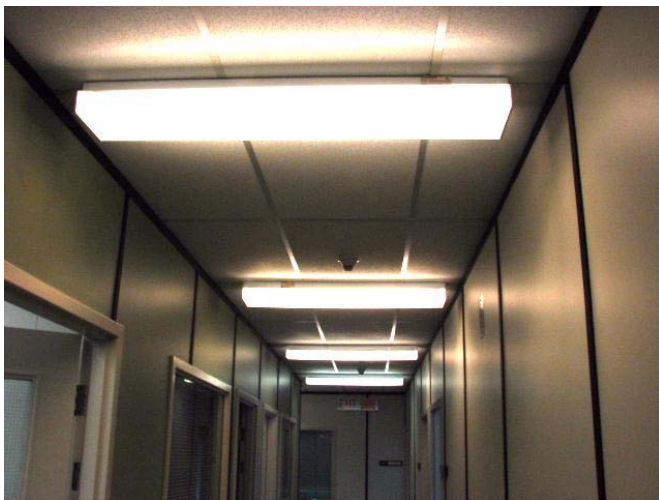
ELE-029 – Office and Lab Corridor lighting.

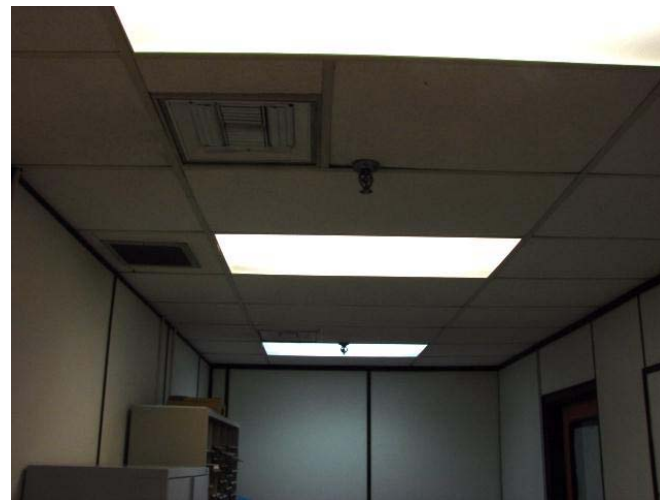
ELE-030 – Typical office lighting.

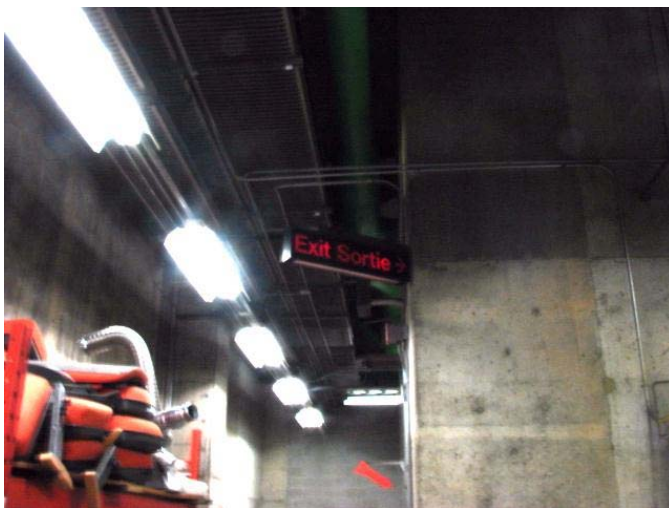
ELE-031 – Third floor mechanical room lighting.

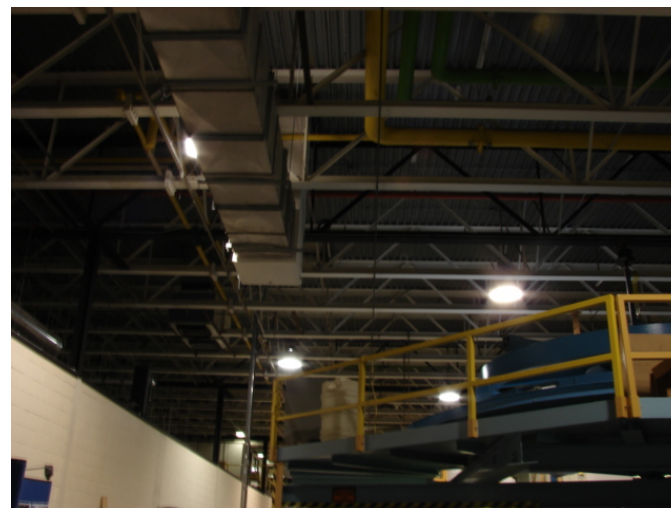
ELE-032 – Typical Wet lab, warehouse and shops lighting.

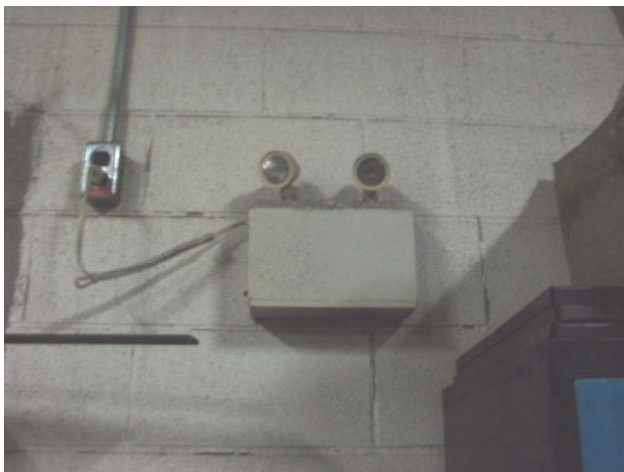
ELE-033 – Typical emergency battery pack.

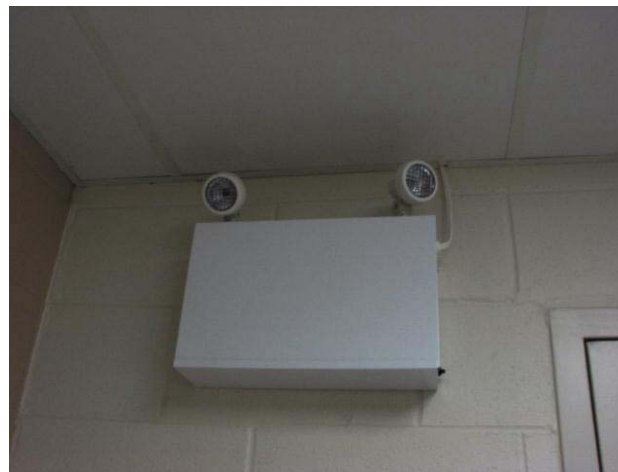
ELE-034 – Typical emergency battery pack.

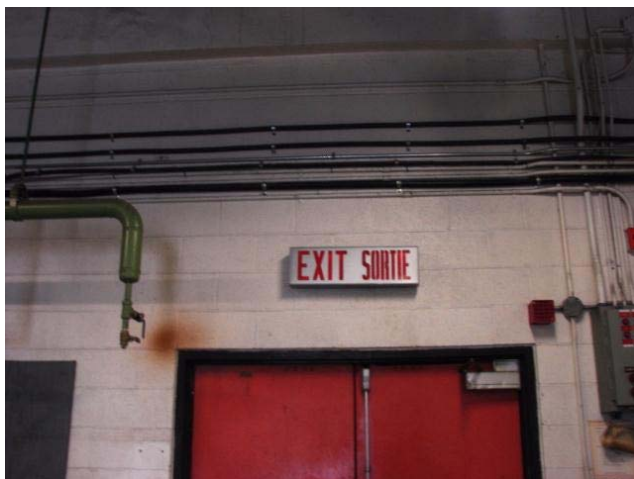
ELE-035 – Exit light sample.

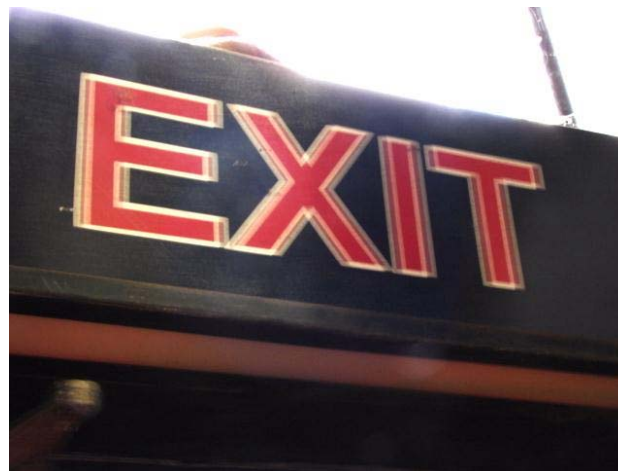
ELE-036 – Exit light sample.

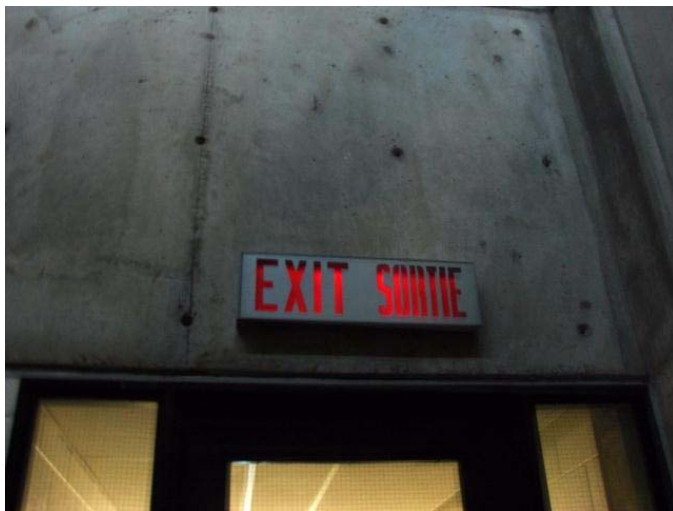
ELE-037 – Exit light sample.

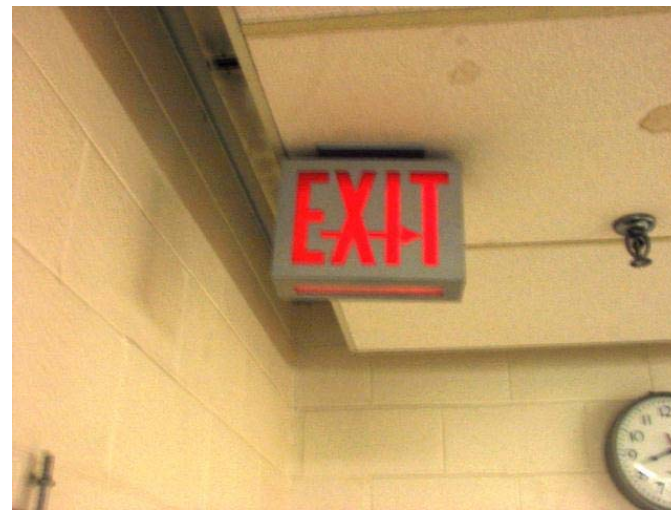
ELE-038 – Exit light sample.

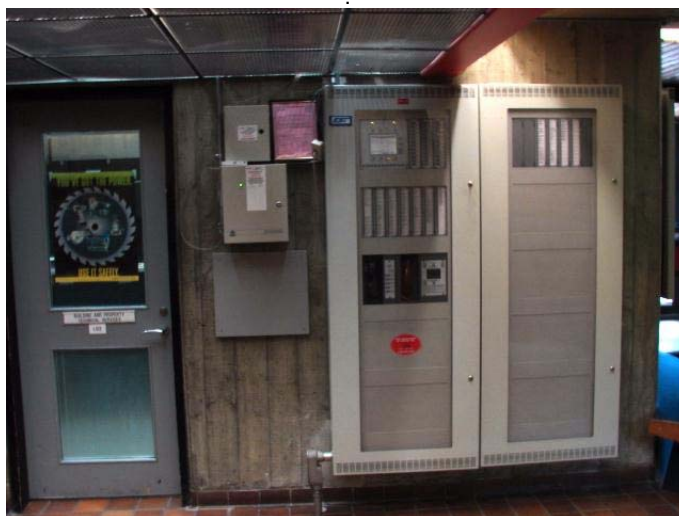
ELE-039 – Main fire alarm panel.

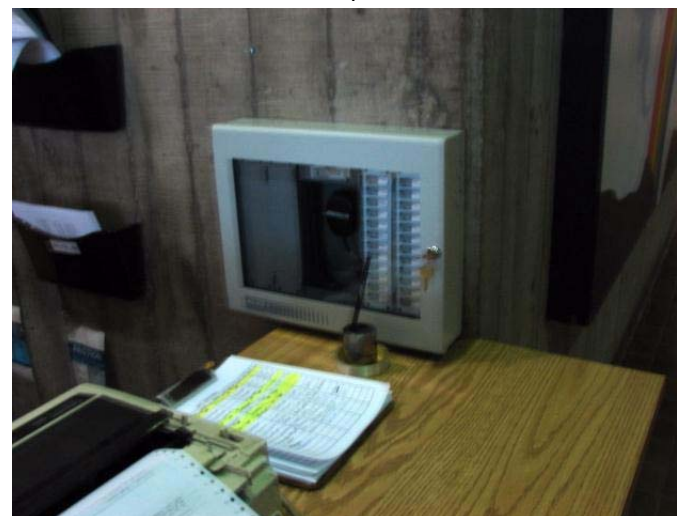
ELE-040 – Security Desk fire alarm annunciator.

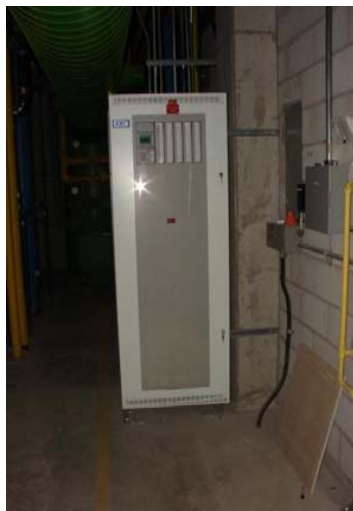
ELE-041 – Additional fire alarm booster panels.

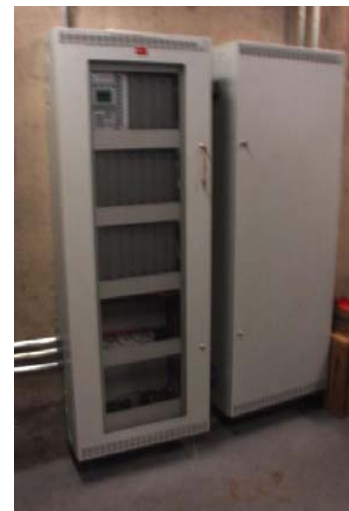
ELE-042 – Additional fire alarm booster panels.

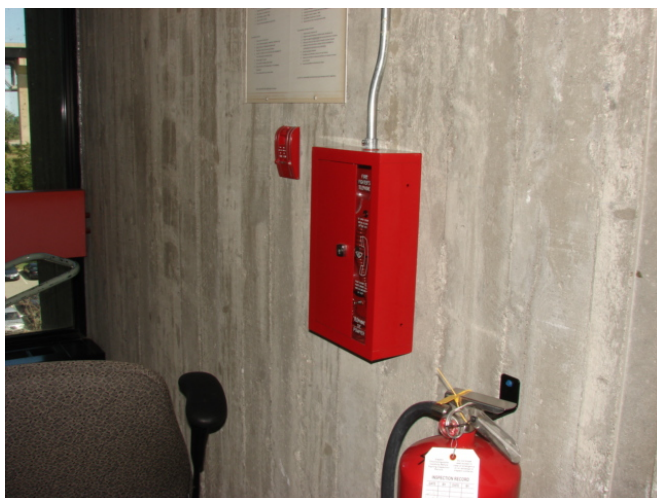
ELE-043 – Pull station and emergency voice telephone.

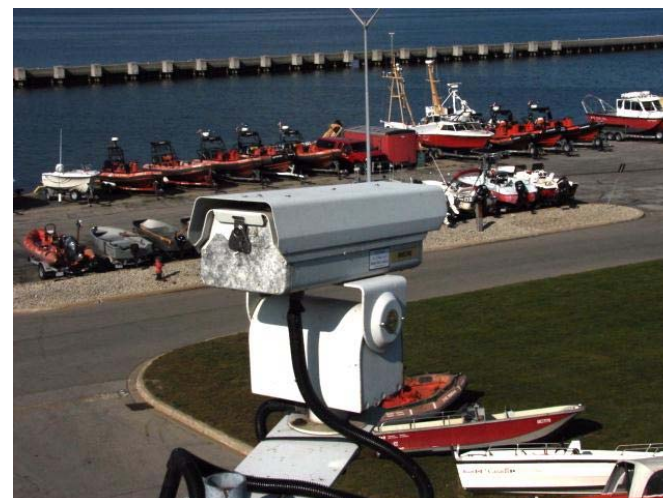
ELE-044 – Typical security camera.

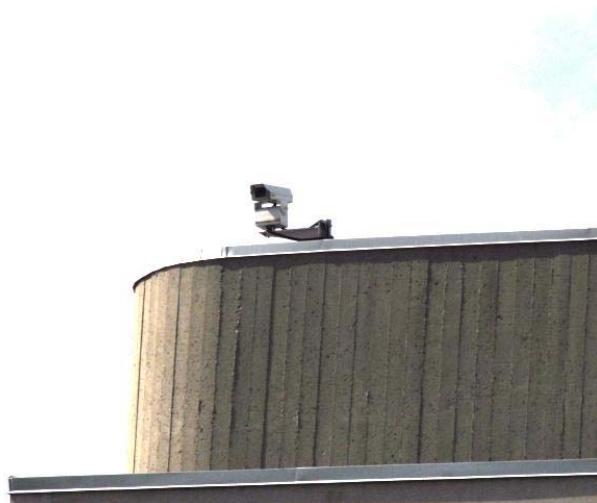
ELE-045 – Typical security camera.

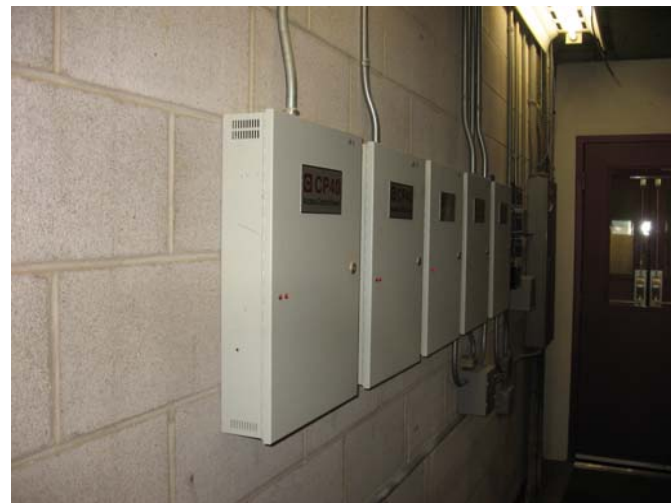
ELE-046 – Typical card access control panels.

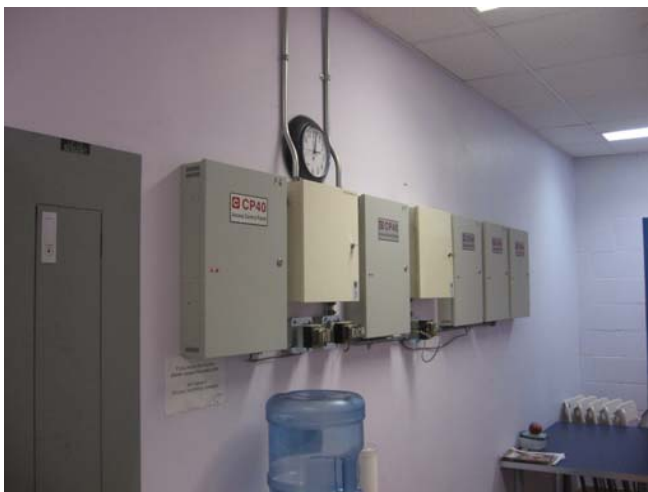
ELE-047 – Typical card access control panels.

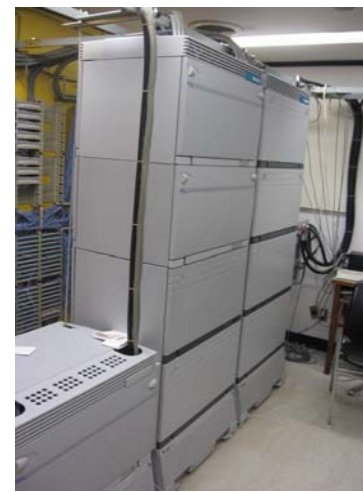
ELE-048 – Main telephone equipment.

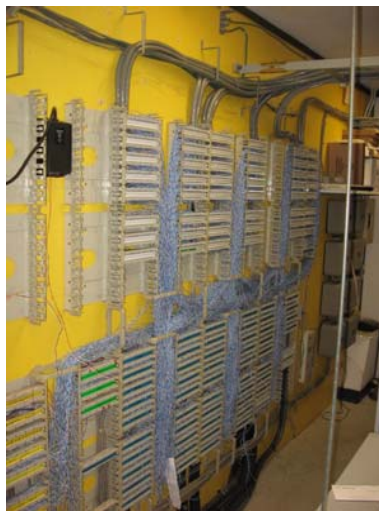
ELE-049 – Main telephone BIX board.

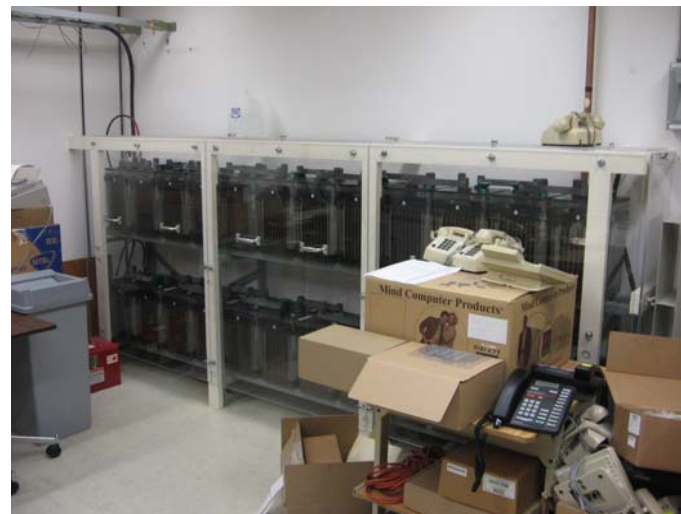
ELE-050 – Main telephone battery rack.

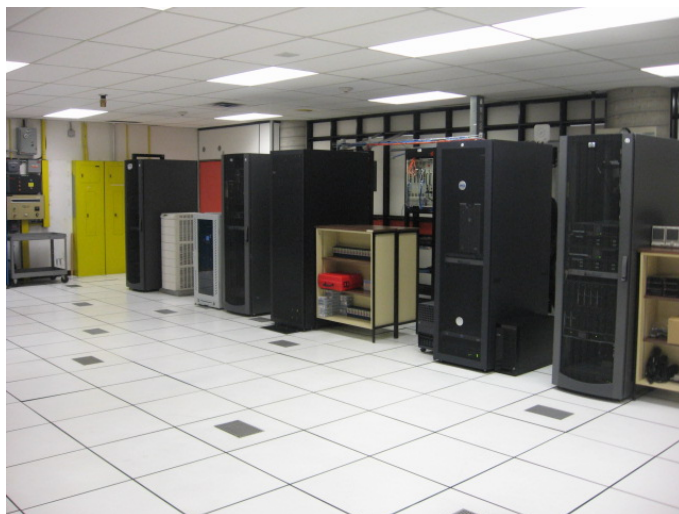
ELE-051 – Main building computer room servers.

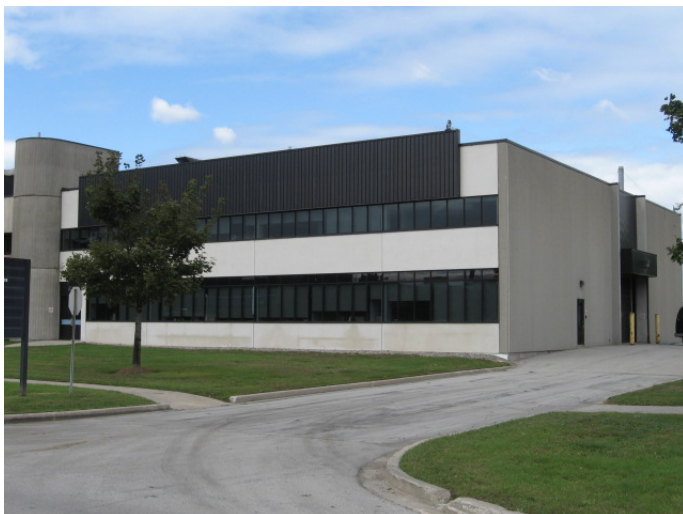
AR-001 – East and south elevations of 'east-side' addition.

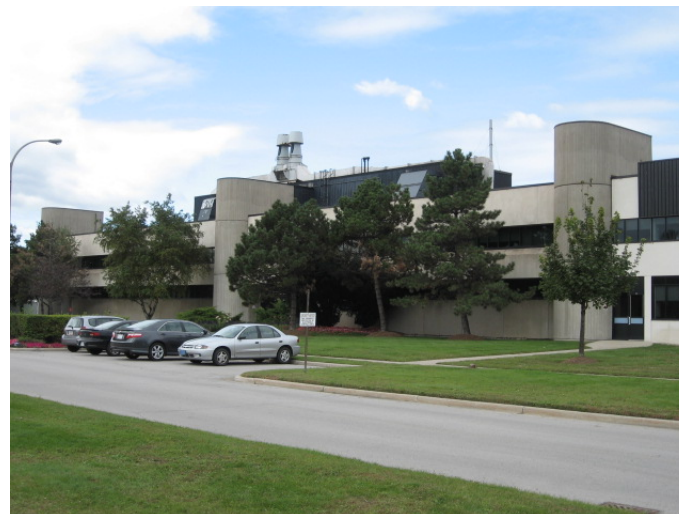
AR-002 – South elevation of original portion of building.

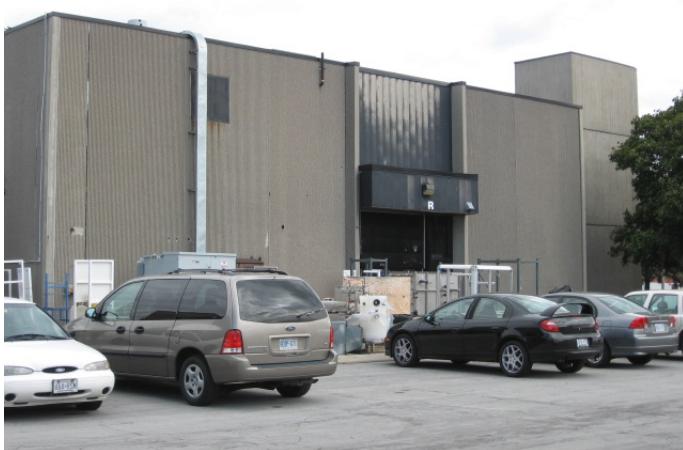
AR-003 – West elevation.

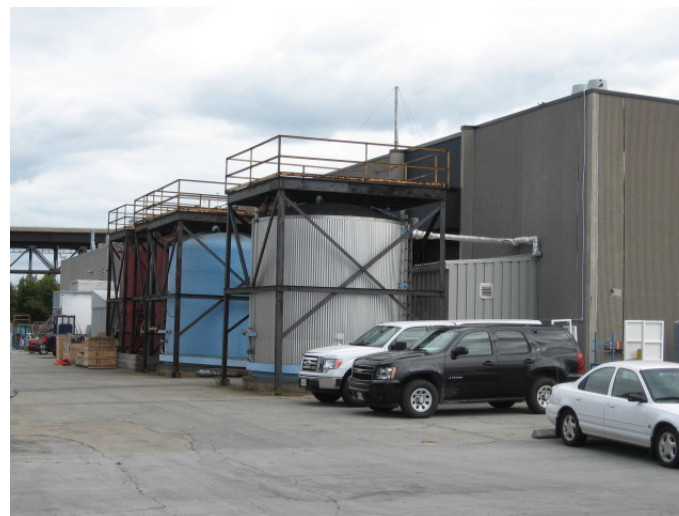
AR-004 – North elevation.

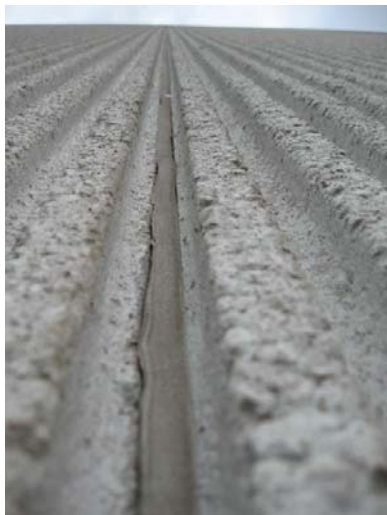
AR-005 – Debonded sealant at precast concrete sandwich panel joints.

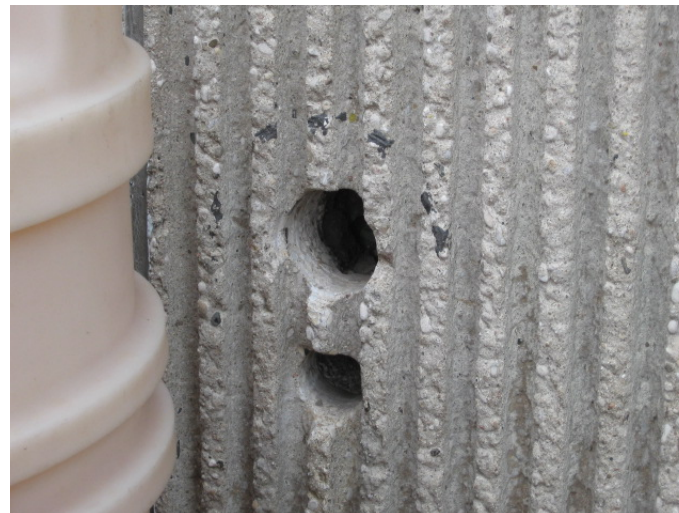
AR-010 – Unsealed wall openings.

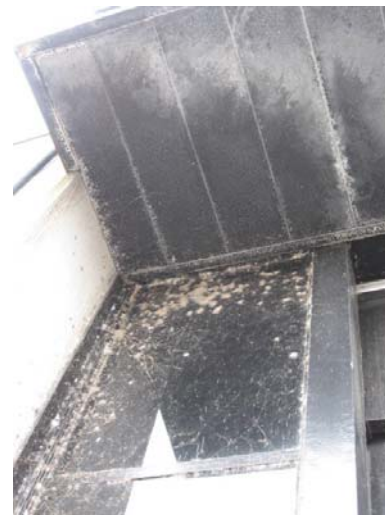
AR-012 – Dirty surfaces (webs, debris, etc.) and deteriorated paint finish at underside of canopy.

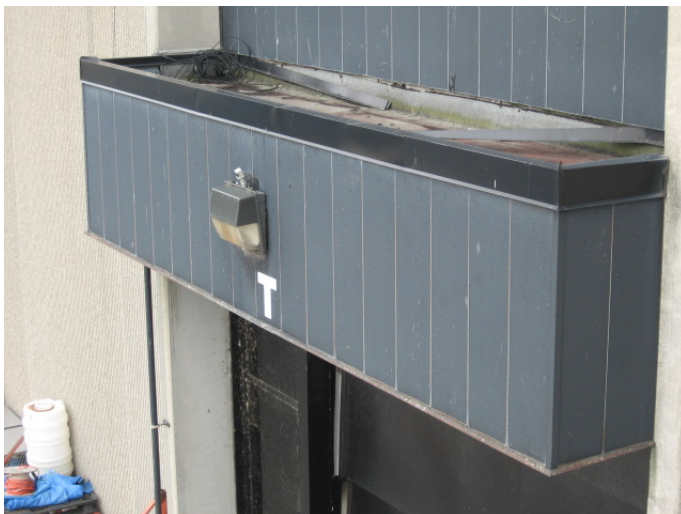
AR-013 – Rooftop debris and tangled heat trace wire at canopy drain.

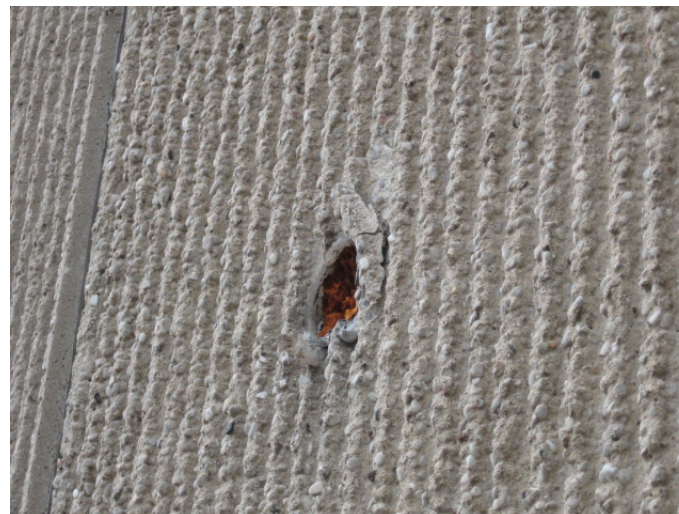
AR-014 – Sealed hole with spalling concrete at wall panel.

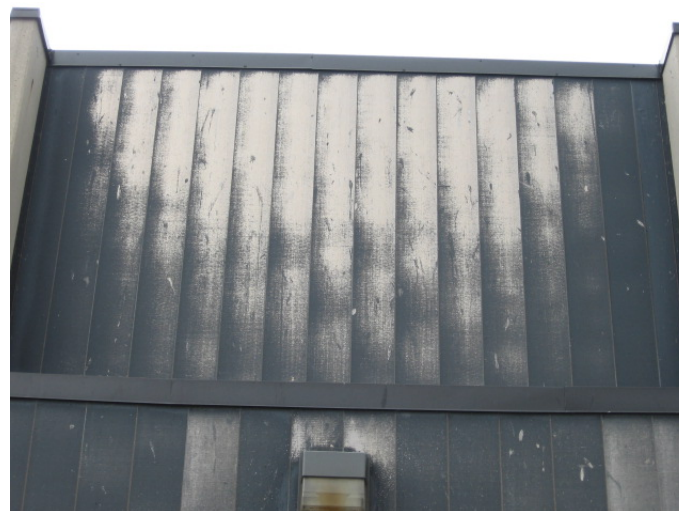
AR-016 – Deteriorated paint finish at metal siding above canopy.

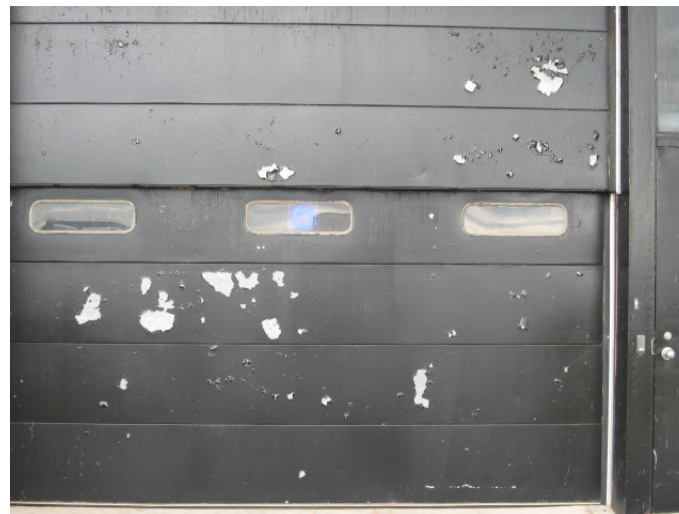
AR-018 – Deteriorated paint finish and rusting metal surfaces at exterior overhead door.

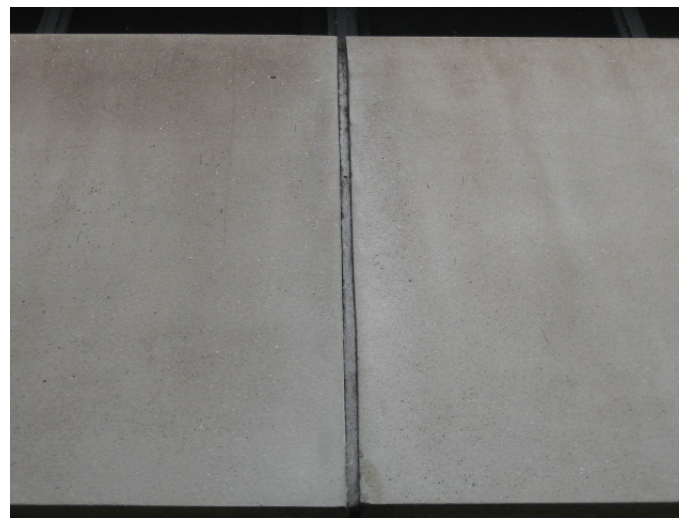
AR-020 – Debonded sealant at precast concrete panel joints.

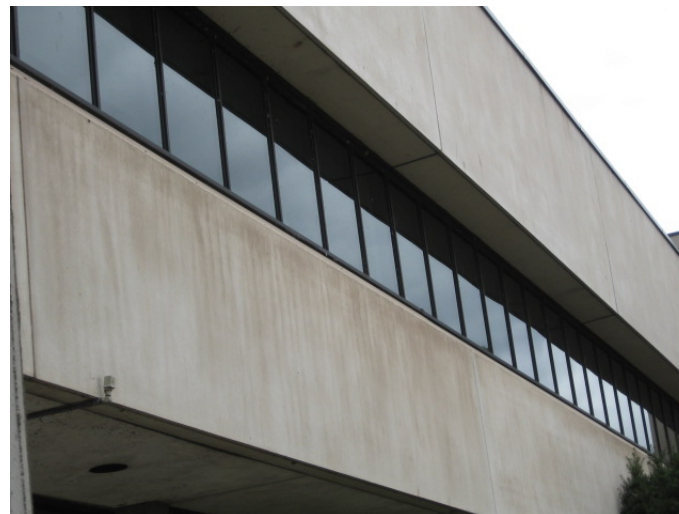
AR-022 – Surface staining at precast concrete panel surfaces.

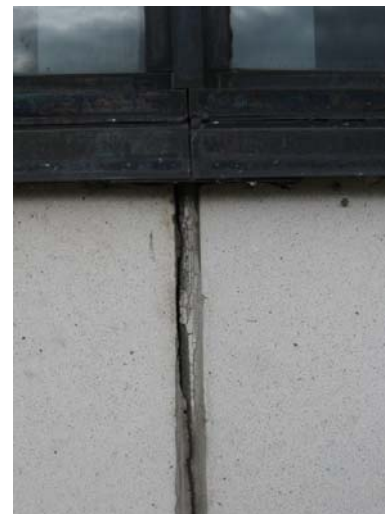
AR-026 – Deteriorating sealants at 'east-end' addition wall panel and window.

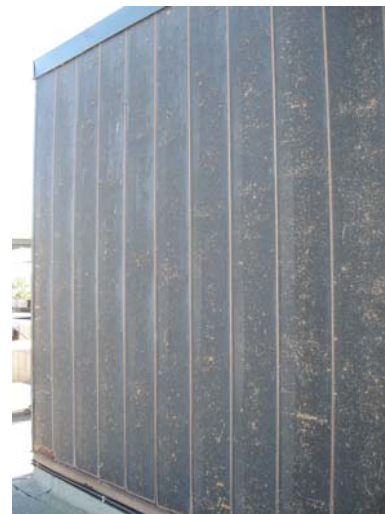
AR-030 – Deteriorating paint finish and rusting surfaces at mechanical penthouse siding.

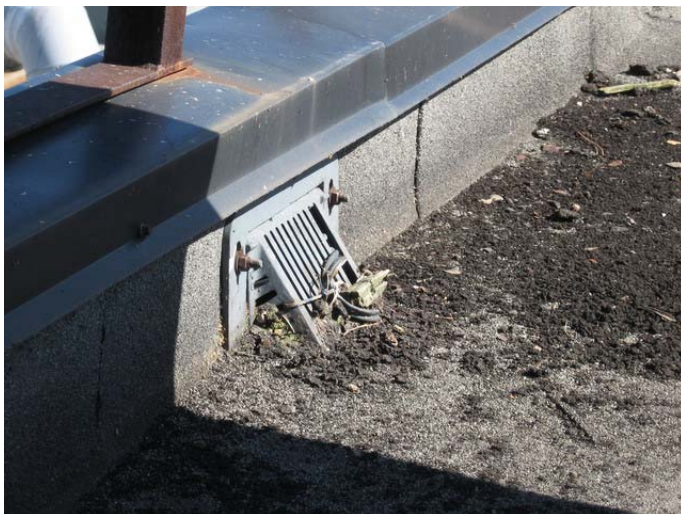
AR-033 – Broken strainer and debris/sediment build-up at stairwell roof.

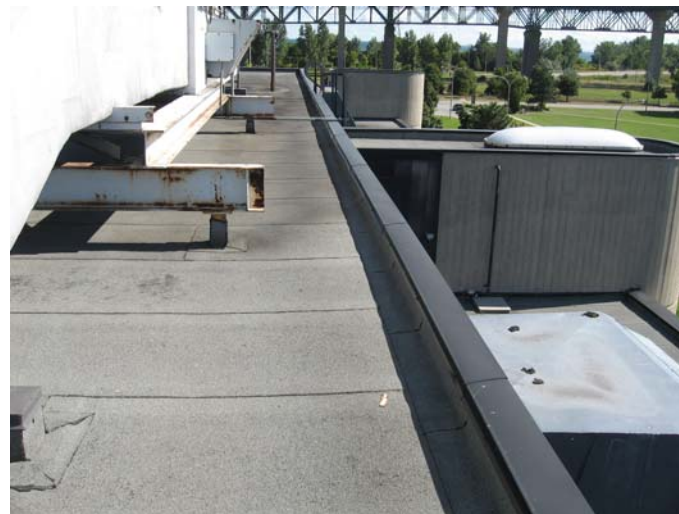
AR-034 – PH roof (south side) looking east - rusting metal equipment supports and stained SBS membrane.

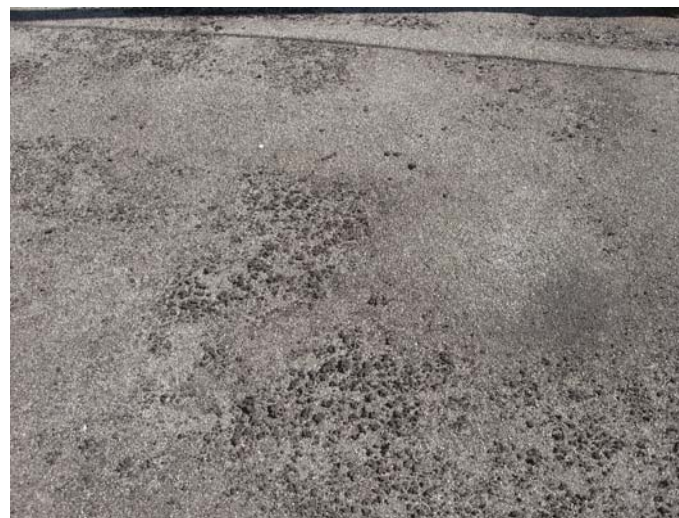
AR-036 – Sediment/debris build-up on SBS membrane source from standing water.
